JOHN NELSON HOUSE AND BARN

Minute Man National Historical Site
Lincoln, Massachusetts

**DOCUMENTATION of PHYSICAL
EVIDENCE 2009-10**

Prepared By:
James J. Lee III
Architectural Conservator
Historic Architecture Program
Northeast Region, National Park Service
Lowell, Massachusetts

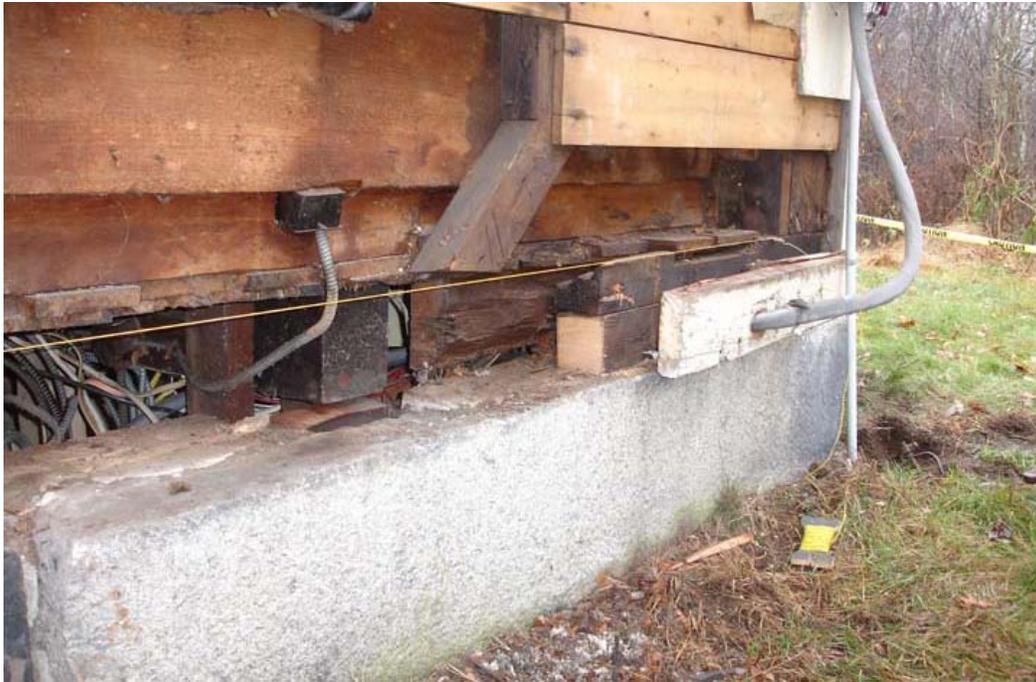
Documentation of the south elevation framing found that large sections of the original 8-inch by-8-inch sills had been replaced or repaired with smaller dimension sills that were in some cases doubled-up to fill the area being repaired (fig. 4). All of the sills on the south elevation were replaced with 8-inch-by-8-inch hemlock. The original framing included 3-inch-by-4-inch studs and diagonal wind braces. Previous repairs included sistering of the studs and some splices. The current work reinforced the studs where required.

Figure 4. John Nelson House, south elevation, main block, east end of sill depicting previous sill repairs.

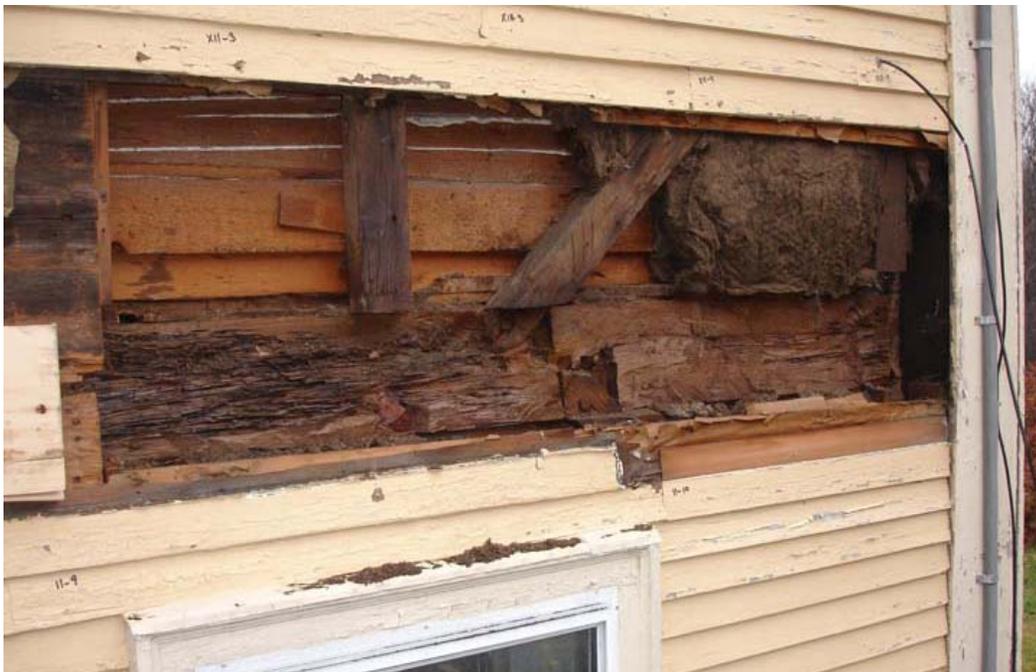
The east end of the second-story south girt was opened during the rehabilitation where a previous repair was failing. The original framing in that location included diagonal braces from the corner post to the girt (fig. 5). The deterioration of the east end of the girt was extensive and about six feet of the girt was replaced with 8-inch-by-8-inch hemlock.

Figure 5. John Nelson House, south elevation, main block, east end of second-story girt depicting deterioration.

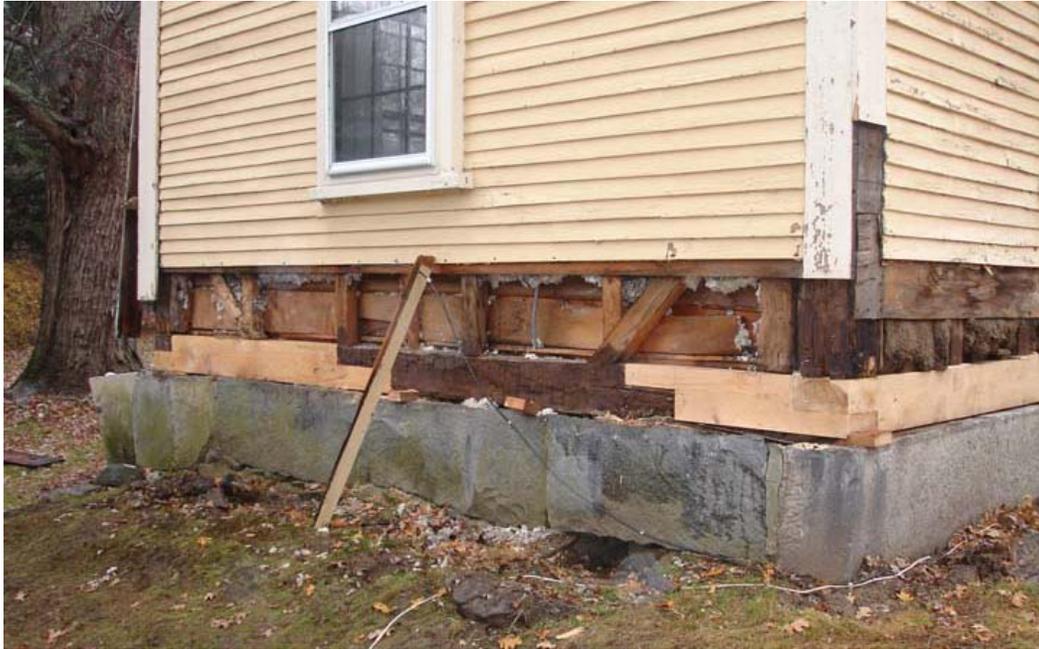
The sill on west elevation of the northwest wing was replaced in two sections. From the south corner approximately three feet of sill was replaced and from the north corner approximately seven feet of sill was replaced (fig. 6). A section of the old sill was left in the middle of the elevation and was joined to the new sections with half-lap joints. This elevation was framed with corner braces, and the jack stud under W117 had waned edges.

Figure 6. John Nelson House, west elevation, northwest wing, showing sill repairs and wall framing.

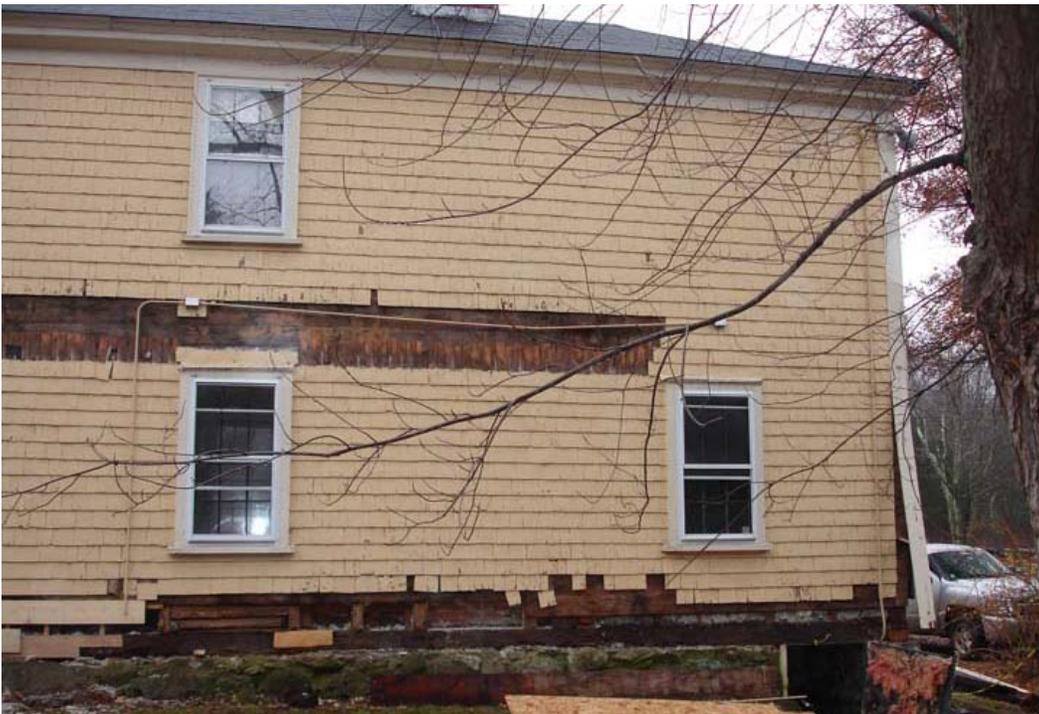
The north elevation had an older sill from the west corner continuing just east of W115 (Room 106). The first section of sill spanned Rooms 104 – 106, but beyond that the sills had been replaced (fig. 7). The posts on the north elevation appeared to be mortised into the older sill and documentation of the first-floor framing determined that the intermediate girts were half-lapped at the sills. Further observations of the first-floor framing suggested that the framing from Rooms 104 – 106, and into the west end of Room 107, was from one period

Figure 7. John Nelson House, north elevation, northwest wing, showing continuous sill from northwest corner to east of W115.

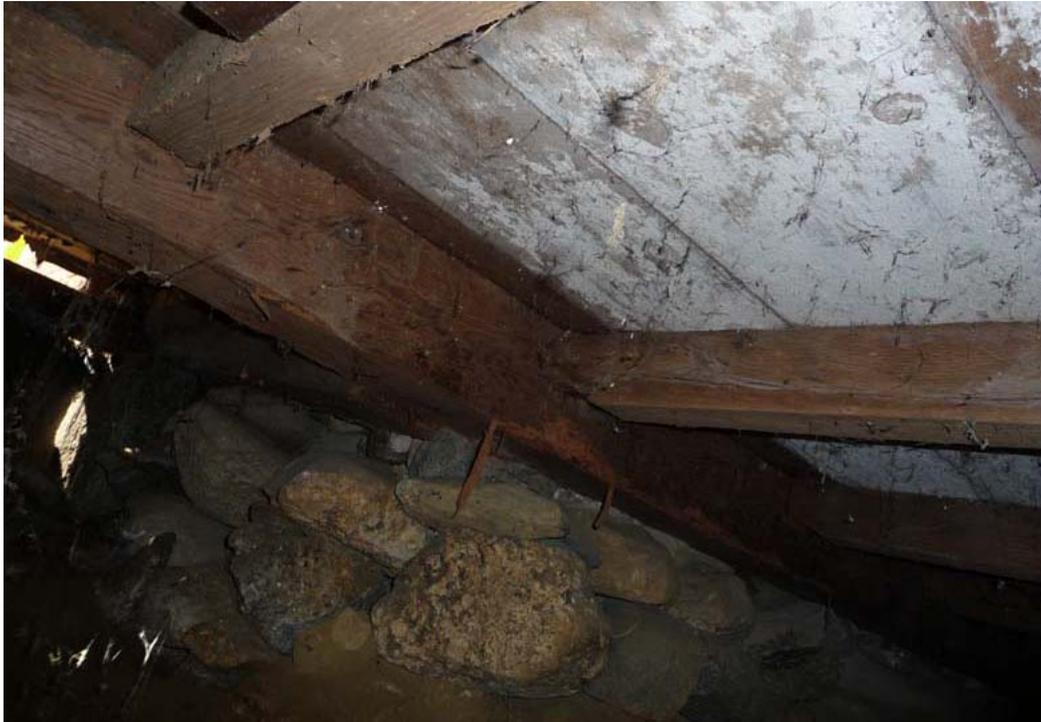
APEM carpenters accessed the crawl space beneath this section of the building and photographed the chimney base and some framing elements. The first floor was framed with timber sills, an east-west beam near the center of the eighteenth-century frame and an east-west chimney girt (fig. 8). The floor joists ran north-south and were mortised into the beams (fig. 9). The northern joists appear to have been replaced. The east-west beam spanning the center of this section of the building was supported by a brick pier. Shims were added between the pier and the beam to reduce the bounce in the floor.

Figure 8. John Nelson House, Room 108, chimney base and first-floor framing.

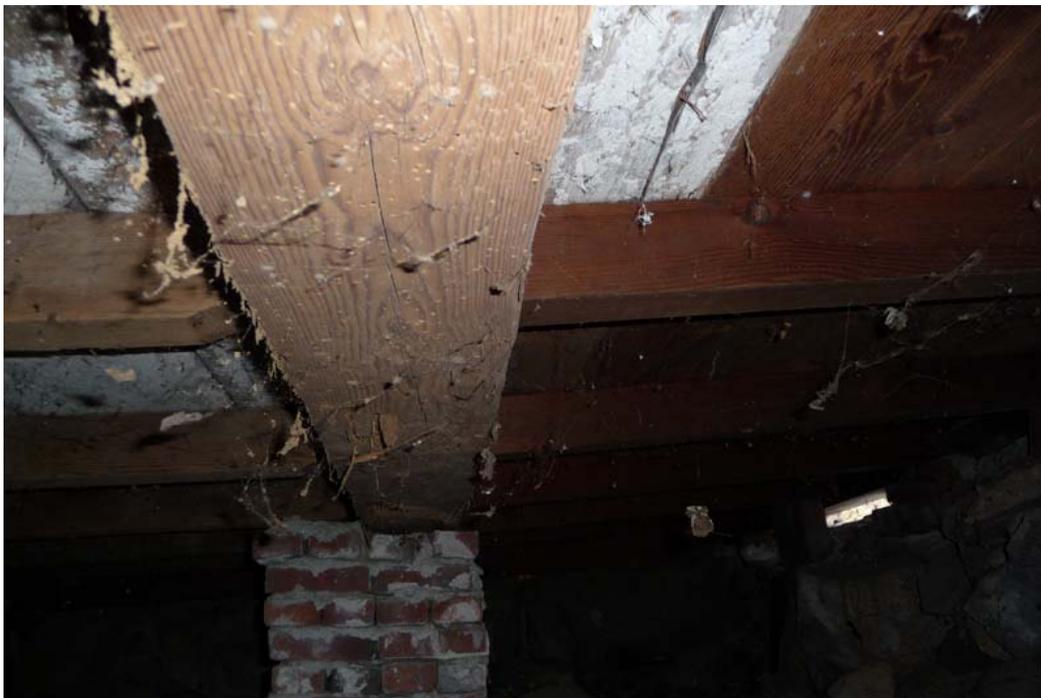
Figure 9. John Nelson House, Room 108, first-floor framing.

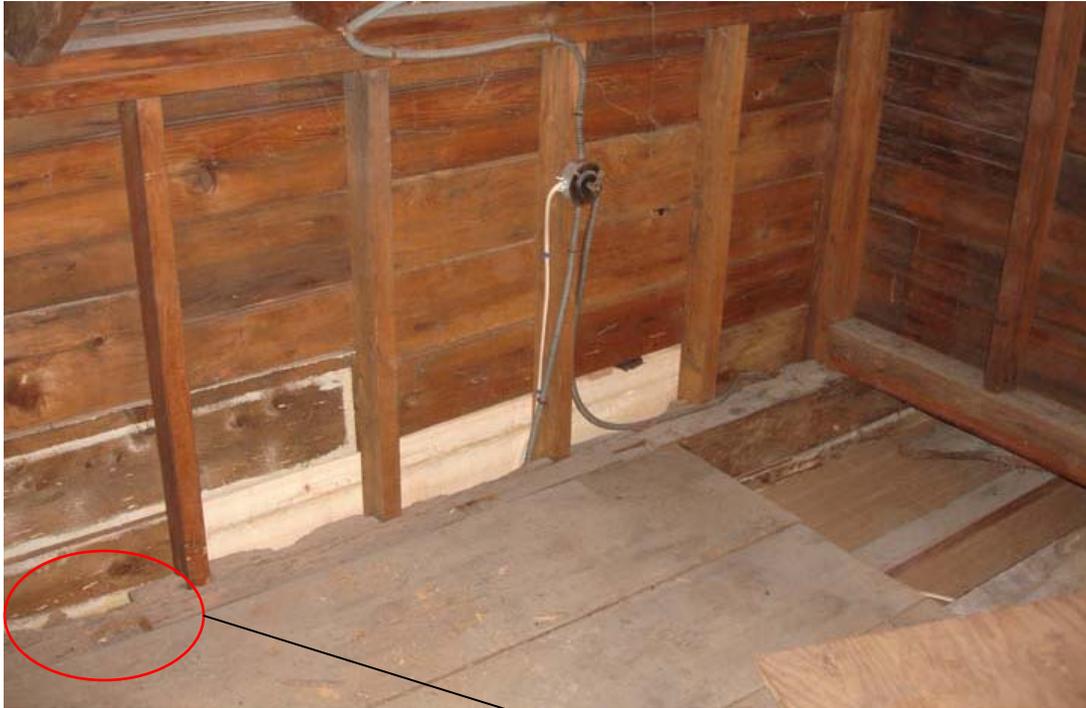
Figure 10a. John Nelson House, eighteenth-century structure, Room 209, north girt and wall framing, 2010.

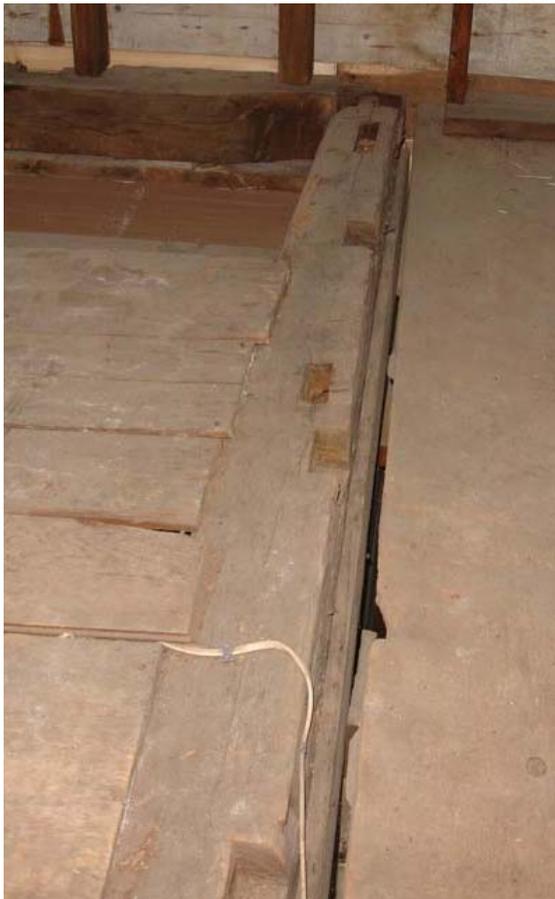
Figure 10b. John Nelson House, eighteenth-century structure, Room 209, north girt with mortised joist and corresponding open mortise, 2010.

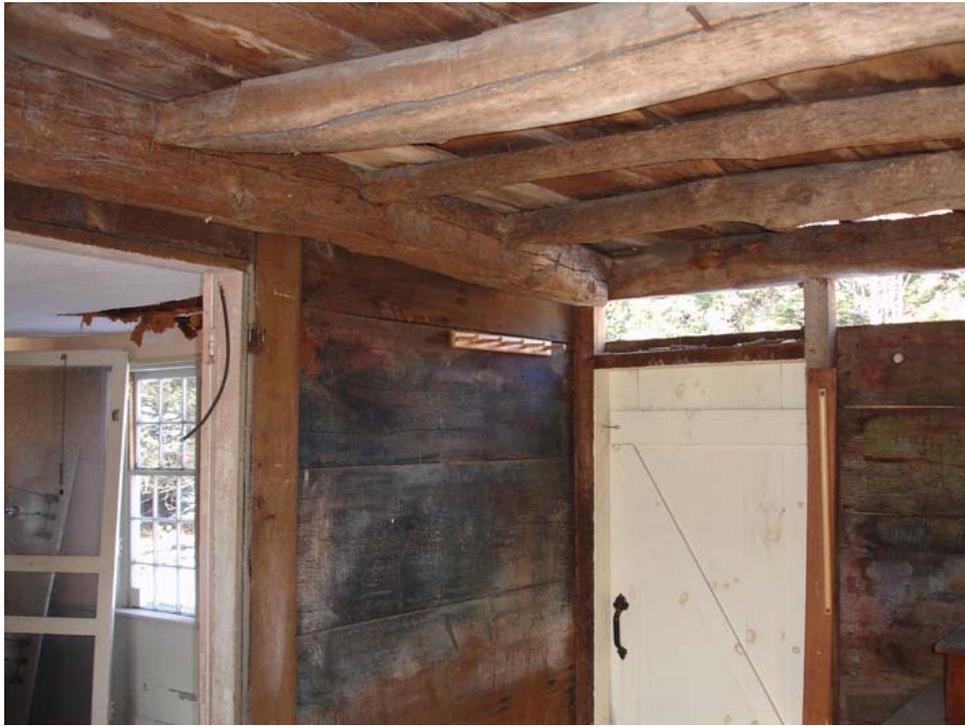
Significant portion of the framing had been previously repaired and much of it required repair during the current rehabilitation. The lower walls were a combination of undersized 4-inch-by-6-inch replacement sills, deteriorated studs with scabbed on sistering, and deteriorated posts (fig. 13); the upper walls were framed with 2-inch-by-4-inch lumber, and the roof was framed with 2-inch-by-6-inch rafters and ridge. The floor in Room 109 was

Figure 12. John Nelson House, northeast wing, Room 109, northwest corner, west wall (exterior wall of 18th century structure), and framing.

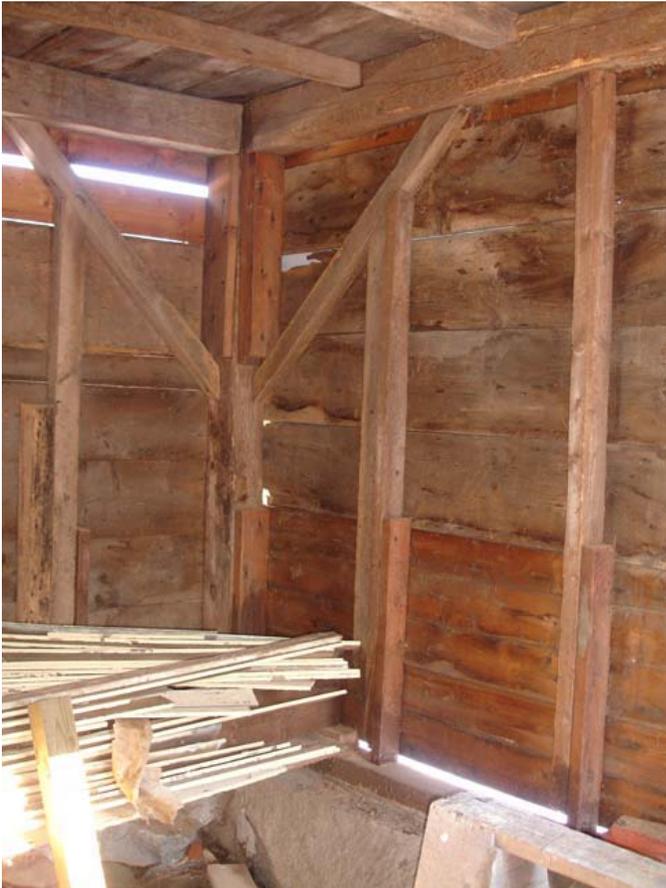
Figure 13. John Nelson House, northeast wing, Room 110, northeast corner framing.

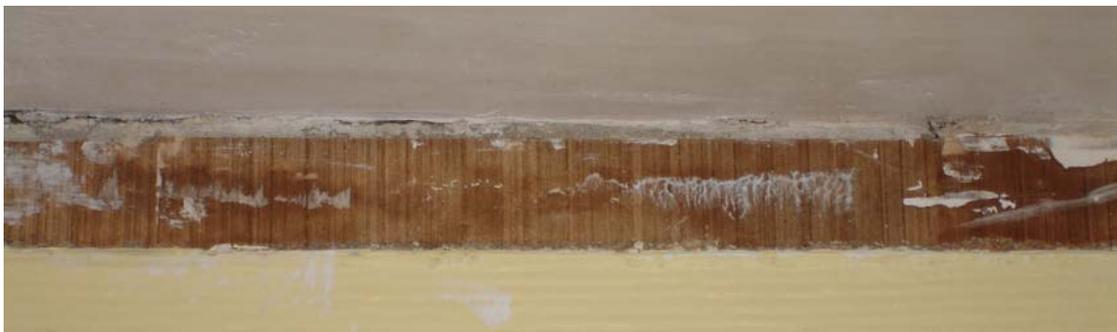
Remnants of a brown-stripe wallpaper were found under the cornice in Room 102 (fig. 15). Based on the paper remnant it was not possible to determine if this was a boarder or representative of a paper that covered the entire wall. Examination of the wallpaper determined that it was printed on a rag/cotton fiber paper. Rag/cotton fiber papers generally predated wallpapers printed on wood pulp, which have been used since the 1850s. However, cotton papers were in use after the introduction of wood pulp papers. It is therefore difficult to date this paper based on that evidence.

Figure 15. John Nelson House, Room 102, brown-stripe wallpaper found beneath cornice molding on west wall.

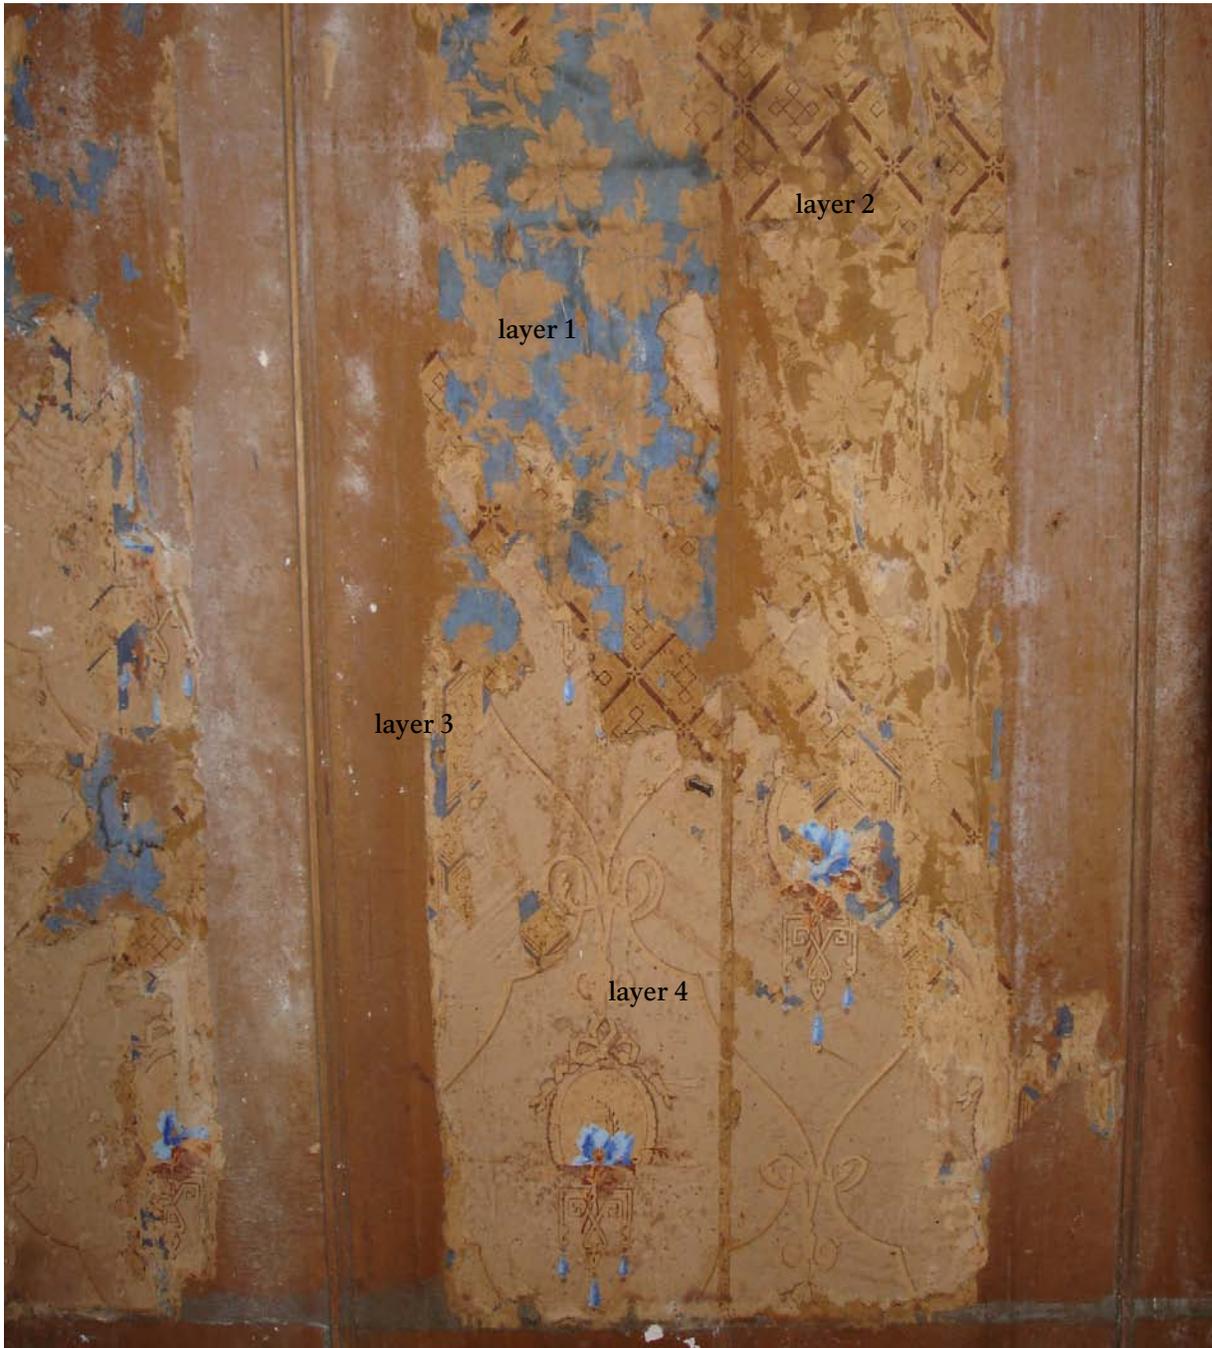
Sections of the vertical board wall were covered with remnants of earlier wall papers. There were four wallpapers observed all of which were left in-situ (fig. 16). The earliest wallpaper (layer 1, fig. 17) was an off-white paper (now tan with age) with a reverse printed bright-blue foliated vine pattern. The build-up of paint around the leaf pattern indicated that the wallpaper was an early machine-printed paper, and the pattern and color suggested that it dated from the early-nineteenth century (circa 1835-40). The layer of wallpaper above that (layer 2, fig. 18) was a monochromatic paper that had a regular diamond pattern with smaller diamonds arranged in the center of each larger diamond. Small pieces of a third layer (layer 3, fig. 18) of wallpaper were also observed, which appeared to have simple corn flowers in parallelograms that were arranged in diamond patterns with a reverse printed blue center medallion. The next layer of wallpaper (layer 4, fig. 19) had a lacey diamond pattern with center medallions composed of blue flowers above geometric brackets with blue pendants. The pattern of that wallpaper is similar to late-nineteenth-to-early-twentieth century designs. The wallpaper evidence was consistent with other physical evidence that indicated an early-nineteenth century period of construction.

Figure 16. John Nelson House, Room 107, south vertical board wall, remnants of wallpaper. Layers are labeled earliest (layer 1) to most recent (layer 4) respectively.

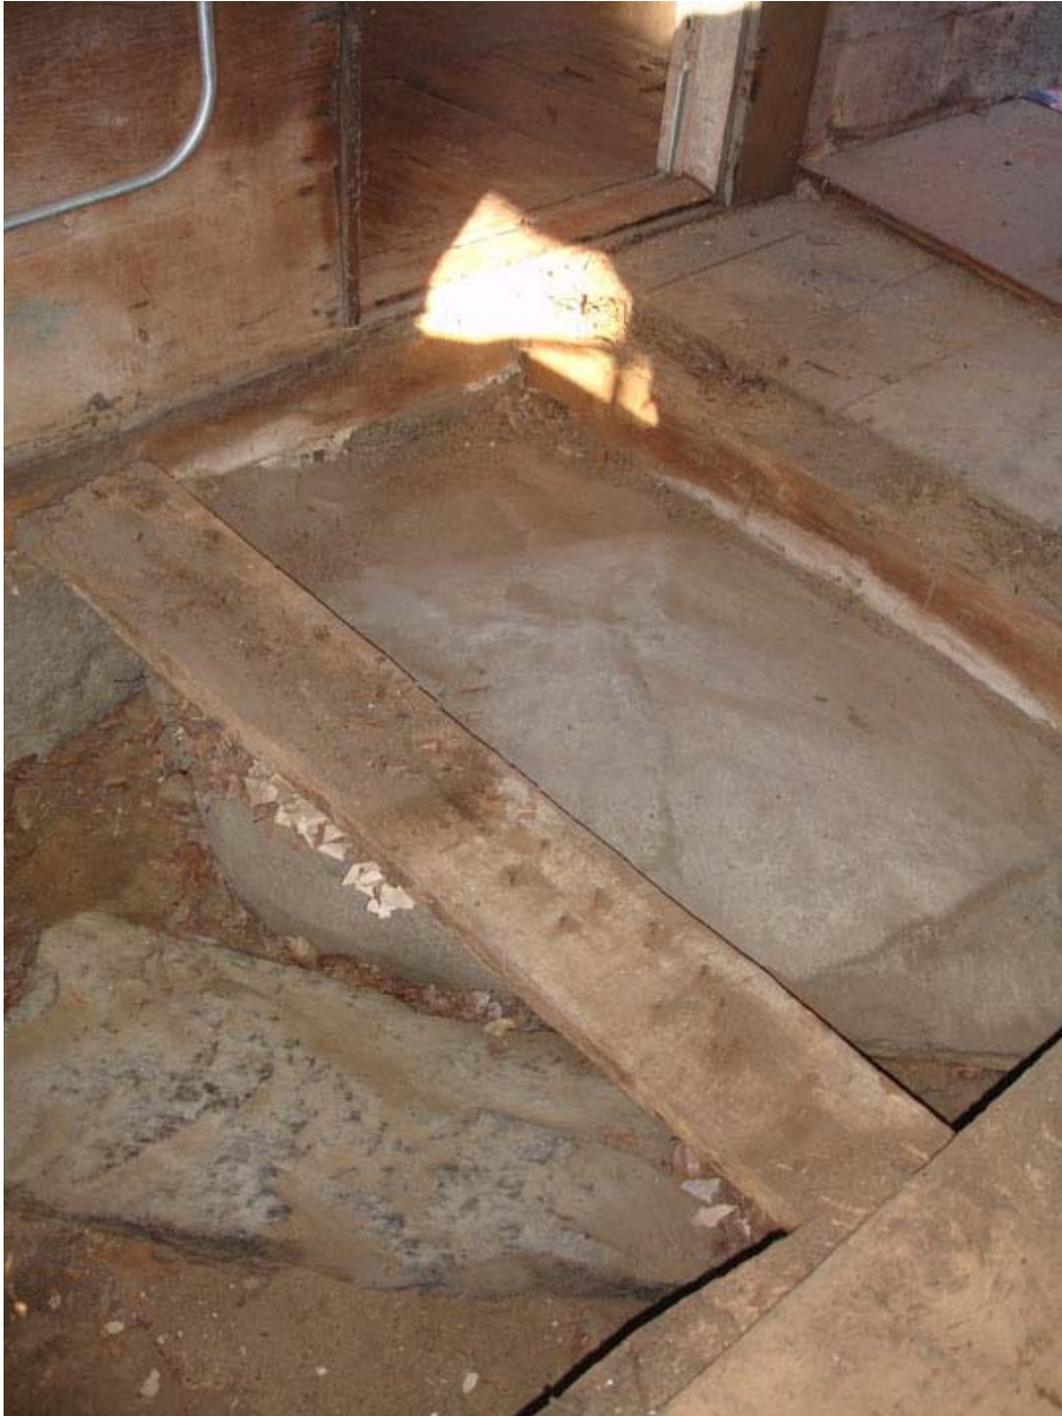
Repairs to the floor framing in Room 109 uncovered two stones that would have lead to the east doorway (D1/108) in Room 108 (fig. 22). The stones were apparently steps to the doorway indicating that it was an exterior doorway prior to the addition of the northeast wing. Whether the stone predated the 1808 main block could not be determined from the extant evidence.

Figure 22. John Nelson House, Room 109, stone steps to D1/108 found under floorboards in Room 109.

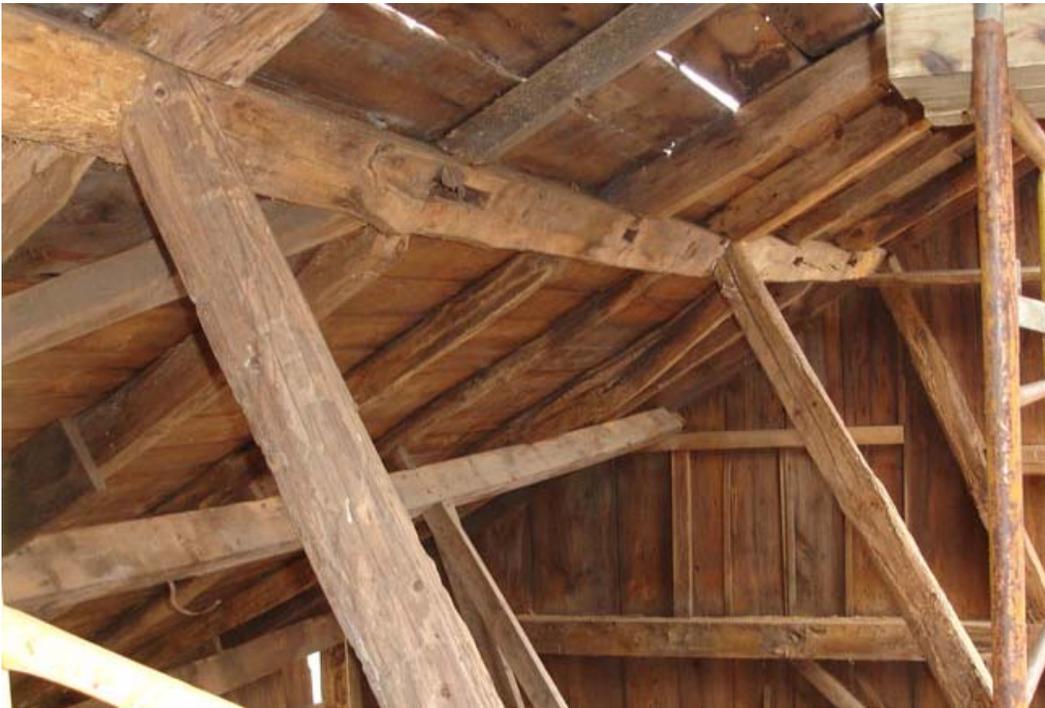
Figure 28. John Nelson Barn, historic 5-sided ridge with open mortises, now serving as purlin.

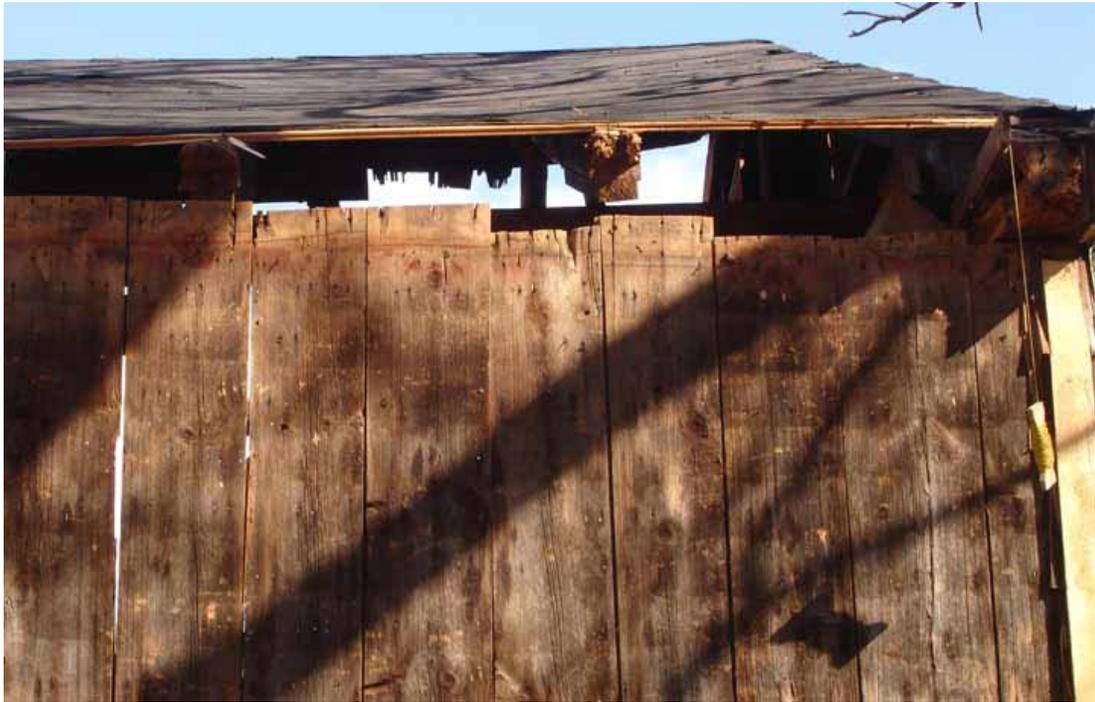
Figure 40. John Nelson Barn, south elevation grit and rafter ends where south plate was removed.

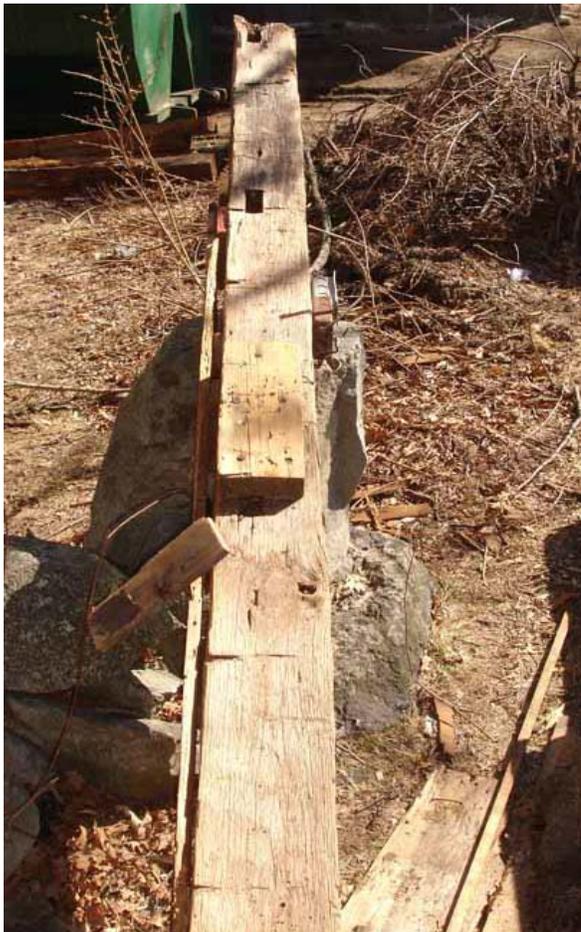
Figure 41. John Nelson Barn, east post of south doorway (P01, bent 2) showing open mortises.

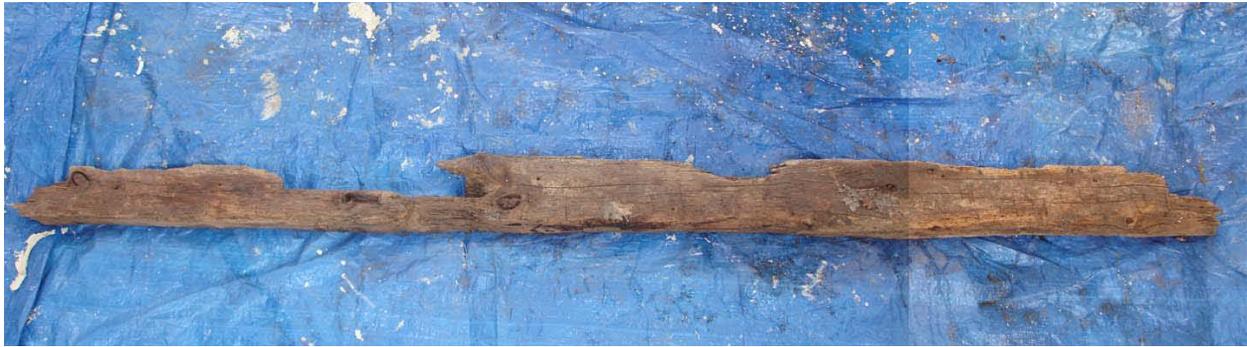
Figure 46. John Nelson Barn, hewn with waned edges; 6½ inches wide by 8 feet 5 inches long; large open mortise 2 inches wide by 1 foot 3 inches long with two peg holes; deteriorated half-lap joint at one end.

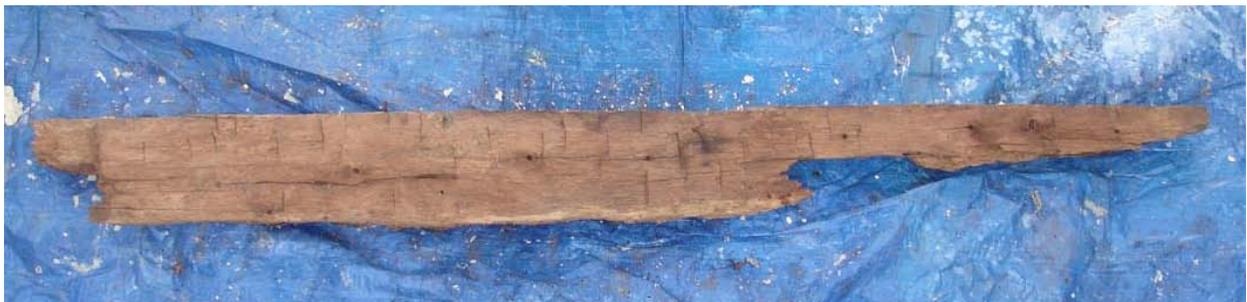
Figure 48. John Nelson Barn, hewn timber; 6½ inches wide by 6 feet 3 inches long; deteriorated open mortise near one end.

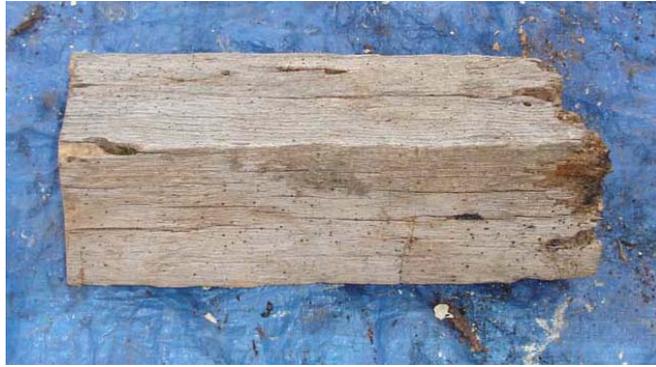
Figure 52. John Nelson Barn, possibly base of post deteriorated at bottom; 8 inches by 7 inches by 1 foot 10 inches long.

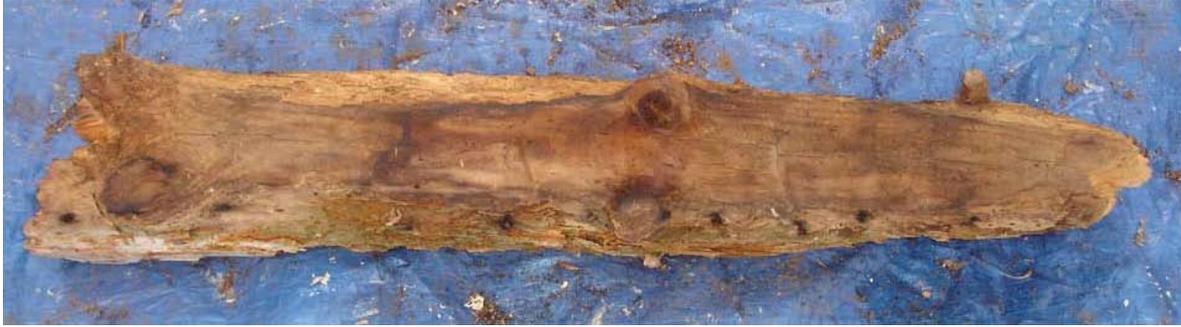
Figure 55. John Nelson Barn, deteriorated timber remnant, appears hewn; 7½ inches by 7 inches by 4 feet long; evidence of cut and wire nails; nailing pattern along one edge.

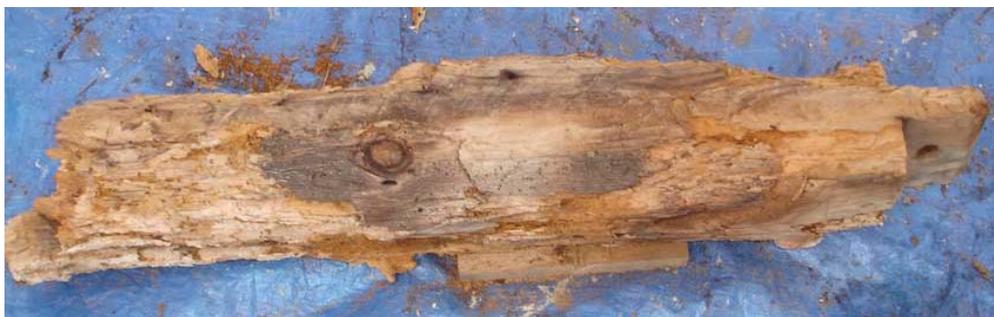
Figure 58. John Nelson Barn, deteriorated timber, possibly remnant of south plate; 7½ inches wide by 3 feet 4 inches long; 5½ inch tenon at one end.

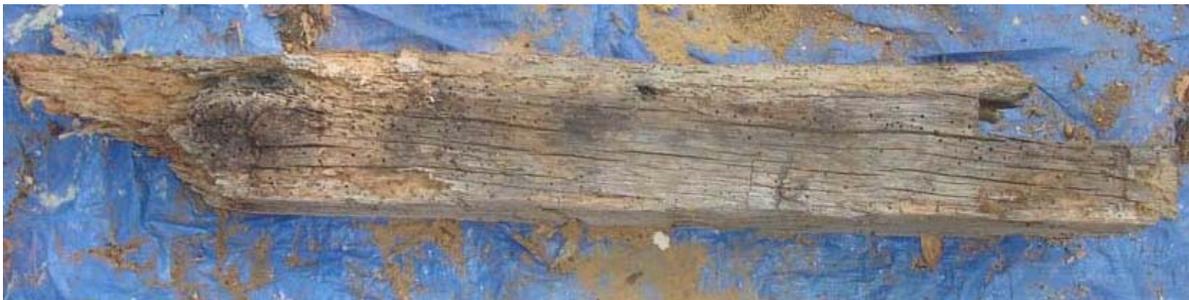
Figure 66. John Nelson Barn, deteriorated timber, appears hewn; 6¾ inches by 6 inches by 3 feet 10 inches long; 4½ inch mortise with two peg holes.

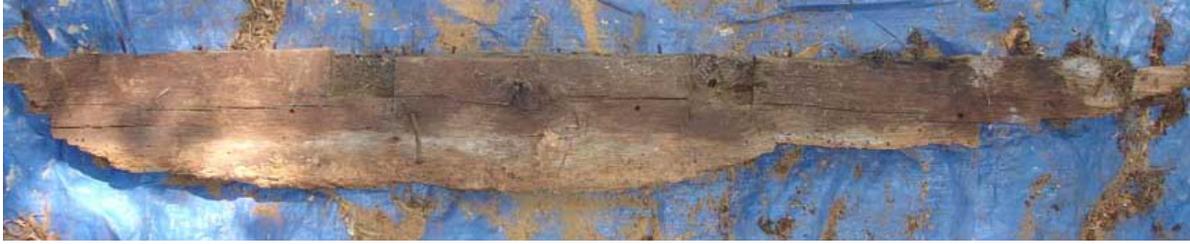
Figure 67. John Nelson Barn, deteriorated timber, appears hewn; 6½ inches wide by 5 feet long; two 3-inch-by-1-inch pockets, 17 ¼ inches on-center; open mortise on “front” face; evidence of cut nails.

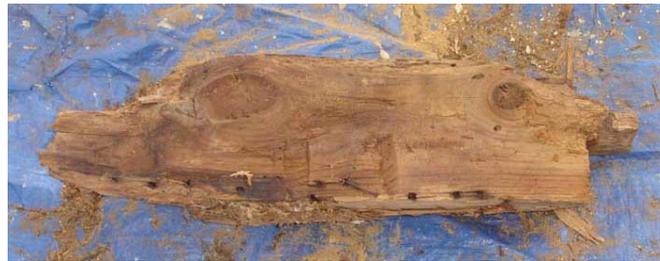
Figure 68. John Nelson Barn, deteriorated timber remnant, possibly hewn; 7 inches by 7½ inches by 2 feet 1 inch long; 3 inch offset tenon; evidence of cut and wire nails; nailing pattern along one edge.

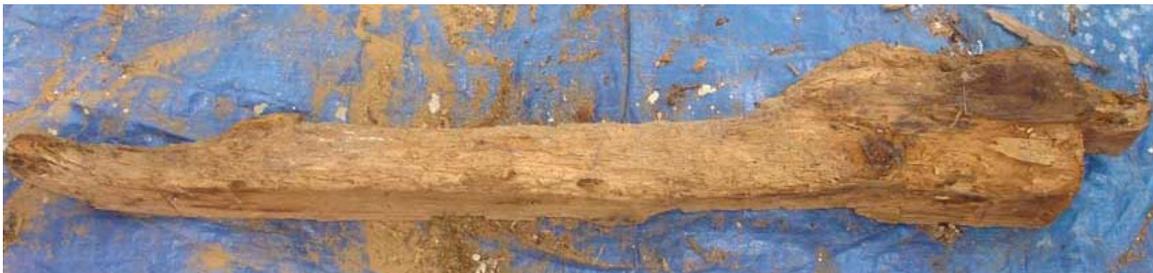
Figure 69. John Nelson Barn, deteriorated timber, possibly hewn; 5 inches by 6½ inches by 3 feet 7 inches long; 3 inch tenon.

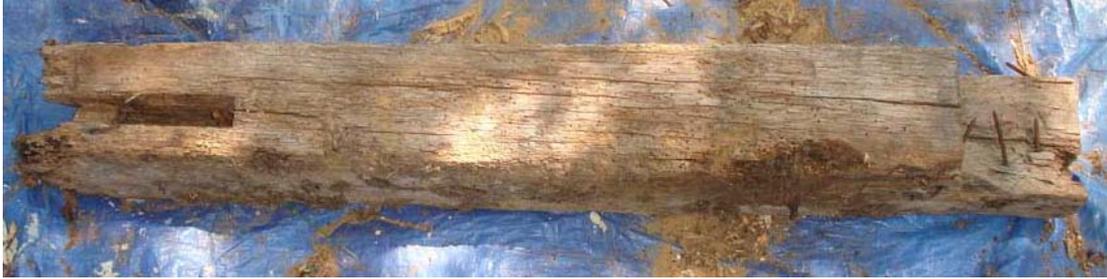
Figure 73. John Nelson Barn, deteriorated timber remnant; 7 inches by 6½ inches by 4 feet 6 inches long; 7 inch half-lap at end (right); 6½-inch-by-2-inch open mortise near broken end (left); evidence of wire nails at half-lap.

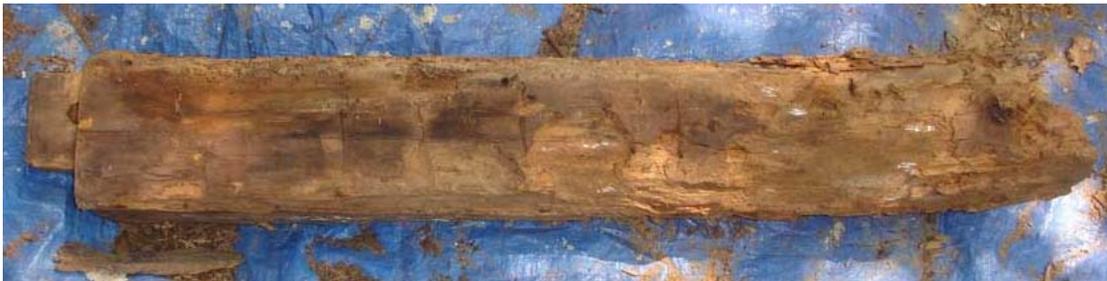
Figure 74. John Nelson Barn, deteriorated timber remnant, possibly hewn; 7 inches by 6½ inches by 3 feet 9 inches long; 4½ inch tenon; evidence of cut and wire nails.

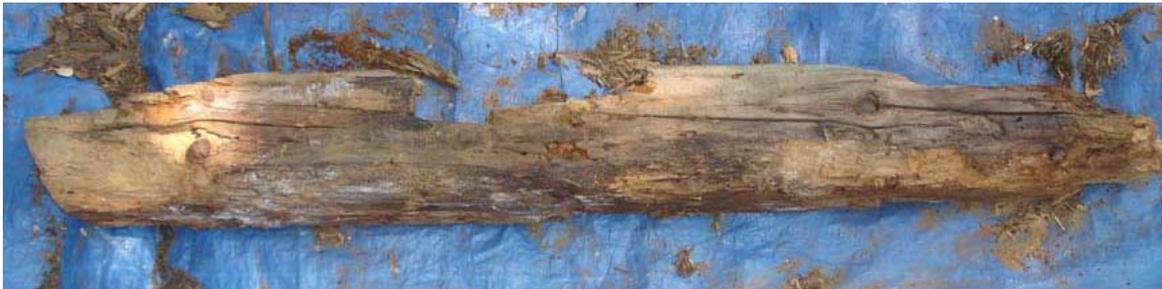
Figure 77. John Nelson Barn, deteriorated timber remnant, possibly hewn; 6 $\frac{3}{4}$ inches wide by 5 feet 1 inch long; 4 $\frac{1}{2}$ -inch-by-1 $\frac{3}{4}$ -inch open mortise.

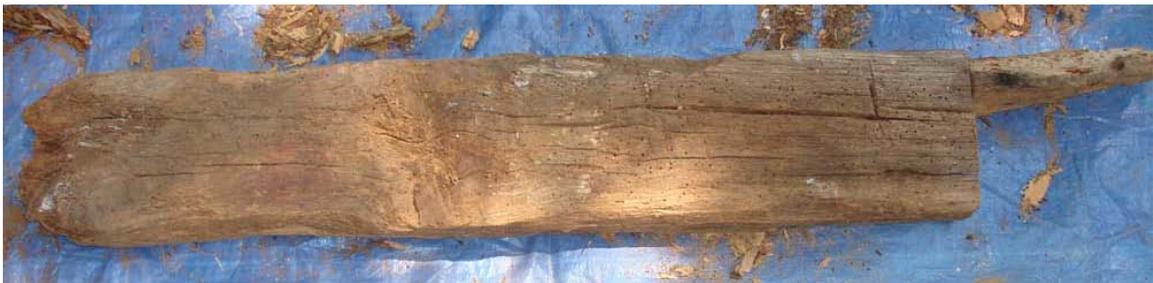
Figure 78. John Nelson Barn, deteriorated timber remnant, appears hewn; 8 inches wide by 3 feet 9 inches long; piece on end (right) fastened with wire nails.

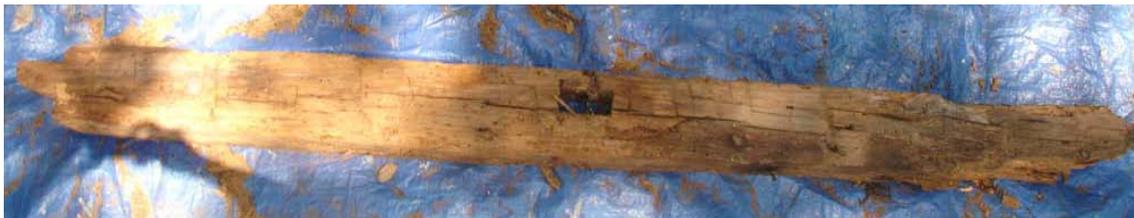
Figure 81. John Nelson Barn, deteriorated timber remnant, appears hewn; $6\frac{1}{2}$ inches wide by 7 feet long; full tenon (left); $3\frac{3}{4}$ -inch-by- $1\frac{3}{4}$ -inch through mortise approximately 3 feet from cheek of tenon.
