HISTORIC STRUCTURES REPORT

ARCHITECTURAL DATA SECTION

THE WAYSIDE

Minute Man National Historical Park  
Concord, Massachusetts

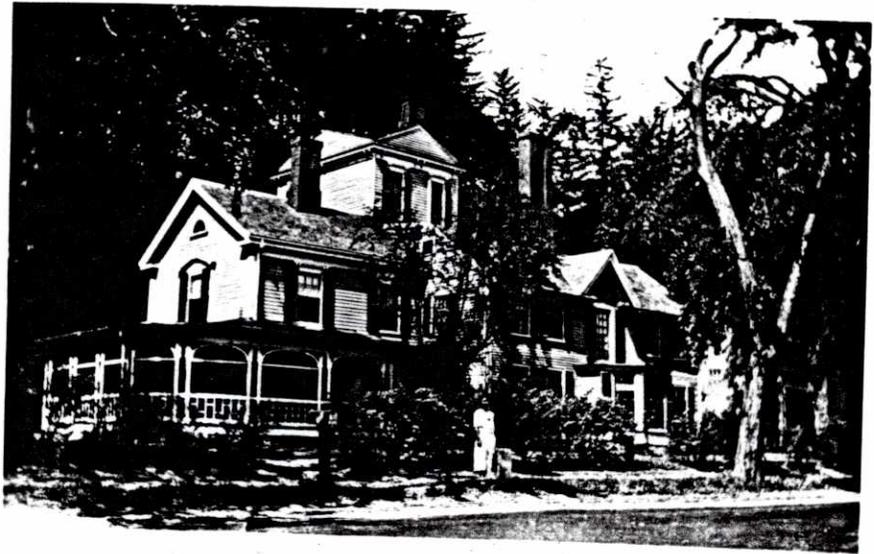
This view of The Wayside, taken in 1925 shows the house as it appeared at the time of Mrs. D. L. Lothrop's death in 1924. Until this photograph was found, the 1922 Shepard photographs were the only photographs known taken of the house between 1923 and 1928. An interesting bit of evidence furnished by this photograph are the gutters and downspouts on the piazza roof which do not appear in the 1922 views.

1. Piazza Gutter: Illustration No. 1, taken in 1925, indicates that the gutter around the Piazza roof was installed between 1922 and 1925. The original zinc gutter was still in use in 1967 when the rehabilitation work started but was found to be rusted beyond repair. A new gutter, made from galvanized steel, was fabricated in the shop by the Allied Sheet Metal and Heating Co., Inc., and brought to the site in five sections. Installation of the gutter was done by our workmen. The 1924 gutter has been saved for architectural evidence as well as a pattern for future fabrications of the Piazza gutter when warranted.

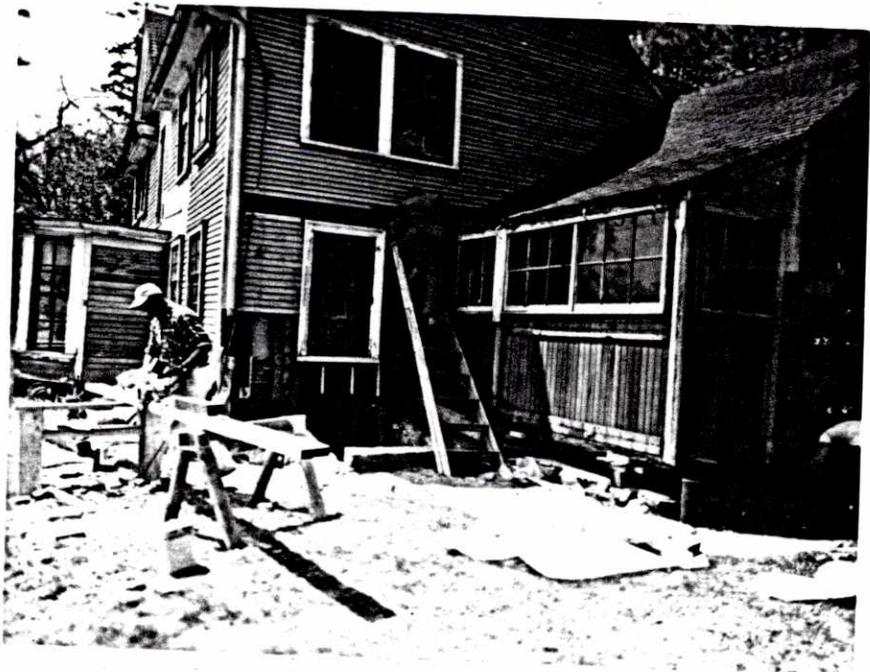
ILLUSTRATION NO. 2

Carpenters, Carl Loomer, left; Fred Di Fillipo, center; and Michael Fortin, right, are shown replacing rotted framing members on the east end of The Wayside. The wooden cellar bulkhead doors were rebuilt.

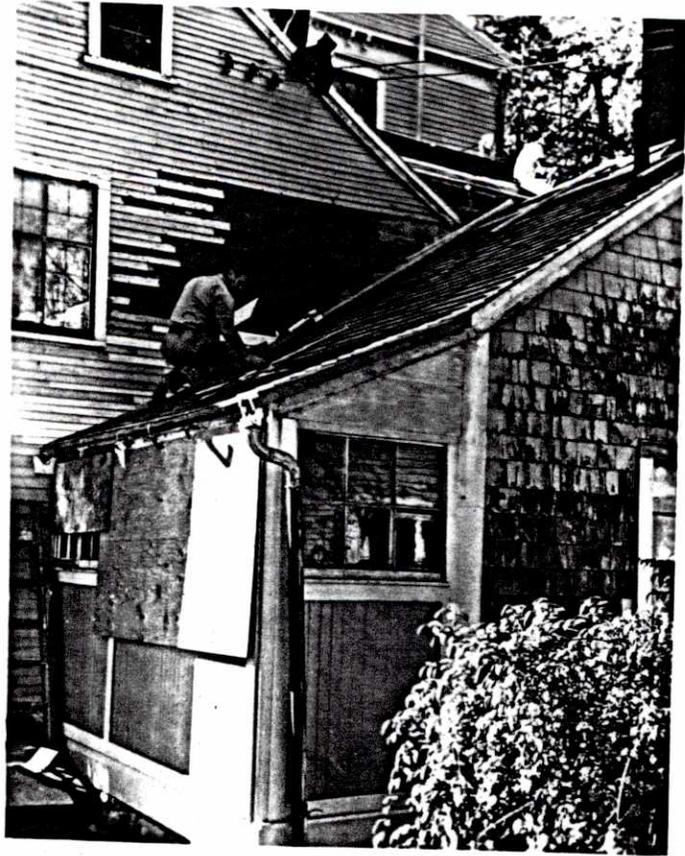
ILLUSTRATION NO. 3

Fred Di Fillipo, carpenter, is shown in this view cutting and fitting new spruce clapboards to the east wall of the ca. 1716 house. The exposed surface of the new clapboards were hand-planed and the ends lapped to match the joints of the ca. 1820 clapboards as seen in several pre-1922 photographs taken of the east end before alterations were made in the 1930's. Removed from the wall in this instance were western red cedar clapboards having butt ends and random lengths. Shingling of the roof over the "Maid's Room" is being done by Carl Loomer of Harvard, Massachusetts.

old growth white pine clapboards with vertical grain. Illustration No. 3 shows a carpenter cutting and fitting the new clapboards to the east wall of the ca. 1716 house. Approximately 140 clapboards were replaced on the east end of the house; about 50 clapboards replaced on the south wall of the Dining Room; 40 clapboards replaced on the south wall of the Sitting Room; approximately 30 clapboards replaced on the west end of the ca. 1716 house; all of the clapboards (73) except five were replaced on the south wall of the Tower Study; all of the clapboards on the west Tower wall abutting the roof were replaced; several clapboards in the Tower pediments were replaced; and several clapboards on the walls of the West Wing were replaced. Every effort was made to repair the original clapboards wherever salvageable. Except for the deteriorated clapboards of 1860, found on the south wall of the Tower Study, 3rd floor, most of the clapboards removed from the house were done so because they were found to be Western Red Cedar boards put on after 1924 when Miss Lothrop took over maintenance of the house. Western Red Cedar lumber should be used with caution in restoration work because of its inability to hold paint, also, because of its close grain that produces a slick appearing finish to the paint. Two varieties of galvanized cut nails used for the clapboards and wood trim were obtained from the Tremont Nail Company of Wareham, Massachusetts.

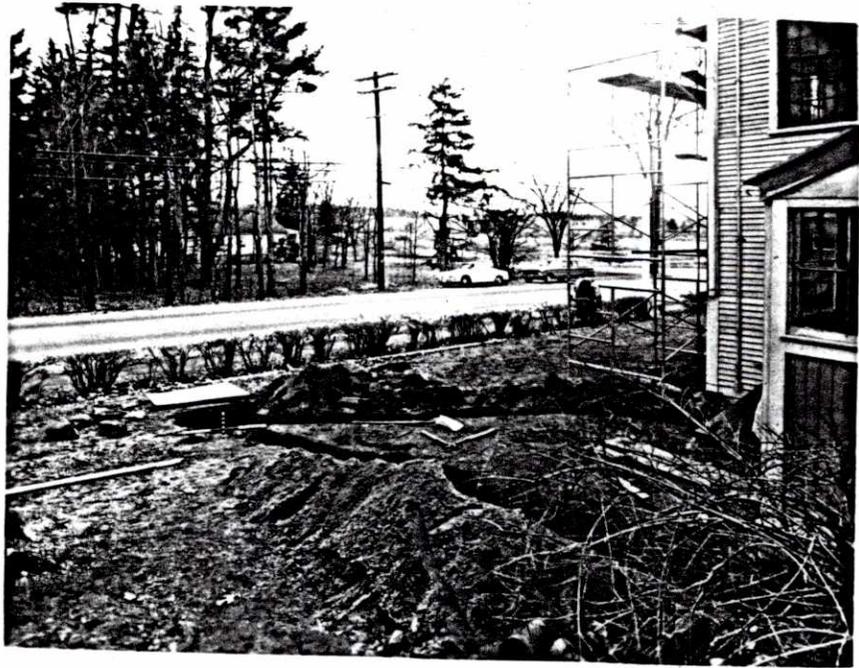
ILLUSTRATION NO. 4

Trenches dug for the installation of drain lines extending from the downspouts at the southeast corner of the Dining Room and the Enclosed Porch to a dry well in the yard. See plot plan in appendix showing new utilities which also includes the locations of drain lines and dry wells installed during 1968. This photograph is a view looking southwest across Lexington Road to the meadow beyond.

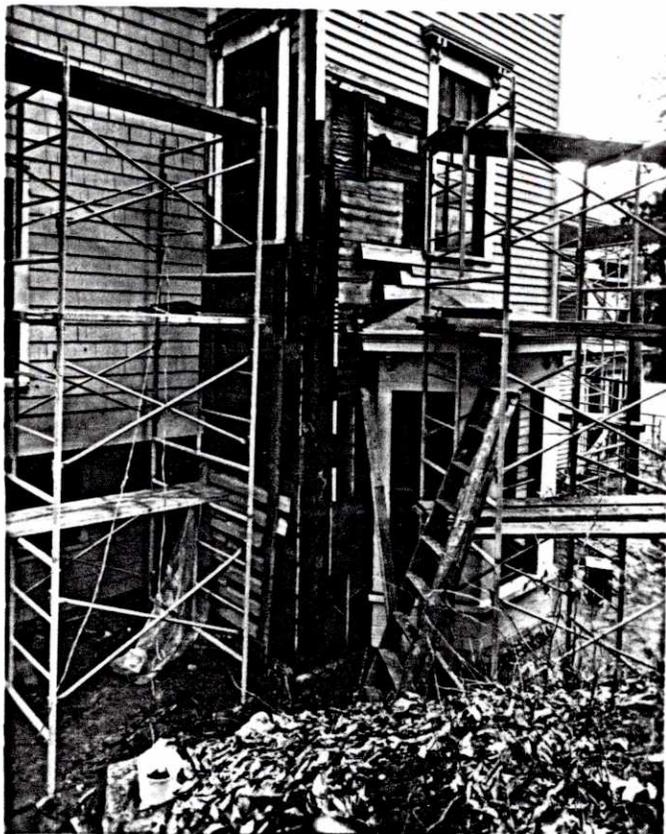
ILLUSTRATION NO. 5

Approximately fifteen feet of the northeast corner post was replaced because of rot caused by a leak in the Tower roof. The upper part of the post had been replaced earlier, ca. 1916.

Illustration Nos. 5 and 6, show the extent of work done in replacing rotted beams and posts along the north wall and Tower. Extensive rehabilitation of the roof framework of the Tower, especially at the northeast corner, was also accomplished at this time.

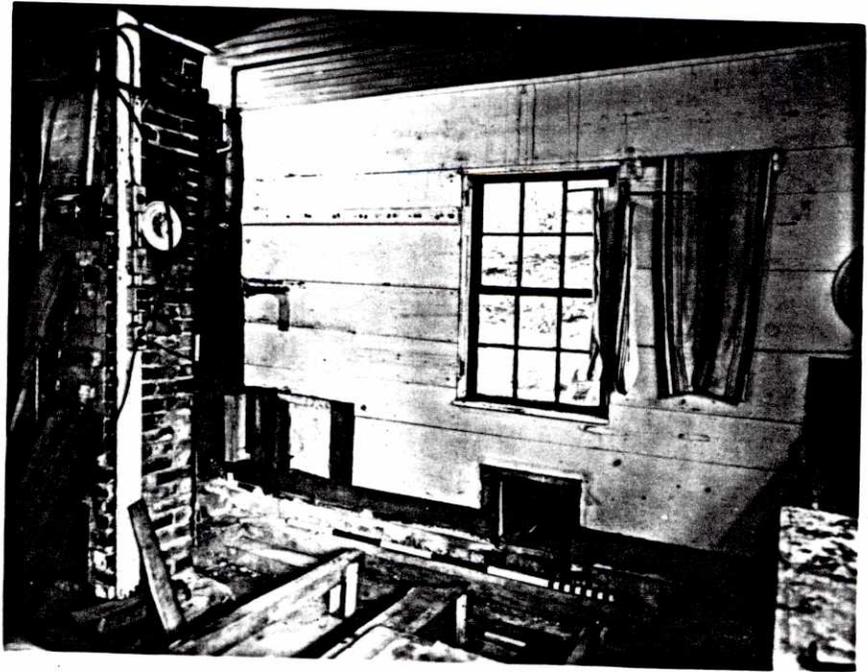
ILLUSTRATION NO. 10

View of the northwest corner of the kitchen after repairs were completed to the chimney base which had partially fallen when floor boards were removed. A concrete retaining wall was poured against the stone foundation wall to stabilize the sandy soil. A new pressure treated foundation sill can be seen in place. New pressure treated floor joists yet to be installed were placed between the existing floor joists to provide additional support for the kitchen floor.

3. Kitchen chimney: The lower front section of the kitchen chimney required rebuilding when the brickwork collapsed after removal of the subfloor for repair work. Prior to rebuilding the chimney, the stone base was reinforced with concrete. Cement mortar was applied to the three exposed sides of the kitchen chimney on the 1st floor to match the original plaster work that had been removed sometime after 1924. Photographs of this work can be seen in the park files.

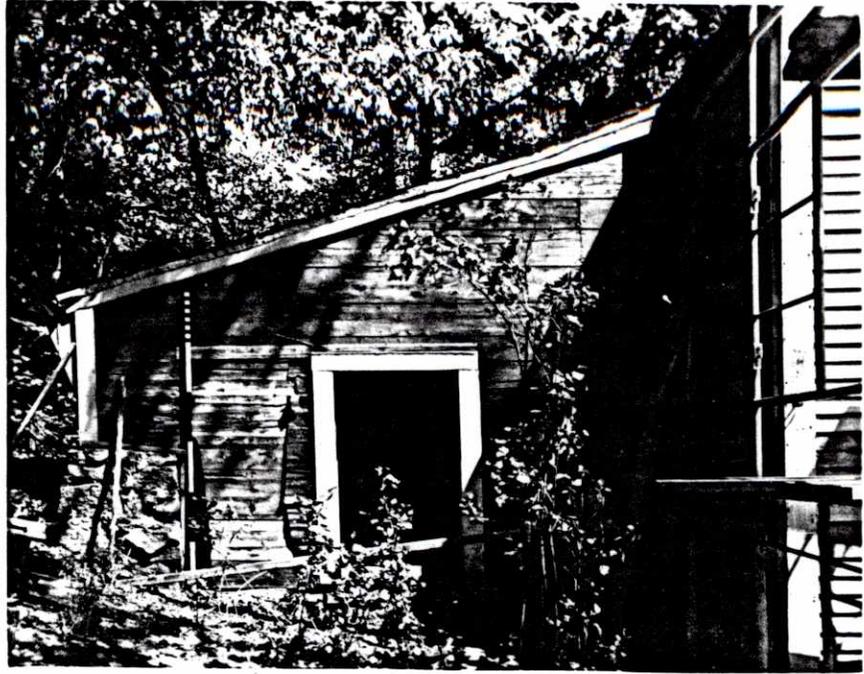
ILLUSTRATION NO. 21

A view of the west wall of the barn leanto after repairs had been started. Extensive deterioration was encountered in the wall which required immediate repair work prior to prime painting. The south and west walls of the barn were rehabilitated as part of the overall view of the house. Much work still remains to be done on the barn.

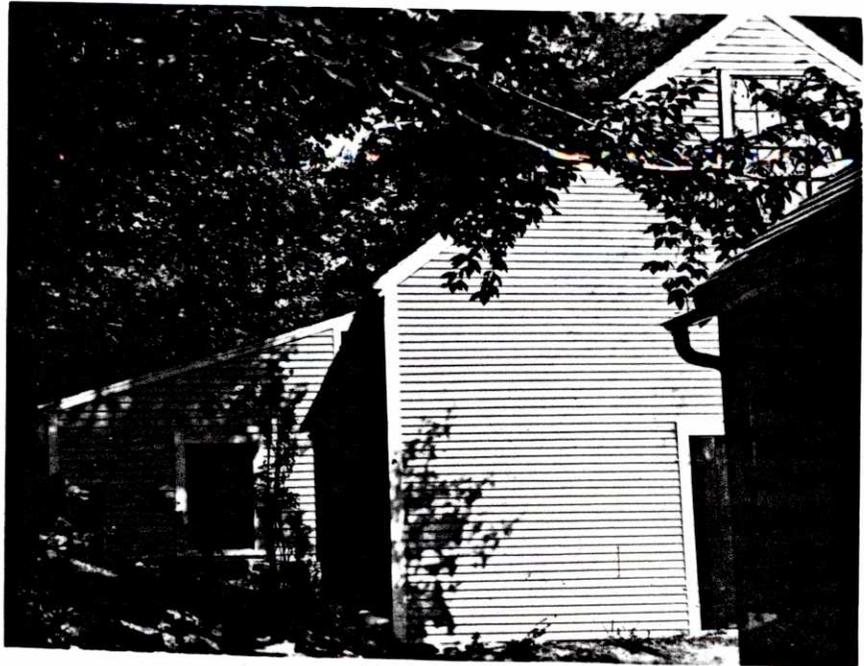
ILLUSTRATION NO. 22

West wall of the barn after repairs were made; also, scraping of the loose paint and prime painting one coat was completed at this time. The small upper frame (once used for ventilation) in the leanto wall is new.
