Tahoma Creek Bridge Focused Condition Assessment

Tahoma Creek Bridge focused condition assessment

Science Report NPS/SR—2024/103

Robert P. Jost, Taylor R. Kenyon

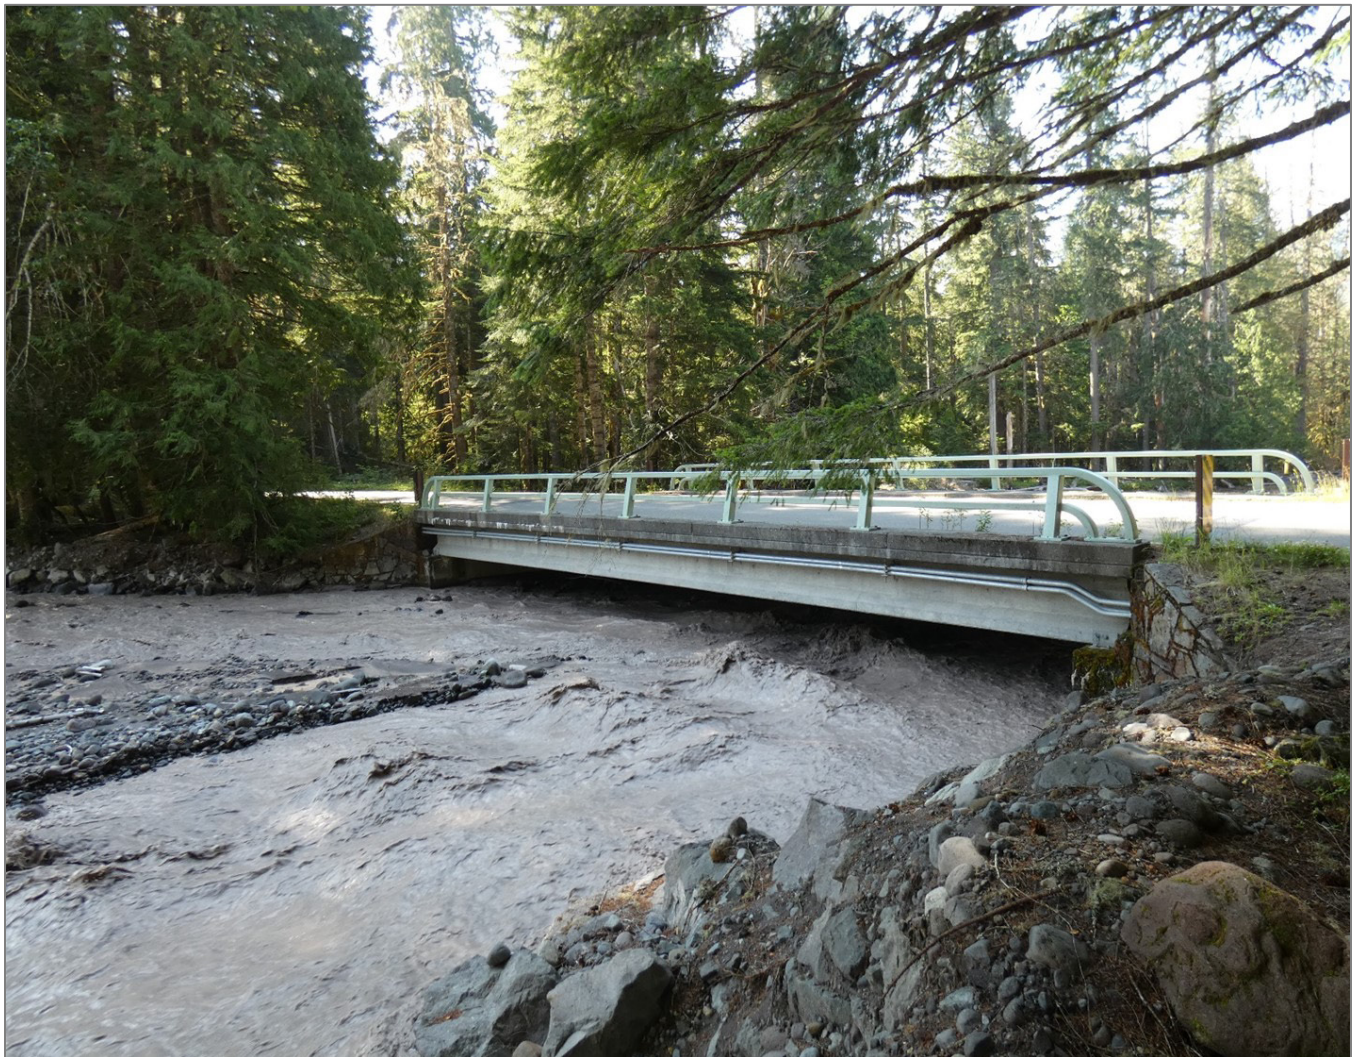
The north side of the Tahoma Creek Bridge, facing south on August 6th, 2019, during a period of increased water stage and sediment transport from an upstream debris flow.

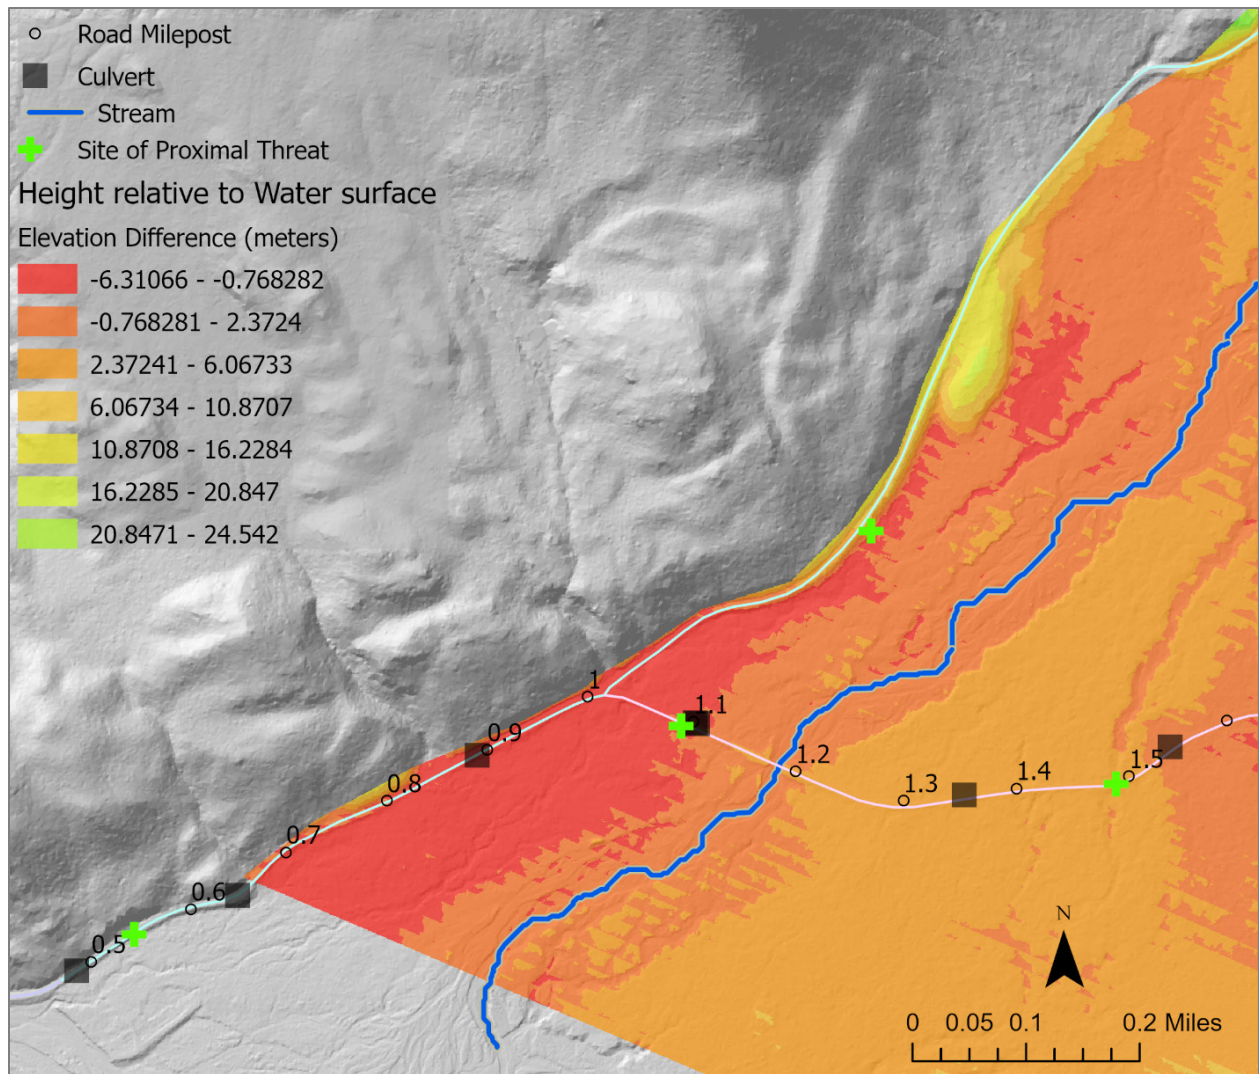
Figure 3. Elevation of the valley bottom relative to the Tahoma Creek active channel denoted as a blue line. Green crosses are locations where the road may become susceptible to inundation during major flooding events.

The study area encompasses the debris fan terrace (DFT) that has formed where Tahoma Creek begins to merge with the Nisqually River (Figure 2). The Nisqually-to-Paradise Highway traverses the full width of this convex landform, with the bridge located near the fan apex. Vehicles traveling along the road must climb the western limb of the fan to reach the bridge, and the western margin of the fan is as much as 6.3 m (20.7 ft) lower in elevation relative to the active channel (Figure 3).

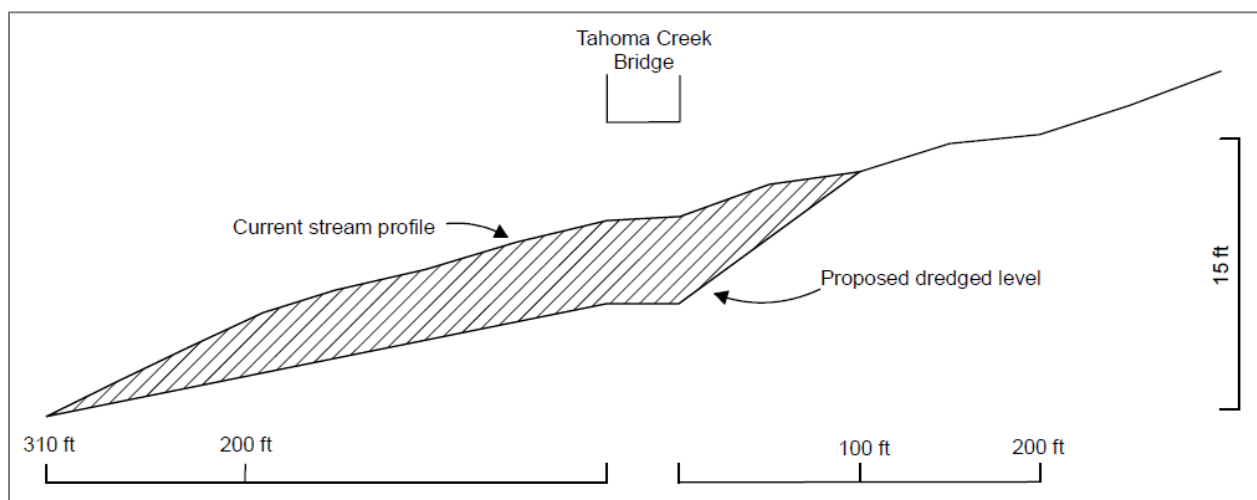
The park experienced the largest flood on record in November 2006, and in response, the USFHA recommended that the active channel be consolidated into a trough 18 m (59 ft) wide with approximately 2–3 m (7–10 ft) of clearance between the bottom deck of the bridge and the streambed. This operation took place in the fall of 2007, with excavation beginning 30 m (100 ft) upstream of the bridge and extending 94 m (310 ft) downstream, maintaining a longitudinal slope of 2%. This slope was estimated to be steep enough to transport sediment in the channel. The profile was tapered to match the elevation of the existing streambed as it approached the distal boundaries of the permitted construction area (Figure 5).

Figure 5. Profile view schematic of the channel modification that took place in fall 2007 (MORA 2007b).

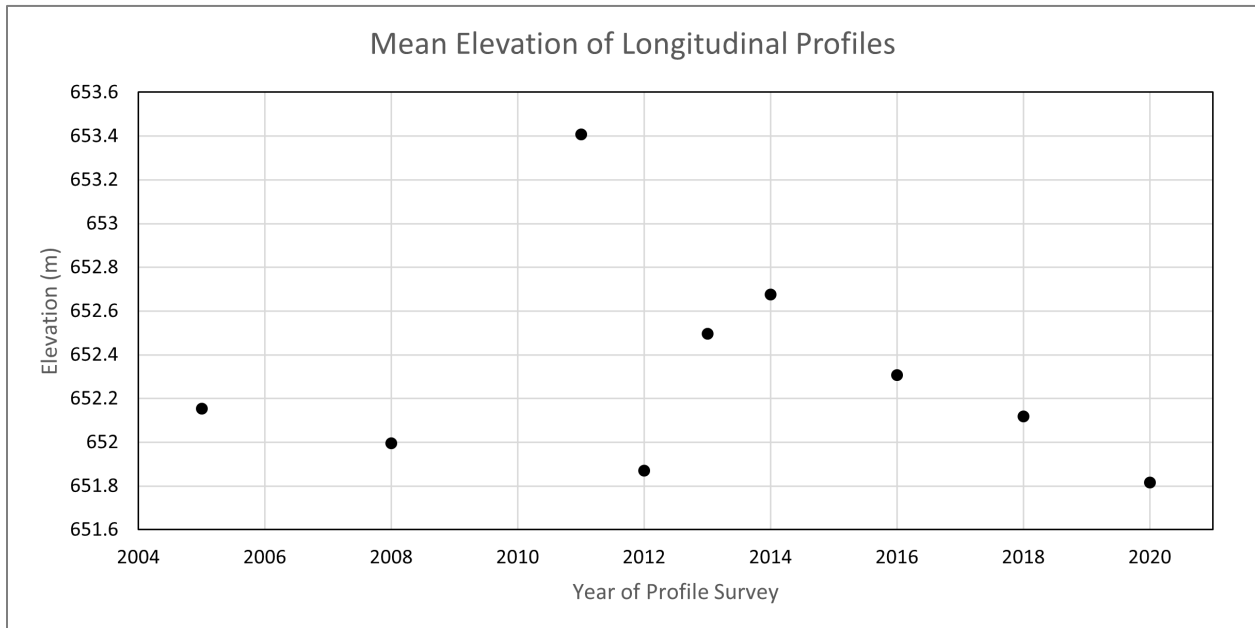
Figure 6 shows the mean elevation of the low-flow water surface of points surveyed along a 200 m (660 ft) channel segment centered around the bridge based on profile data shown in Appendix A. The profile with the highest overall elevation is from 2011 and was surveyed immediately prior to channel modification that led to the sudden decrease in the 2012 datapoint. A steady elevation increase is observed between 2012 and 2014, when no channel modifications took place, followed by a lowering of the mean elevation between 2016 and 2020, when only one operation took place.

Figure 6. Mean elevation of the low-flow water surface for points surveyed 100 meters downstream and 100 meters upstream from the bridge.

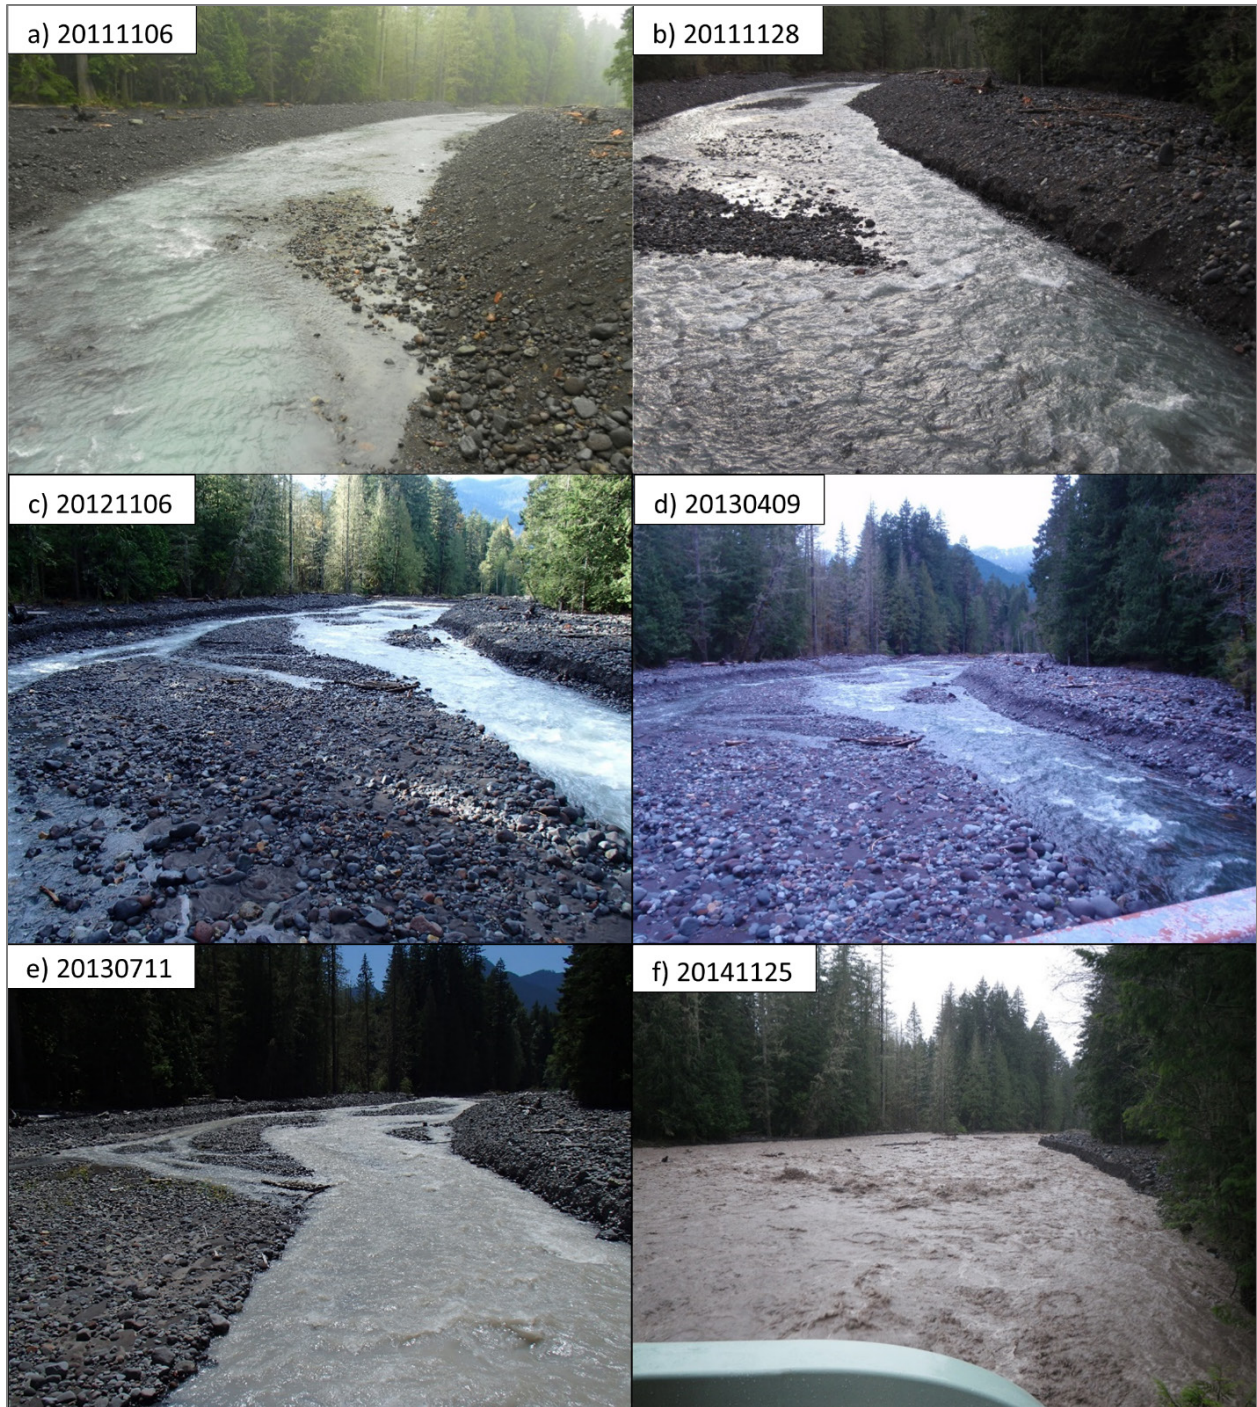
Figure 7 shows the evolution of the channel below the bridge. Figure 7(a) depicts the modified channel in the days following the 2011 alignment operation. The channel widens and begins to braid as the banks get eroded (Figures 7[b] and 7[c]). There is an abundance of sand in the bank material that is capable of being transported even during the low-flow conditions present in Figures 7(a), 7(b), and 7(c). Selective entrainment of sand causes bank failure, delivering pulses of sediment to the channel bed. While the sand may continue to travel downstream, the larger particles remain close to the point of failure until a higher flow occurs, reducing overall conveyance through the bridge. This channel achieves a conditional level of stability by arranging particles into hydraulically smooth bedforms.

Figure 7. Evolution of the modified channel over three years. Panels (a) through (f) are looking downstream from the bridge deck. The stream flow in (a) through (d) is representative of low-flow conditions. Flow in panel (e) is typical of summer runoff. Panel (f) is near bankfull runoff during a precipitation induced flood (Photos: NPS and US Federal Highways Administration).

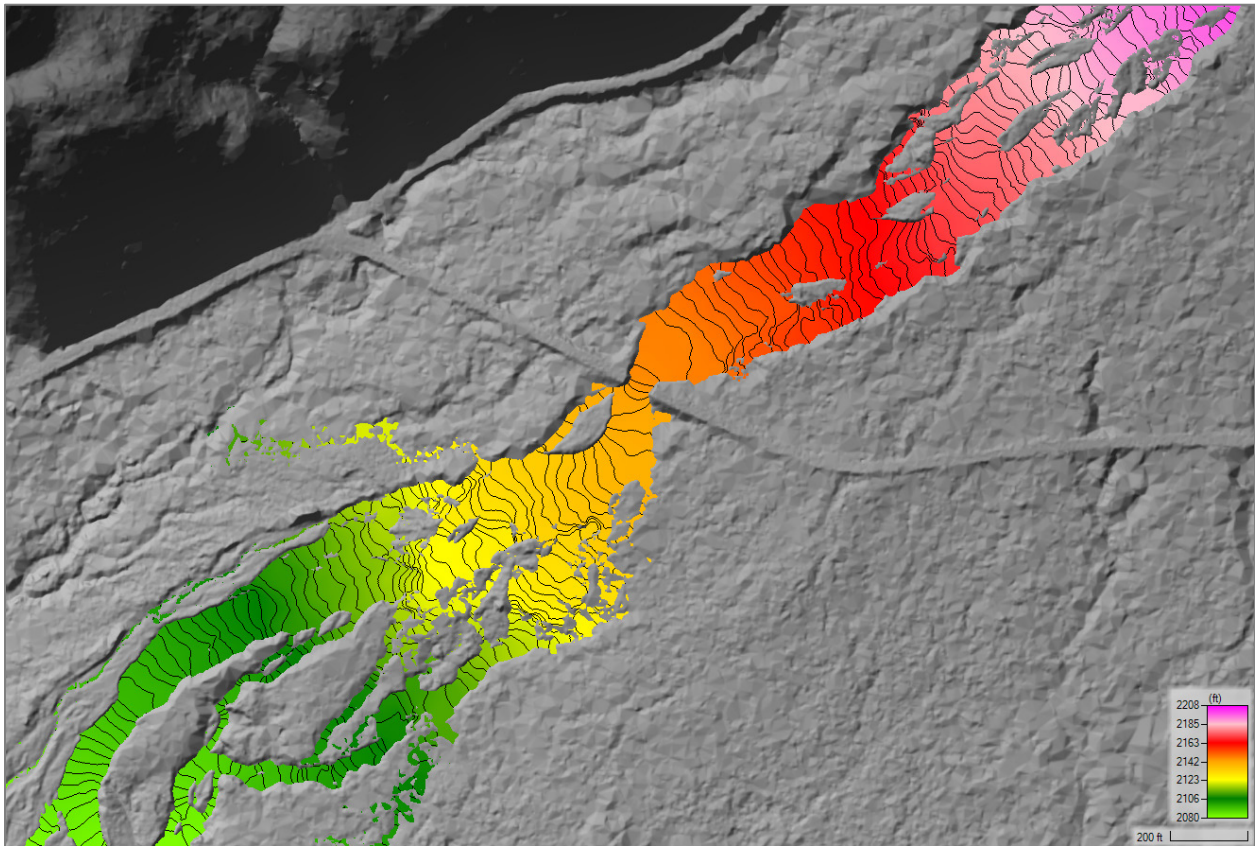
Figure 8. Water surface elevation of modeled 100-year flow event in the unmodified channel. Contour interval is 1 ft (0.3 m). Colors represent elevations above mean sea level in feet (Modified from Figure 9A in Leon [2020]).

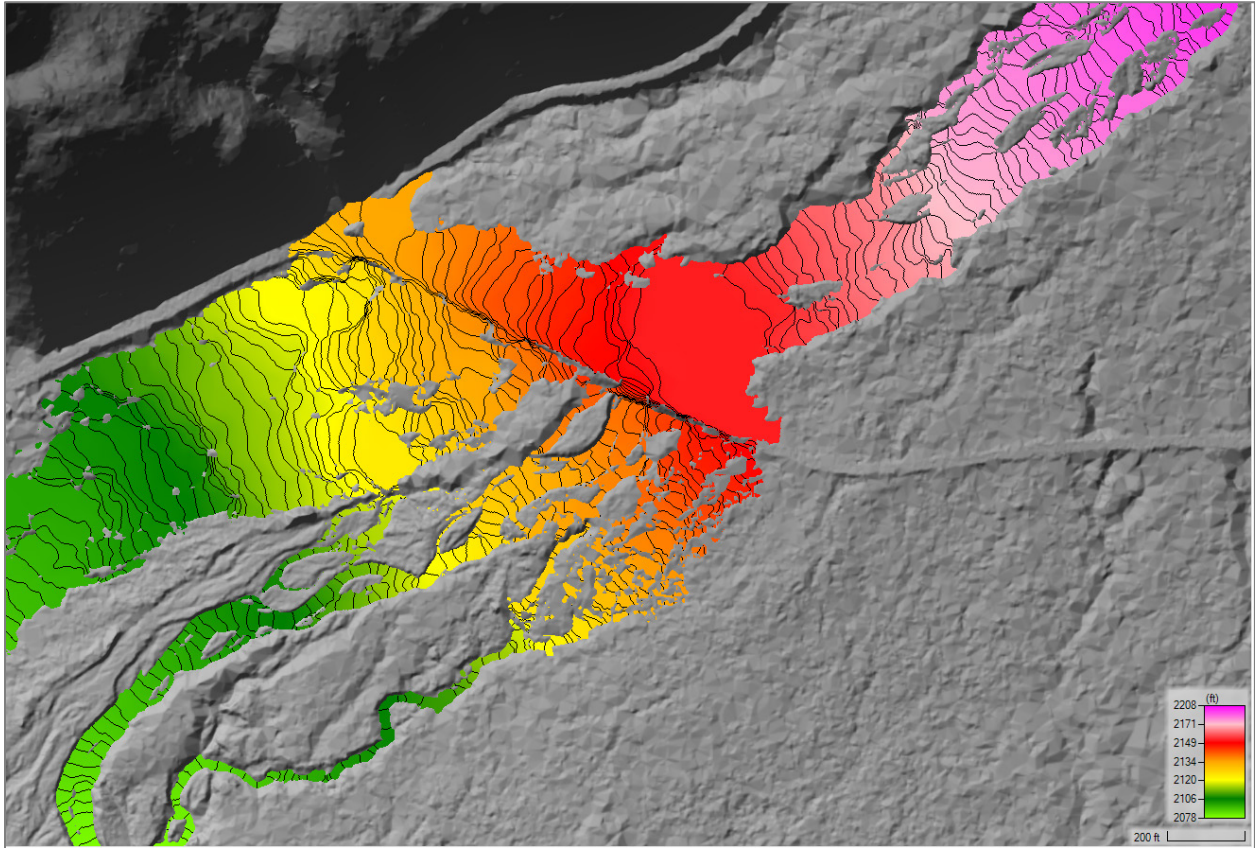
The result depicted in Figure 9 is an overtopping and lateral migration of the Tahoma Creek active channel, causing spill-over locations on the road to appear across roughly 274 m (900 ft) of the active

floodplain (Leon 2020). Most of the flow, visually estimated to be roughly two-thirds or more of the modeled discharge, heads west and flows parallel to the roadway, spilling across most of it. Several potential head cuts are visible along the 152 m (500 ft) of road west of the bridge, with the Westside Road junction being inundated by up to 0.6 m (2 ft) of water.

Figure 9. Water surface elevations of modeled 100-year flow event interacting with a debris plug at the upstream face of the bridge. Contour interval is 1 ft (0.3 m). Colors represent elevations above mean sea level in feet (Modified from Figure 9A in Leon [2020]).

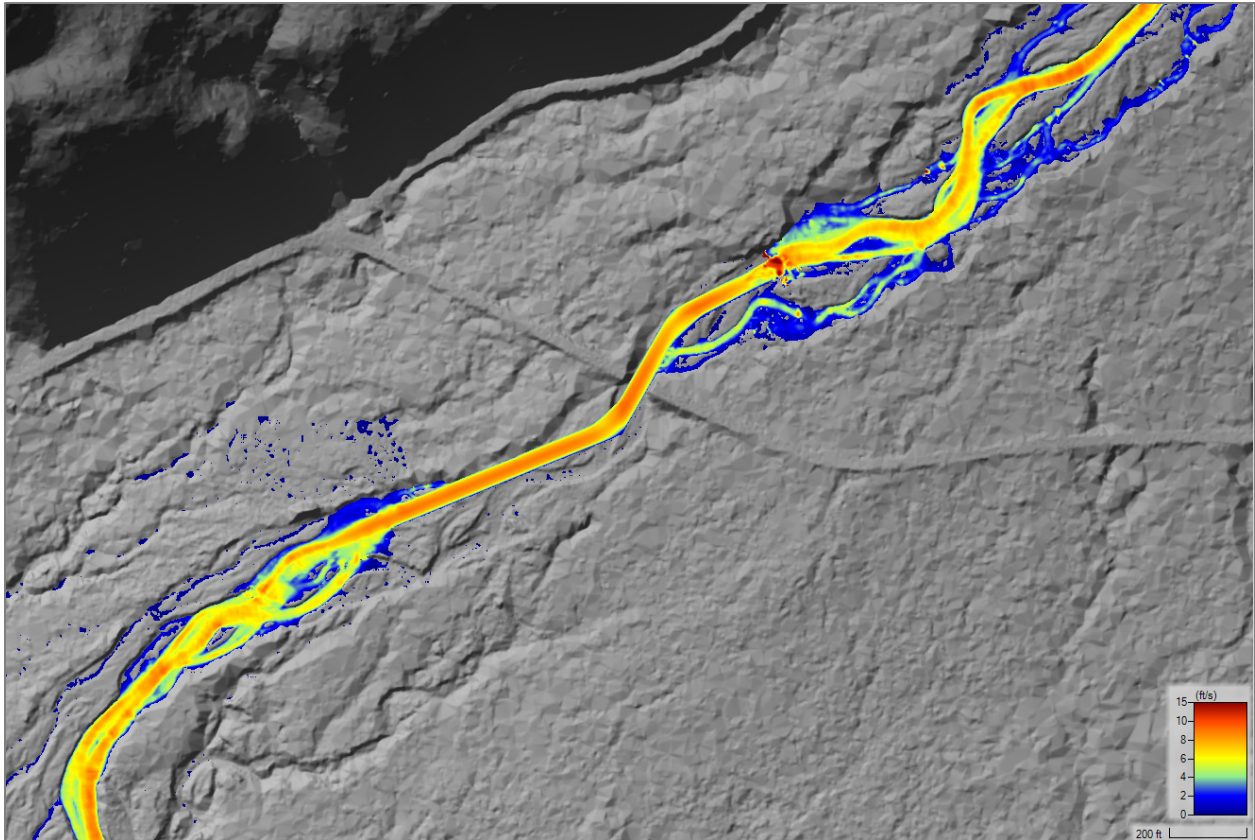
Figure 10 depicts the flow velocities of a 2-year flow in the modified channel. High velocity values are sustained through the length of the dredged channel and suggest that this design is sufficient to facilitate sediment transport. The upstream end of the modified channel shows a velocity increase associated with the sudden change in slope where the modified channel tapers to meet the natural channel profile.

Figure 10. Velocity of a 2-year flow in the modified channel. The warmer colors represent higher velocity values of up to 15 ft/s (4.6 m/s) where entrainment of sediment is likely, while cool colors represent areas of lower velocity where deposition is expected. The highest velocity values are located at the upstream end of the modified channel (Modified from Figure 7D in Leon [2020]).

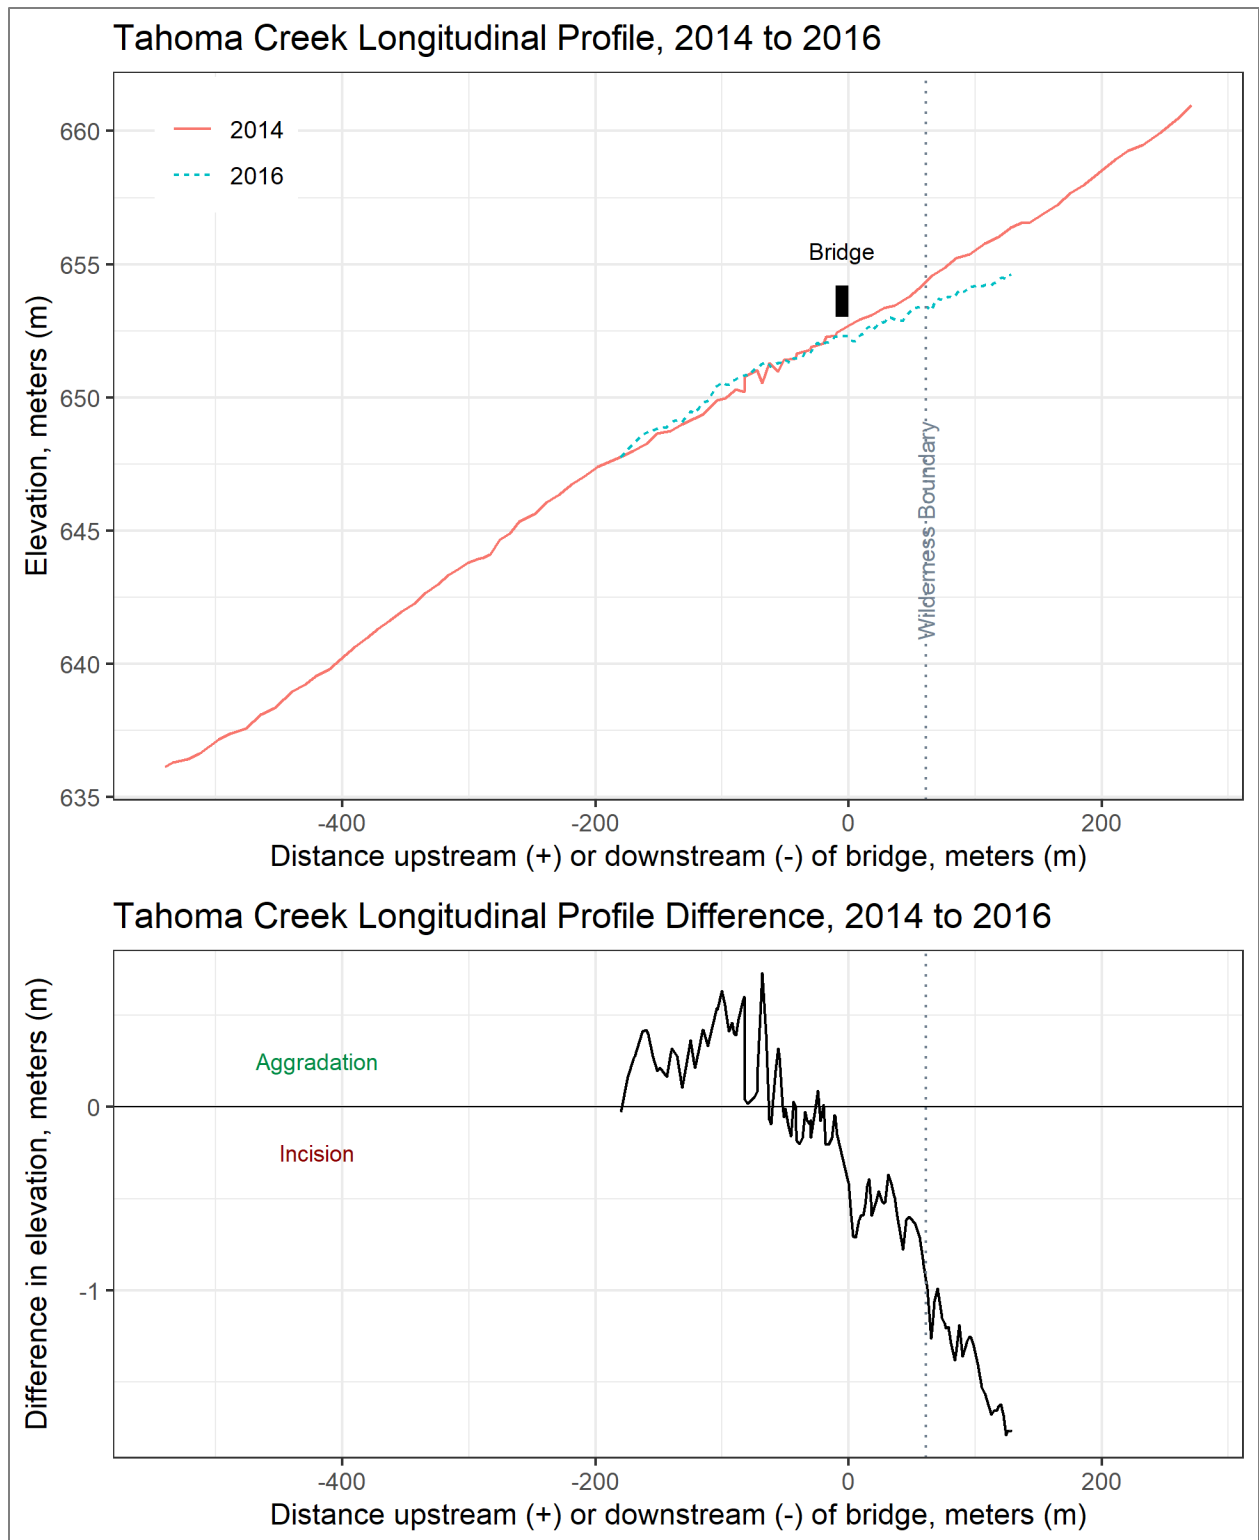
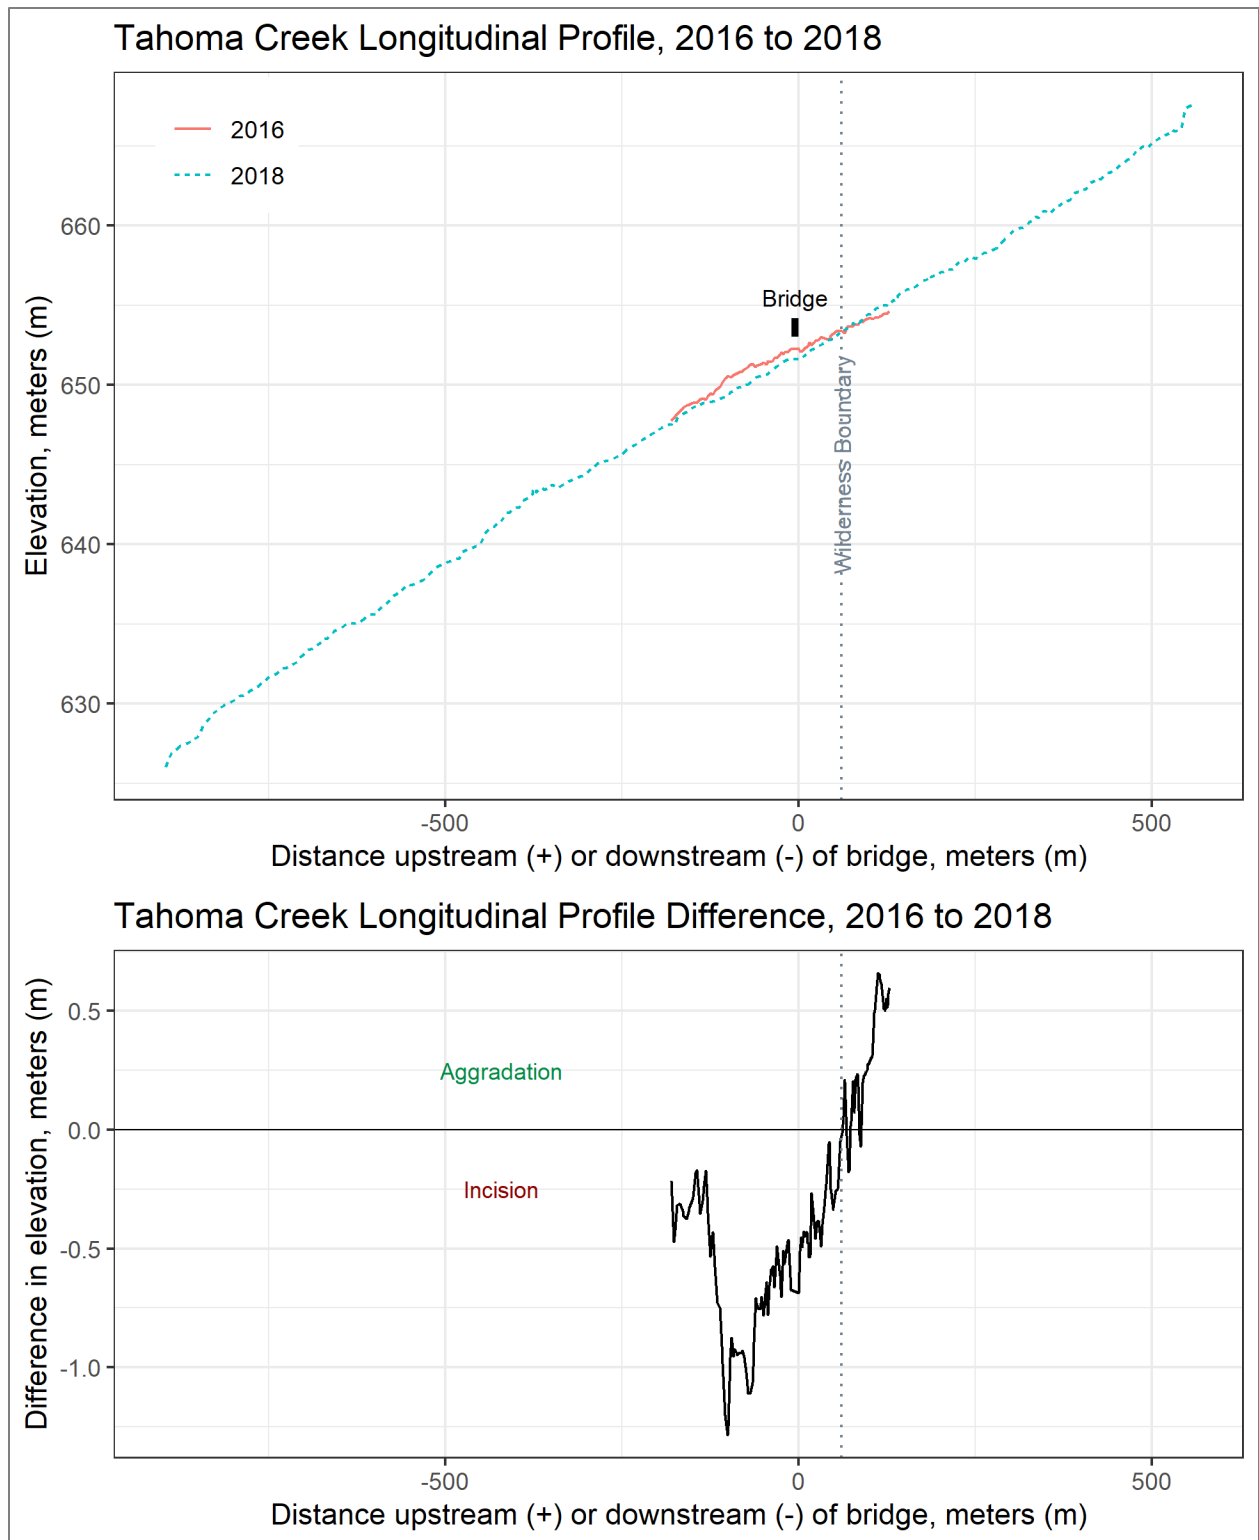
Furthermore, the change in profiles in Figures 16 and 17 were surveyed during a time when only one dredging operation took place (2016) and show less variability in elevation changes. It is especially interesting to note that the profile difference between 2018 and 2020 (Figure 18) is net negative. The profiles surveyed during time periods with frequent dredging have a more widespread aggradation signal along the profile. In contrast, aggradation appears more isolated during periods of less frequent dredging, and incision can be observed.

Figure 16. Longitudinal profiles of Tahoma Creek surveyed in 2014 and 2016 (top), and elevation difference between the two profiles (bottom). Elevation difference is calculated as the elevation of the more recent profile minus the elevation of the older profile, along the longitudinal distance of the profile. Vertical exaggeration: ~21.0x (top); ~145x (bottom).

Figure 17. Longitudinal profiles of Tahoma Creek surveyed in 2016 and 2018 (top), and elevation difference between the two profiles (bottom). Elevation difference is calculated as the elevation of the more recent profile minus the elevation of the older profile, along the longitudinal distance of the profile. Vertical exaggeration: ~22.6x (top); ~336x (bottom).
