Melrose Servants' Barn

Historic Structure Report

Natchez National Historical Park

Natchez, Mississippi

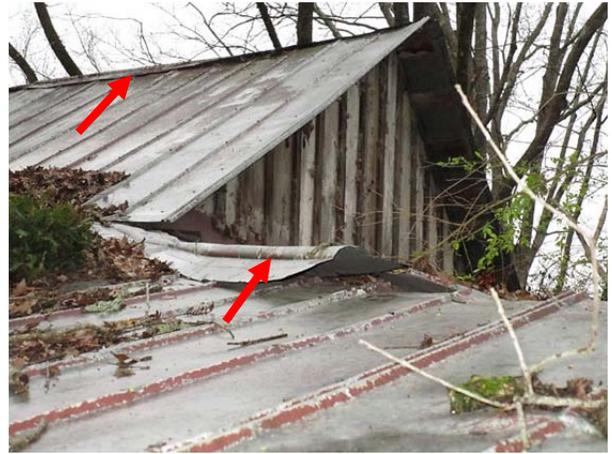
FIGURE 36. Metal roofing on the gable roof of the barn and the covered storage area. Note the missing metal hip ridge cap in the foreground.

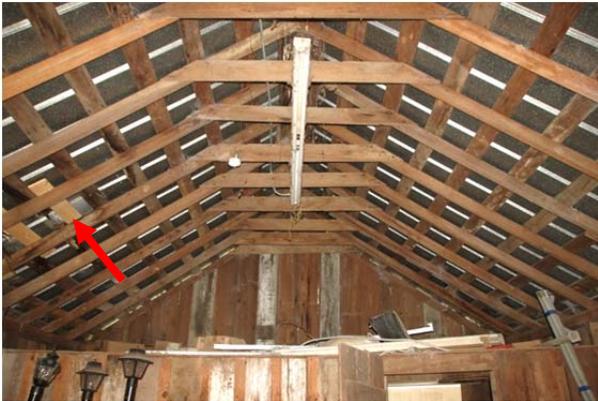
FIGURE 35. New wood nailing strips where roof was repaired.

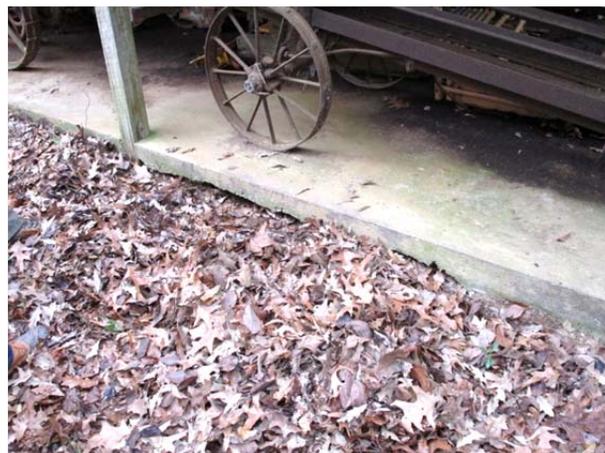
- On the southwest side of the covered storage area, the concrete slab is undermined (Figure 40).
- Spalled brick and deteriorated mortar joints were observed in the masonry piers that support the enclosed rear section of the barn (Figure 41 and Figure 42).
- As a result of inadequate consolidation, there are voids and exposed coarse aggregate in the edge of the concrete slab of the covered storage area (Figure 43).

FIGURE 40. Concrete is undermined in the southwest corner.

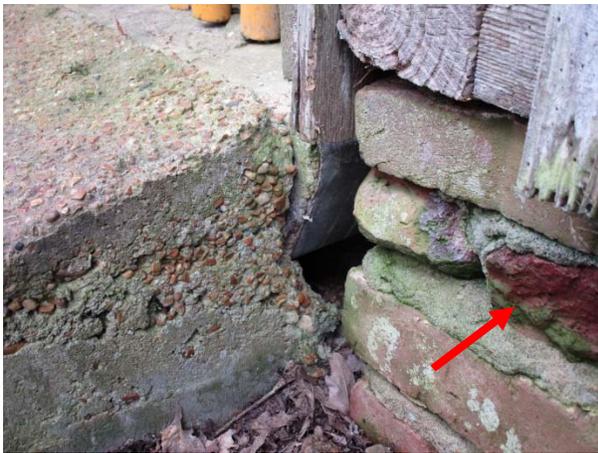
FIGURE 42. Spalled brick and deteriorated mortar at a pier and the edge of the adjacent concrete slab.

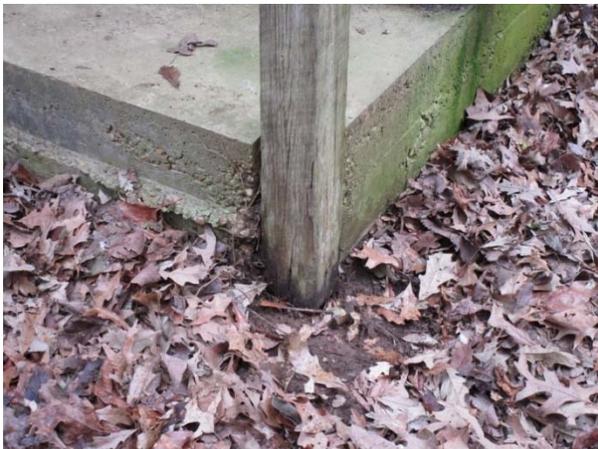
FIGURE 43. Voids and exposed aggregate at the concrete slab edge.

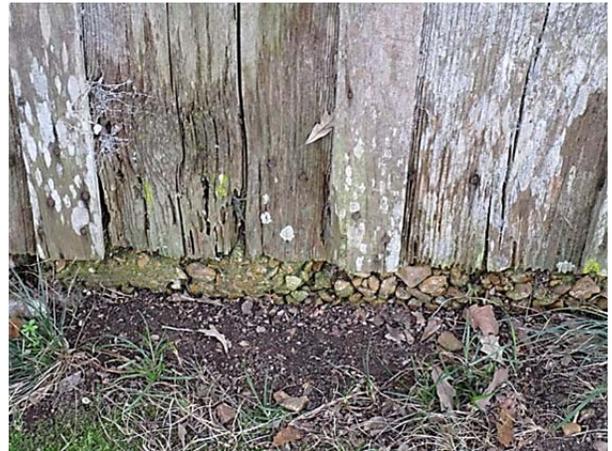
FIGURE 44. Organic growth, including mildew, at the base of exterior walls.

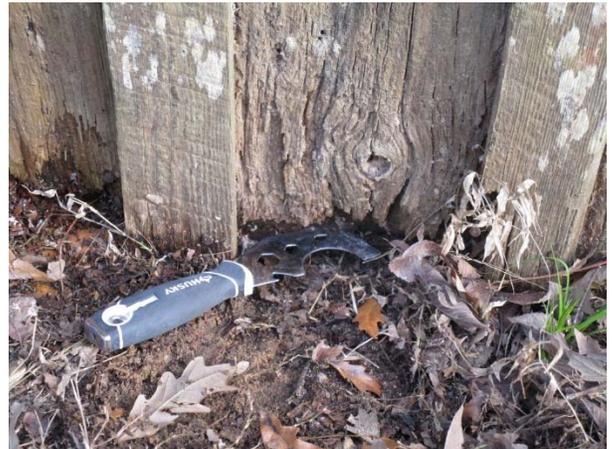
- There is heavy decay and organic growth at the base of the wood siding, because it is in direct contact with the ground (Figure 45).
- In addition to decay, there is staining and organic growth at the base of the walls under the covered storage area where water collects and cannot drain away. This condition occurs on the southwest side of the structure where the bottom of the wall is visible, but it is also likely to occur on the southeast-facing wall (Figure 46).

FIGURE 45. Heavy decay at the base of the walls

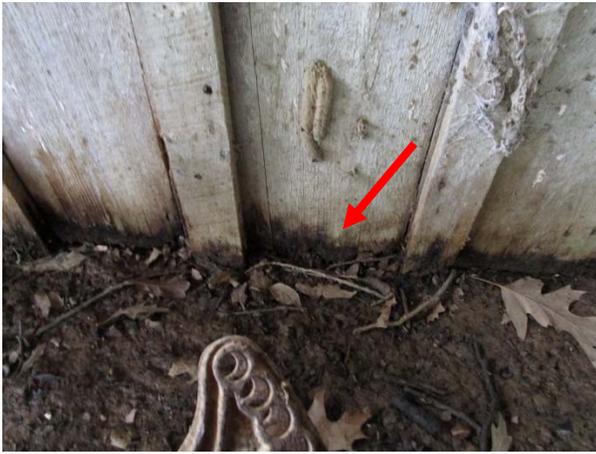
FIGURE 46. Staining and rot along the base of the board and batten walls.

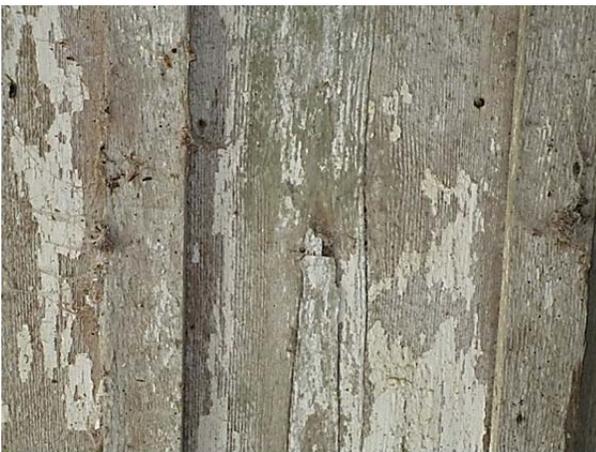
FIGURE 47. Deteriorated paint or whitewash finish on the exterior walls.

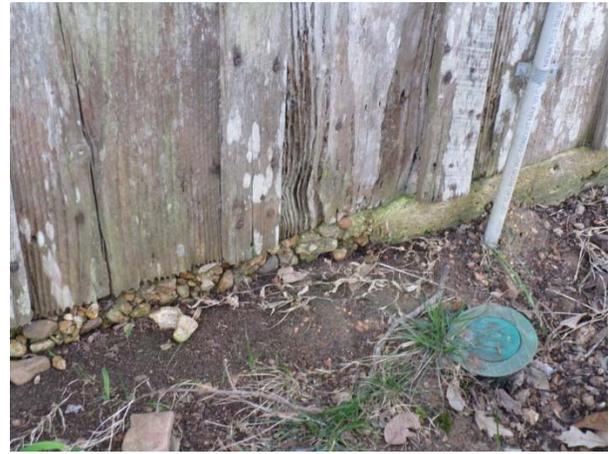
FIGURE 48. Organic growth and deterioration at the base of the barn walls.

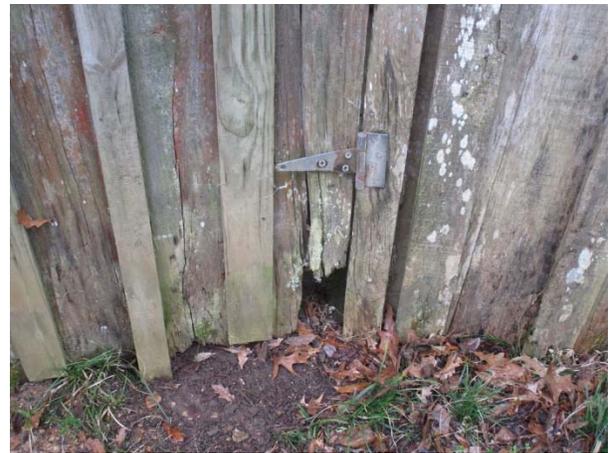
FIGURE 49. Staining, organic growth, and deterioration on the main carriage door at the northwest elevation.

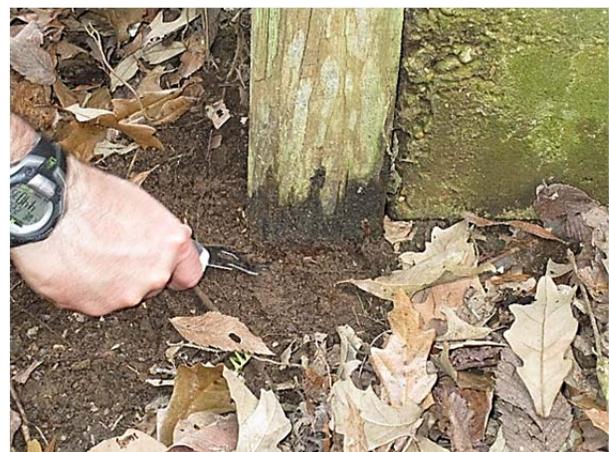
- Moist conditions plus wood in contact with the ground and concrete and masonry foundations are attractive to termites and other destructive insects.
- Protective finishes on the exterior wood walls have almost entirely deteriorated (Figure 47). This leaves the wood vulnerable to moisture, organic growth, deterioration, and decay (Figure 48 and Figure 49).
- There is decay at the base of the 4x4 wood posts that support the roof of the covered storage area. These posts sit on the ground and not on the concrete slab, and are in contact with moist soil and wet leaves from the surrounding vegetation (Figure 50 and Figure 51).

FIGURE 50. Decay at the base of the post at the south corner of the covered storage area.

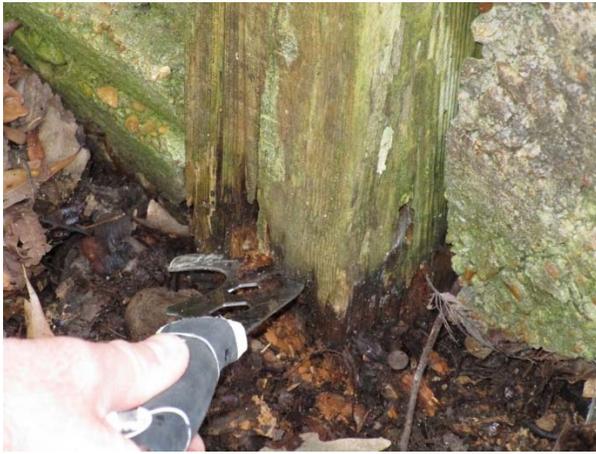
FIGURE 51. Decay at the base of the post at the east corner of the covered storage area.

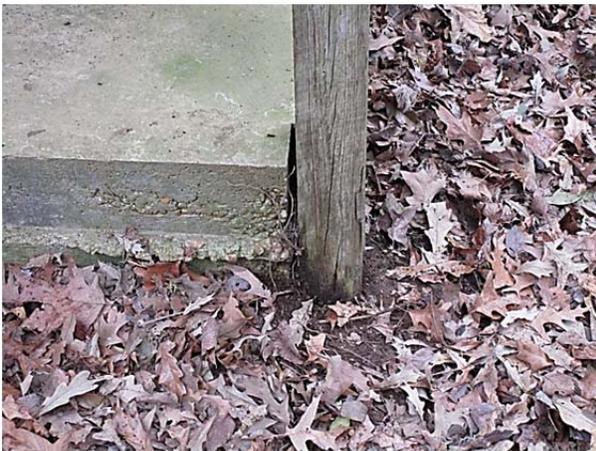
- The wood post at the south corner of the covered storage area has also separated from the edge of the slab probably because the concrete slab was poured around the post and there is no mechanical connection of the post to the slab (Figure 52 and Figure 53). Eventually, the end of the post will rot, and the post and the beams it supports will drop down accordingly.
- Corrosion and rust are prevalent on the galvanized steel roofing that has been in place for a long period of time (Figure 54).

FIGURE 52. Deterioration of the wood post and the lack of a connection to the concrete foundation resulted in a gap between the post and the slab.

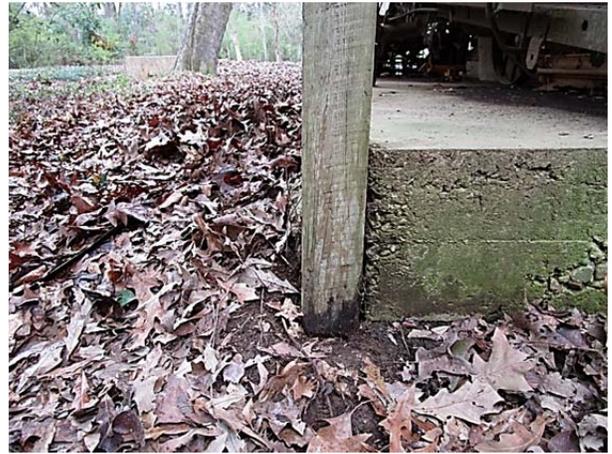
FIGURE 53. A concrete slab was poured around the wood posts leaving the posts bearing directly on the ground.

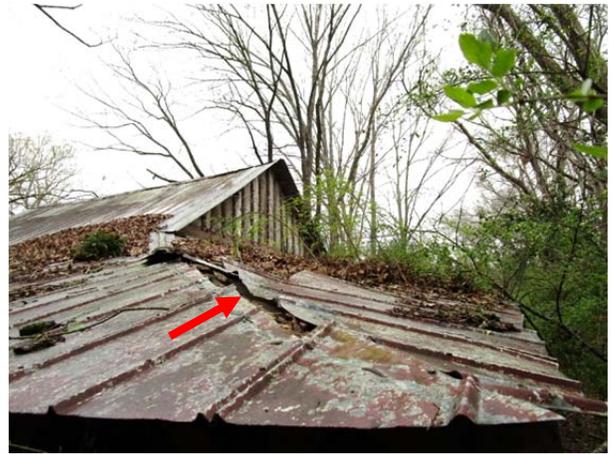
FIGURE 54. Corrosion on the roof panels and open joint along the hip ridge.

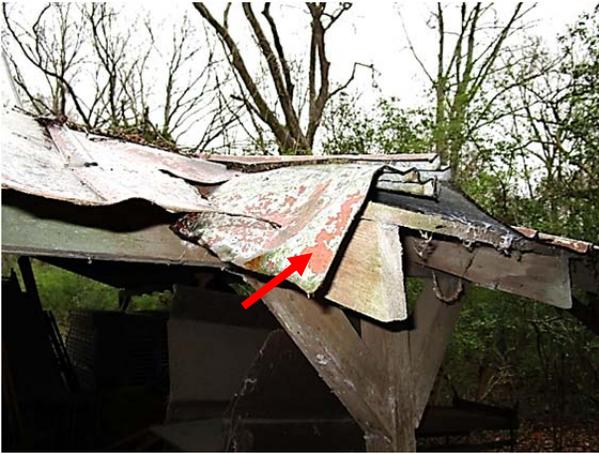
- Some of the metal roofing panels have signs of a red paint coating that has deteriorated and delaminated from the galvanized steel substrate. Exposure to ultraviolet (UV) radiation and environmental pollutants may be the cause (Figure 55).
- At the south corner of the open storage area, the hip ridge cap is missing, and the roof panels are corroding (refer to Figure 36). The open seam along the hip ridge channels rain water to the wood framing and concrete slab below. Consequently, the wood framing has deteriorated and failed leaving a hole in the roof (Figure 56).

FIGURE 55. Red paint coating on some of the metal roofing panels.

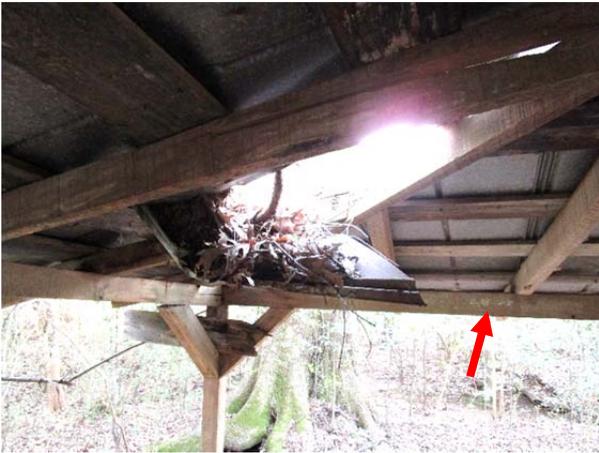
FIGURE 56. Failure of the wood roof framing and metal roof panel. Note sagging perimeter beam to the left of the roof opening.

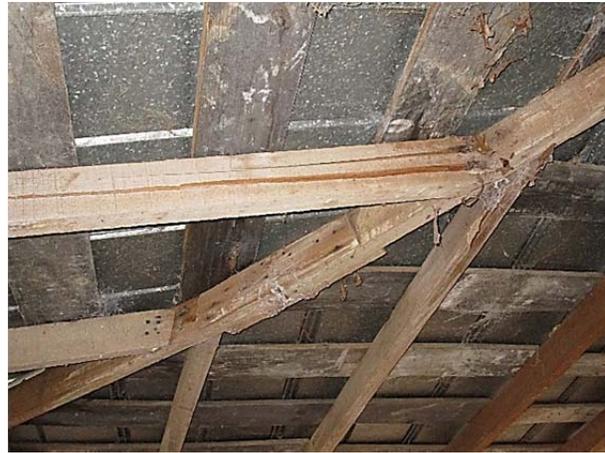
FIGURE 58. A fractured joist was noted at the hip ridge, at the south corner of the shed roof.

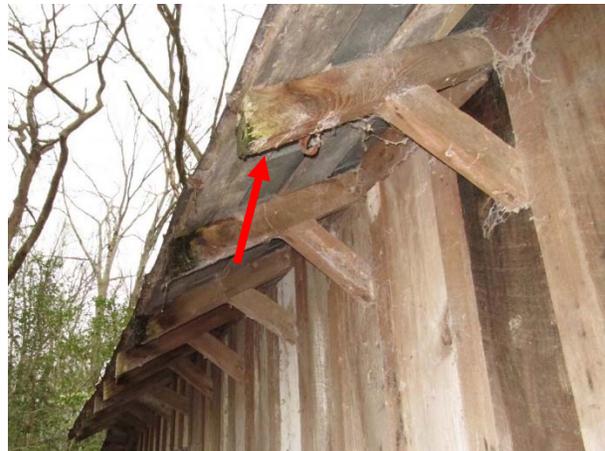
- Decaying wood structural members at the east and west ends of the covered storage area have resulted in sagging beams and joist failures that also contribute to deformation of the metal roof panels, particularly along the eave (Figure 57 and Figure 58).
- Generally, deterioration of wood structural components was observed throughout the structure, especially where the wood has the most exposure to exterior environmental conditions (Figure 59 and Figure 60).

FIGURE 59. Decay at the ends of the gable roof rafters.

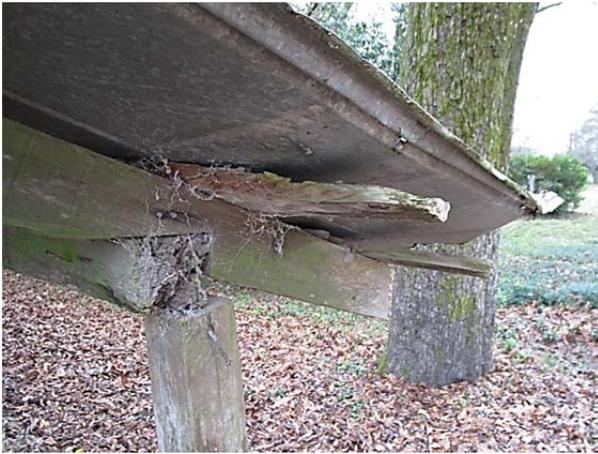
FIGURE 60. Decay in the ends of support beams, roof joists and nailing strips.

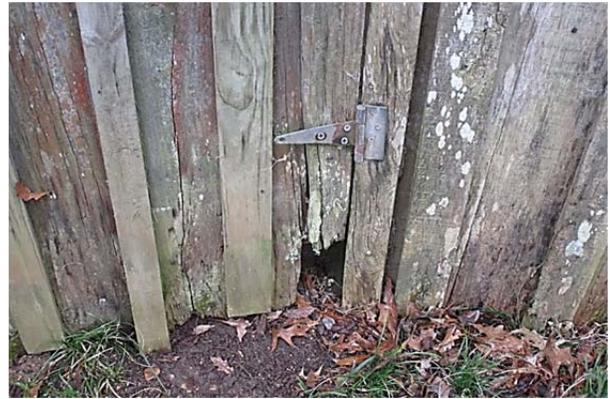
- Numerous rotted siding boards and battens were observed. Most of the decay occurs at the base of the siding where it is close to or in contact with the ground (Figure 61 and Figure 62). A number of gaps and openings in the siding in and the doors, because of rotten wood and missing battens, contributes infestation by rodents, birds and insects.
- The strap hinges and hasps on the carriage doors have corroded, and the screws fastening them to deteriorating wood will eventually fail (Figure 63).
- Some battens are missing on the carriage doors (Figure 64).
- The grade of the wooded area to the south of the barn flattens and appears to hold water between the uphill culvert at the road (Figure 65) and the inlet of a concrete headwall further in the woods to the east (Figure 66).

FIGURE 61. Rotten boards on the carriage door that faces the road. Also note corroding strap hinge.

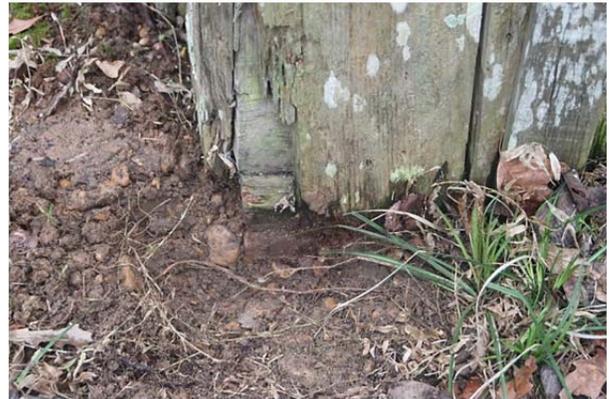
FIGURE 62. Rotten siding boards in contact with the ground.

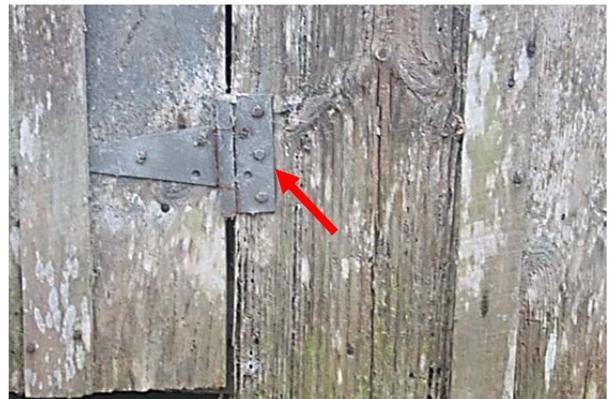
FIGURE 63. Strap hinges have corroded.

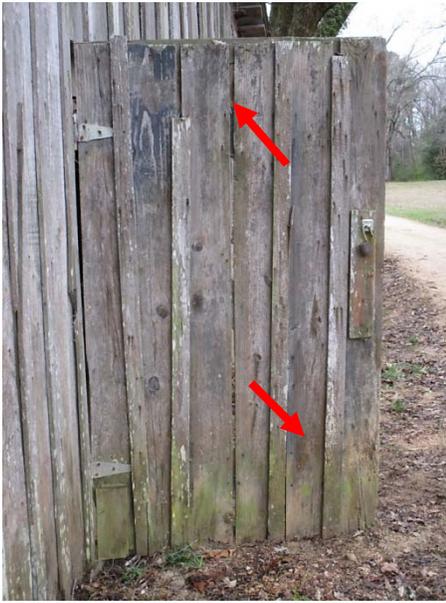
FIGURE 64. View of missing battens on the carriage door.

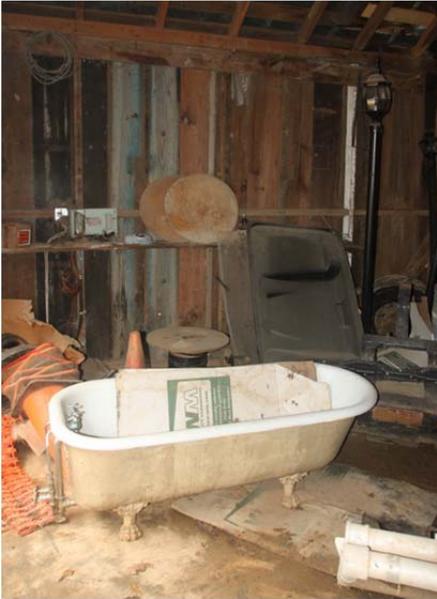
The concrete slab is barely discernable because of the clutter and a layer of moist dirt (Figure 71). Dust, dirt, spider webs, and rodent droppings are prevalent in both spaces. The carriage doors do not close properly, leaving wide gaps along their perimeter and where they meet. Also refer to the above description of the doors.

FIGURE 71. Interior view. Note the floor covered with a layer of dirt and wet cardboard.

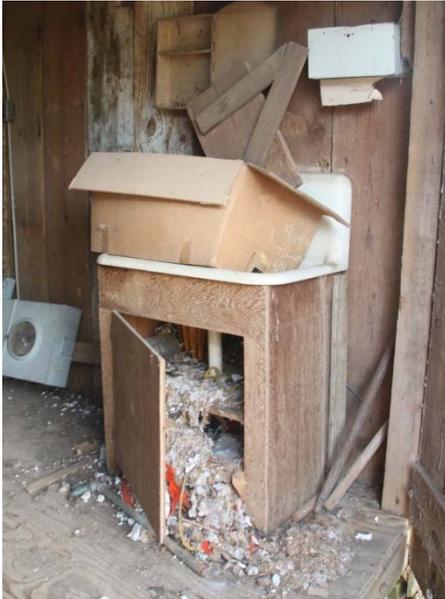
FIGURE 78. A utility sink mounted in a wood cabinet in the small secondary space. Note the debris from rodent nest in the sink cabinet.

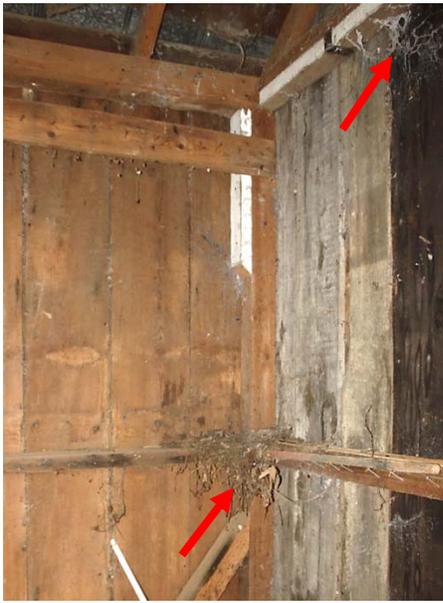
- The barn is cluttered and dirty, and it has copious amounts of spider webs, insect and rodent droppings, and the remains of nests (Figure 79 and refer to Figure 78). It will require thorough cleaning before a final determination of which materials are historically significant, and to confirm which are to be retained in rehabilitation of the structure.

FIGURE 79. Remains of a nest in the corner and some of the spider webs in the upper right.

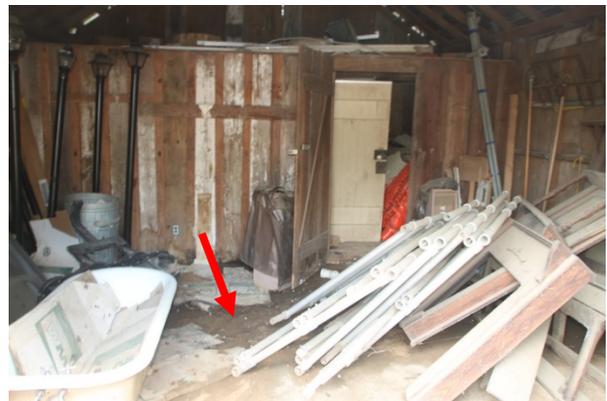
FIGURE 81. Dark area of moisture under stored materials on the interior concrete slab.

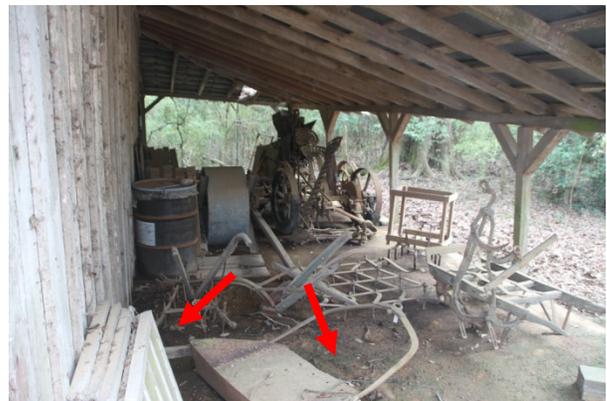
FIGURE 82. Dark area of wet dirt on the slab along the board-and-batten wall of the covered storage area.
