SNAKE HOUSE RUIN 1978

Stabilization of Snake House Ruin

Report submitted to
National Park Service
Southwest Cultural Resources Center
Santa Fe, New Mexico

May, 1979

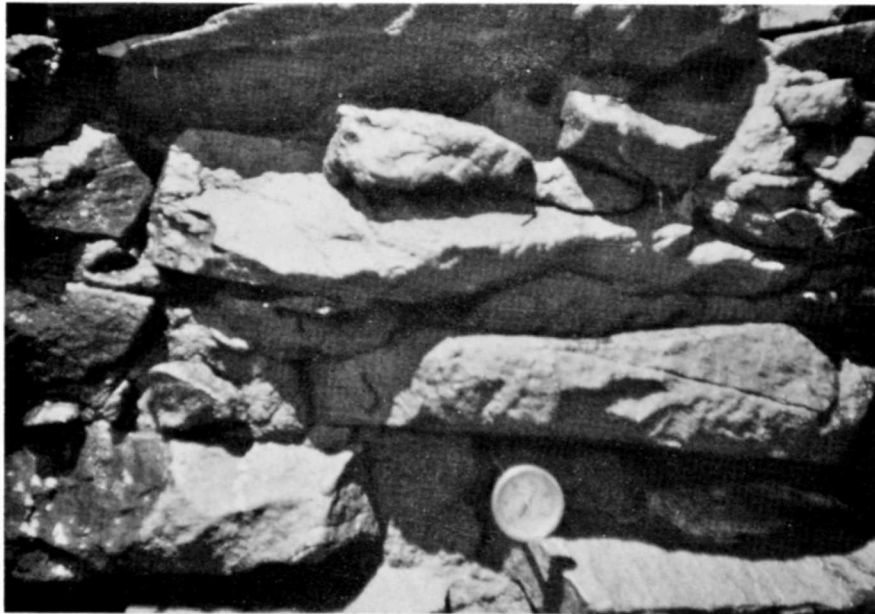
Figure 22.
Close up of coated area still wet, and
uncoated natural stone.

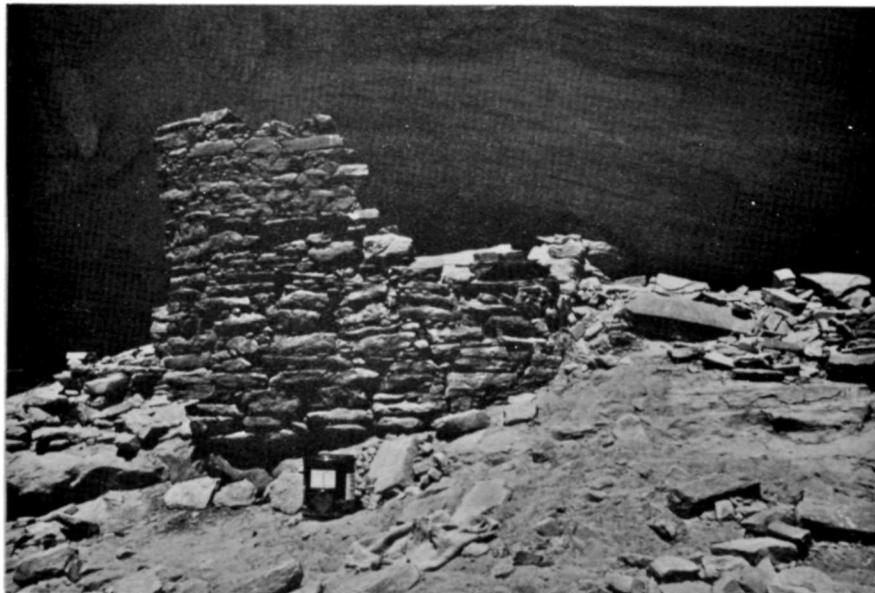
Figure 23.
Room 3 after the final application of
methyl methacrylate.

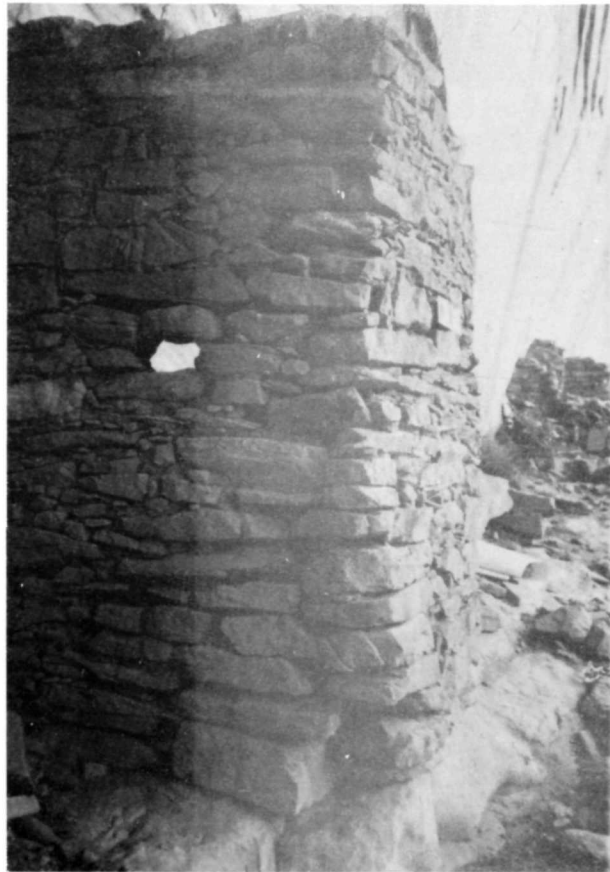
Figure 29.
SHP-78 1-11-13. Room 3, job 1 south exterior of corner before stabilization, May, 1978

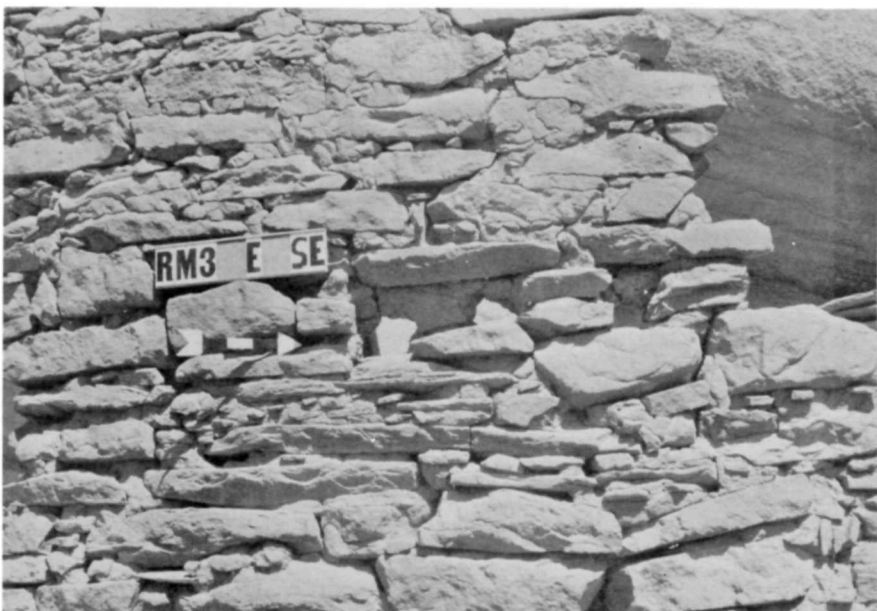
Figure 32.
SHP-78 1-2-4. Room 3, job 2 exterior of southeast wall, before stabilization, May, 1978.

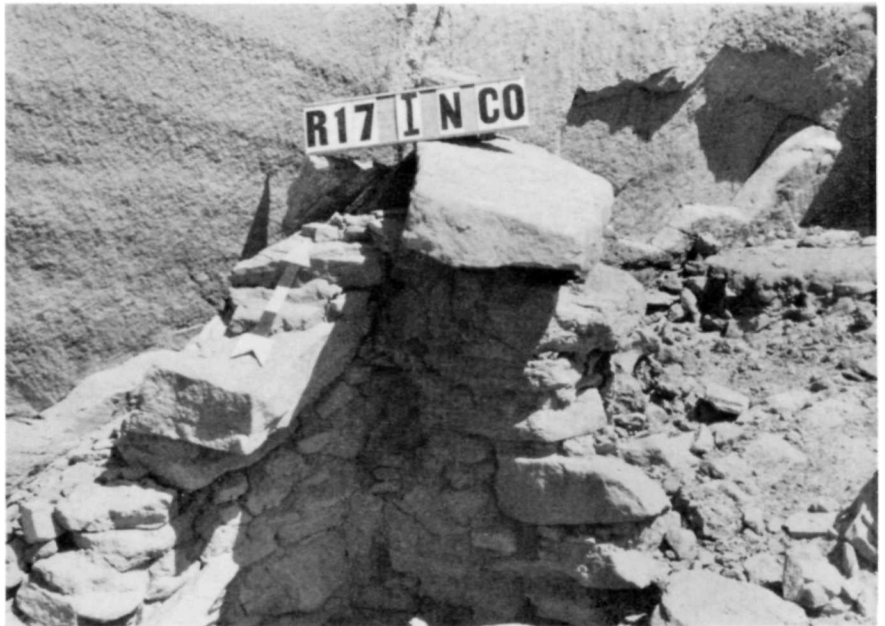
Figure 39.
SHP-78 1-12-14. Room 17, job 4,
interior of north corner before
stabilization, May, 1978.

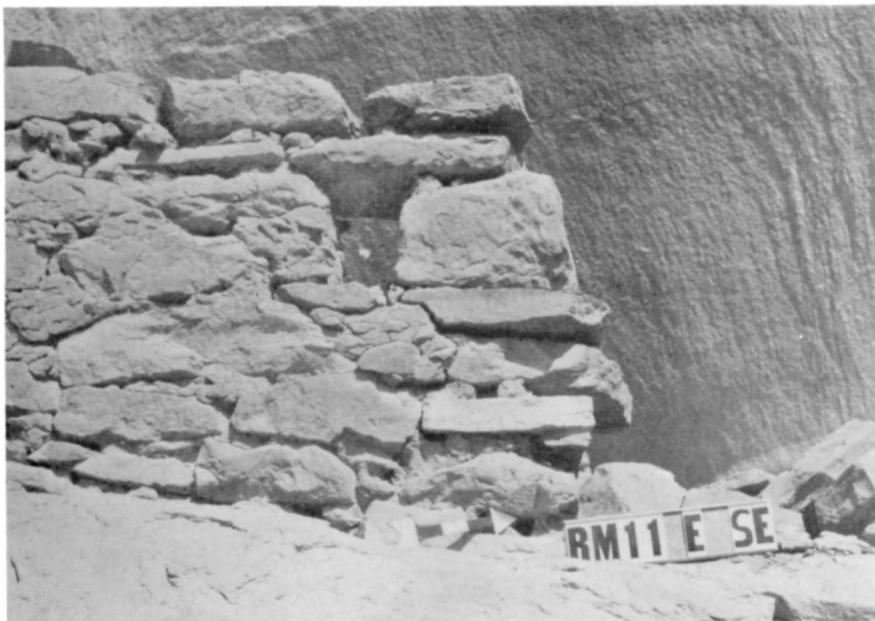
Figure 51.
SHP-78 1-4-6. Room 11, job 9,
northeast wall end before
stabilization, May, 1978.

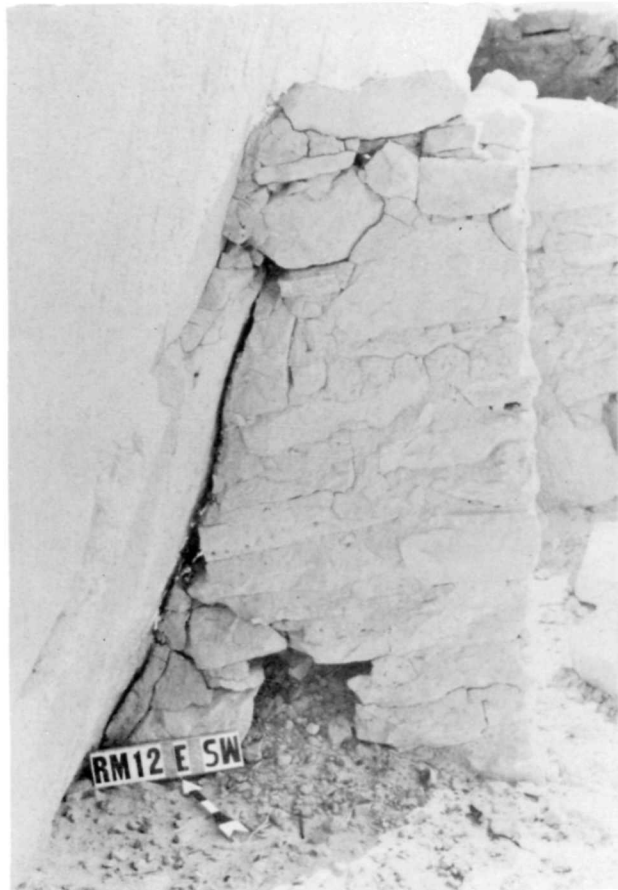
Figure 54.
SHP-78 1-5-7. Room 12, job 10-11,
southwest exterior wall before stabilization, May, 1978.

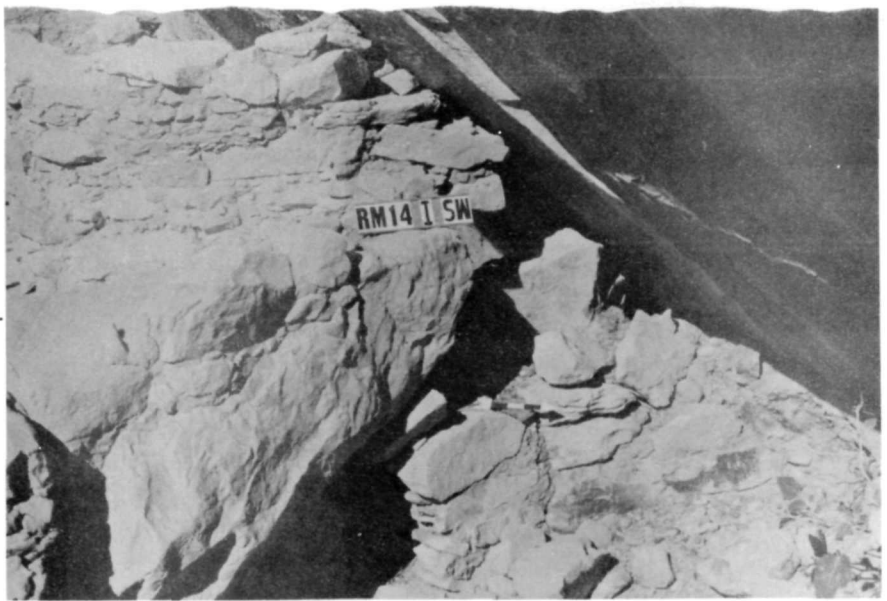
Figure 66.
SHP-78 1-16-18. Room 14, job 15 southwest interior wall before stabilization, May, 1978.

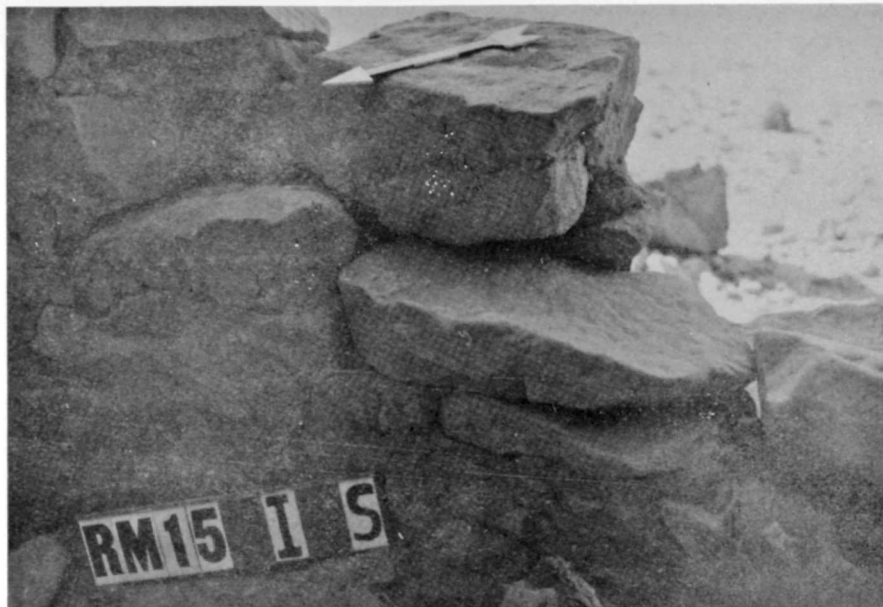
Figure 77.
SHP-78 1-17-19. Room 15, job 19 interior of southeast wall before stabilization, May, 1978.

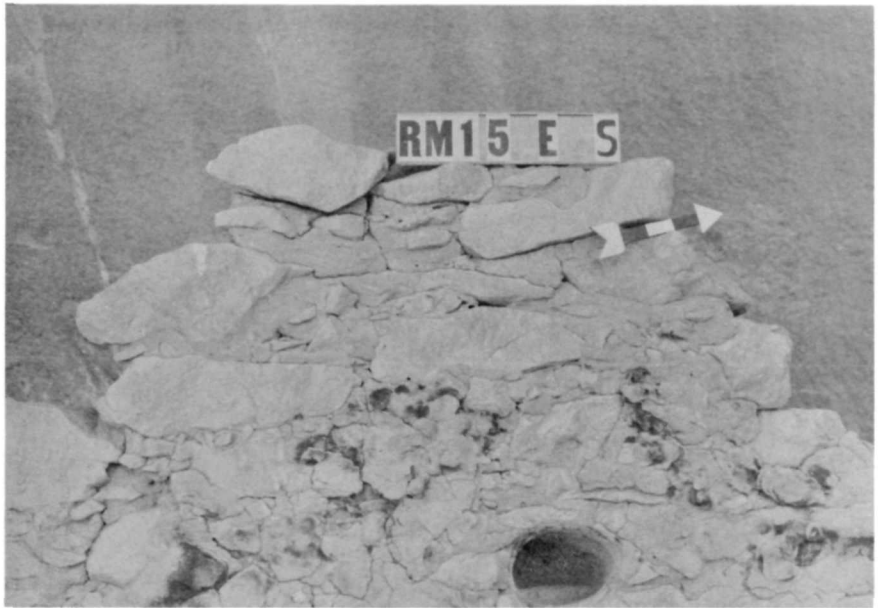
Figure 80.
SHP-78 1-18-20. Room 15, job 20 exterior of southeast wall before stabilization, May, 1978.

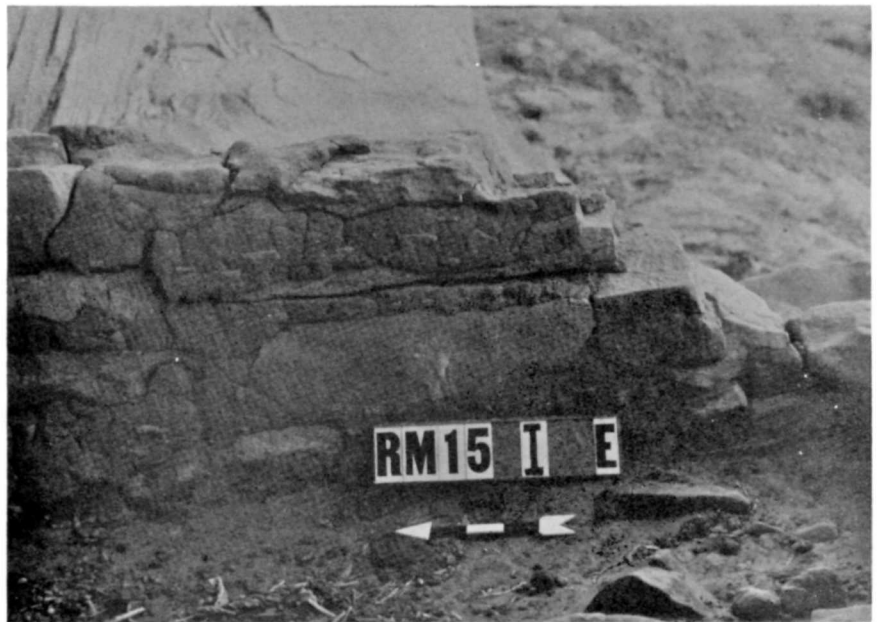
Figure 83.
SHP-78 1-7-9. Room 15, job 21-22
northeast wall before stabilization,
May, 1978.

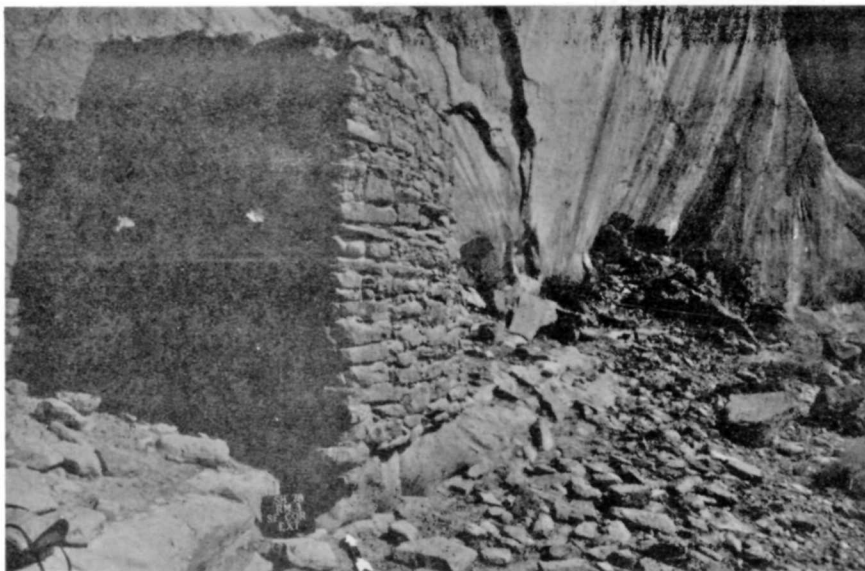
Figure 92.
SHP-78 4-1-3. Winter check
Room 3, southeast exterior
wall. Note the excellent
condition of the stabili-
zation. March 1979.

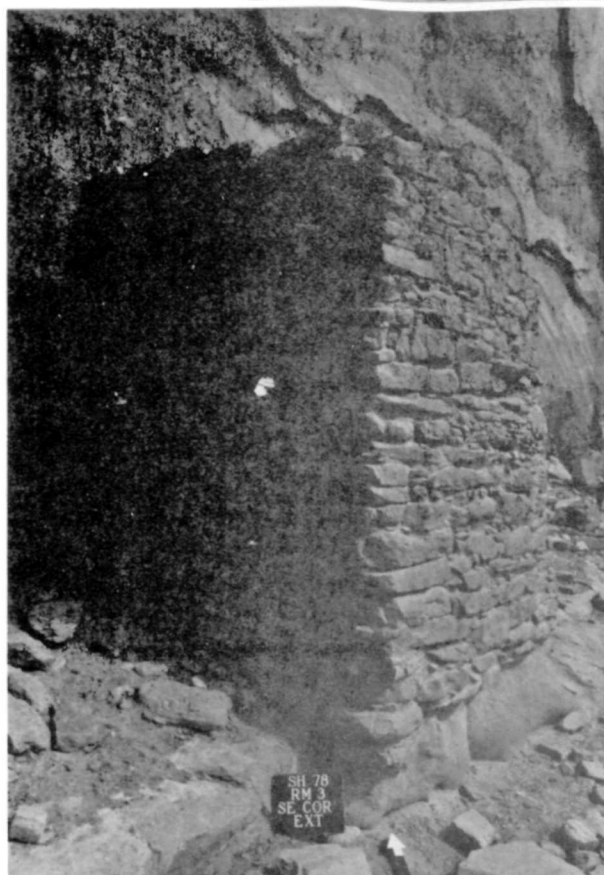
Figure 93.
SHP-78 4-2-4. Winter check
Room 3, southeast exterior
corner. Note the condition
of job 1 stabilization area.
March 1979.

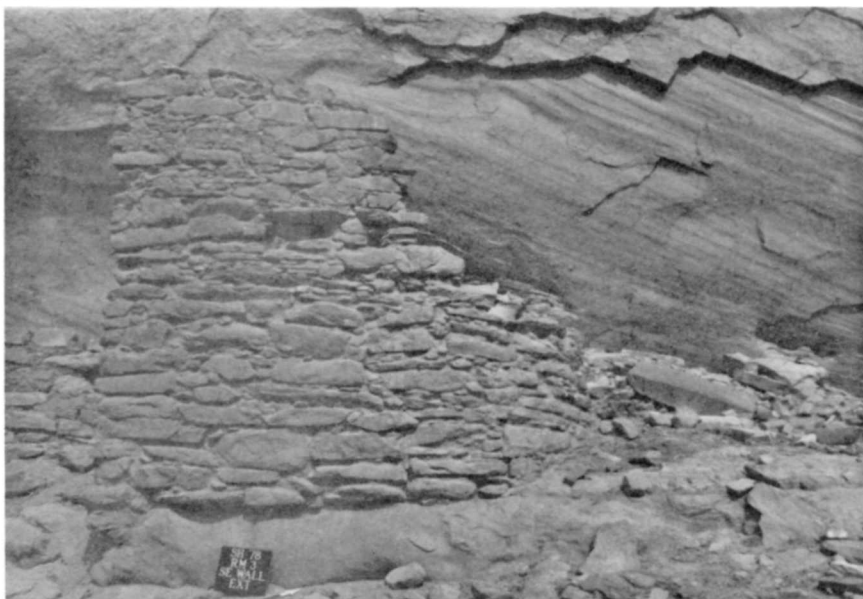
Figure 95.
SHP-78 4-4-6. Winter check
Room 3, southeast exterior
wall. Close-up of painted
and methyl methacrylate
areas. March 1979.

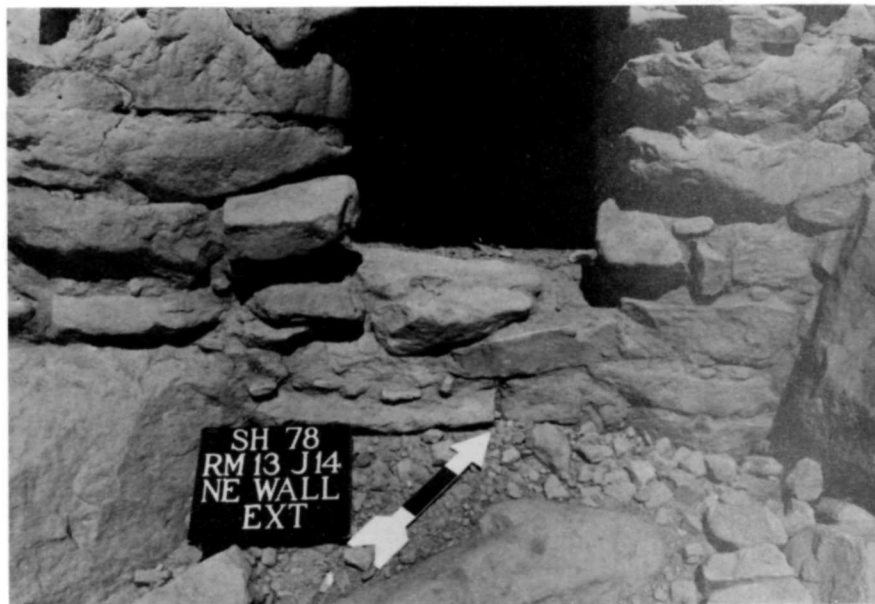
Figure 99.
SHP-78 4-12-14. Winter Check
Room 13, job 14; northeast ex-
terior wall. Different soil
source used. March 1979.

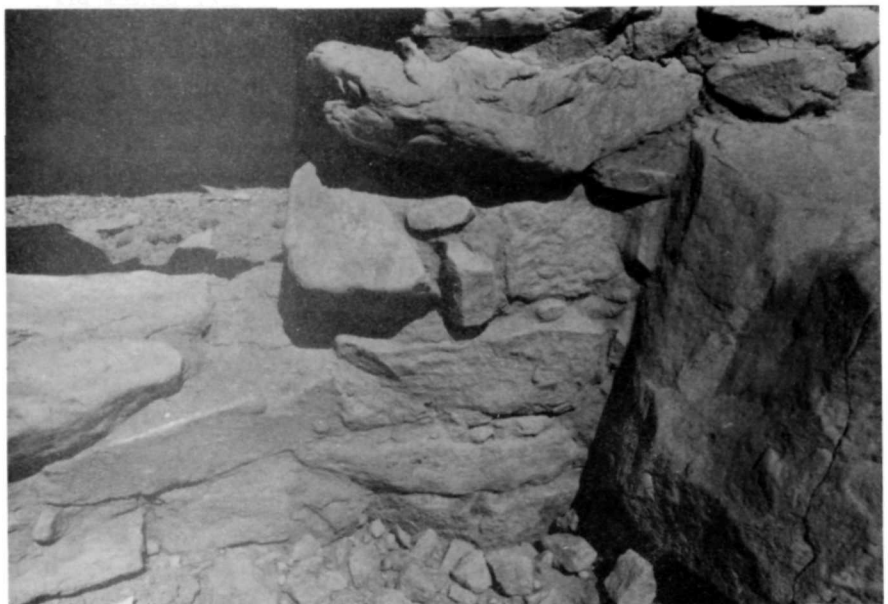
Figure 100.
SHP-78 4-11-13. Winter Check
Room 13, job 14; close-up of
soil. March 1979.
