PHYSICAL CONDITION ASSESSMENT

RESTORATION RECOMMENDATIONS

DOE CREEK SCHOOL

Henderson County, Tennessee

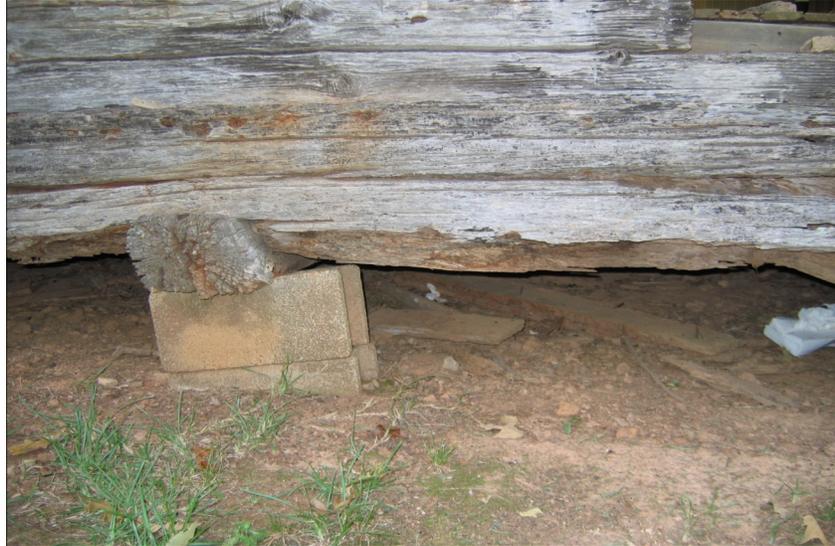
Foundation – Consists of piers composed of rocks and concrete blocks, some turned sideways, laid on the bare earth. These piers should be replaced by ones that are made from large flat limestone rocks, at least two rocks high, set on 12” thick concrete footers dug below the frost line. A minimum of 18” of clearance should exist between the ground and the nearest surface of the wooden sill logs.

Sill Logs – Consist of three large squared timbers running the long way under the building, one under each long wall and one down the center. One end of the middle timber is shown in the above photograph. Some have been repaired at some time in the past. Due to deterioration, these timbers should be replaced by similarly-sized stock, preferably utilizing a decay resistant wood (such as white oak or red cedar).

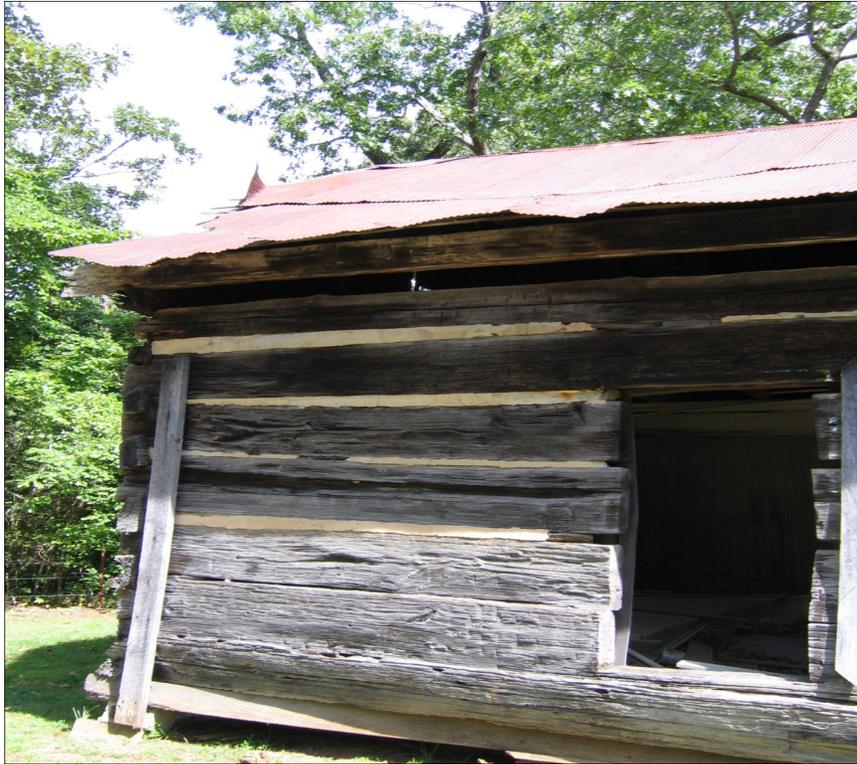
Wall Logs – Consist of hewn yellow poplar logs, 12” to 16” in diameter and half dovetail notched at the ends. Some of these logs, particularly near the bottom of the walls, have deteriorated beyond repair. They should be replaced with similar stock, worked and notched to match the others. A member of the community has saved some of the shorter logs from the west wall and has them stored at his home.

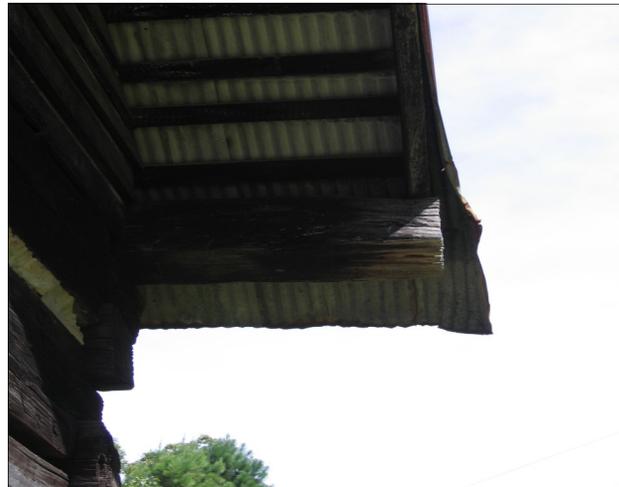
Plates – Consist of two large squared yellow poplar logs at the top of each long wall that support the roof system. These timbers extend beyond the walls in order to provide an overhang front and rear. Since considerable deterioration at the ends of these plates can be observed from the ground, they should be inspected carefully to ensure their soundness. Repair may be possible; otherwise they should be replaced with similar stock, worked in the original way.

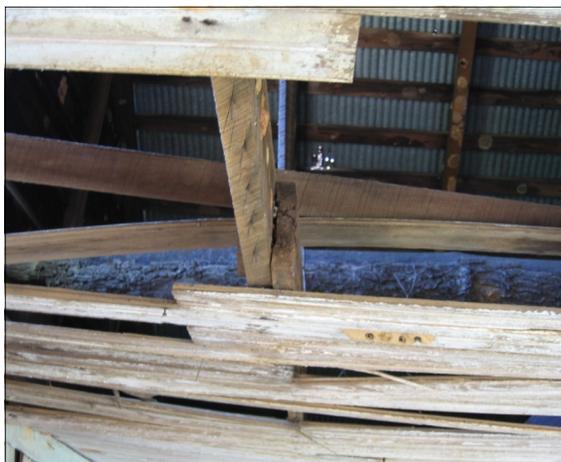
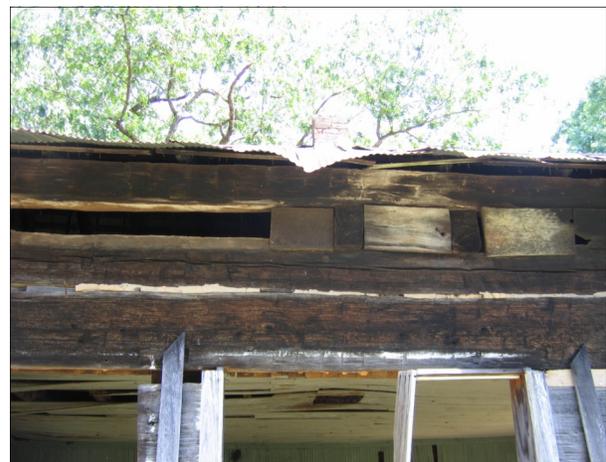
Ceiling Joists – Consist of regularly-spaced 2" by 8" circular-sawn lumber that supports the ceiling itself. In addition, two 4" thick hewn joists support the brick flue in the center of the building. (see photograph below right) 1" by 4" circular-sawn braces connect the joists and the rafters, thus forming crude trusses. All components should be inspected carefully and replaced if necessary with similar material.

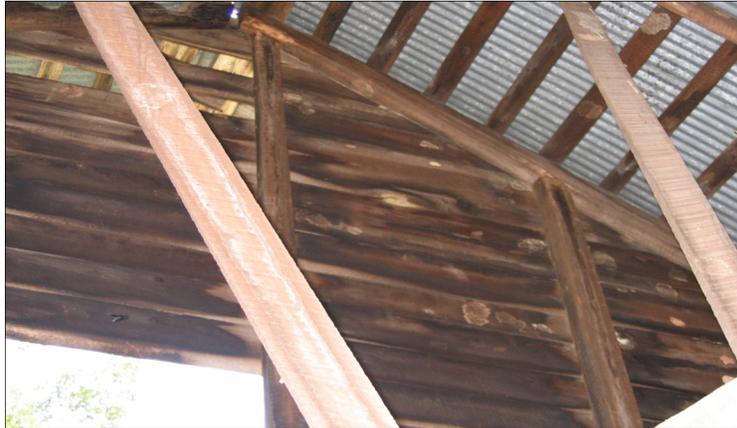
Rafters – Consist of regularly-spaced 3” by 4” circular-sawn lumber butted together at the peak of the roof. Each rafter should be inspected carefully and replaced with similar material if necessary.

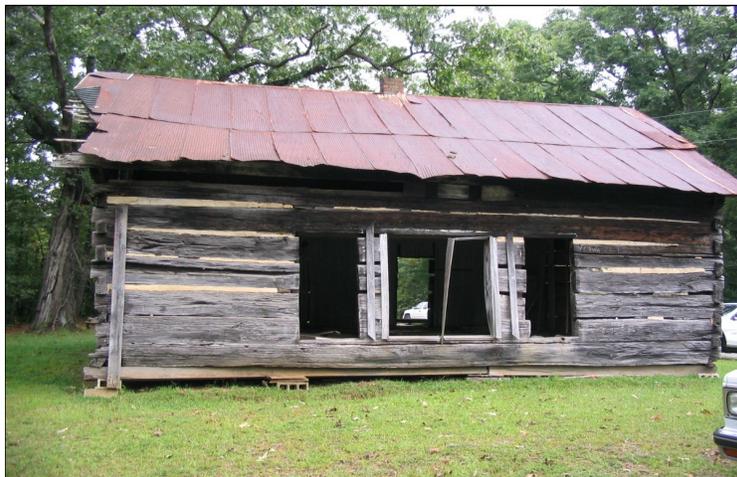
Roofing – Consists of corrugated sheet metal fastened to the lathing with lead-headed nails. The roofing is heavily rusted and in poor condition. It should be replaced with similar new material. Sheet metal in the 5-V pattern would be an acceptable substitute because of its superior water-shedding ability, but modern sheet metal fabricated in agricultural patterns should be avoided.

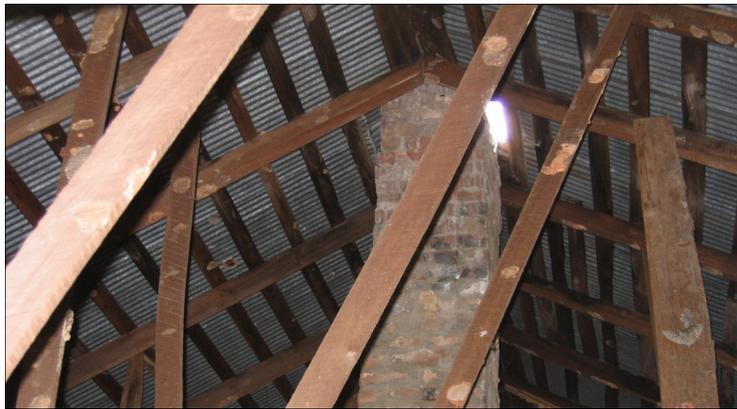
Brick Flue – Consists of a brick and mortar chimney suspended from iron brackets set between two extra-thick hewn joists and extending through the roof. The mortar should be checked for voids and crumbling material and replaced where necessary. The junction of the chimney and roof should be flashed and counter-flashed with appropriate sheet metal.

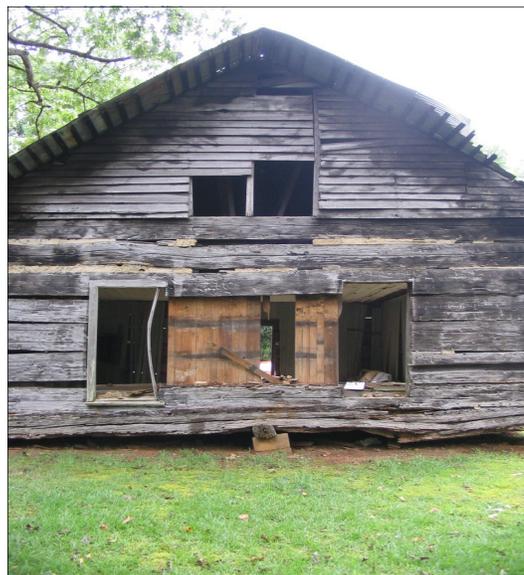
Siding – Consists of overlapping six-inch-wide circular-sawn beveled yellow poplar boards nailed to 3” by 4” circular-sawn yellow poplar studs, enclosing the two gable ends. All elements should be inspected carefully and replaced if necessary, using appropriate nails.

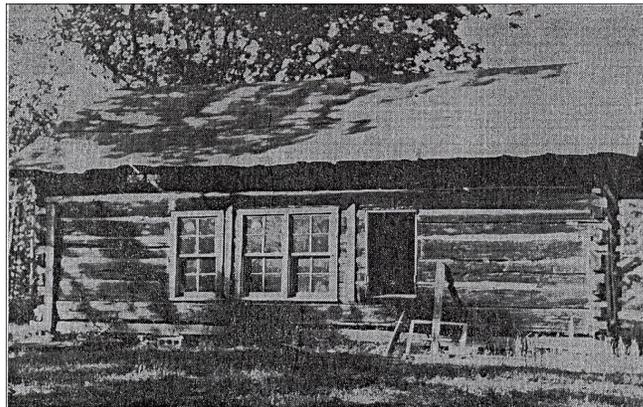
Windows – Each consists of double-hung 4/4 sashes in a simple wooden frame with flat wooden trim. There are a total of eight in the building. Some are completely gone and others are quite deteriorated. These window units should be replaced with similarly-sized units made from the same type of materials used in the originals. Each opening should be reinforced with a vertical 2” thick vertical frame nailed to the logs on either side of the opening. The historic photograph below and remnants on the site provide the information needed to replicate the window units.

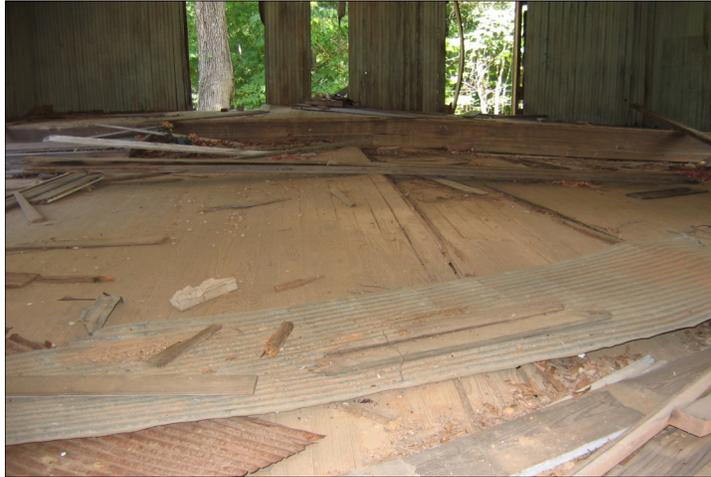
Flooring – Consists of 1” by 4” tongue-and-groove southern yellow pine boards. This flooring is well worn and probably would need to be replaced with similar new material. If enough could be salvaged, it could be used for the stage flooring.

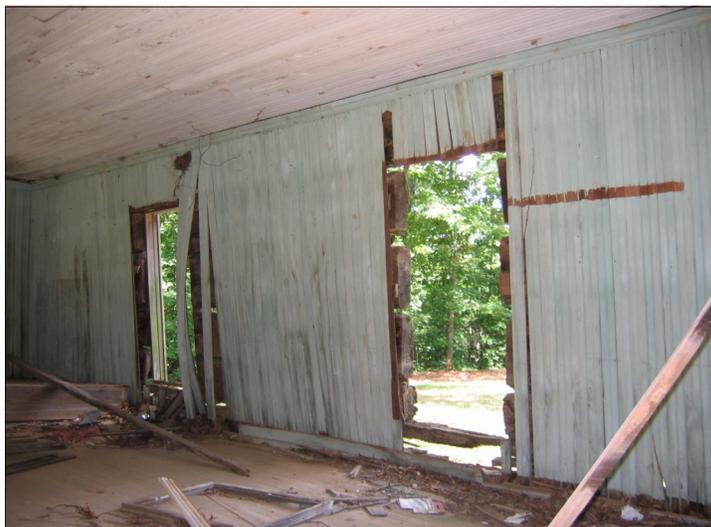
Paneling – Consists of narrow 1” by 2” wooden strips with a bead along one side. The paneling is found on all four walls and the ceiling. Much of it looks salvageable and the needed replacement pieces would be relatively easy to fabricate.

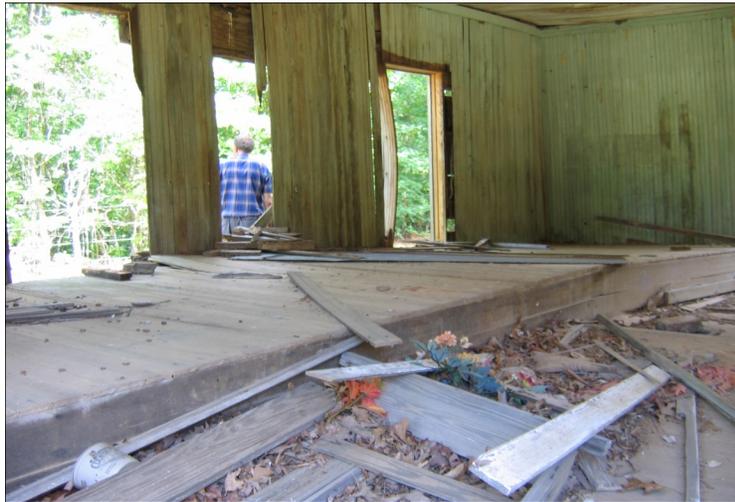
Stage — Consists of a raised platform built on top the floor with the same type of flooring used throughout the building. Much of the material used to construct the stage appears to be sound and could probably be recycled.
