Sabine Hill

Elizabethton,
Carter County, Tennessee

Historic Structure Assessment

Summer 2012

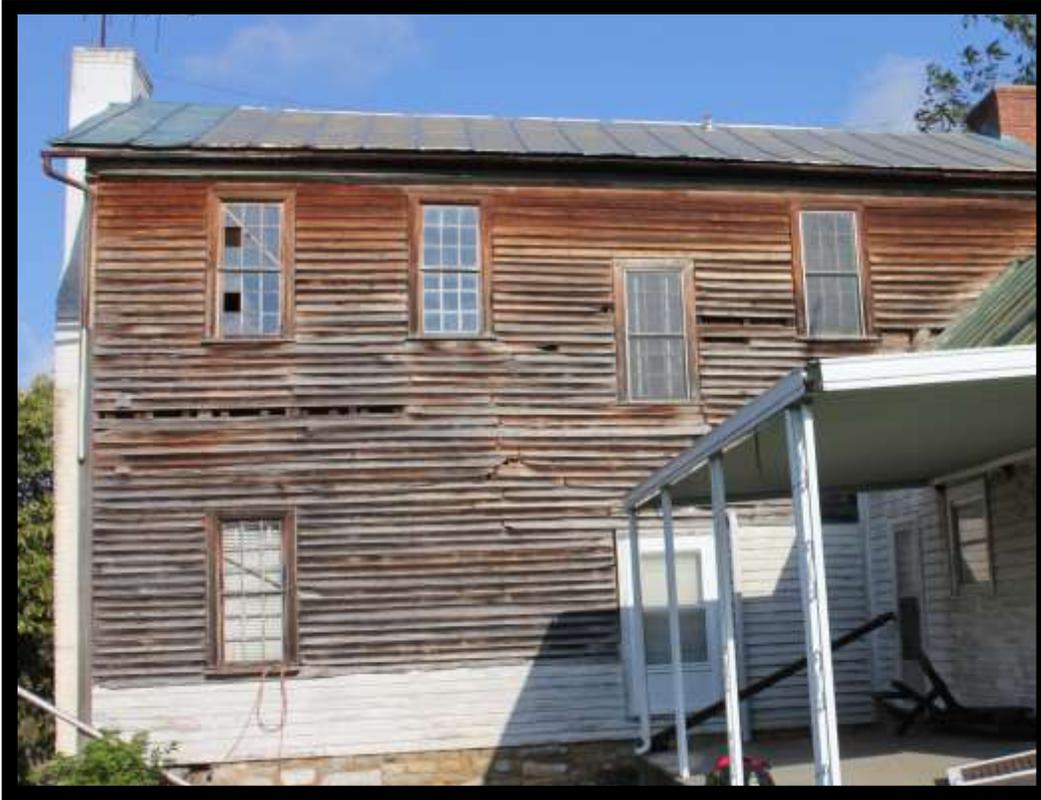
Figure 4. Photo from 2011, provides evidence that the SE siding has been realigned.

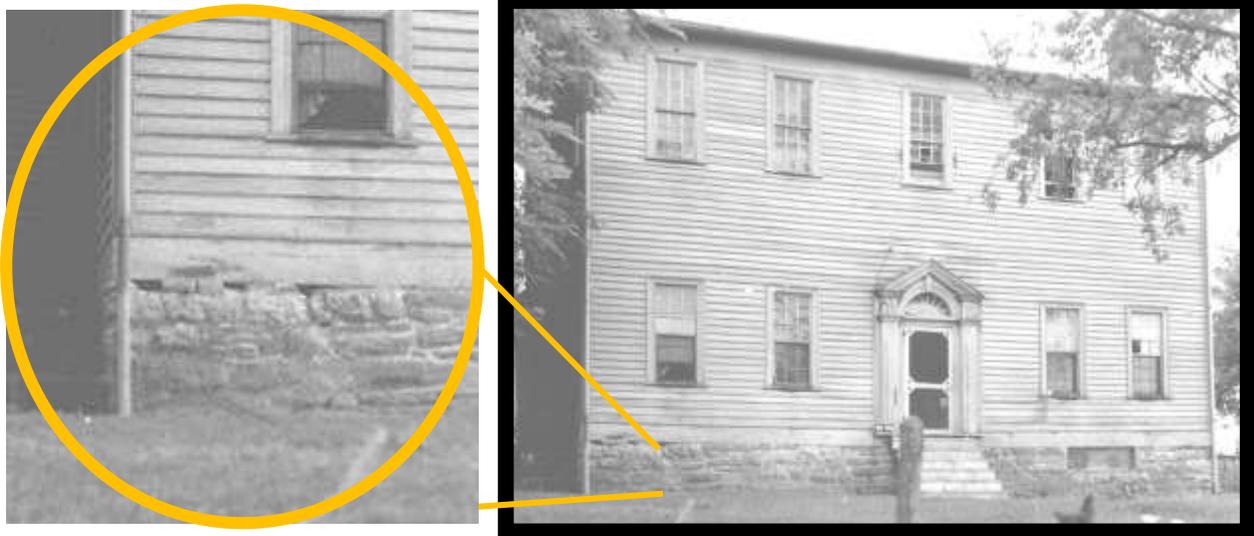
Extensive cracking and shifts in the foundation of Sabine Hill can be seen in the 1936 HABS photographs (Figure 6). The foundation of the house was reworked during the 1950s to correct cracking and tilting issues. Most of the foundation problems have been caused by a basement addition to the 1818 section of the house. The basement was added some time before 1936 as HABS images clearly show a basement entry and window (Figures 7). The basement walls were not properly reinforced when the basement was constructed and has caused the walls to weaken and start to give way.

Figure 6. 1936 HABS photograph shows damage to the foundation.

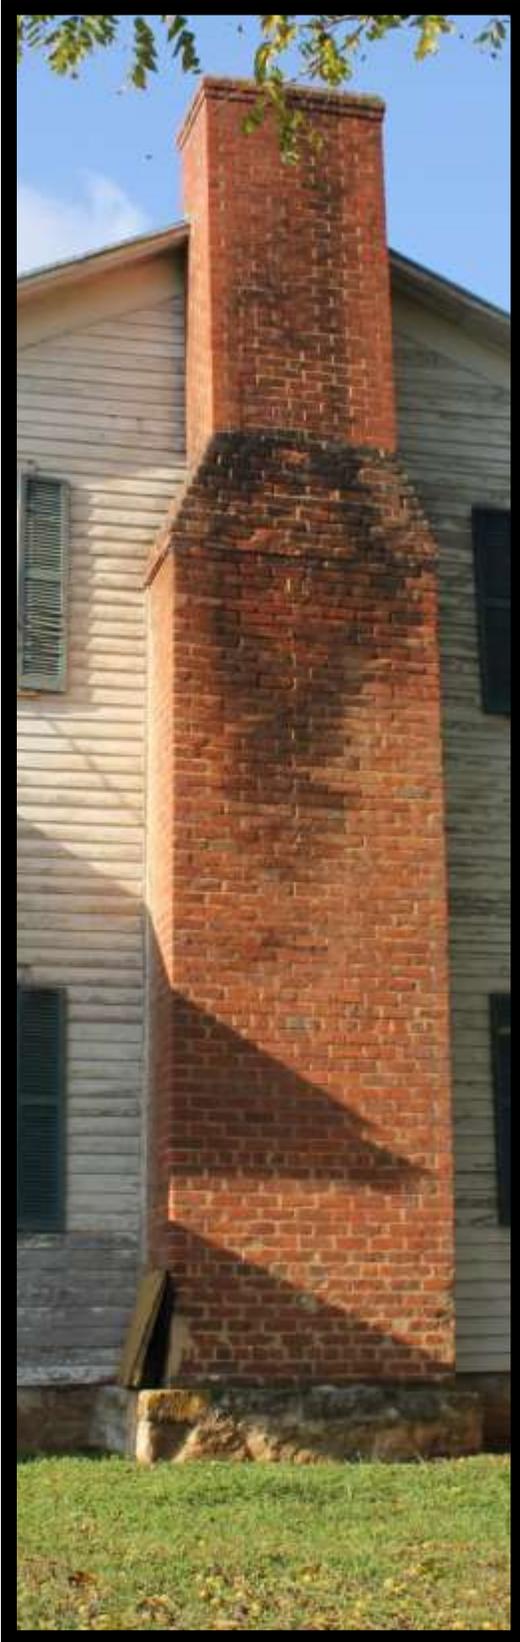
Figure 14. Left: Full view of the NE chimney. Note the water damage marks starting at the shoulders.

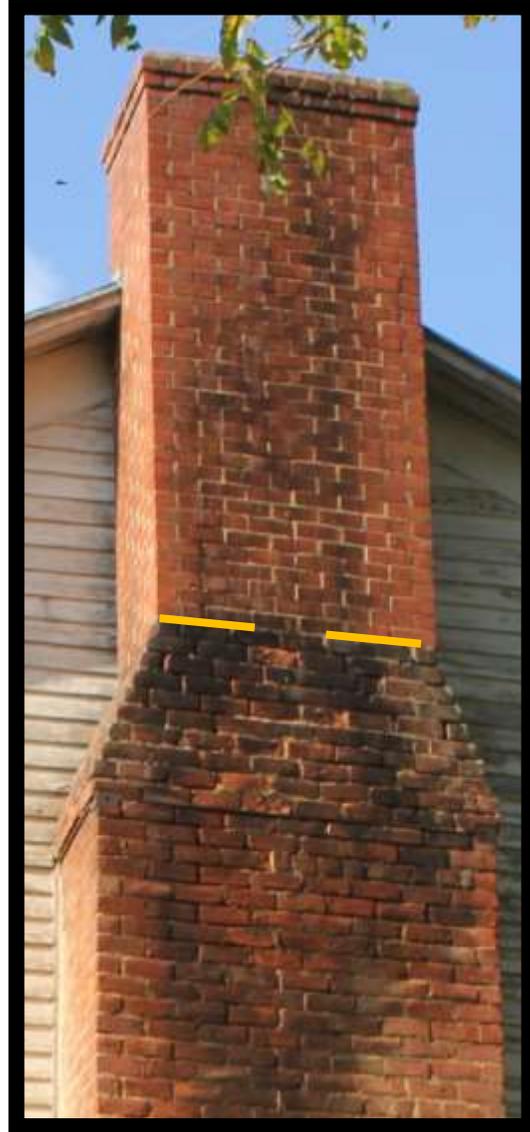
Figure 15. Above: Note the ghosting marks just above the shoulder where the top half of the chimney was reworked.

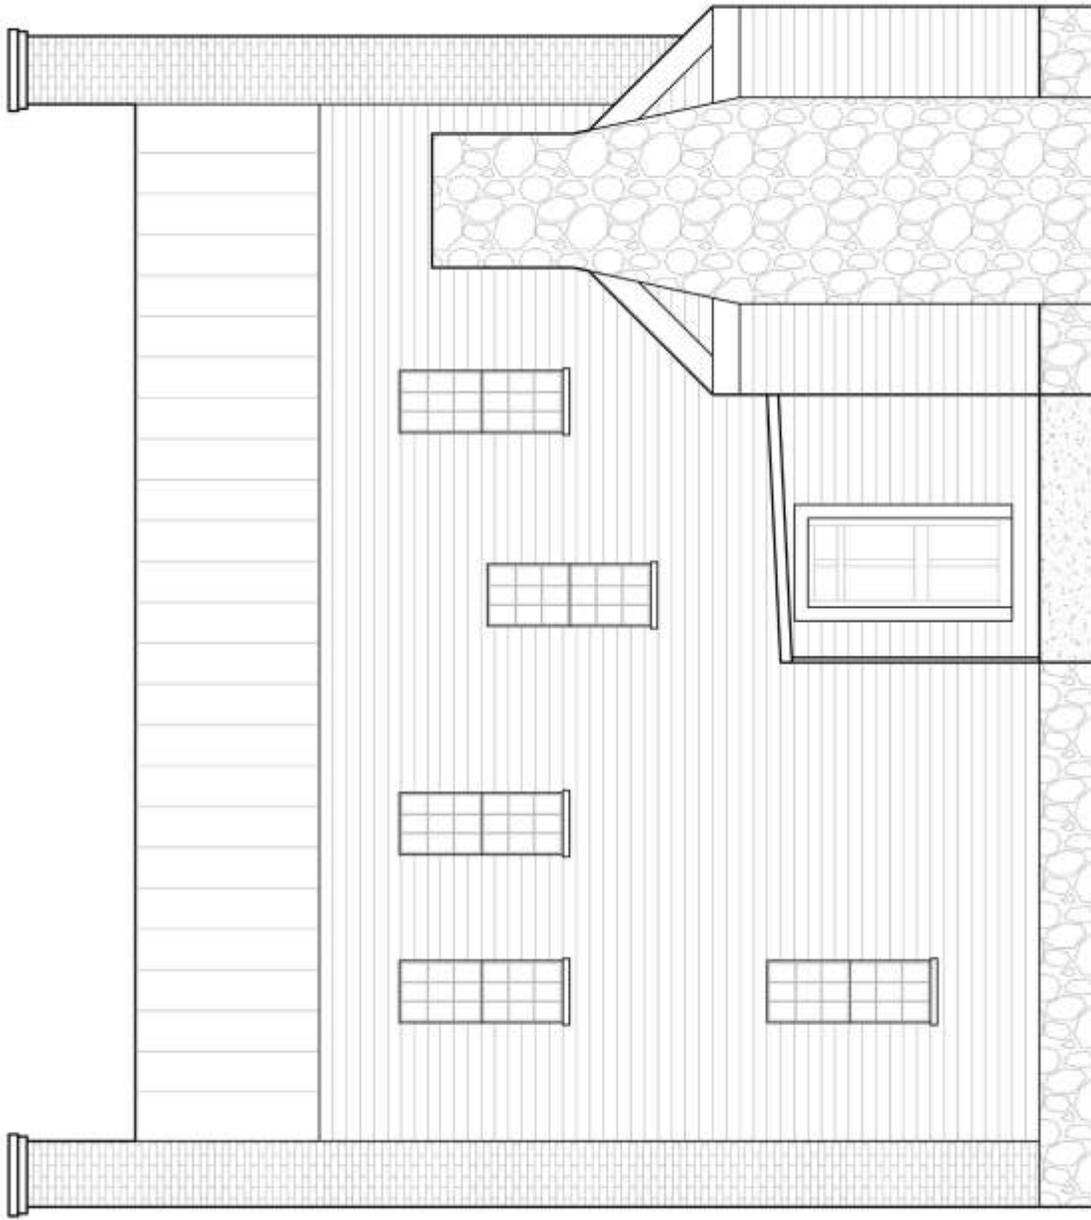
The southeast façade of the main block is divided into five bays and has an attached ell. The first floor features a 9/9 double-hung wooden sash and a six-panel wood entry door. The builders probably anticipated adding the rear ell at a later time (Figure 30 & 31). Current images of the house suggest that the exterior weatherboard may not be original, or may have been flipped.

The boards are warped and should be replaced in-kind.

Figure 31. SE Façade.

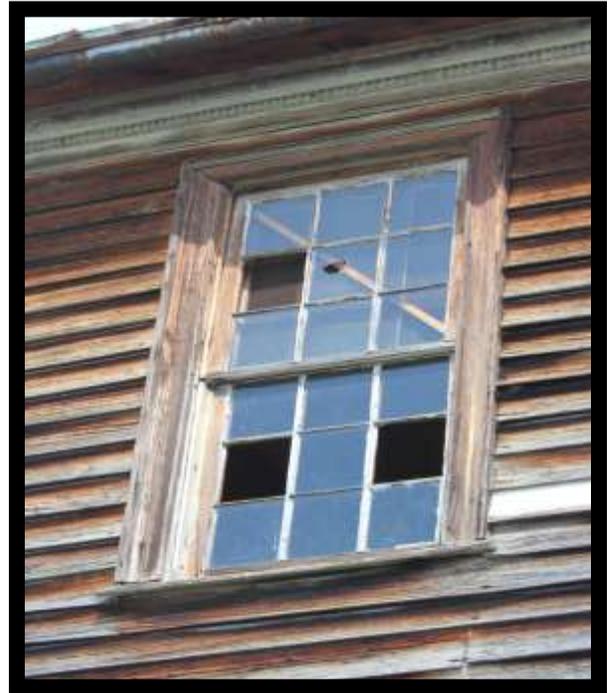
Figure 59. Missing panes in window

- The exterior of the house should be thoroughly examined for access points, which should be sealed off to prevent the intrusion of vermin. Sabine Hill has several openings which should be closed up immediately. A window on the southeast wall is broken and is providing an entry for birds and other animals (Figure 59). An opening in the foundation of the rear ell allows access to the house’s crawlspace (Figure 60). Finally, a large hole in the foundation of the northeast wall of the main structure serves as an entryway for vermin and has compromised the stability of the foundation wall (Figure 61).

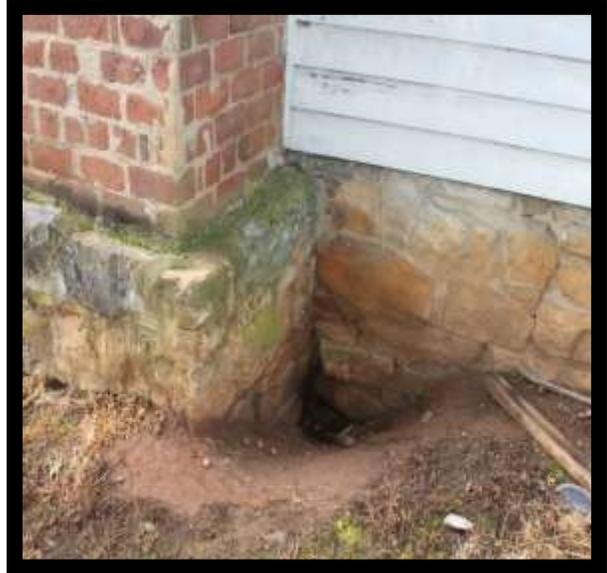
Figure 61. Access point for vermin into the northeast foundation wall of the main structure. —
Foundation

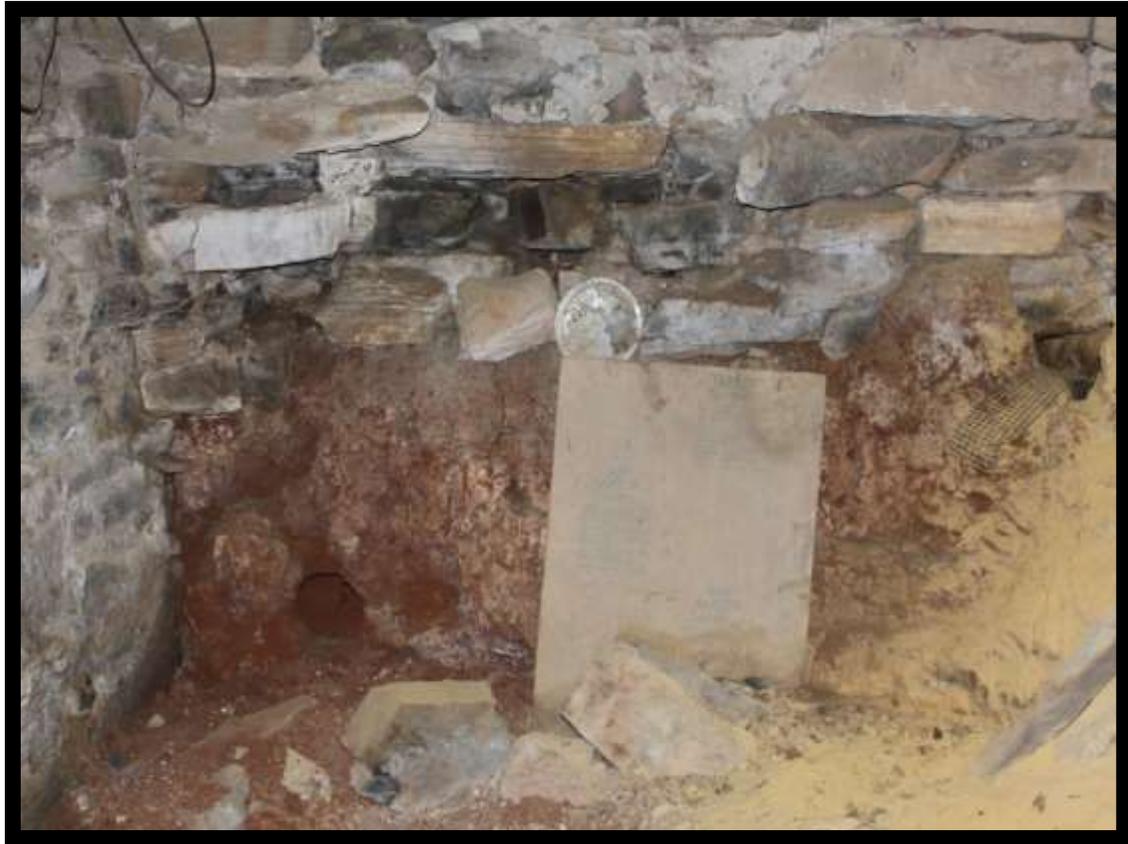
- The later addition of a basement space to the main block of the house raises concerns about the structural stability of the foundation walls of the building. On the east side of the house, the foundation wall has collapsed in some areas and may be effecting the soundness of the structure, as well as the attached chimney. An experienced professional should be consulted immediately to determine potential danger and foundational stability (Figure 62).

Figure 62. Foundation on the NE wall of the main structure.
—Chimneys

- 1) The exterior should be sealed properly for both weatherization and pest control. The foundation should be examined closely by a qualified professional. The building needs to be sealed, painted, and protected from moisture and vermin penetration.

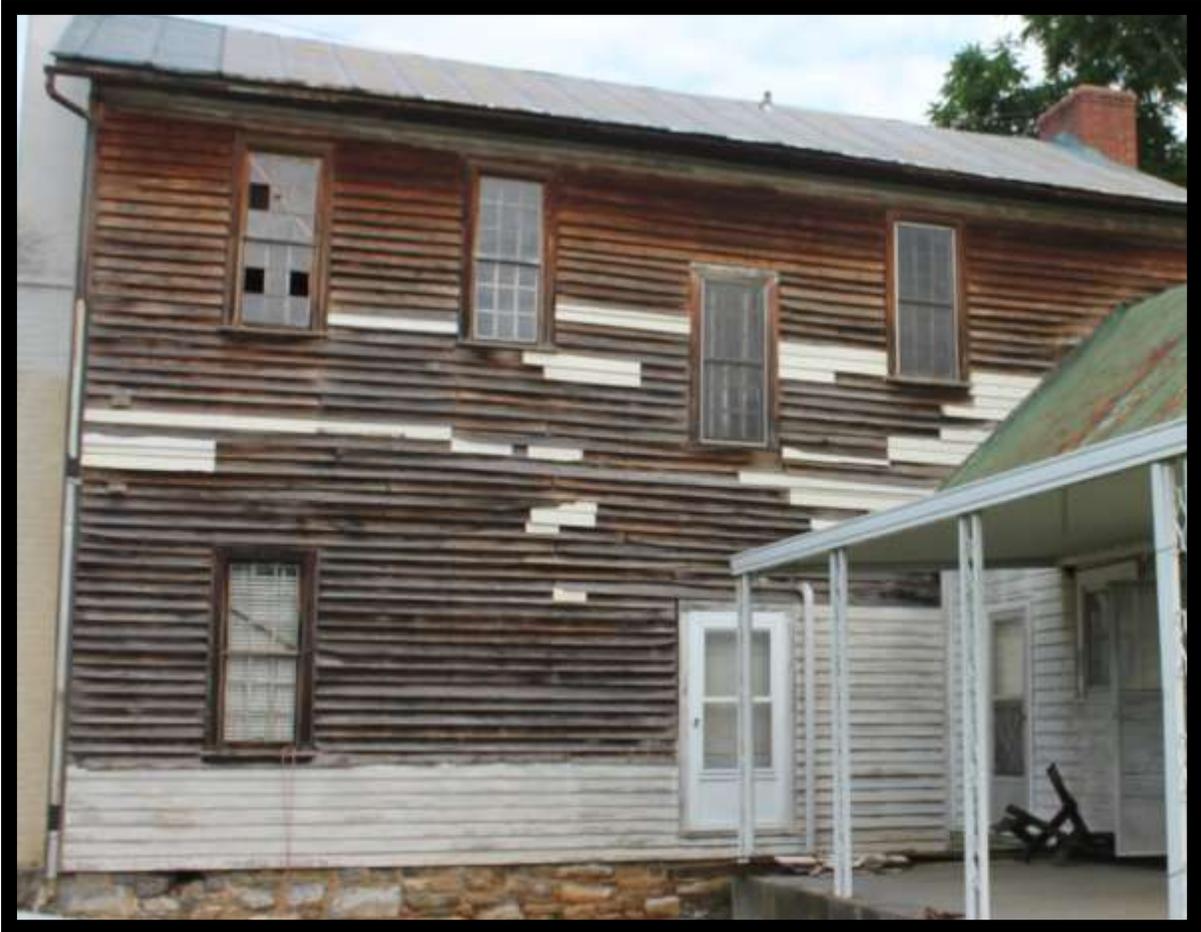
- The weatherboards on the south façade are in poor condition (Figure 64). In some areas the wood siding is extremely weathered and some of the boards have rotted. There are also numerous holes in the siding caused by rodents.
- These holes should be carefully patched and the damaged boards repaired or replaced.
- Sand, prime, and paint all wooden building components.

Figure 64. SE façade weatherboard siding deterioration.
—Weatherboard Siding

- 3) The weatherboard siding, particularly on the southeast wall of the main block, should be repaired/replaced in-kind, and properly sealed and painted.

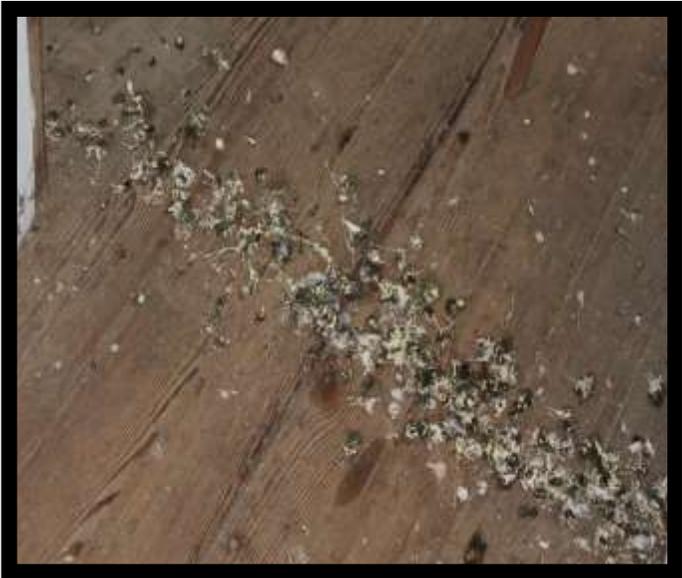
Figure 69. Accumulation of bird guano and other debris.

- The interior of the home is also in poor condition (Figures 69, 70). Various access points throughout the house have allowed the accumulation of guano, dirt, and other various types of hazardous debris. There is also a collection of hazardous chemicals and a wine still in the basement of the house. All of these materials can pose health risks for any who enter the house and should be removed.
- Seal access points for rodents and birds; remove guano from property.
- Remove old wine containers, ensuring that the bottles are handled safely.

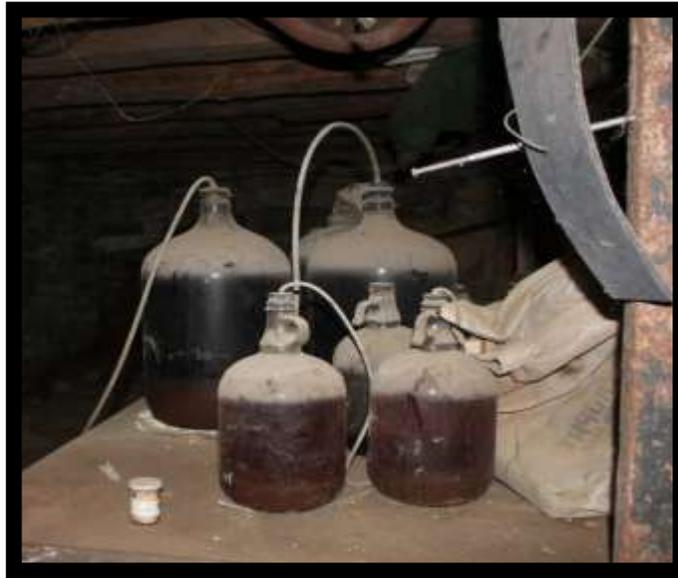
Figure 70. The wine still located in the house's basement.

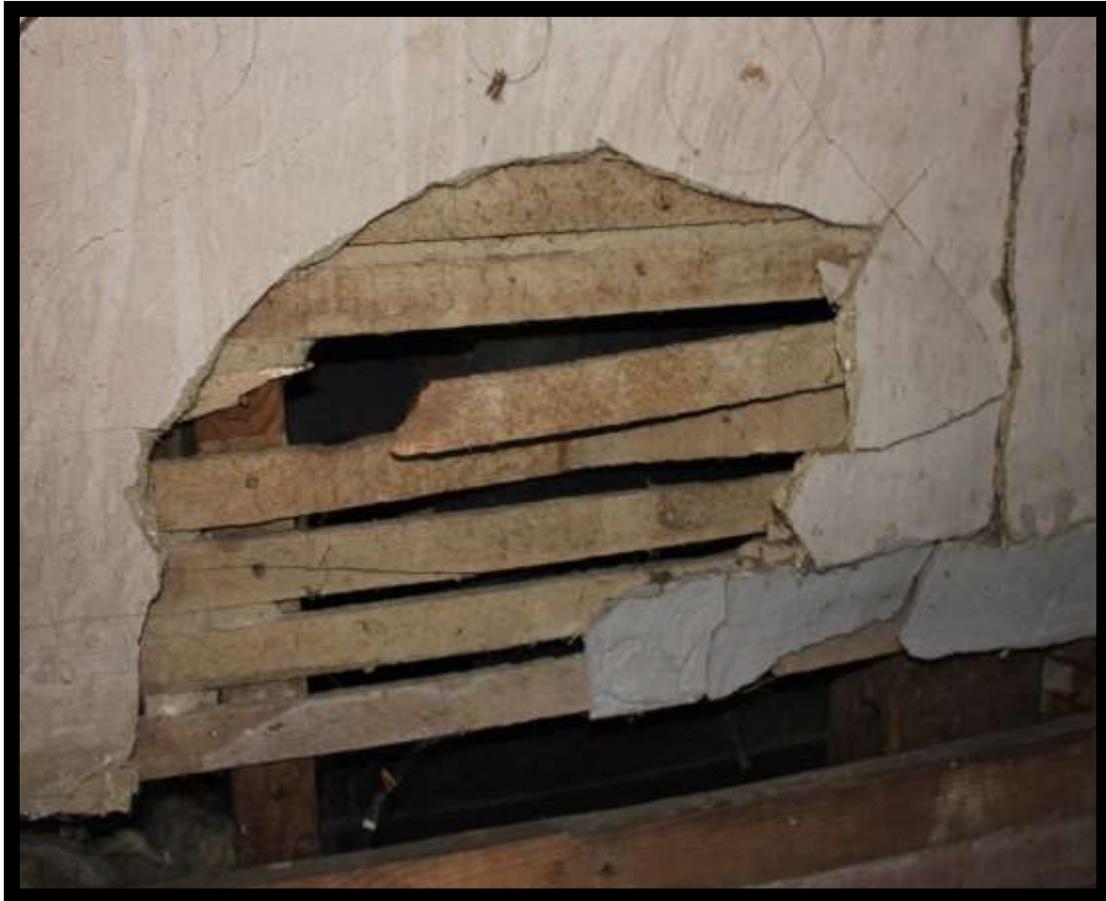
- The plaster work in some areas of the house, specifically in the “Red, White, and Blue” Room, is extremely deteriorated and should be restored and maintained (Figures 69 - 71).
- Repair and/or replace old lath as necessary; metal lath may be used to shore up the older material.
- Allow for proper curing.
- Repaint, using alkaline-resistant primer for new plaster.

Figure 71. Deteriorated plasterwork on SW wall in “Red, White, and Blue” Room.
—Plaster Walls
