## **Executive Summary**

This Historic Structure Report was prepared as part of the implementation of the Olympic National Park General Management Plan (approved August 8, 2008 • See Appendix 1) and in accordance with the Secretary of the Interior's Standards for the Treatment of Historic Properties.

The subject of the report is forty-two structures within the backcountry of the Park.

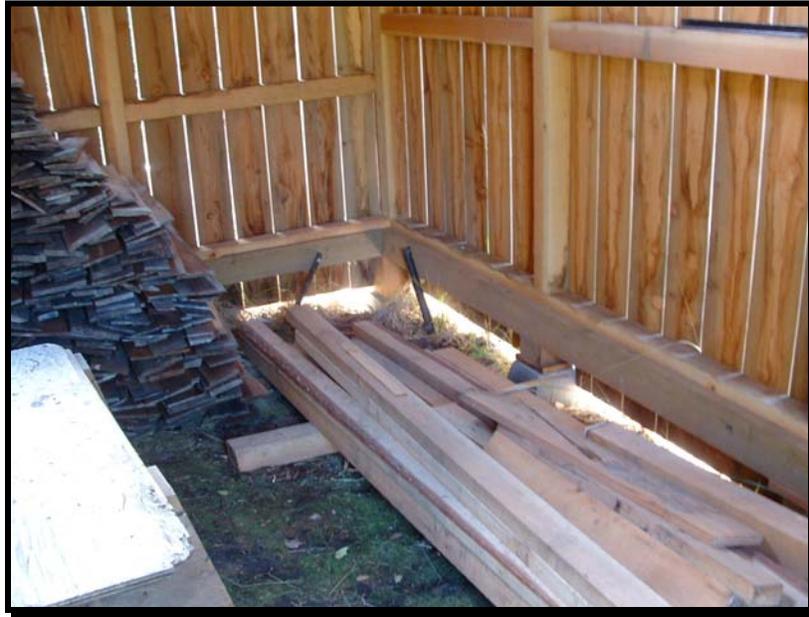
**Figure No. 8: Interior corner of Roose Homestead Barn showing sill beam and base of frame.**

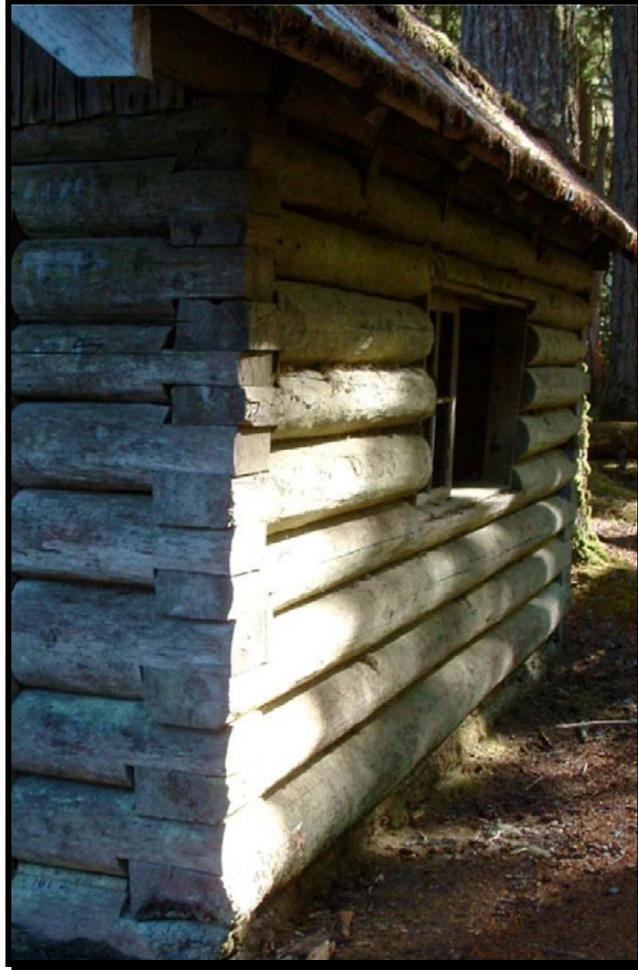
deterioration has caused settlement in the southwest corner, distorting the plane of the wall and causing logs to begin to slide out of the notching. In addition, there are serious signs of powder post beetle activity in the logs.

**Figure No. 2: Corner notching, Judge Frederick Remann's Cabin**

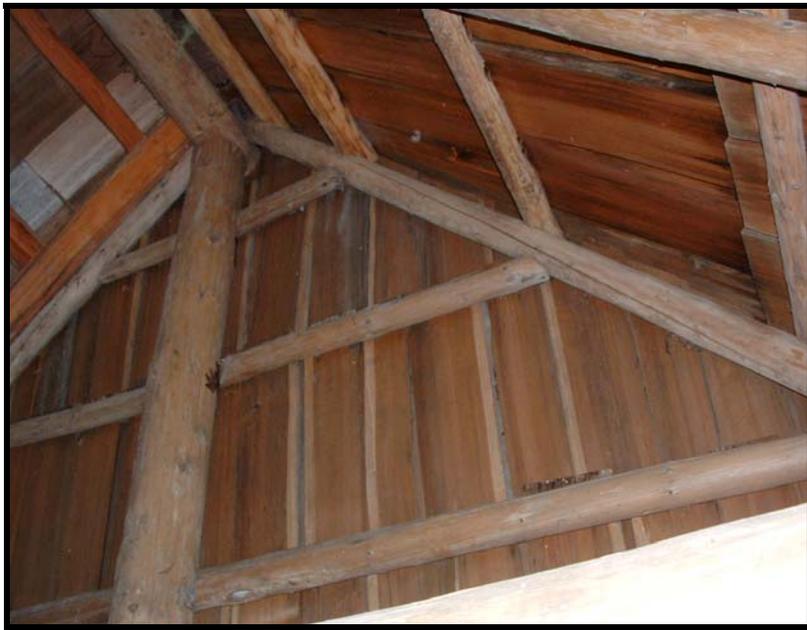
**Figure No. 3: Ridge log, gable framing, and rafters.**

At a minimum, log columns should be installed to support the front roof overhang. It would be preferable if photograph evidence exists to rehabilitate the front deck too, but it is not necessary to stabilize the building.

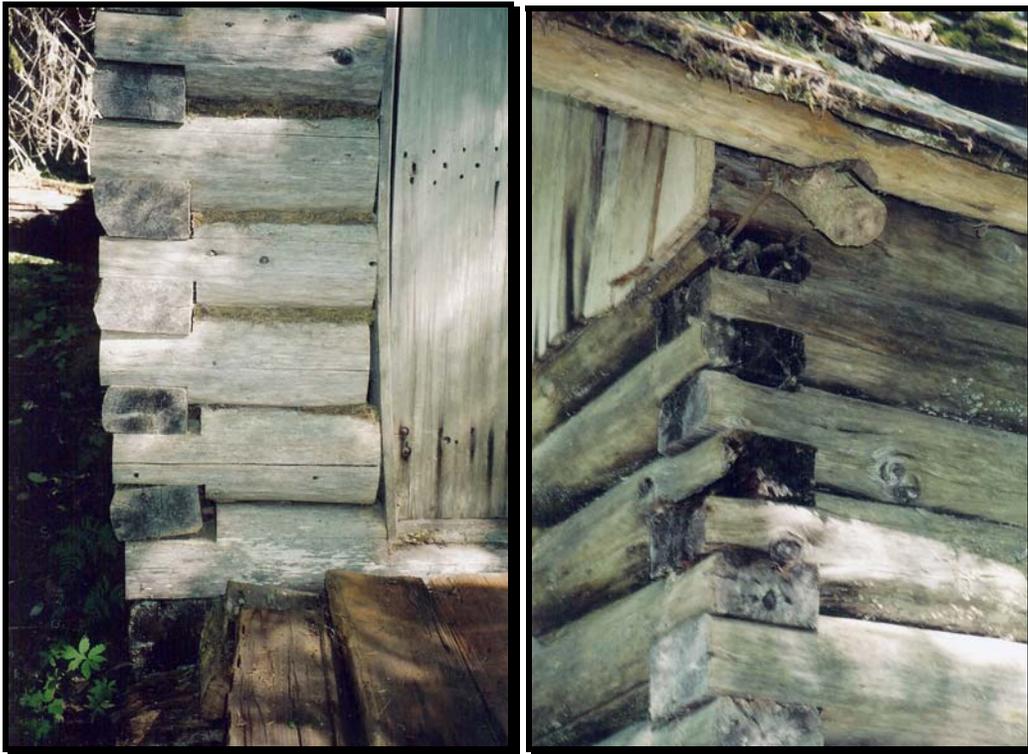
**Figure No. 2: Right: Rotational twist in NW corner due to deterioration of sill logs; Left: Deterioration of joints in the upper wall courses at SW corner.**

It will entail substantial repair work to stabilize the cabin. The cabin needs to be lifted and have new sill logs replaced. The logs range in size from 13” to 19” in diameter. They should be placed on stone piers with at least an 8” elevation from grade. At the same time, in leveling the building, the northwest corner will need to be rotated back to plumb and the notching realigned. Some adjustment will probably be required to square the doorframe. The degree of repair needed to the sill logs is not known, but if it occurs only at the end notches then a new introduced ledger board on the new sill log may be the optimal solution.

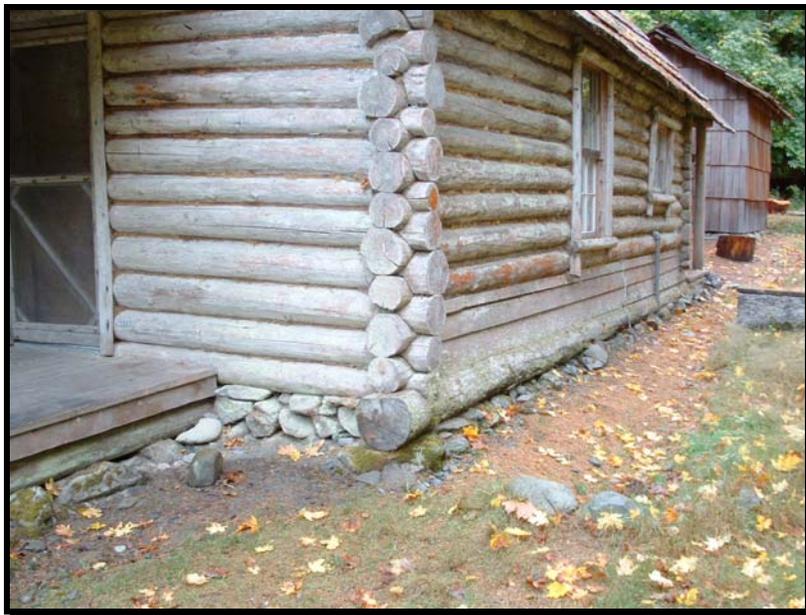
The cabin is constructed with log walls resting on a flat river rock. The log corners are saddle notched. The logs are tightly laid with only some areas of wood chinking on the interior of the walls. There are log sill logs on the north and south sides, but the two courses immediately above the sill logs have been replaced with 6" x 6" fir beams. The gable end walls are log. The roof structure consists of longitudinal purlins on either a two or three log spacing of the gable log courses. In the 1990's it was recorded that log rafter were present under the purlins at the gable ends and one at the center. Since then three additional rafter braces have been added at each ceiling joist location in the storage loft section of the roof.

**Figure No. 3: Note fir beams replacing logs in sidewalls.**

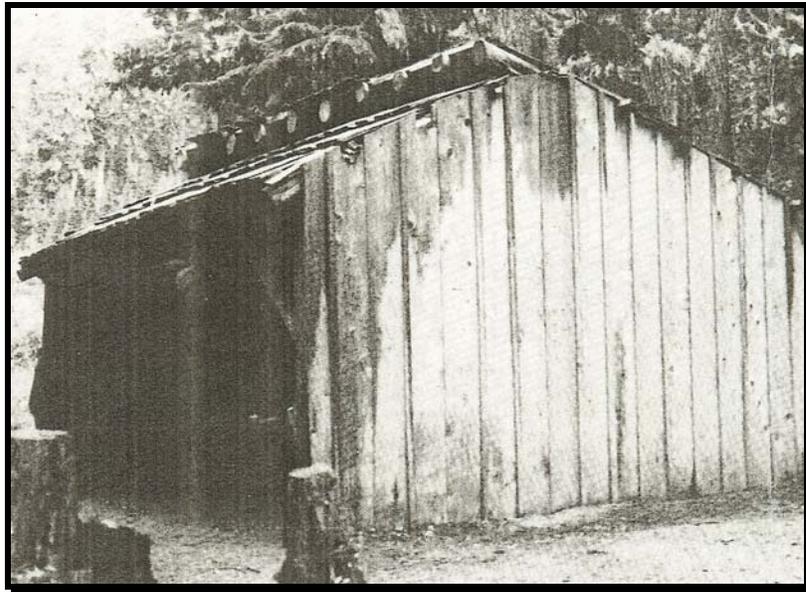
While rafters were thought to be reusable, all the shake nailer boards on the front roof slope required complete replacement due to the ends breaking off under snow load.

**Figure No. 2: File photo of Anderson Pass Shelter taken for 1984 Cultural Resource Inventory; note the broken shake nailers at the sidewall.**

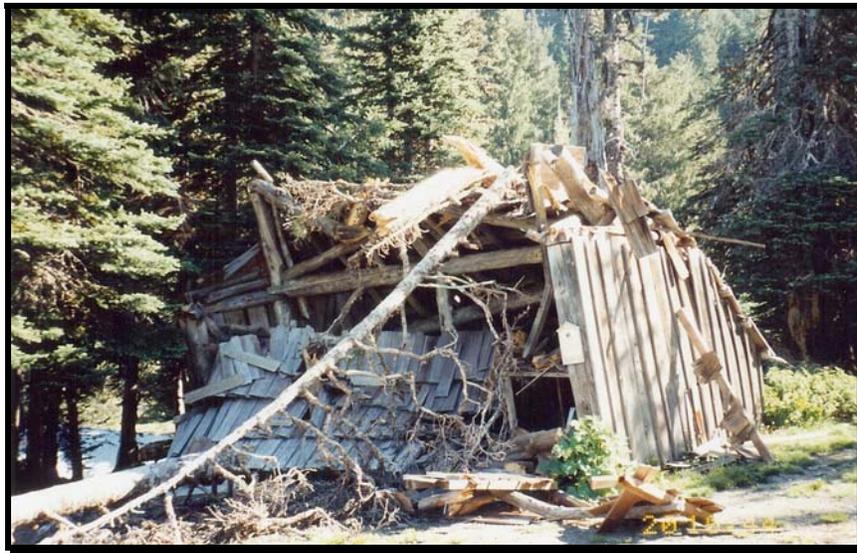
During the winter of 1998-99, a tree fell on the shelter resulting in major damage.

**Figure No. 2: Home Sweet Home Shelter in 1999.**

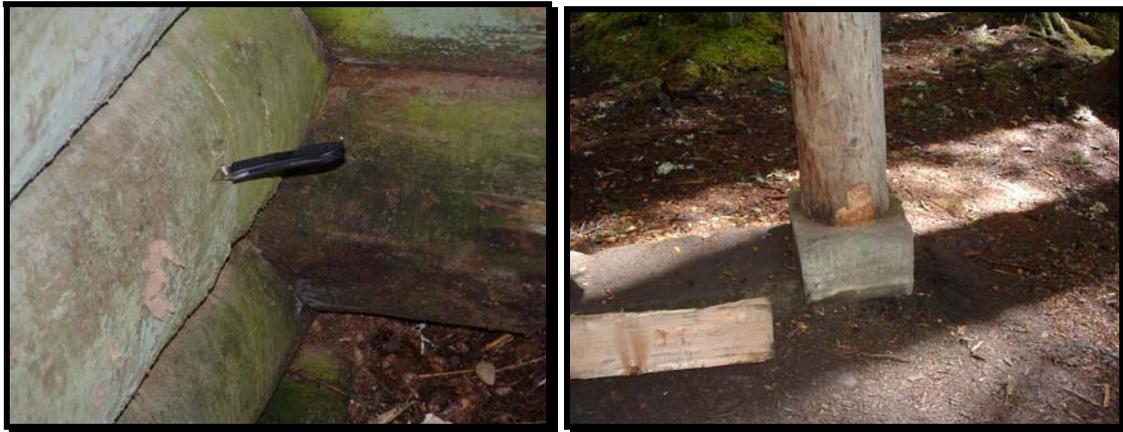
**Figure No. 2: Soleduck Falls Shelter, May 2006; on left, note penetration of three inch knife blade into 2<sup>nd</sup> course log; on right, the base of the log column is developing deterioration.**

Replace deteriorated crown ends using scarf joint with stainless steel connections and wood plugs; use of epoxy is not recommended. Use of borate insert rods to reduce deterioration is recommended for the column bases.

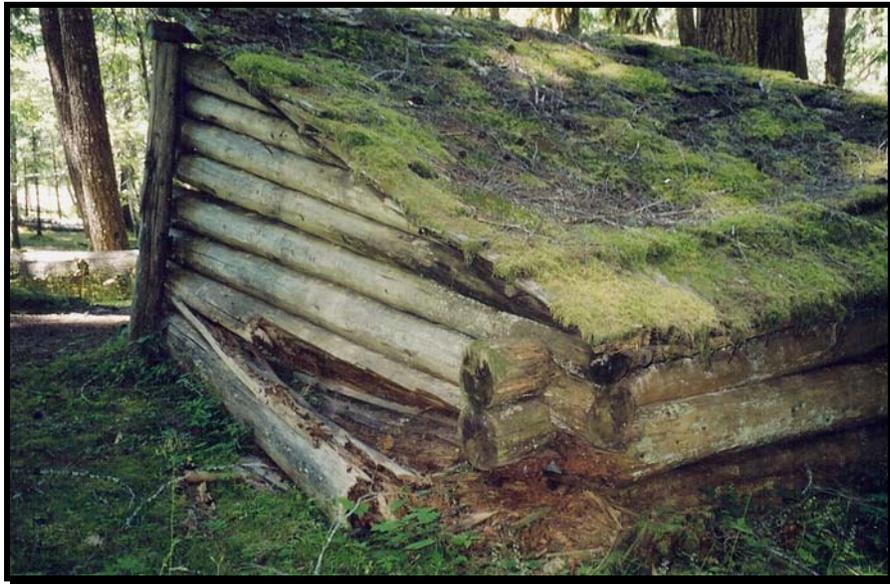
**Figure No. 2: Wilder Shelter, August 2006.**

Regrading of site for moisture management and sill log exposure required. Site vegetation should be cleared. The grade has grown with vegetation to the point that the stone footings for the sill logs are completely below grade.

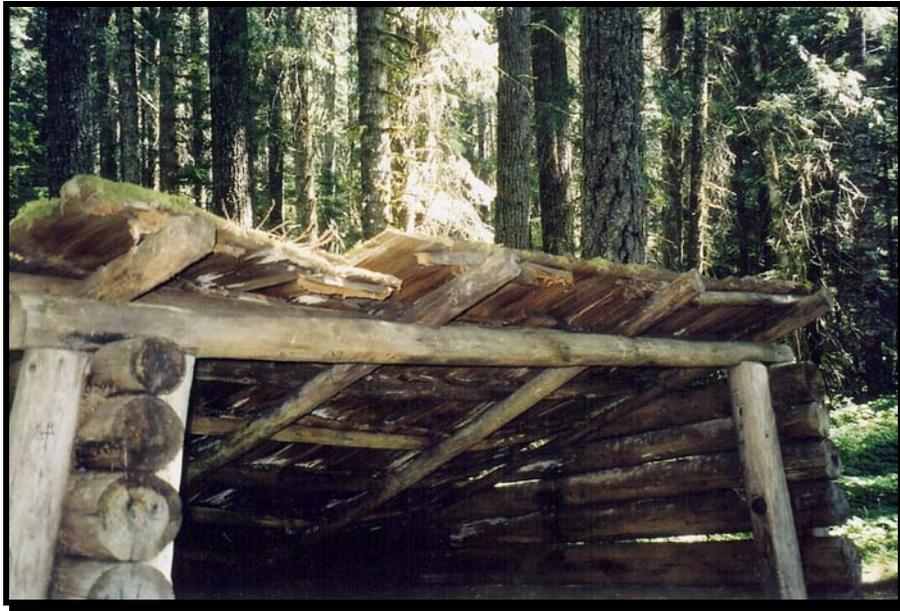
**Figure No. 3: Wilder Shelter, August 2006.**

Replace the four vertical logs that stabilize the front ends of the sidewalls.

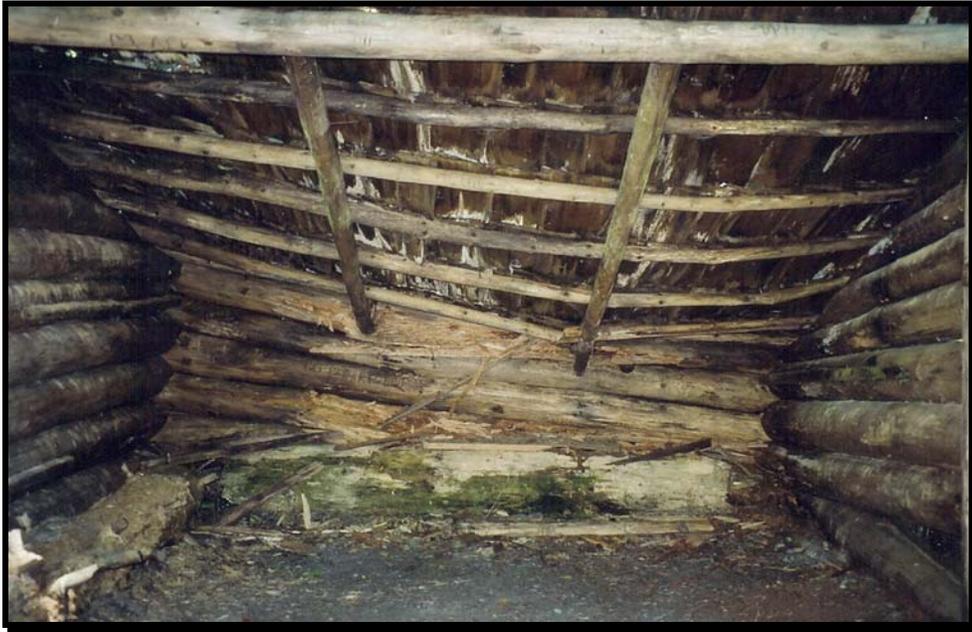
**Figure No. 4: Wilder Shelter, August 2006; the interior shows no sign of the four bunks records indicate to have been in the shelter in 1970.**

The roof structure and shakes require complete replacement

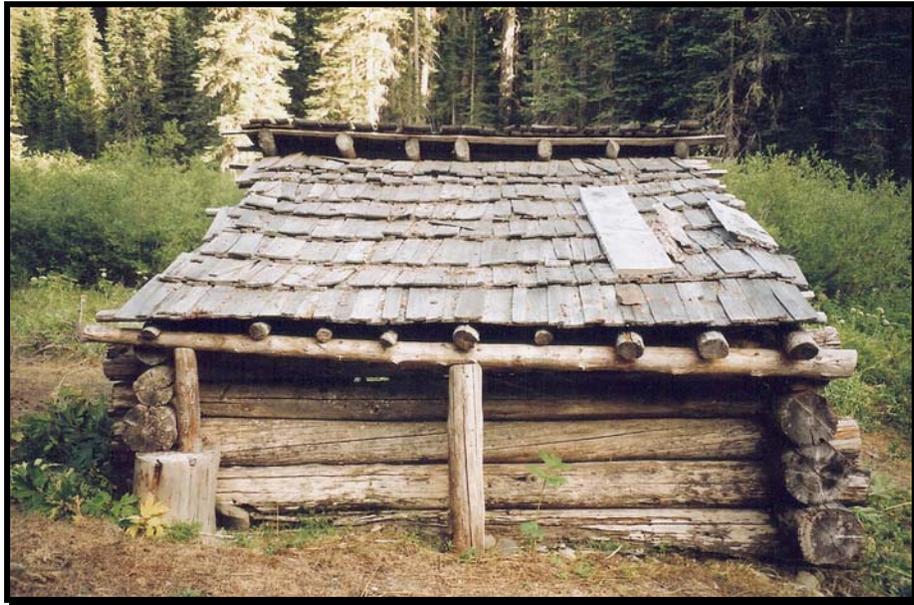
**Figure No. 3: Bear Camp Shelter rear roof slope; note lack of overhang at rake edges and interspaced shake pattern.**

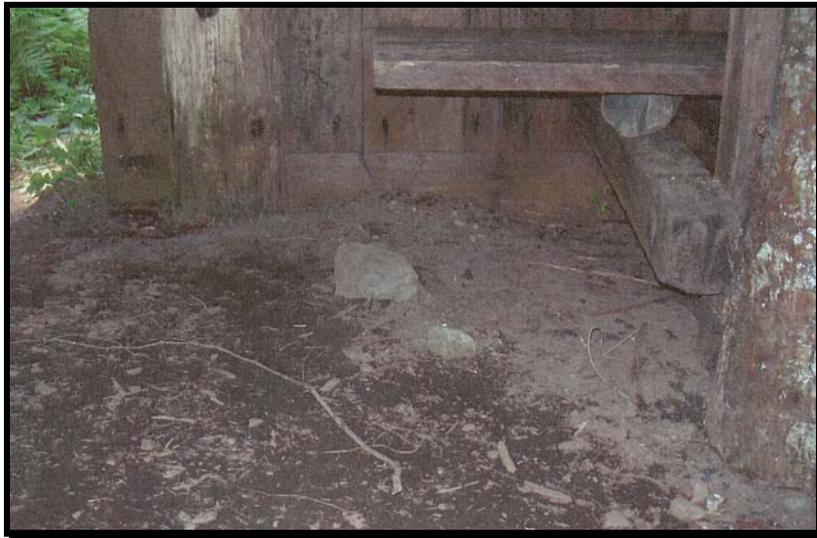
**Figure No. 2: Trapper Shelter, August, 2006; note debris build-up around base of sill log.**

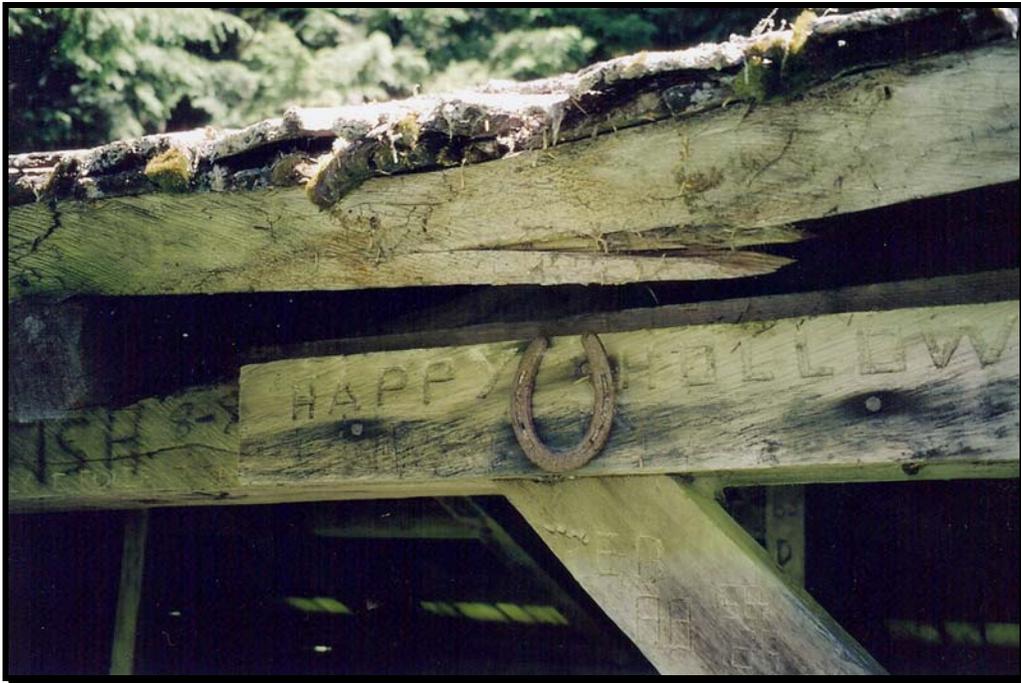
**Figure No. 2: Broken front shake nailer on Happy Hollow Shelter**
