National Park Service  
U.S. Department of the Interior

Organ Pipe Cactus  
National Monument

**Emergency Actions to Stabilize Quitobaquito Pond,  
and Related Activities**  
**Final Project Report and Revised Biological Assessment**  
**ESA Emergency Consultation #22410-2008-FE-0273**  
**July 2008**

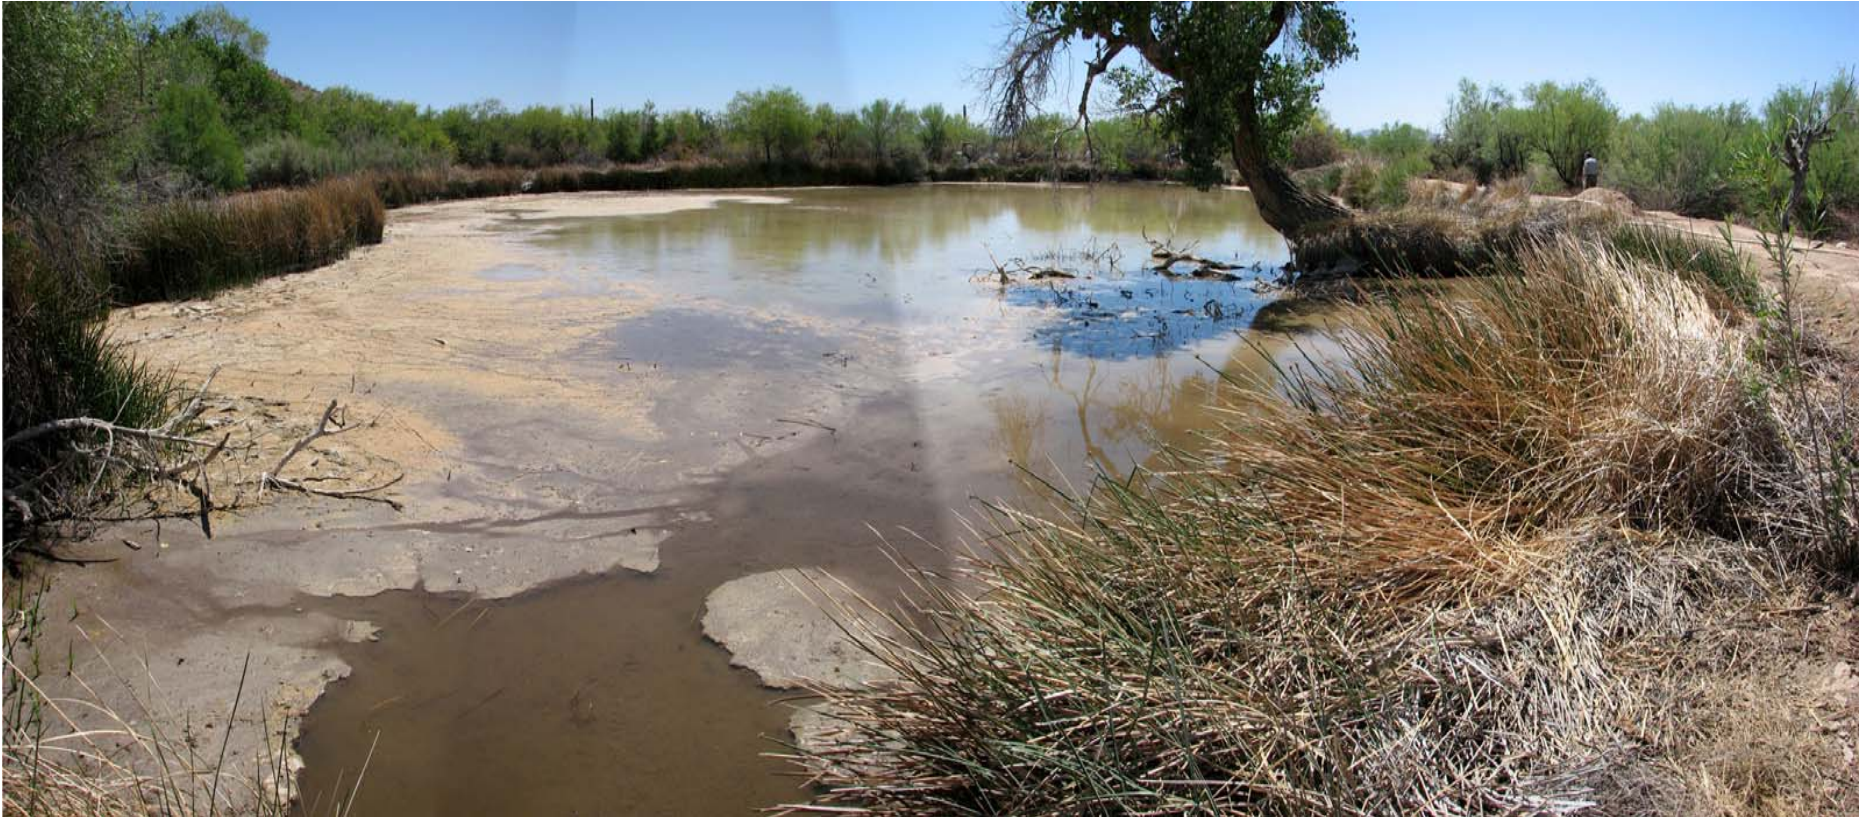
In April-May 2008, we discovered another threat to Quitobaquito pupfish resulting from low water levels. During this time, the pond surface was 24" to 26" below the outflow pipe, leaving most of the remaining pond only 1" to 4" deep. This made pupfish vulnerable to piscivorous birds, in a way they are not when the water is deeper (Figure 3). During this time period (during the diaphragm wall construction described below), we observed mixed groups of wading birds feeding heavily on pupfish, a phenomenon seen rarely if at all at normal water levels. Depredating birds included great egret, snowy egret, green heron, black-crowned night heron, black-necked stilt, and white-faced ibis. The latter two species are known more for feeding on invertebrates. However, at Quitobaquito they methodically took smaller pupfish from very shallow water. With up to 15 or 20 predatory birds sometimes present, we estimated up to 100 pupfish per hour were being predated during some parts of the day. This predation problem diminished in May, after the bird migration season had passed.

Figure 2. Quitobaquito Pond at minus 26" level. May 2, 2008. Panoramic view looking southeast from the west viewing bench. The exposed brown flats of mud and detritus would normally be covered by 18" to 26" of water. Most of remaining pond is 1" to 4" deep. Organ Pipe Cactus National Monument, Arizona.

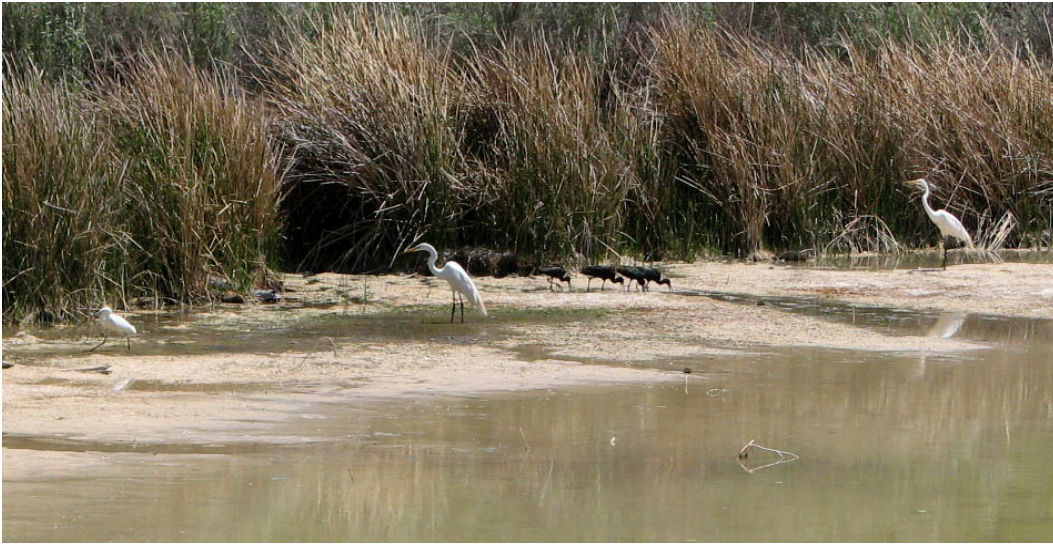
Figure 3. Snowy egret, great egret, and white-faced ibis feeding on Quitobaquito pupfish in abnormally shallow water. May 1, 2008. Quitobaquito Pond, Organ Pipe Cactus National Monument, Arizona.

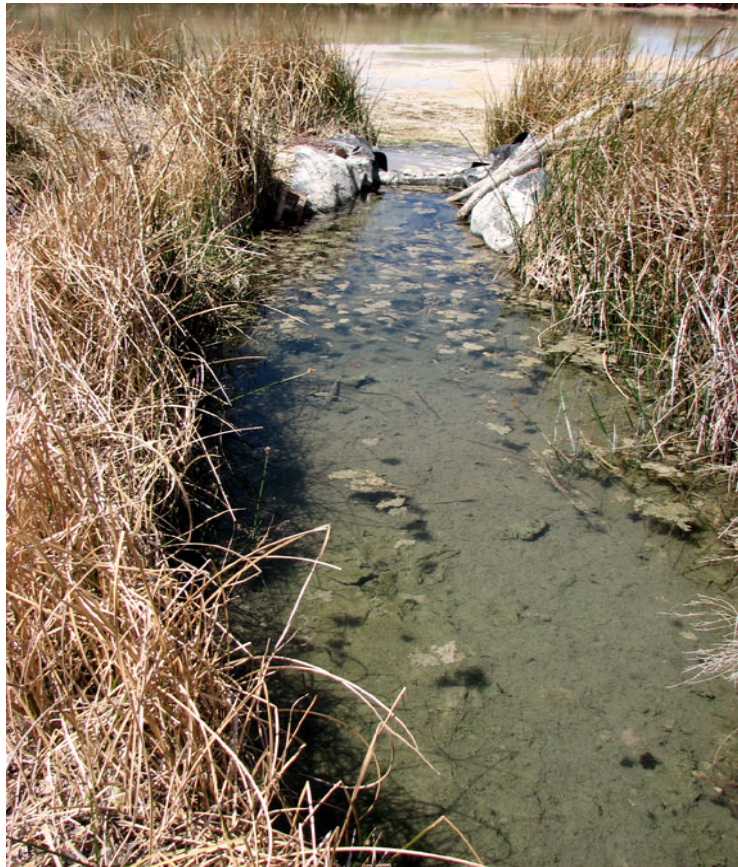
Figure 4. Impounded moat, view over eastern dam to remaining pond. Quitobaquito Pond, Organ Pipe Cactus National Monument, Arizona.

Damming the moat re-established the moat pupfish habitat – approximately 600 to 900 square feet of water, at depths ranging from 9" to 16". This was intended to provide a net increase in the habitat available to pupfish, during the current low-water situation. This action created a refuge pool of sufficient size to support at least 2,000 to 4,000 pupfish. To initiate re-population of the moat, 823 pupfish were moved from the pond to the moat (647 on April 23, and 176 on May 7). Pupfish were captured in the pond using minnow traps, which were emptied into 5-gallon buckets with pond water, and immediately carried to the moat and released.

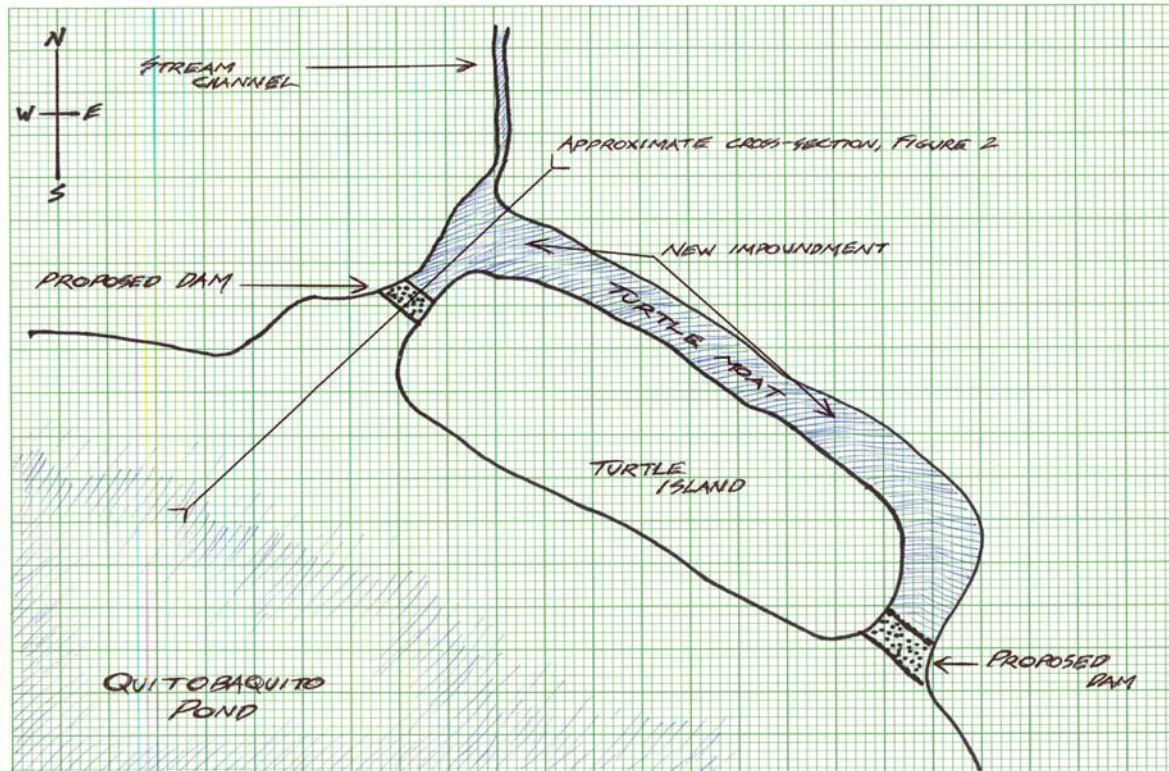
Figure 5. Schematic overhead view of temporary impoundment of turtle moat, Quitobaquito Pond. Organ Pipe Cactus National Monument, Arizona. Not to scale.

We proposed to re-establish pooled water in the moat, providing a refuge pool for pupfish and mud turtles, while the pond level is at extremely low levels. This action was carried out April 22, 2008, prior to constructing the diaphragm wall. This was accomplished by damming the east and west ends of the moat (Figures 4 and 5). Damming the moat at both ends allowed it to fill to a depth of approximately 9 inches at the west end, and 16 inches at the east end. The moat was dammed using bricks and concrete blocks, forming obstructions approximately 12" to 18" high in both ends of the moat. These block obstructions were then covered with 45 mil pond liner material, to make them water-impermeable. The pond liner material was weighted down with additional bricks and blocks placed on top of the material to hold it in place. The dams worked, re-establishing the moat as a pool perched slightly above the current pond level.

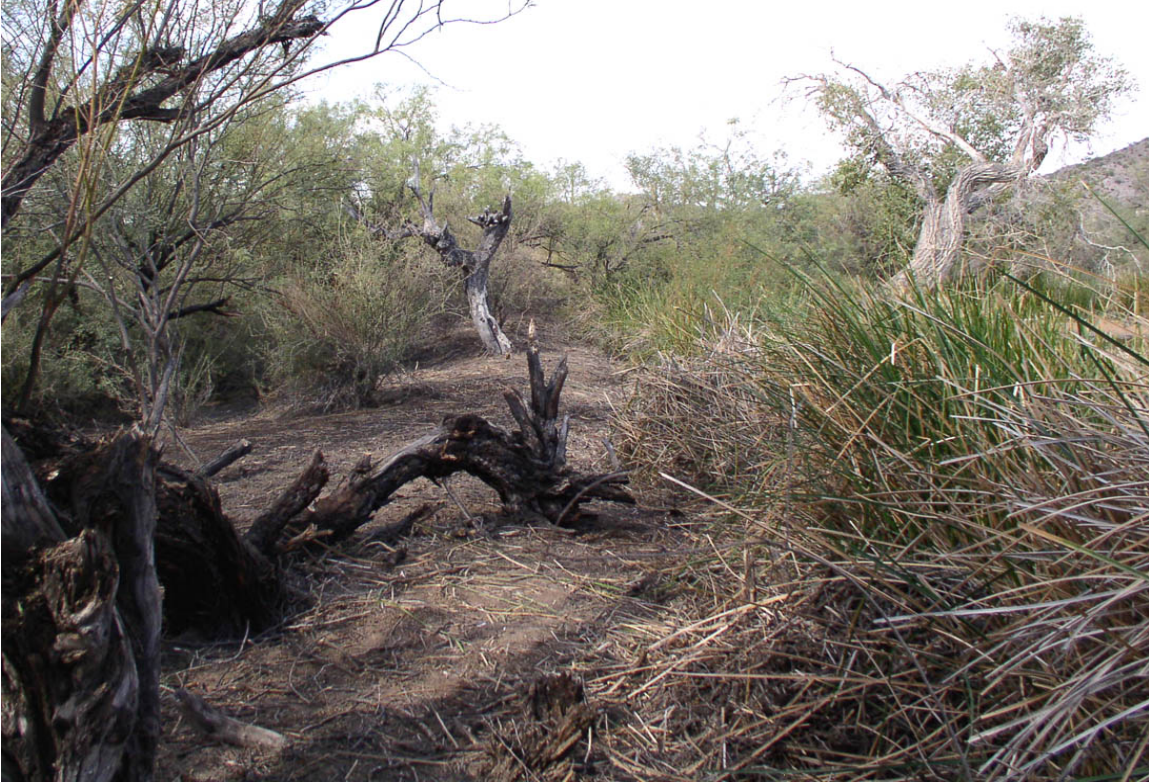
Figure 6a. The retaining berm, view to the northwest from near the spillway. Note the leaning cottonwood in upper right. Understory shrubs and dead lower tree branches had been removed to allow this view. Note large mesquite trees rooted in the berm. November 15, 2007. Quitobaquito Pond, Organ Pipe Cactus National Monument, Arizona.

All trees growing on the retaining berm were removed, except the large leaning Fremont cottonwood (Figures 6a and 6b). Cutting down these trees and preventing regrowth will prevent additional growth of their root systems into the berm and new diaphragm wall. Removing the existing trees was viewed as catching up on overdue maintenance, because the trees should not have been allowed to establish on the berm at all. Chainsaws and handsaws were used to cut trees down, and into pieces that could be carried by hand, wheelbarrow, and hand-cart to the west parking area. The “bee willow” at the southeastern corner of the pond was removed first, to eliminate the recurring problem with Africanized honeybees in the work area. This tree had numerous large interior cavities, some extending deep into the root system. Following installing the diaphragm wall, the larger portions of this tree’s root mass were dug out with a backhoe, and soil was packed into the resulting void at the pond edge (Figure 7). All other trees were cut off flush with ground level, except three mesquites at the pond edge of the berm, whose root masses were also pulled out with a backhoe. Cut trees were carried out to trucks and removed from Quitobaquito. Smaller branches were taken to the monument’s brush dump. Intermediate-sized branches (3” to 4” diameter) were saved for possible use in reconstructing corrals at historic ranching structures in the monument. Large pieces (e.g. > 6” diameter) are stored at a brush storage site. Future tree regrowth will be controlled manually, and/or by herbicide (e.g. Garlon or Roundup), applied using only compounds and methods that will pose no potential harm to Quitobaquito pupfish, Sonoyta mud turtles, and other aquatic organisms. For example, to eliminate wind drift, herbicides would be applied from within 6 to 8 inches using hand-held spray bottles. Some tree branches fell from the berm into the southwestern edge of Quitobaquito Pond; all such branches were immediately removed from the pond.

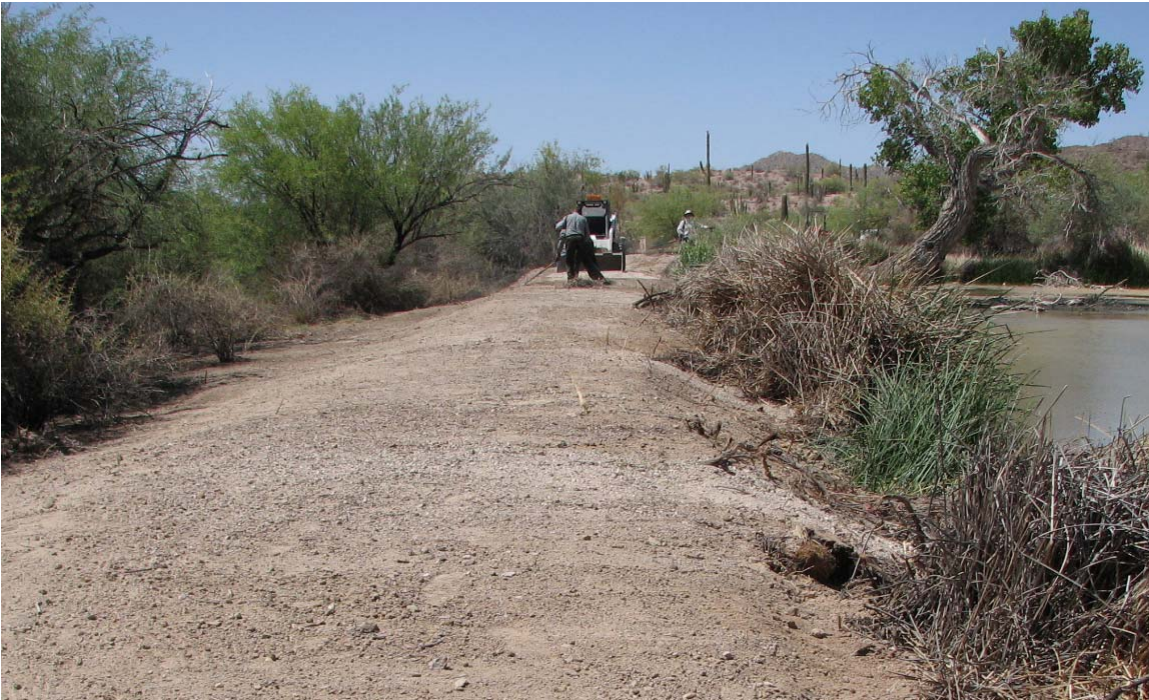
Figure 6b. The retaining berm after clearing trees and shrubs and installing the diaphragm wall. View is from approximately the same point as Figure 6a. Note leaning cottonwood tree in upper right. May 1, 2008 Quitobaquito Pond, Organ Pipe Cactus National Monument, Arizona.

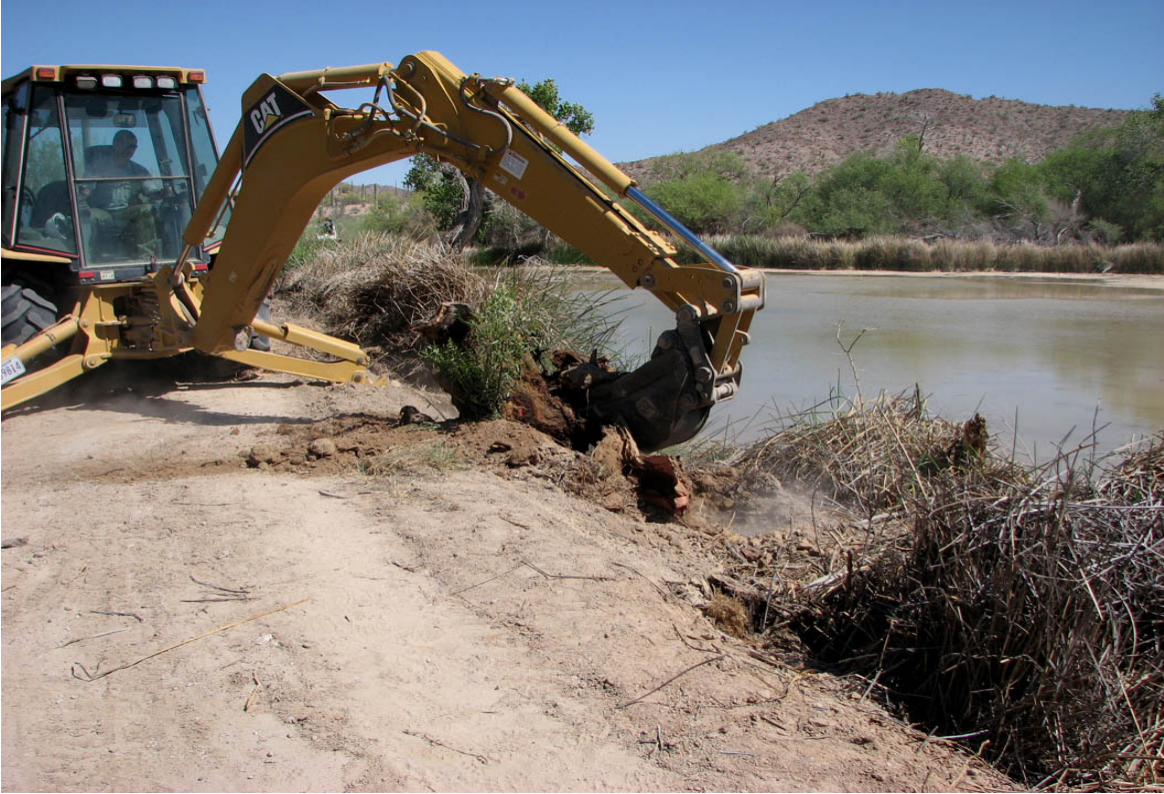
Figure 7. Removing “bee willow” stump and roots from the inner side of the retaining berm. May 5, 2008. Quitobaquito Pond, Organ Pipe Cactus National Monument, Arizona.

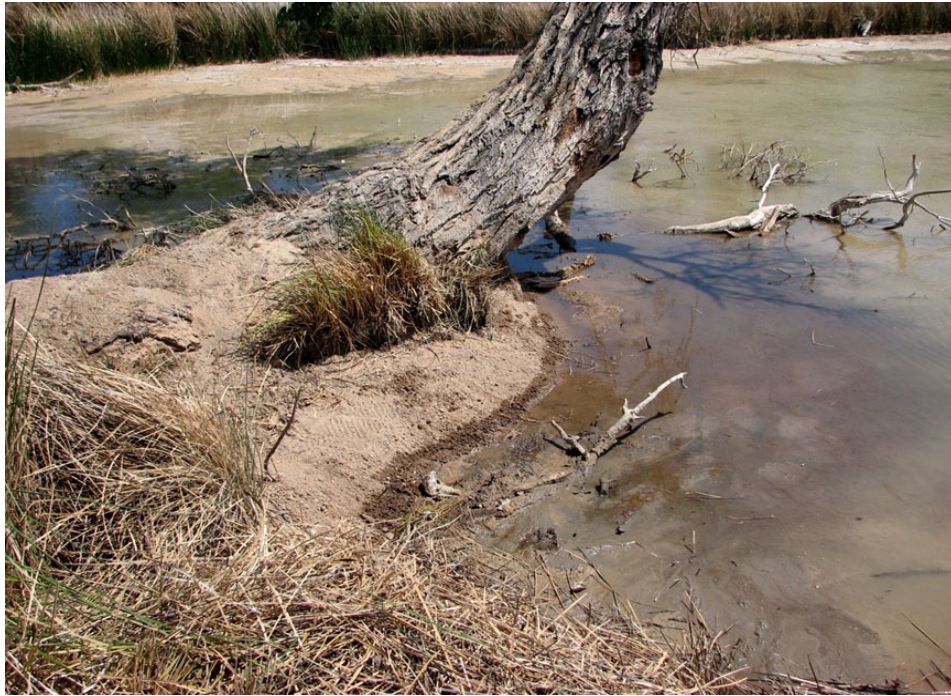
Figure 8. The leaning cottonwood, after packing earth around the lower trunk. May 7, 2008. Quitobaquito Pond, Organ Pipe Cactus National Monument, Arizona.

The horizontal trunk of the leaning cottonwood was to some extent sealed and supported by building an earthen pier or peninsula around and underneath the trunk (Figure 8). Sufficient earth was packed around the trunk to isolate it from open water in the pond. Approximately 5 cubic yards of material were used in this action. Earth used in this action was spoil dirt from the berm trench (see below), and spoil earth from the April 2007 northeast springhead renovation.

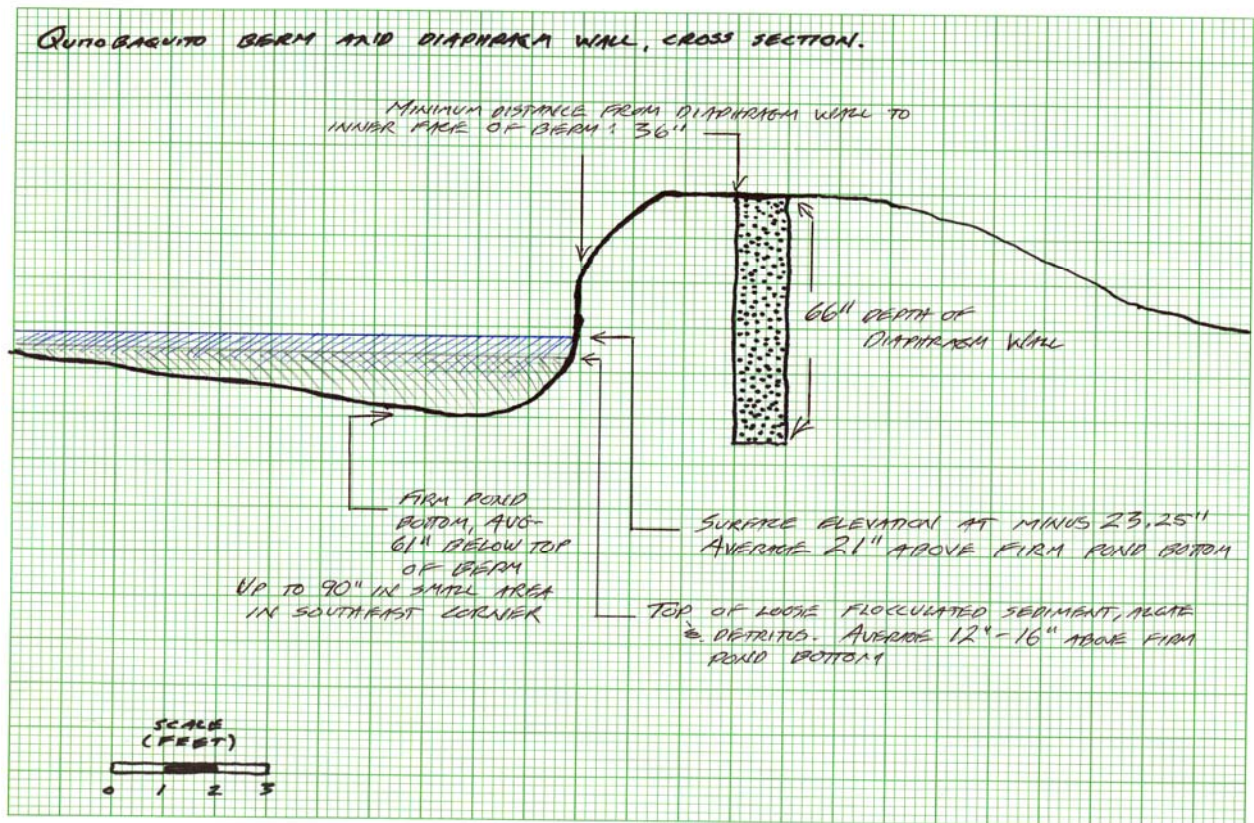
Figure 9. Schematic cross-section of retaining berm at Quitobaquito Pond, including diaphragm wall. Diagram illustrates water level of 23.25” below outflow pipe. The diaphragm wall as built is 66” to 72” deep. Organ Pipe Cactus National Monument, Arizona.

The diaphragm wall consists of an unreinforced wall of concrete, backed on one side by pond liner material, approximately 1 foot wide, 4.5 to 5 feet high in a trench 5.5 to 6 feet deep, and 341 feet long (Figure 9). The wall was constructed down the center of the retaining berm, working from the observation bench at the pond’s west bank, to the bench on the east bank. The construction sequence was:

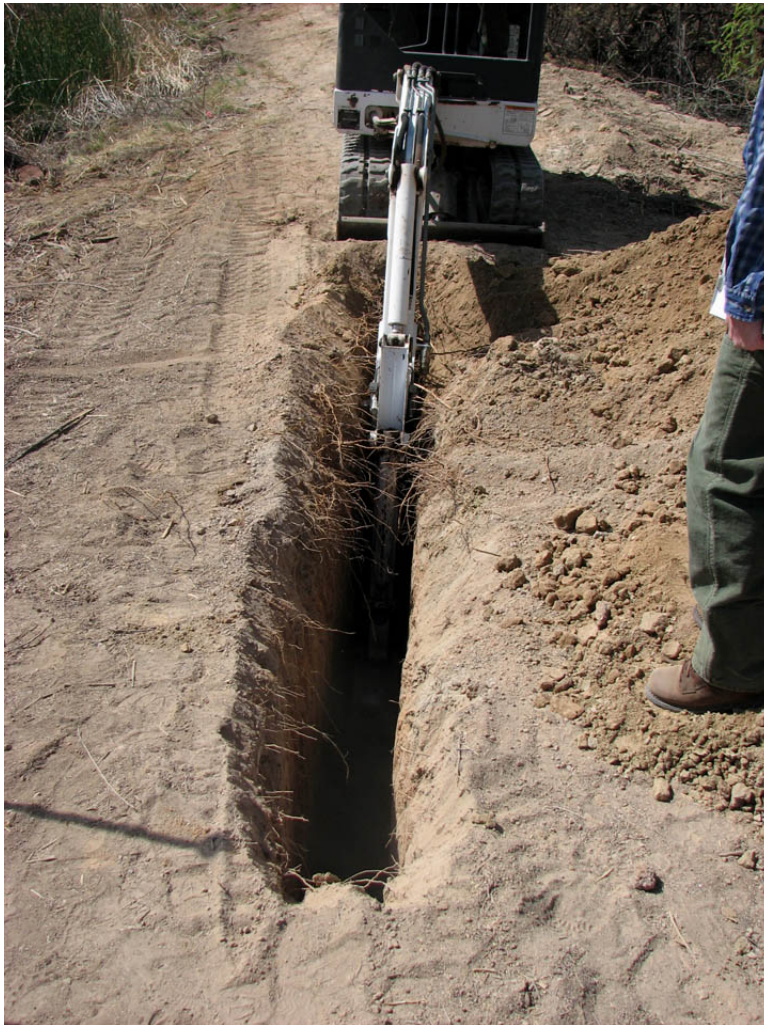
Figure 10. Excavating trench for installing a diaphragm wall in the retaining berm. April 29, 2008. Quitobaquito Pond, Organ Pipe Cactus National Monument, Arizona.

1. A small track-cat trencher on rubber tracks excavated a trench 1 foot wide and 5.5 to 6 feet deep. During project planning, we anticipated that the walls of this trench would likely collapse to some degree, resulting in a “V”-shaped trench with somewhat uneven sides. We recognized a potential danger to the overall integrity of the berm from this effect, and were prepared to modify or suspend the project if the problem became unmanageable. Fortunately, the berm material and skill of the trencher operator resulted in a trench that was identical to our ideal plan. The trench was a uniform slit trench 1 foot wide and 5.5 to 6 feet deep. The trench ran 341 feet in length, and was 3 to 5 feet from the the inner face of the berm (Figure 10). Small deviations from a straight line were made to avoid trenching directly through the center of tree root masses. By passing next to, rather than through root mass centers, we discovered the trench could be excavated neatly, cutting through the subsurface roots. An archaeologist was present during trenching to examine excavated material for artifacts (Beckwith 2008). Excavated earth was placed on the outer, downstream (southwest) face of the berm. Little or no excavated material fell over the inner face of the berm, so no sedimentation/turbidity issue existed for the pond water. At the current low level the water’s edge was 1 to 5 feet from the inner face of the berm. Materials for shoring up the trench walls were available on site, but were not necessary. The trench walls remained intact, and no workers entered the trench once it was deeper than about 4 feet.

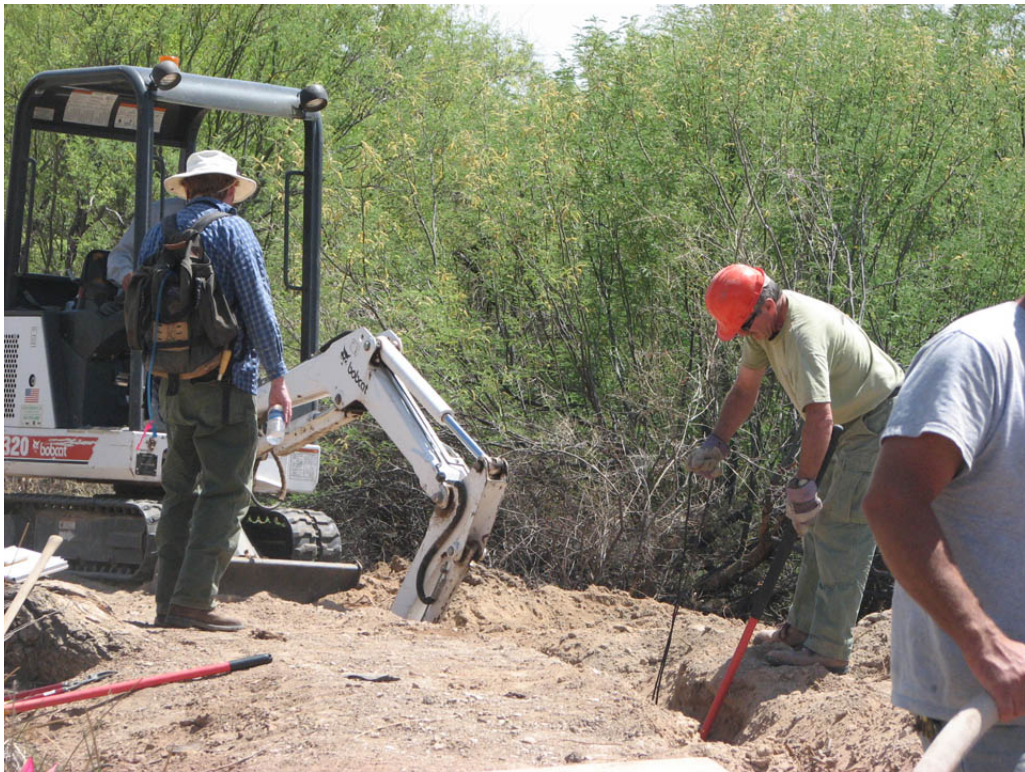
Figure 11. Worker on the right is using pole pruner to trim roots in the trench for diaphragm wall in the retaining berm. Worker standing on the left is an archaeologist monitor examining excavated earth for cultural resources. April 29, 2008. Quitobaquito Pond, Organ Pipe Cactus National Monument, Arizona.

2. As tree roots were encountered during trenching, smaller roots were simply torn up as the soil was excavated. Their remaining loose ends were cut with pruners and loppers, flush with the inner trench walls (Figure 11). Larger roots were sawn through with handsaws and chainsaws. Originally, the route of the trench was expected to deviate around the base of the leaning cottonwood tree, curving down the berm face, to the base of the berm, to swing wide around the tree. The intent of this was to avoid severing large cottonwood roots that may be holding the tree up. However, trenching proceeded carefully along the berm top, curving slightly outward to avoid the base of the cottonwood. No large roots were encountered, so the diaphragm wall alignment stayed essentially on top of the berm, immediately adjacent to the point where the cottonwood trunk emerges from the berm top surface.

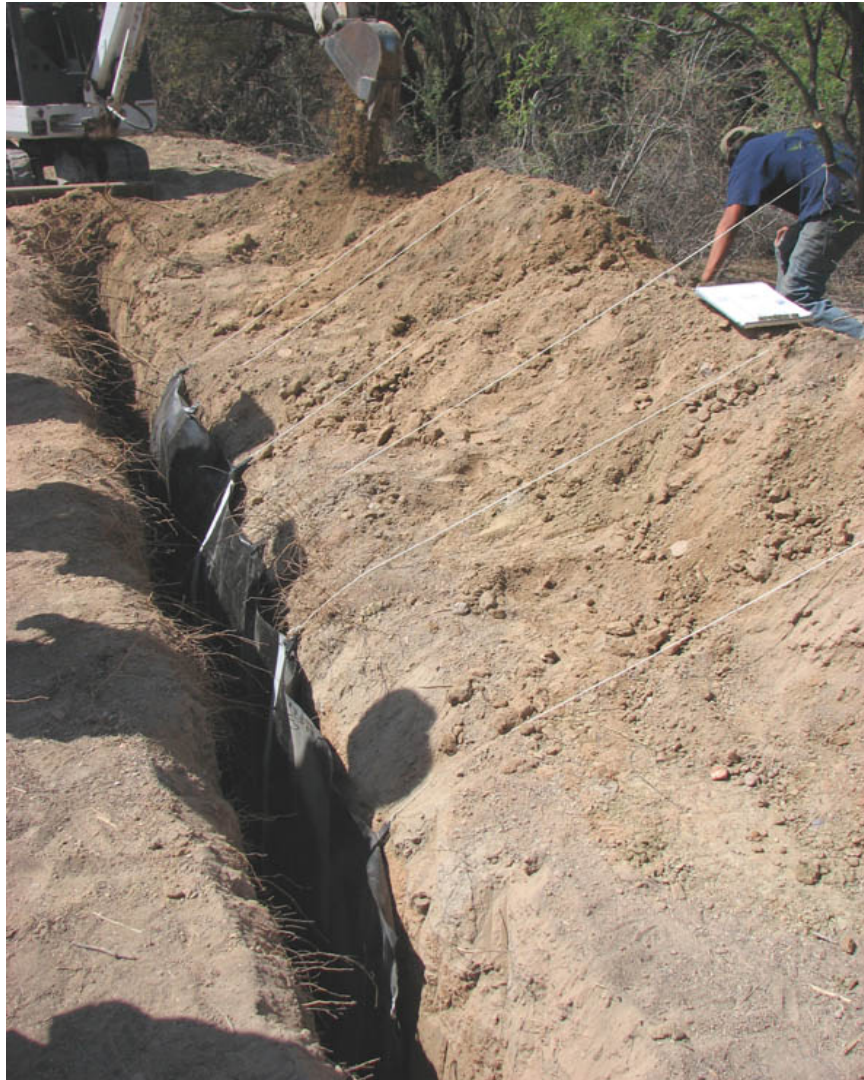
Figure 12. Pond liner material is suspended against the outer wall of the trench, to form a supplemental water barrier. April 30, 2008. Quitobaquito Pond, Organ Pipe Cactus National Monument, Arizona.

5. After about 30 feet of trench were excavated, a water-impermeable curtain was placed against the wall of the trench farthest from the pond (Figure 12). For the western 170 feet, a relatively thin (20 mil) but stiff pond liner/ground cover material was used (Permalon high-density polyethylene). For the eastern 171 feet, a thicker (45 mil), more pliable pond liner of EPDM (ethylene propylene diene monomer) was used. The material was cut into 5-foot wide strips, in lengths ranging from 10 to 20 feet. The material was hung against the trench wall by attaching large plastic alligator-type clips to the top of the curtain. An 8-ft cord was attached to each clip at one end, and was then tied to a rebar stake placed in the excavated soil on the south side of the trench. The 5-ft high vinyl curtain was hung so it reached the bottom of the trench, with the top of the curtain approximately 6" below the top of the berm (well above highest possible pond surface elevation). The ends of adjacent strips were overlapped by 12" to 18". No glue was used.

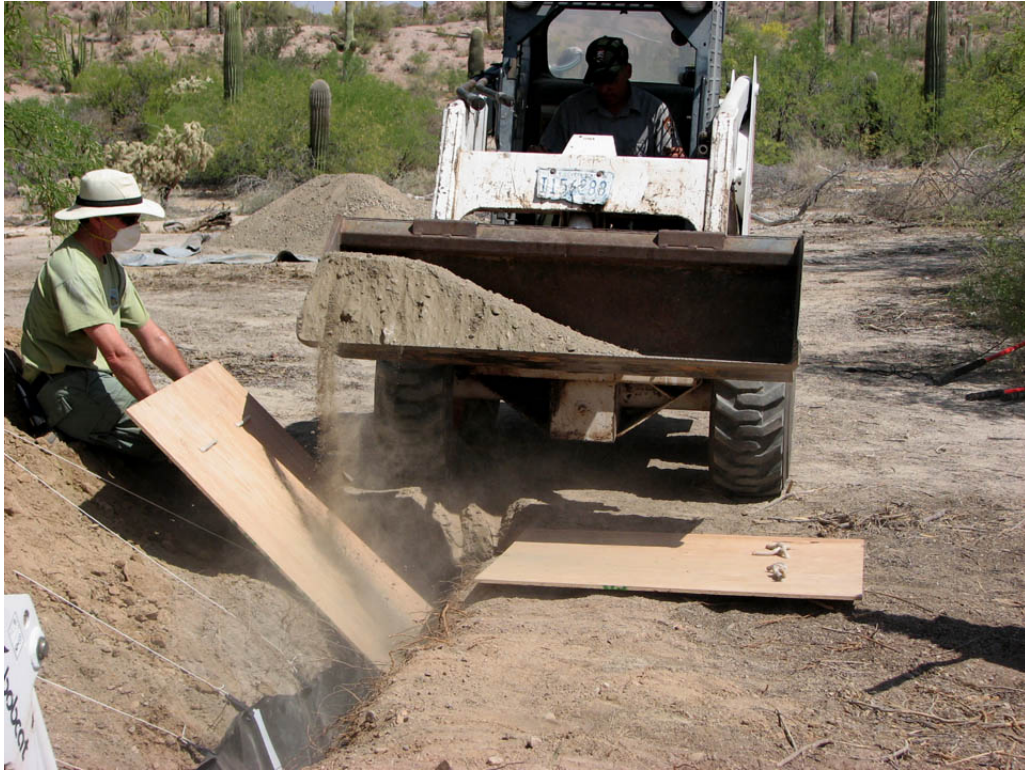
Figure 13. Pouring dry concrete mix into diaphragm wall trench. April 29, 2008. Retaining berm, Quitobaquito Pond, Organ Pipe Cactus National Monument, Arizona.

6. After 10 to 20 linear feet of the pond liner material was in place in the trench, backfilling with concrete was done. An “amended mortar” dry concrete mix of approximately 4:1 ratio (gravel to cement) was prepared in the eastern (public) parking area. This mix was then transported to the western parking area adjacent to the pond. From there, a small “bobcat” loader carried the mix along the berm. The mix was poured from the bobcat’s bucket into a “V” shaped funnel formed by one or two workers holding plywood sheets on either side of the trench (Figure 13). This funnel prevented spills of concrete mix outside of the trench, and also directed the mix so that none fell between the pond material curtain and the trench wall. The dry concrete mix was backfilled to a depth approximately 14” from the top surface of the berm, or the approximate elevation of the outflow pipe (Figure 14). Once backfilled to that elevation, the concrete mix was wetted by spraying with a water truck hose. The trench was then backfilled to the approximate original level of the berm surface, using the original excavated material and hand shovels. The plastic alligator clips were removed from the pond liner material at this point. This soil was also then wetted, and the bobcat driven over the filled trench repeatedly, to compact the backfilled material. Final smoothing and contouring of the berm surface was done using the bobcat, rakes, and shovels. At the northwest end of the berm where its elevation above the ground south of the pond is greatest, the exposed new soil slope was covered with jute erosion fabric and mesquite branches (Figure 15).

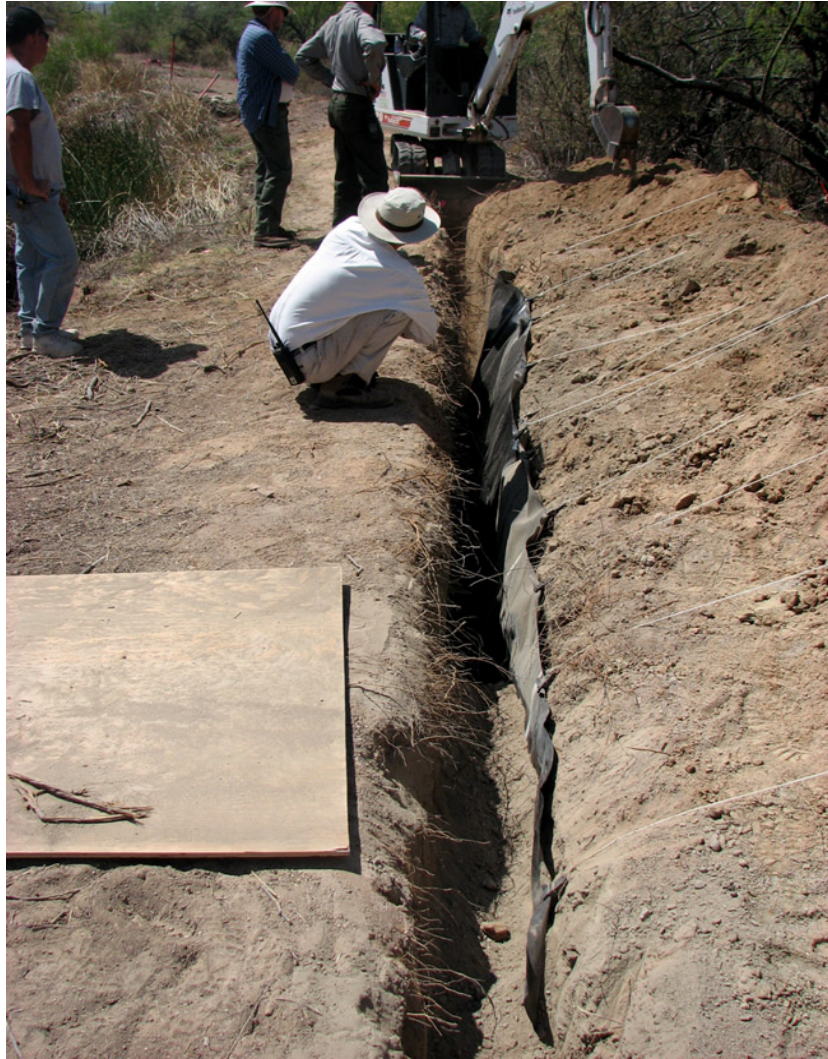
Figure 14. Progression of diaphragm wall construction. Trench in background is being excavated, in the middle ground is ready for backfilling, and in foreground has been backfilled with dry concrete. April 30, 2008. Organ Pipe Cactus National Monument, Arizona.

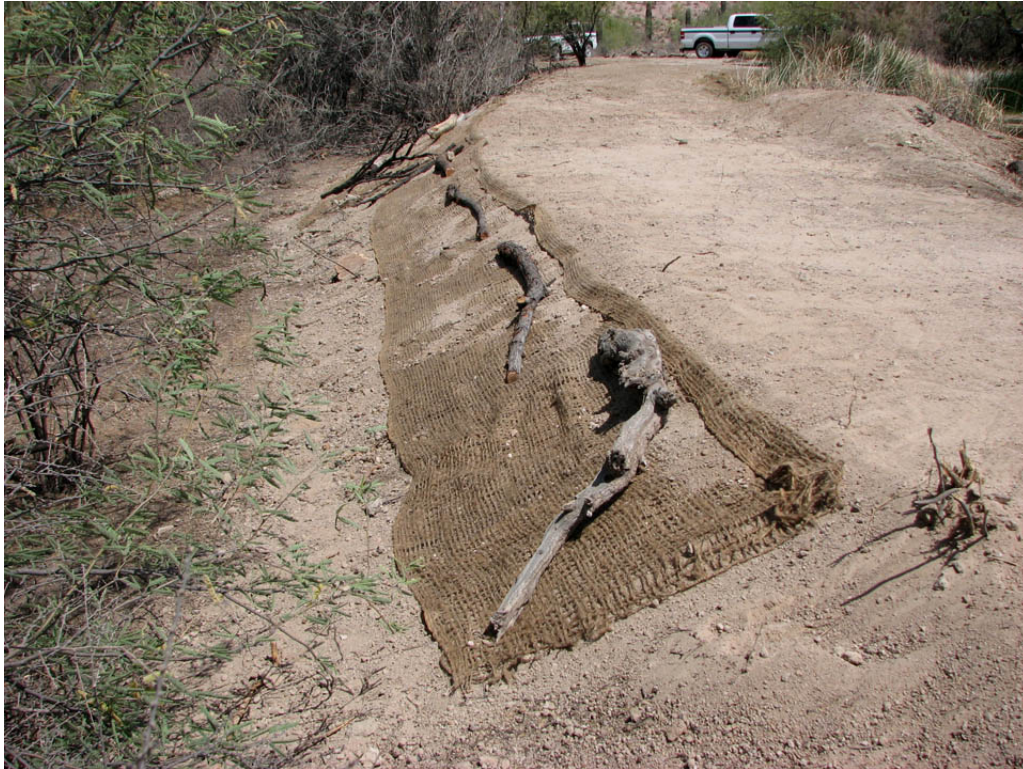
Figure 15. Jute erosion matting and mesquite branches placed to minimize erosion on outside face of the retaining berm. View is to northwest. Quitobaquito Pond, Organ Pipe Cactus National Monument, Arizona.
