PECOS NATIONAL HISTORICAL PARK  
KOZLOWSKI'S TRADING POST RESTORATION PROJECT

EAST WING MILLWORK RESTORATION  
COMPLETION REPORT

Prepared for  
Pecos National Historical Park  
March 2011

by  
School of Engineering, University of Vermont

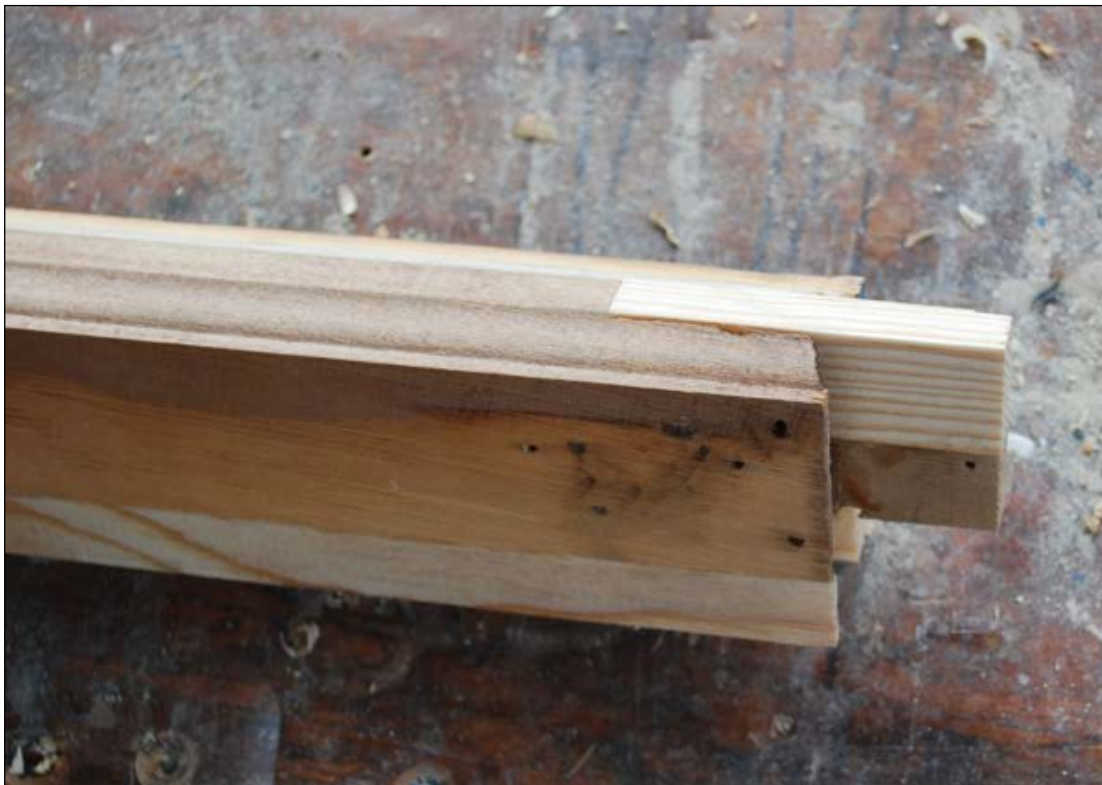
**Figure 3.** Repaired rail with lamination along full length of outside edge and partial replacement of tenon.

- Several rail-end tenons were deteriorated and were repaired prior to lamination. The damaged tenon or portion was cut off at the shoulder, and a half-mortise was put in using a straight cutter on a router table. A floating tenon was then glued into place. (Fig. 3)

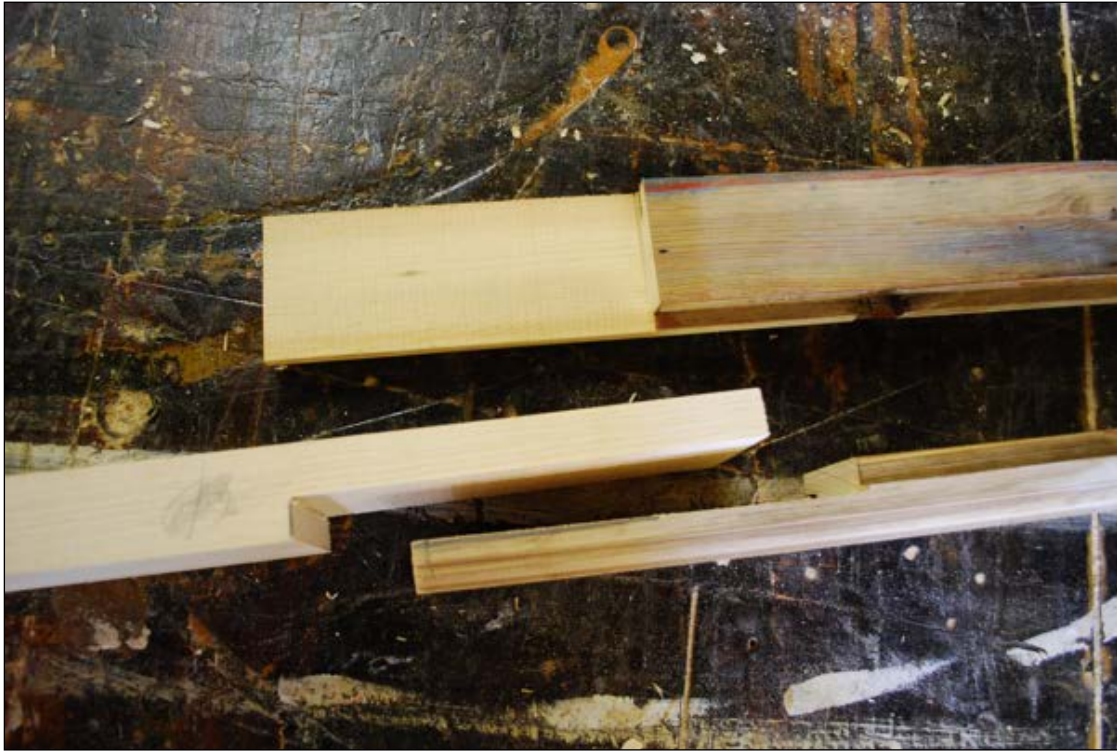
**Figure 4.** Half-lap joint prior to gluing.

saw and both halves were trimmed using a handheld router and shop-made fixture prior to final fitting. Where the repair was expected to come under a particularly great amount of stress (bottom ends of door stiles, for example), the joint was reinforced at the shoulders using four Festool Dominoes.™

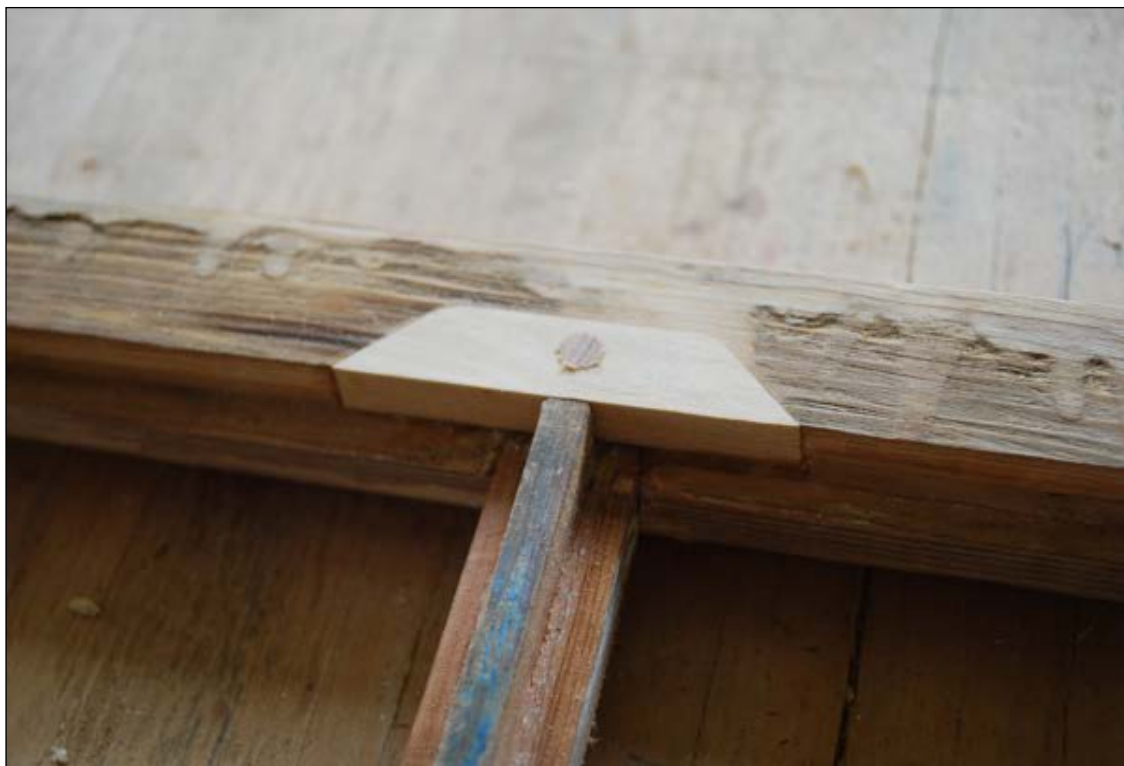
**Figure 5.** Dutchman repair at joint of meeting rail and muntin.

- Moisture and ultraviolet radiation damage weakened much of the mortise-and-tenon joinery, particularly where muntins met rails and stiles. These joints were typically held fast with a small metal pin, and in some cases the oxidization of the pin caused the wood around it to deteriorate. In order to disassemble each sash, the metal pins were removed. At the corners of rails and stiles, wooden dowels were used in place of the pins to secure the joints after reassembly. Where rails were badly deteriorated at the joints with muntins, Dutchmen were let in to replace a small amount of material on the face of the rail. Smaller wooden pins were then used to secure the muntin during reassembly (Fig. 5)

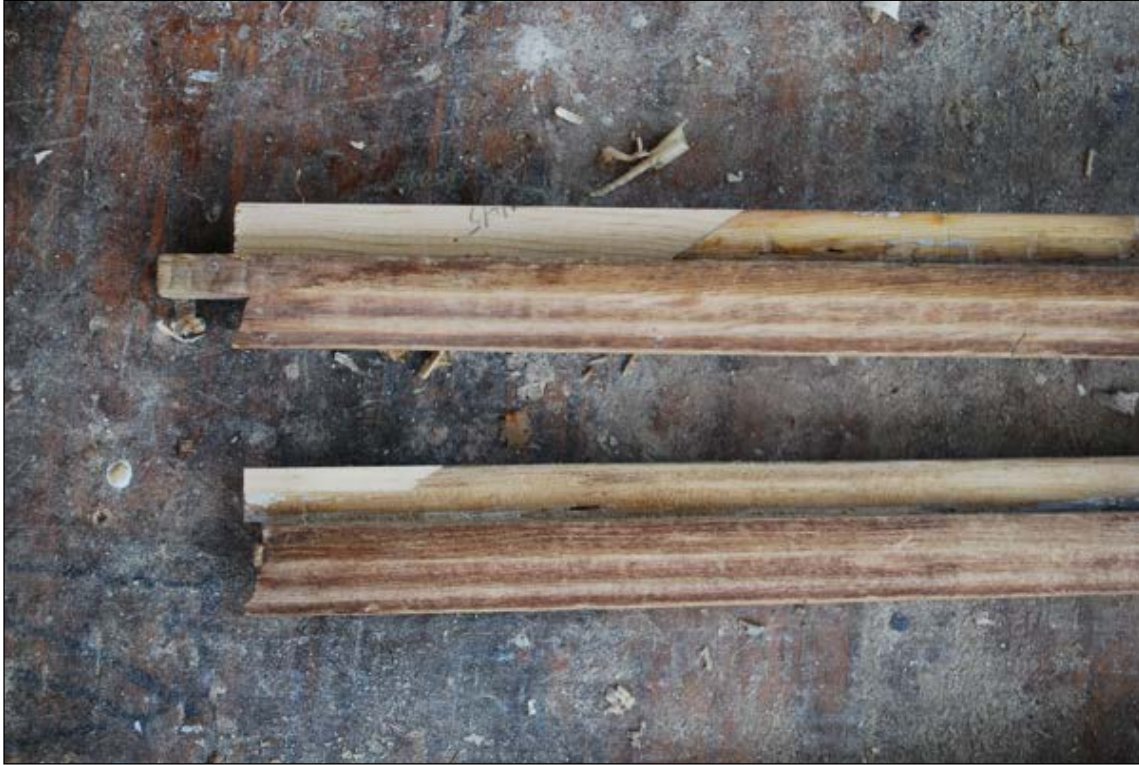
**Figure 6.** Repairs to damaged glazing bars on muntins.

- Repairs to the glazing bar were done using either a spline (for larger repairs) or simply by edge-gluing a small piece of new material. Where splines were used, the exterior face of the muntin was dadoed to accept a new glazing bar. For smaller repairs, the damaged portion was removed and a patch was edge-glued into place. (Fig. 6)

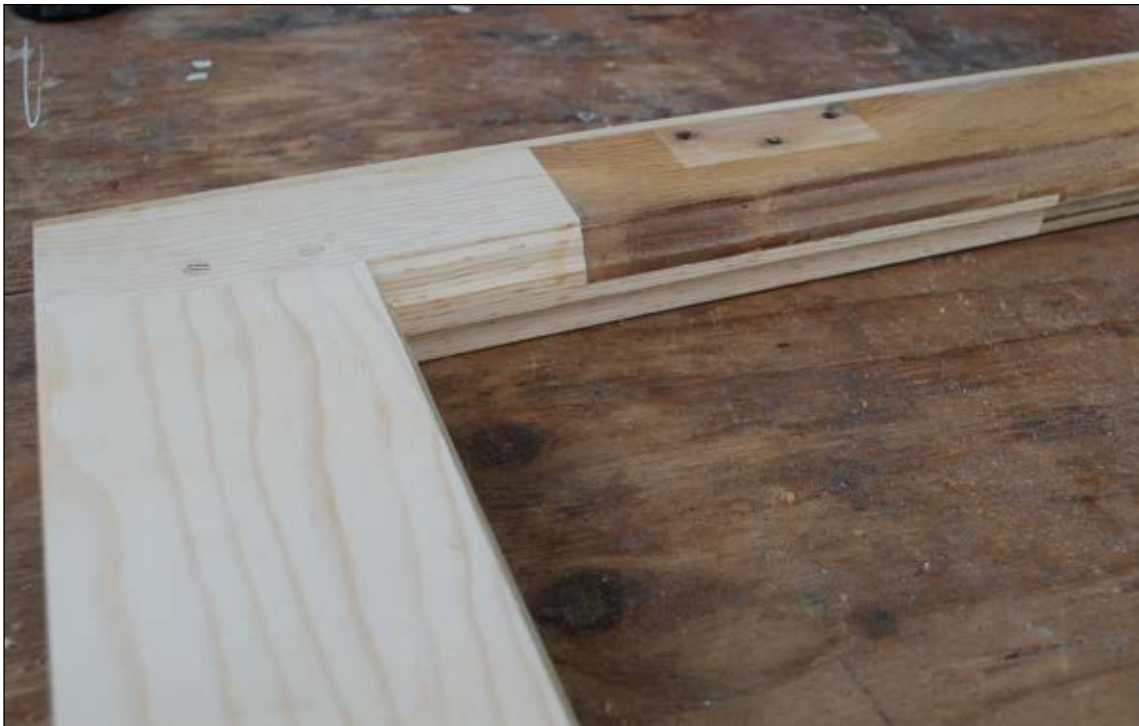
**Figure 7.** Corner of repaired casement window sash showing lamination, stile extension, replacement of a rail, and wooden dowels to secure the mortise and tenon joinery.

- Minor cracks were glued and clamped as needed, but several units and individual elements were so badly deteriorated that it was necessary to fabricate replacements. Depending on the sticking profile, replacement parts were made using one of two techniques. In all instances, stock was milled to the appropriate dimensions, and the cope and stick profiles were either run on a shaper using custom-made cutters or profiled by hand using a filletster plane with a shop-made iron ground to match the historic profile.

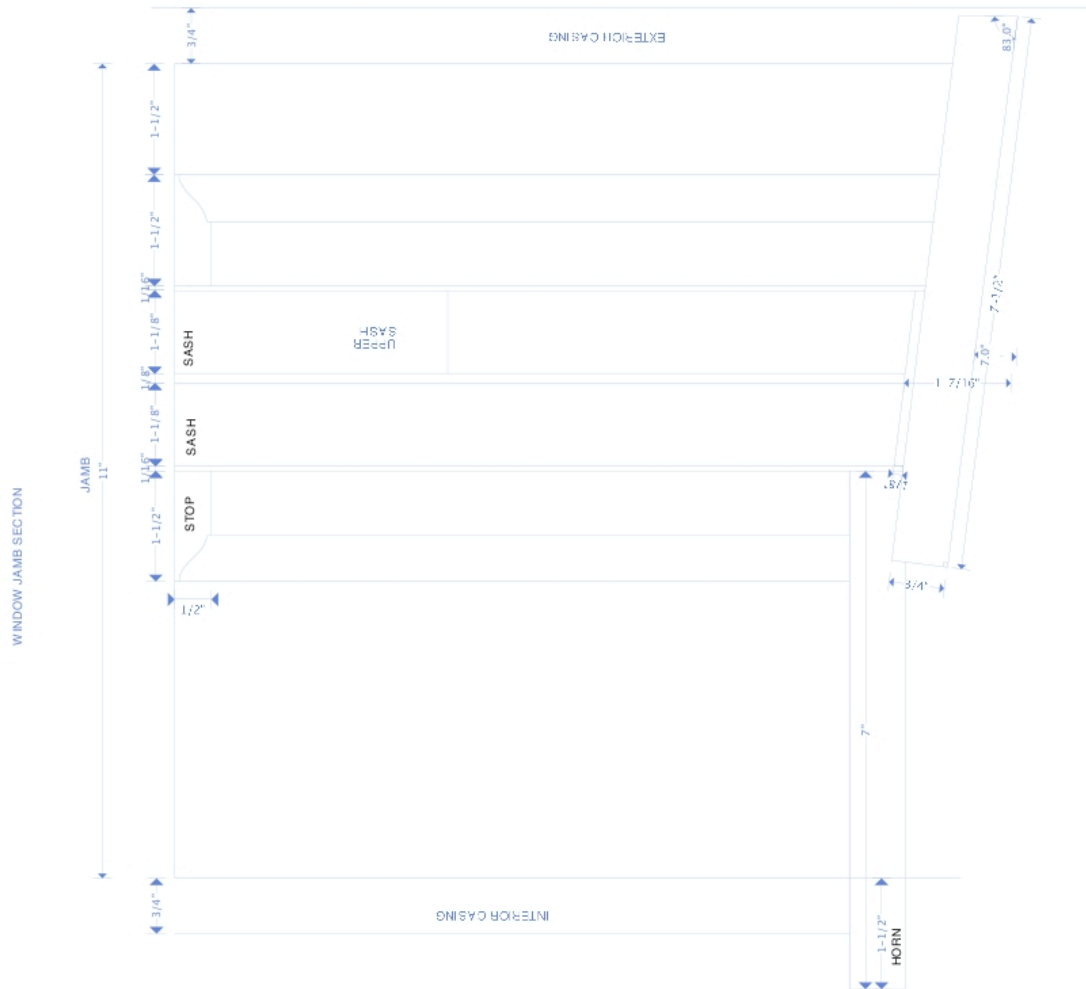
Design for replacement jambs, all double-hung units

With the exception of the brick mold above E1W1, none of the casings, door or window jambs were determined to be salvageable. Most were badly weathered, moisture-damaged, out of square, and the design of the sills was not appropriate for the structure. Much of the later carpentry work during the building's period of significance was done by ranch hands rather than trained professionals, and poor construction and design led to damage that was otherwise preventable. At the beginning of the project, Pecos NHP employees removed the old jambs and some bucks (see individual unit descriptions in Appendix D) and repaired the adobe as needed. New bucks were built and delivered for installation by the Pecos NHP employees. New jambs were then fabricated for all doors and windows using an altered sill design to improve drainage away from the building and prevent a recurrence of the moisture damage that had plagued the structure (a section drawing of the redesigned jamb can be found in Appendix B of this report). As with

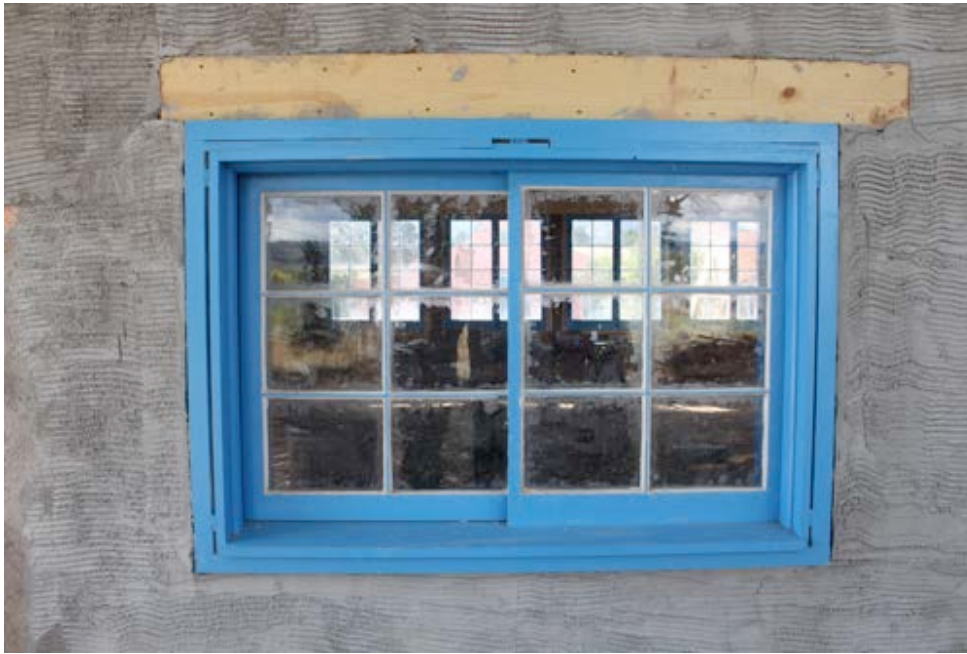
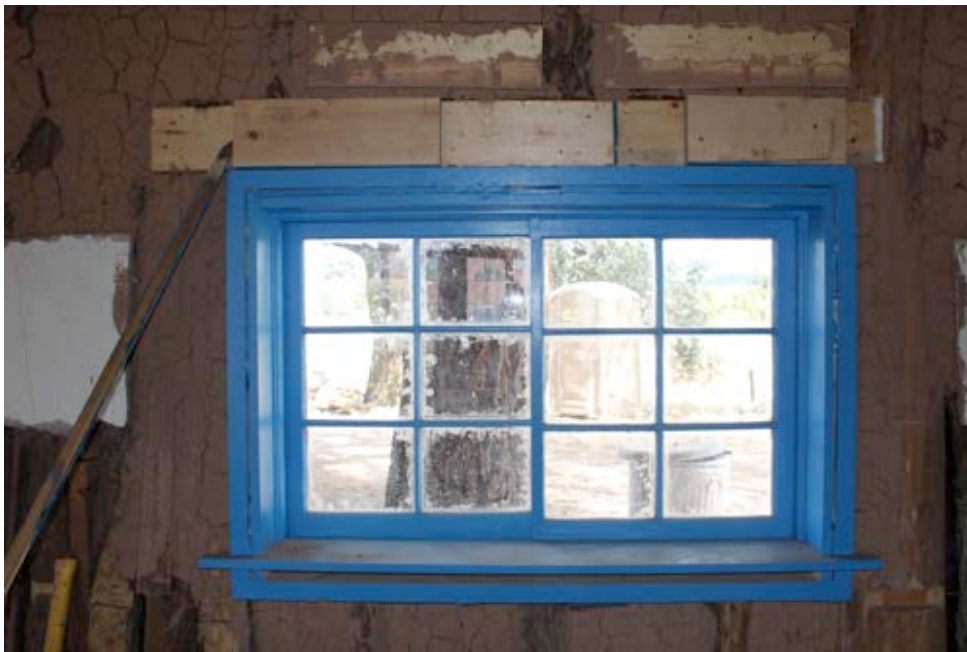
E1W1

This window is constructed of two factory made wooden sashes, probably intended for a double hung window, set side by side to give the appearance of a paired casement window. Sash features an ogee profile in 1 1/8" stock (Profile B), which only appears in one other unit, S1W2. Sashes are installed directly in rough buck and the opening has no lintel above the buck. A piece of molding has been applied where the sashes meet to give the appearance of an astragal. The window is inoperable; no hinges or other hardware to facilitate opening.

- Replaced horizontal muntin #2 and all three vertical muntins
- Replaced top stile
- Replaced left rail
- Removed and replaced  $\frac{3}{4}$ " of material at lower edge of bottom stile
- Sash disassembled and all metal pins replaced with wooden dowels

**NOTES:** A new jamb was constructed and this window was redesigned to function as operable slider.

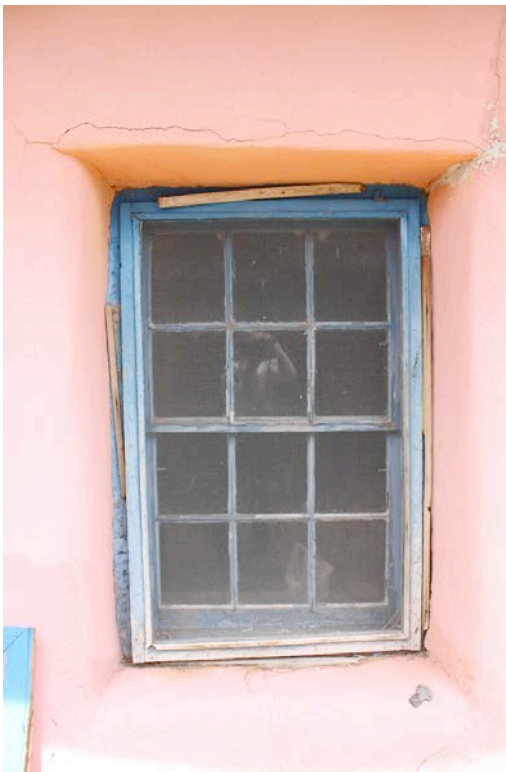
Exterior before treatment

- Missing several sash pins

- Replaced horizontal muntin #3
- Replaced right stile
- Dutchman to meeting rail at junction with vertical muntin #1
- Replaced metal pins with dowels on right stile

New buck and jamb fabricated

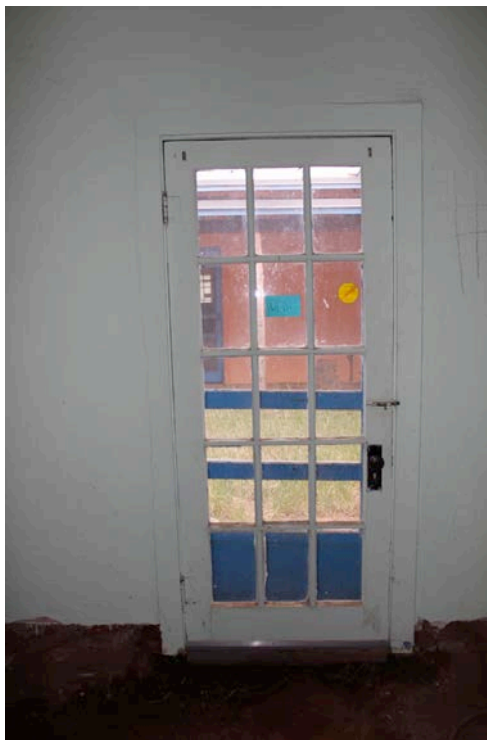
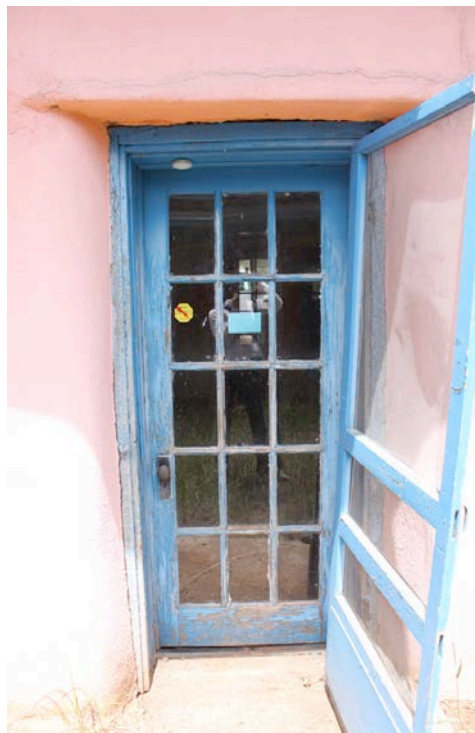
- Top of handle side stile missing
- Bottom of both stiles decaying
- Bottom rail decaying
- Bottom hinge broken
