# National Park Service Cultural Landscapes Inventory

2023

Au Sable Light Station
Pictured Rocks National Lakeshore

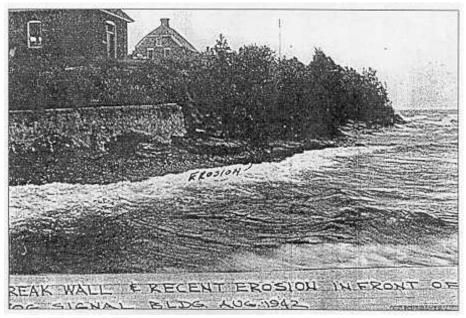
August 1942 photograph of seawall erosion at fog signal building (1999 CLR, p. 70). For full size image please reference the CLR Figure 24.

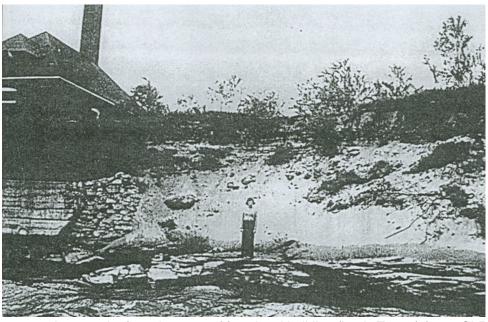
1950s photograph of erosion west of fog signal building (Louis Torres) (1999 CLR, p. 73). For full size image please reference the CLR Figure 30.

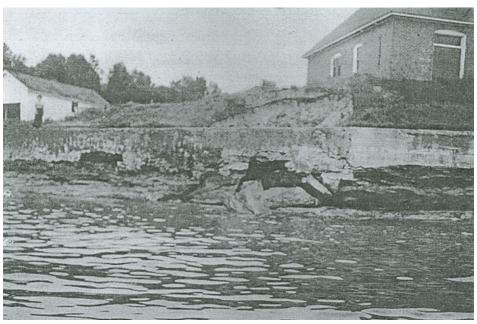
1950s photograph of deteriorated concrete seawall with boathouse and fog signal building (Louis Torres) (1999 CLR, p 74). For full size image please reference the CLR Figure 31.

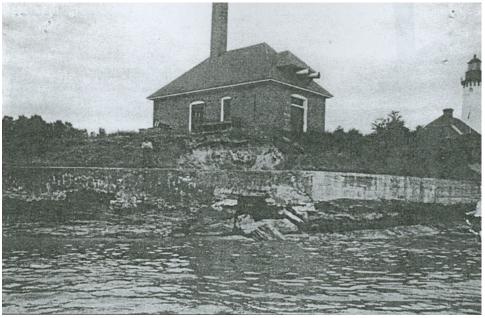
1950s photograph of fog signal building with deteriorated concrete seawall and 1942 extension (Louis Torres) (1999 CLR, p. 74). For full size image please reference the CLR Figure 32.

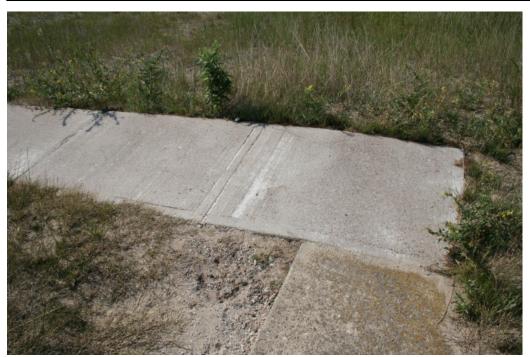
Photo of old and new pavement on sidewalk system - HS-09B (August 2012) Rusch/Young, NPS

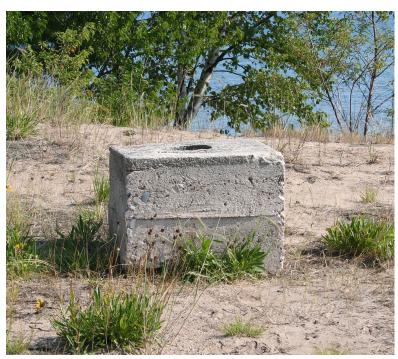
Old flagpole foundation (stabilized) at top of bluff. (August 2012) Rusch/Young, NPS

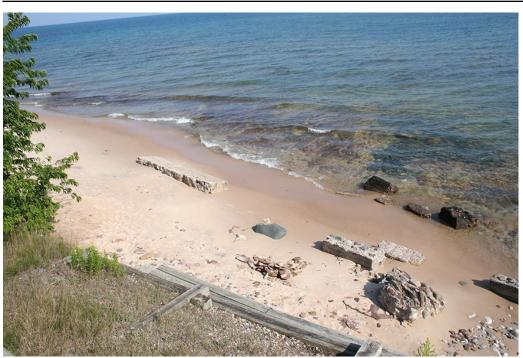
Concrete and wood remnants just below the modern wood cribbing stabilization effort along the shore. These remnants are indicative of the on-going effort to protect the site from erosion at this highly exposed site. (August 2012) Rusch/Young, NPS
