Subject: New Openings in Secondary Elevations or Introducing New Windows in Blank Walls

Applicable Standards: 2. Retention of Historic Character
9. Compatible New Additions/Alterations

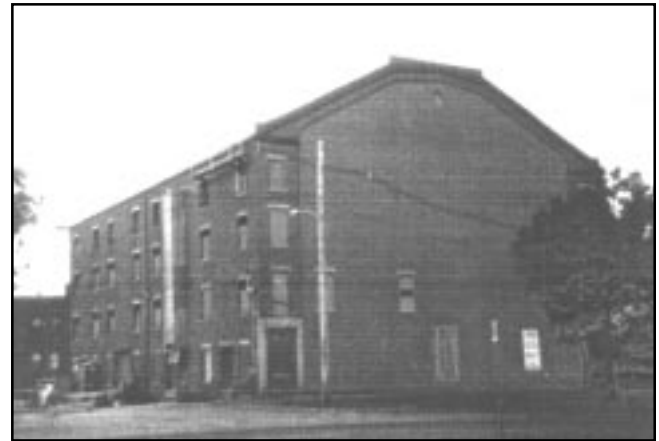
Application I (*Incompatible new openings*): This freestanding brick warehouse was constructed in 1859 to store grain and dry goods. Although the largely solid end wall elevations were secondary, they were highly visible and contributed to the historic character of this building. During a conversion to offices, a series of new openings were inserted in the end walls to admit more light and take advantage of desirable views. The number and design of the new windows, which mimic the historic windows in size, proportion, detail and light configuration, fundamentally altered this building's historic character giving the building a significantly different look. The treatment did not meet the Standards.

Top: The historically important 1859 brick warehouse with largely solid end wall.

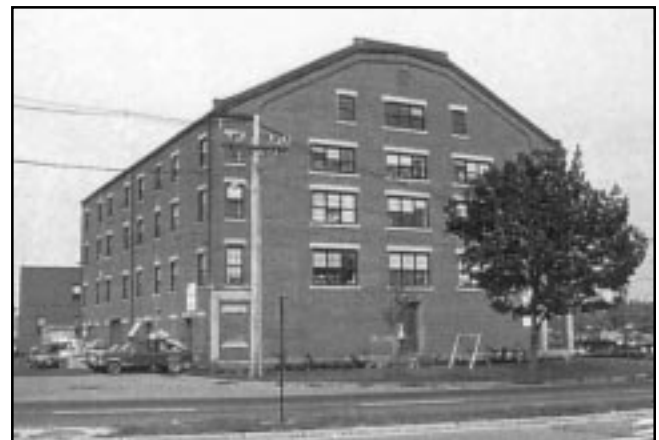
Bottom: The number and design of the windows added to the end wall make this an inappropriate treatment.

New windows could have been installed while maintaining the historic massiveness of the end wall. This would have required the introduction of only a few smaller windows.

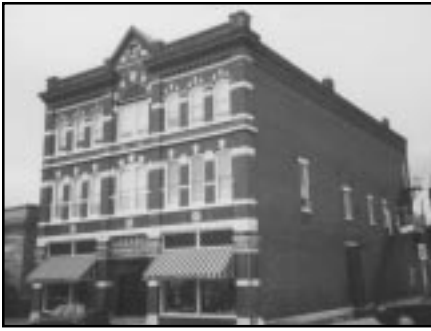
Left: 1882 corner commercial building.

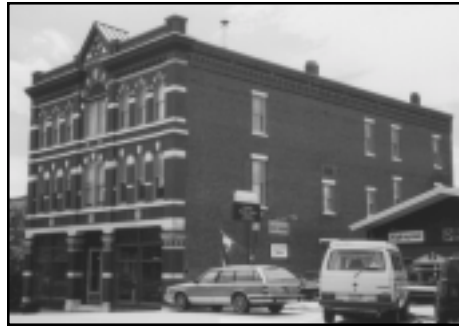
Right: The number and location of the new openings do not alter the historic character nor cause this elevation to compete with the facade.

Application 2 (*Compatible new openings*): This 1882 structure exemplifies the transition in commercial architecture after the Civil War from simple, domestically scaled buildings to structures distinguished as symbols of commercial prestige by their size and height, decoration, quality of architecture and prominence. When rehabilitating this building into bank offices, the owner proposed inserting new openings on the third floors of the secondary side elevation for added light and ventilation. The number and location of these new openings did not impact the character-defining features nor direct too much focus to the secondary elevation.

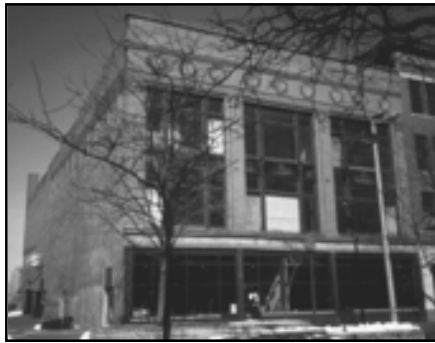
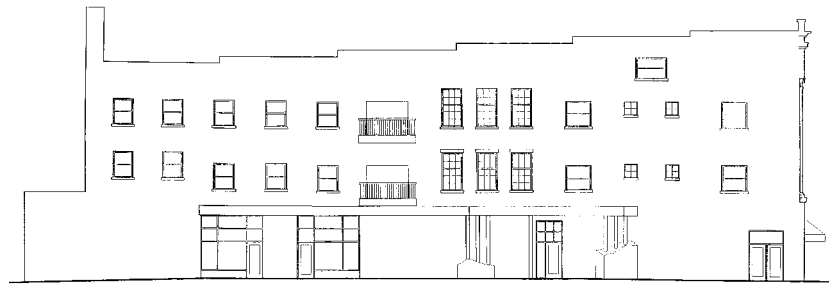
Left: 19th century commercial building with exposed party wall. Above: Inappropriate treatment. Below: Appropriate solution.

This 1897 commercial building with exposed party wall on the west was constructed to house a significant early twentieth century retail establishment. Four entry doorways were cut into the party wall when the building was altered in 1937 and 1992. When rehabilitating this building for mixed-use in 1999, with a restaurant and specialty shops on the first floor and residential apartments on the upper three stories, twenty-five new openings were proposed on the west elevation. These new openings with varying header heights included four different window sizes and pane configurations, and two projecting balconies. The number, placement, rhythm created by the variations in header heights and window sizes and proposed balconies make a strong architectural statement that is incompatible with the historic character of this large solid masonry wall.

The revised elevation design eliminated the balconies and some of the new window openings, standardized the header heights, sash size and pane configuration. This compatible treatment meets the standards.
