## Interpreting The Secretary of the Interior's Standards for Rehabilitation

### Subject: Replacement of Missing or Altered Storefronts

December 2007, ITS Number 48

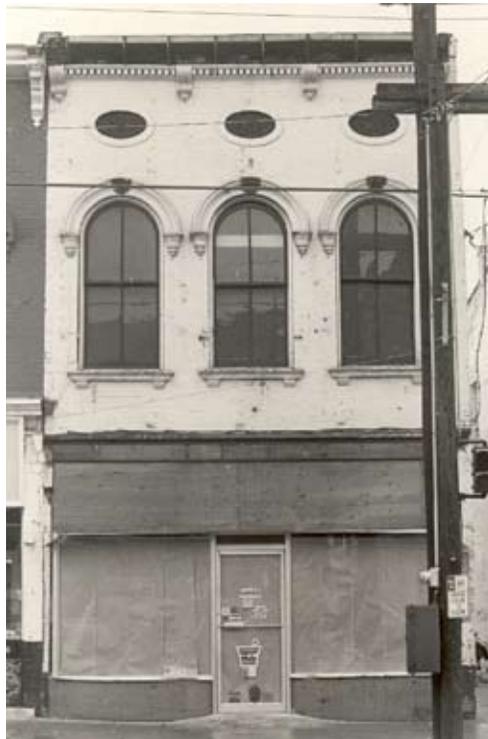
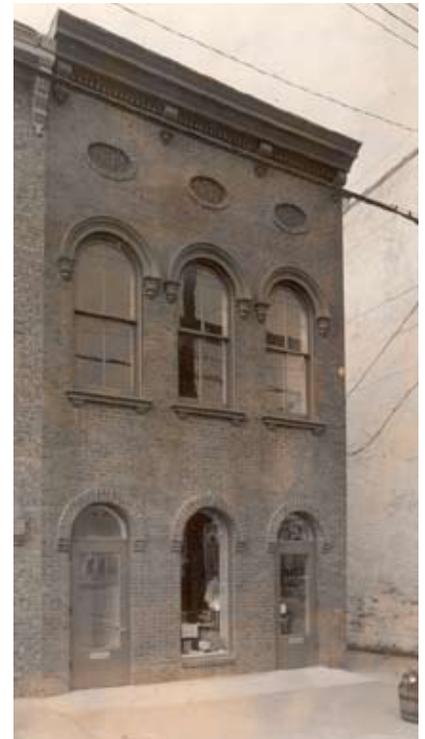
**Application 1 (*Incompatible treatment*):** This late-19th century, two-story, brick commercial building was rehabilitated for office use. The existing storefront, which was not original, was in poor condition but could have been retained and repaired. The owner did not wish to keep the non-historic storefront and could find no information to document its historic appearance. Instead of designing a compatible new storefront, the owner constructed three separate arched openings that copied the arched windows on the second floor. Generally, the first floor of a historic commercial building did not reflect the design of the second floor openings, but typically featured a storefront with large glass windows to display merchandise. Replacing the storefront with residential-type openings resulted in a loss of the historic commercial character of this building. The project does not meet the Standards.

*The storefront on this Victorian building prior to rehabilitation was a later replacement (left). During rehabilitation the storefront was removed and replaced with three residential-type openings that are incompatible with the building's retail character (right).*

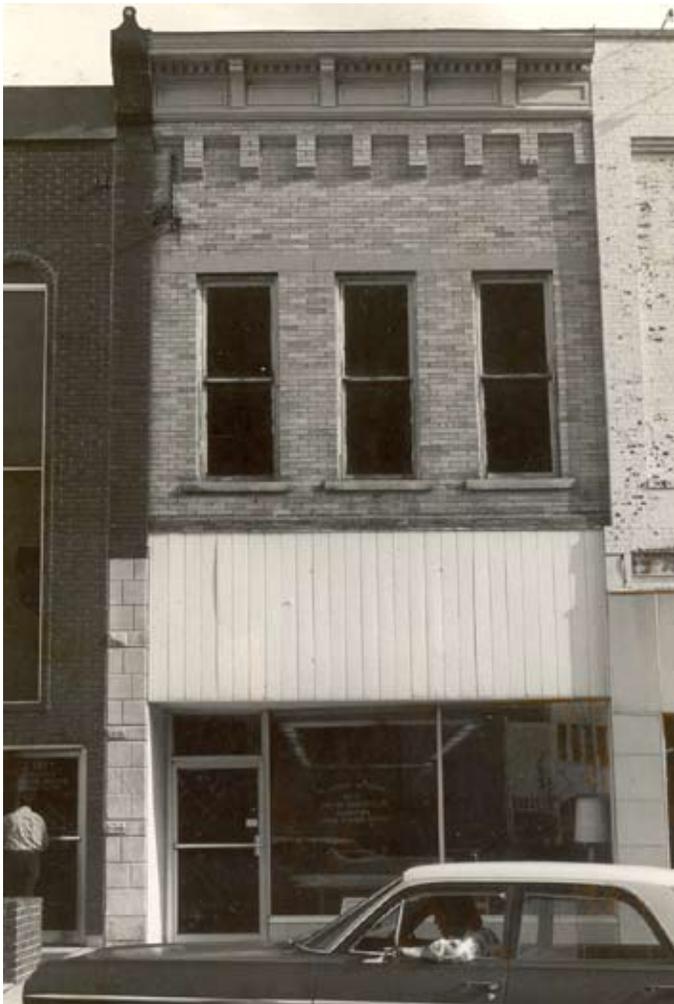
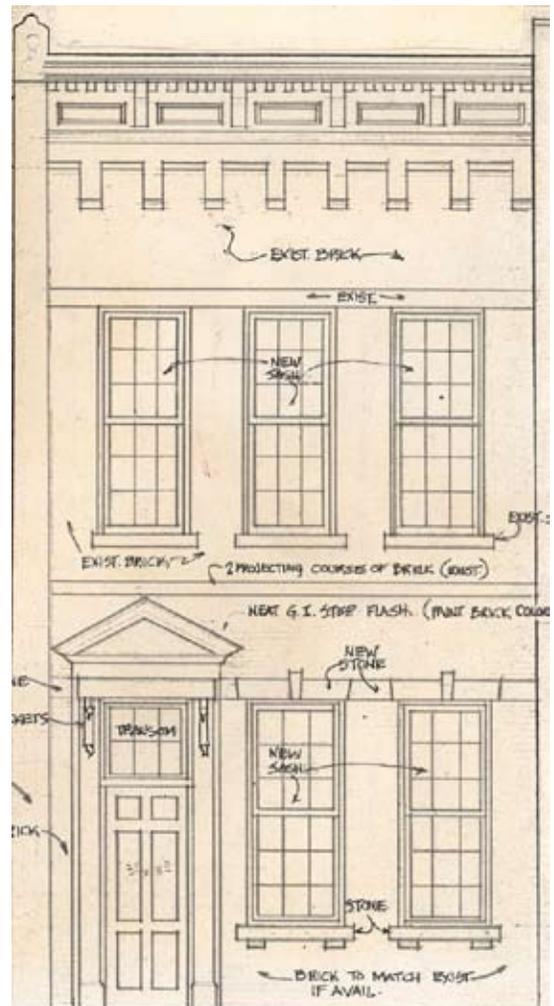
**Application 2 (*Incompatible treatment*):** Another historic commercial building constructed c. 1900 with a 1950s storefront was to be converted into offices. This rehabilitation also proposed to replace the storefront with residential-type openings, but with nine-over-nine windows, keystone lintels and a pedimented doorway in an 18th century

“Georgian” style inappropriate for this early-20th century building. (The one-over-one sash on the second floor windows was proposed to be replaced with nine-over-nine sash to match the new first floor windows.) Not only is installing residential-type openings to replace a storefront an incompatible treatment, but removing original windows and replacing them with historically inaccurate windows is also not a compatible rehabilitation treatment. Accordingly, this proposal does not meet the Standards.

*Prior to rehabilitation this early-20th century commercial building had a 1950s storefront (left). Rehabilitation plans proposed replacing the storefront with 18th century-style residential-type openings, inappropriate for this commercial building and its period of construction (right).*
