# Tech Notes

## LAMAR BARN Yellowstone National Park Wyoming

## EXTERIOR WOODWORK NUMBER 3

### Log Crown Repair and Selective Replacement Using Epoxy and Fiberglass Reinforcing Rebars

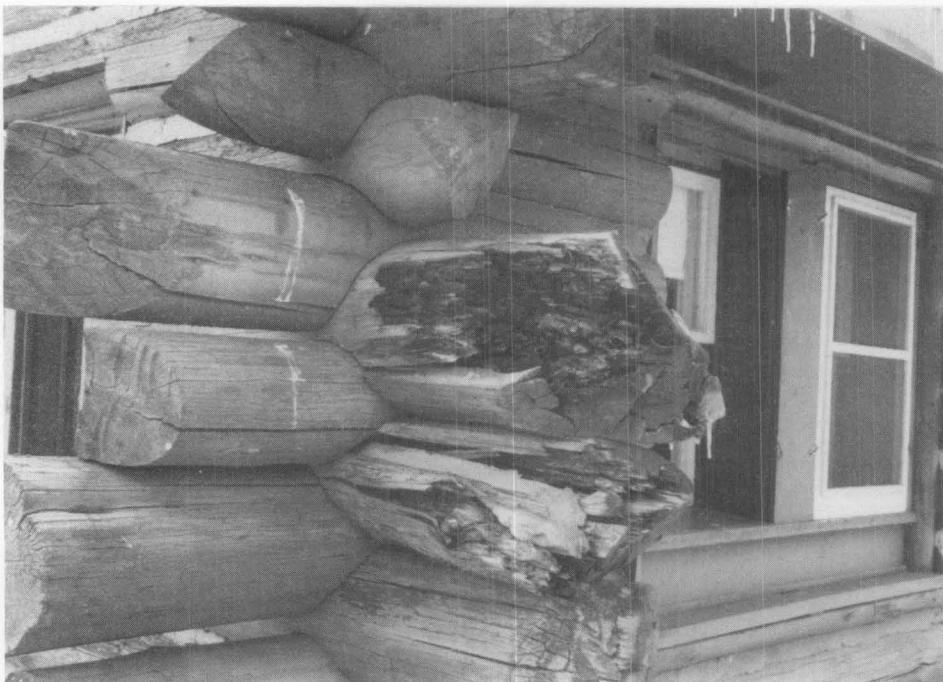
portions of the logs directly exposed to the weather were deteriorated. The culprit in every case was moisture. It was easy to predict where to find the greatest pockets of decay. Log crowns extending beyond the drip edge of the roof were in the worst condition. Sill logs, particularly on the north side of the building, were also badly deteriorated. The amount and depth of decay in both instances followed a pattern: the further out from the roof they extended, the greater the deterioration (*see figure 1*).

After about sixty years, decay had taken its toll. More than half of the extending crowns were so rotten that it was possible to pull large chunks of the heartwood out of the exposed ends. In some cases, the log crowns were almost totally gone. In others, the shells of the crowns had given way and the soft mulch-like interior had fallen out. In the most severe cases, the decay had penetrated beyond the notch where the logs intersected and had traveled into the log as much as ten to twelve inches. This impacted both the visual and the structural integrity of the walls and their appearance.

Figure 1. Typical deterioration of log crowns is seen at the Institute Building, adjacent to the Lamar Barn. This is the condition of many of the log crowns at the Lamar Barn prior to the repair and replacement work. Logs are notched at the corners. Photo: Harrison Goodall.

Option #3 involved cutting off the deteriorated log crowns at the area of greatest decay (the intersecting notches), and splicing on replacement crowns of the same size, configuration, and texture. This approach had several advantages:

The treatment selected for the log crowns was to splice replacement sections onto sound portions of the wall logs. Additionally, one totally deteriorated sill log required replacement, a few wall logs needed facing, and some decay in checks or horizontal cracks required consolidation with a flexible epoxy. The rafters and purlins, previously cut back, were left untouched.

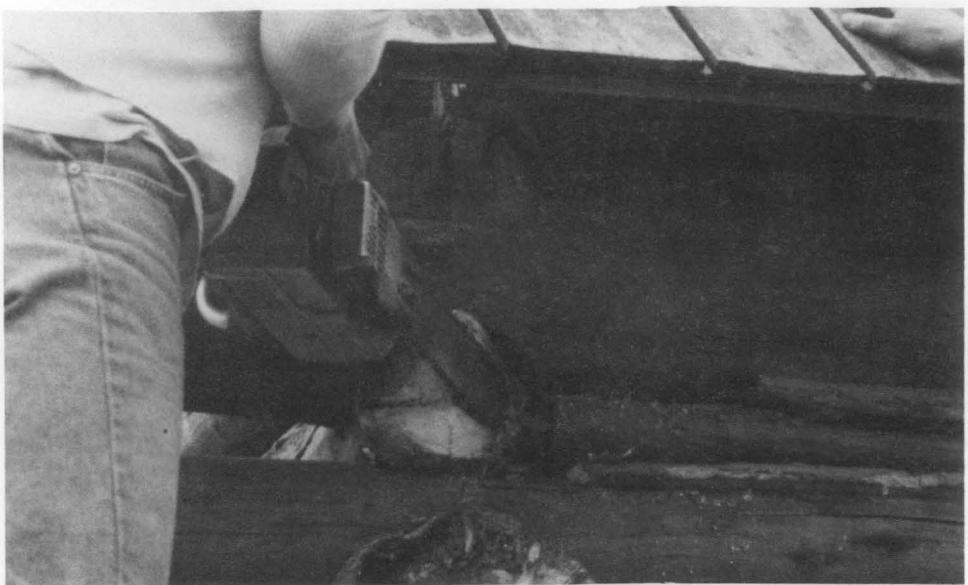
Figure 2. Small chainsaws were used to cut off deteriorated log crowns. The darker portions of wood at the log ends are the soft punky deteriorated fibers. Photo: Harrison Goodall.

Each of the deteriorated log crowns was carefully photographed and documented. Diameter, length from the wall and surface configuration of the cut end of the log were recorded. Then the crowns were cut off, at an angle towards the notch (*see figure 2*). Next, the original logs were drilled back to the center line of the intersecting walls, using a plumber's bit (*see figure 3*). This gave a flat surface to begin the new crowns. The recessing with a flat surface to the center line of the wall was more difficult than first anticipated because the barn builder had anchored each log with four galvanized square spikes 8" x 3/8". These spikes had to be chiseled and sawn back to a flat surface so the new crowns could be properly anchored.

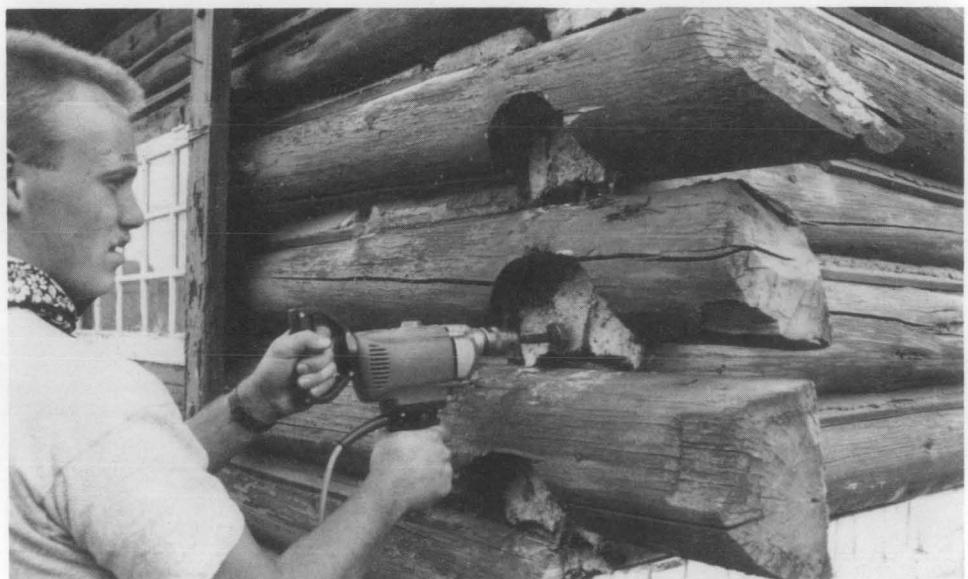
Figure 3. A plumber's bit was used to recess the crown back to the center line to create a flat surface for attaching the replacement crowns. Photo: Harrison Goodall.

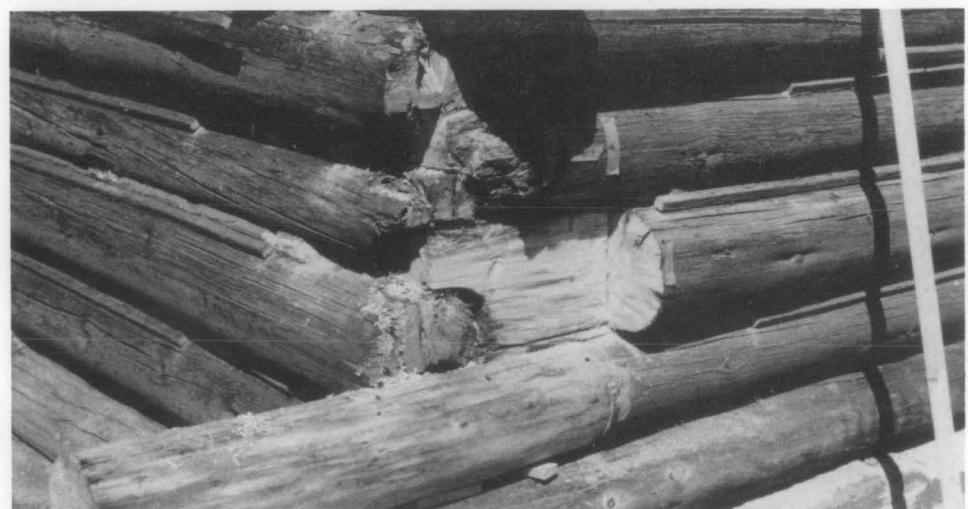
Figure 4. In a few cases, the deterioration had penetrated beyond the center line of the log corners and portions of the wall face were removed. Photo: Harrison Goodall.

In a few cases, deterioration penetrated beyond the center line of the wall, and more material had to be cut back to reach sound wood. A rotary rasp, not unlike a king-size dental drill, was used to remove remaining decay at the center line. The sound wood surface was treated with an epoxy consolidant to encapsulate remaining soft absorbent wood, thereby retarding future decay. Where the decay had traveled into the log walls, sufficient wood was removed and the surface flattened to permit new faces to be attached to the logs (*see figure 4*). These new faces were notched to match the log surfaces removed.

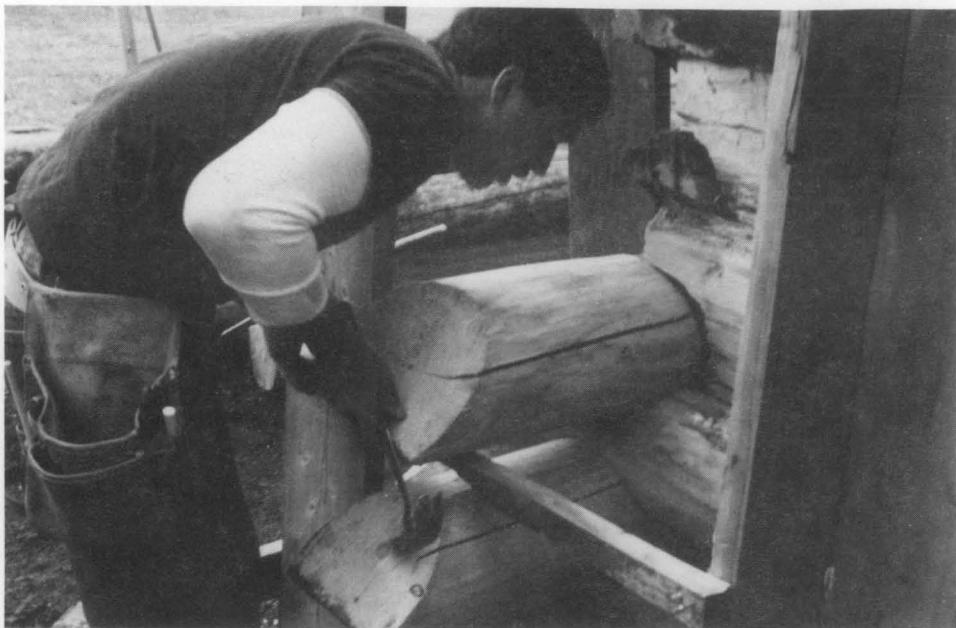
**Figure 5.** A framework or cribbing held the replacement crowns as they were fabricated. All the crowns had to be temporarily put in place to ensure a proper fit. Once stacked up, they were numbered to make sure they would be properly aligned at the time of anchorage.

The photographs of the deteriorated crowns were used to reconstruct the replacements. Each replacement log crown was cut and fitted until it matched the notch of the original. A wood framing not unlike cribbing was constructed at each corner to hold the replacement log crowns as they were marked, cut, and fitted in place from the bottom level up (*see figure 5*). As much as possible, checks in the wood were placed in a downward position to prevent water from collecting in the wood. As the crowns were extensions of the logs and not supported by the ground, it was necessary to provide temporary support until the replacement crowns were epoxied in place. The log crowns were not anchored until all had been stacked in place with all notching complete. They were then marked to ensure proper alignment when anchored.

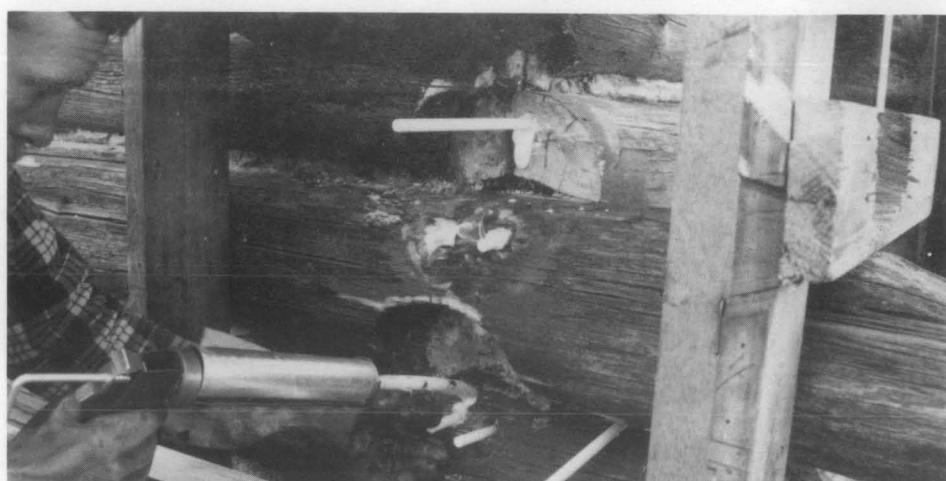
**Figure 6.** A flexible tube was stapled onto a caulking gun in order to fill the 12"-12 1/2" deep holes that had been drilled into the sound end of the historic log. The individual hole was filled two-thirds with epoxy adhesive and a 1/2" diameter fiberglass reinforcing rebar was then inserted.

The holes (7/8" diameter) for the 1/2" reinforcing fiberglass rebars were drilled into the original logs. Corresponding holes were drilled into the crowns. An 8" piece of flexible tubing was stapled onto the nozzle of a caulking tube in order to reach to the back of the long drilled hole. The caulking gun was filled with a high-strength structural two-part epoxy in a paste-like consistency, which was then injected into the original log. The cavity was filled two-thirds. The paste-like consistency of the epoxy kept it from draining out of the drilled hole. The precut rebar was then inserted using a twisting motion (see figure 6). The replacement crown was also filled two-thirds with epoxy, then aligned, inserted and left to cure (see figure 7).

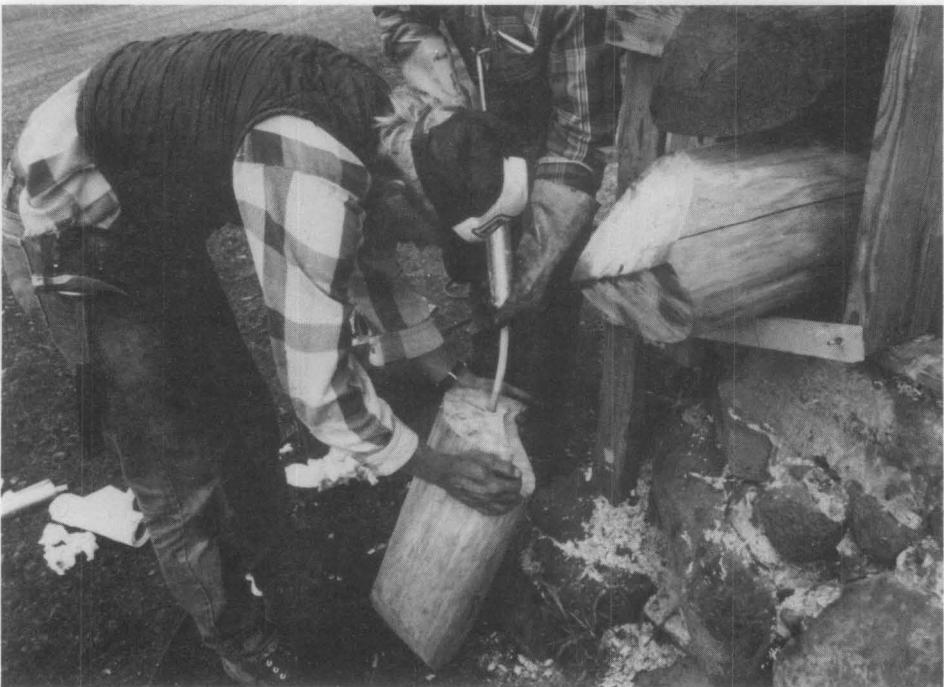
Figure 7. A 12 1/2" long hole was drilled into the new crowns. This hole was filled in the same manner as were the old logs. The crown was then immediately lifted into position and supported by the cribbing framework for several days until the epoxy cured. Photo: Harrison Goodall.

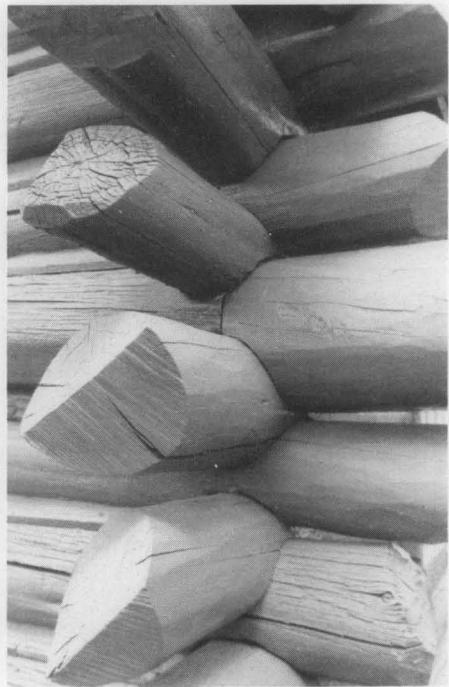
Figure 8. The joints between the historic logs and the new crowns are visible, but not disconcerting. The unsealed joint will help keep future decay isolated to the log crown. Photo: Rodd Wheaton.

While there is a tendency to caulk the cracks in wood, it has been found that in many instances it is best to leave small checks open to let wood breathe naturally (*see figure 8*). For this reason the joints between the log crowns and the original log walls were also left open and not sealed. The new crown ends are expected to last between 10 and 30 years. The upper crowns directly under the roof runoff are likely to deteriorate first. These can be replaced as required. As with any completed preservation project, the better the routine maintenance the longer the work will last and the more cost-effective it will be in the long run (*see figure 9*).

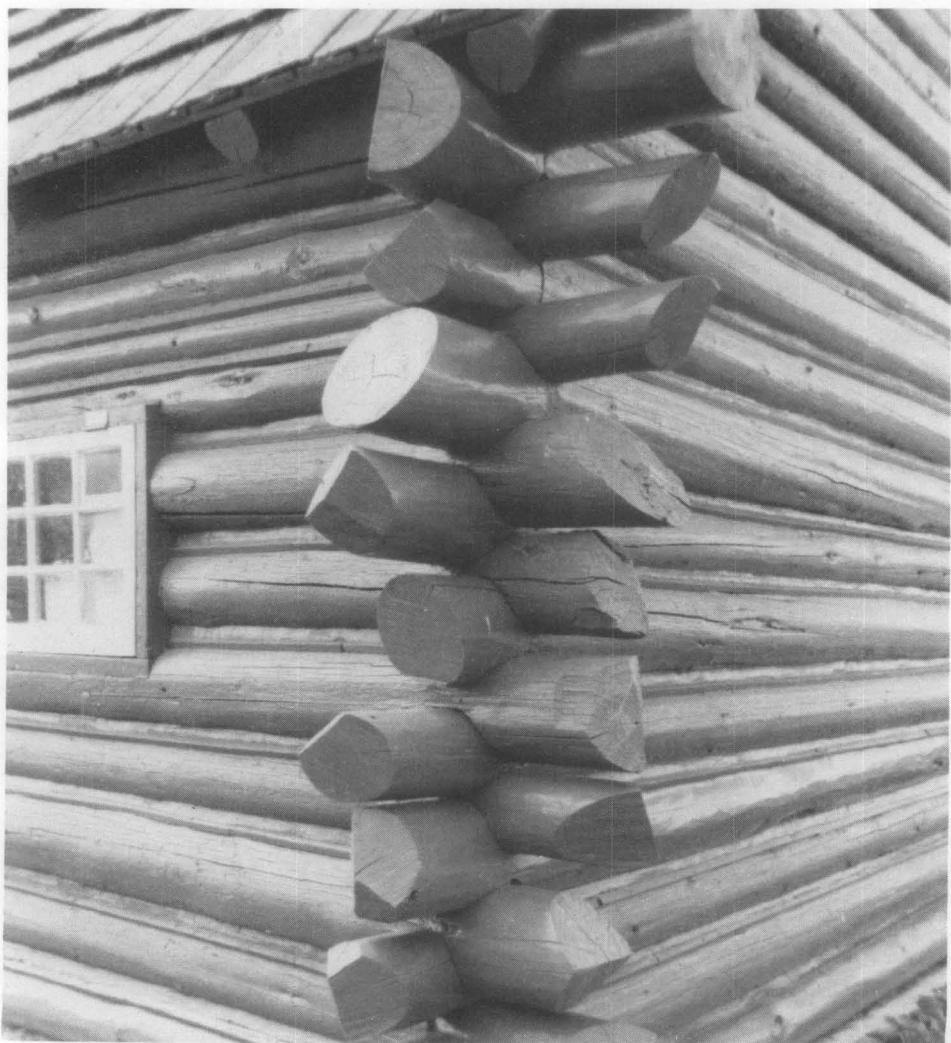
Figure 9. A repaired corner of the Lamar Barn. It is expected that the log crowns will need replacing in 10-30 years. Photo: Rodd Wheaton.

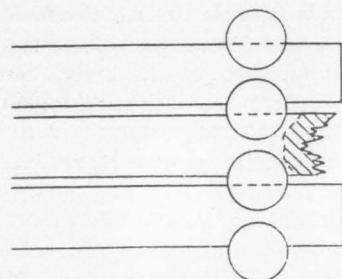
Deteriorated log crown.
