**552-554 BROADWAY**  
New York, New York

# Preservation Tech Notes

## **HISTORIC GLASS** NUMBER 2

### **Repair and Rehabilitation of Historic Sidewalk Vault Lights**

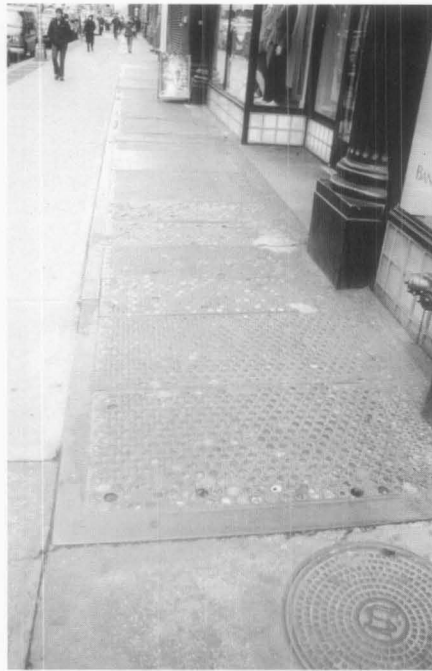
Figure 2. At the outset of the restoration project, the original cast-iron and glass vault lights in front of the building's storefront were in poor condition.

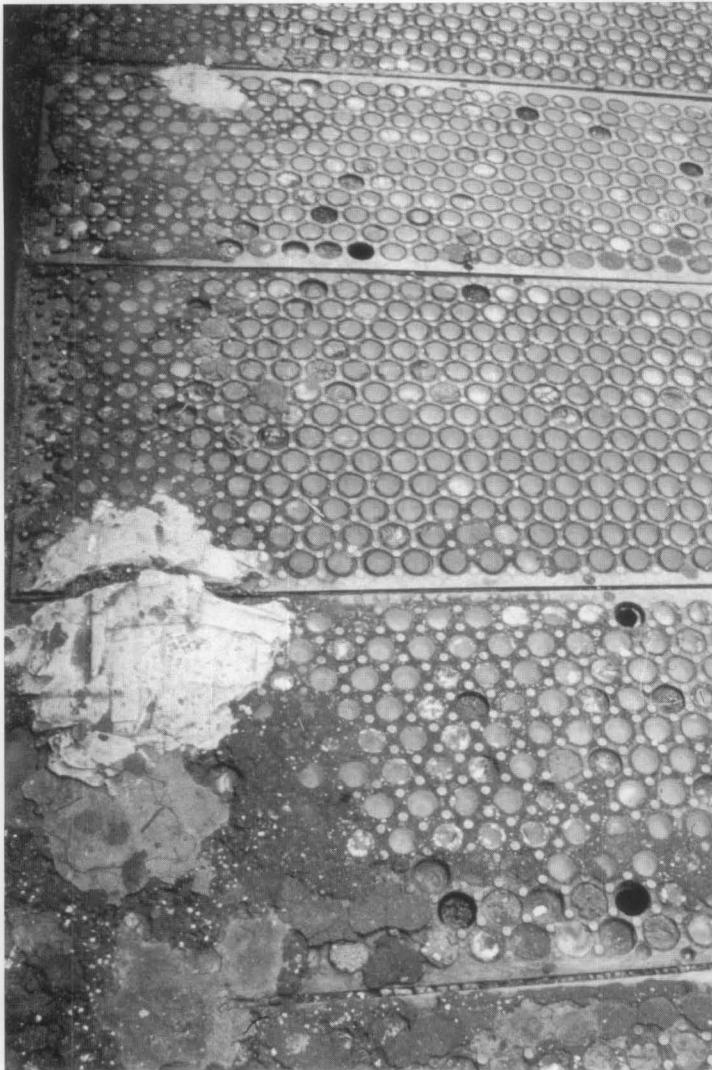
At the outset of the project, the vault lights at 552-554 Broadway were in poor condition (see figure 3). As with many old vault light installations, broken glass lenses and deteriorated seals allowed considerable water infiltration through the individual panels and the surrounding framework. A majority of the glass lenses were either cracked, missing or replaced with a variety of materials including wood, concrete and asphalt (see figure 4). Of the twenty-one cast-iron panels, six sections had areas which were cracked or missing altogether. Two original vault light panels had been replaced with steel diamond-plate hatchway doors to the basement and a variety of materials had been applied over the remaining panels in repeated attempts to prevent further leaks. Worn and lacking a protective coating, the cast-iron panels

Displaced panels and uneven asphalt and concrete patches presented trip hazards at sidewalk level.

Figure 3. The individual cast-iron panels were displaced and coated in some areas with asphalt and concrete. A number of glass lenses were missing, allowing water to enter the basement of the building.

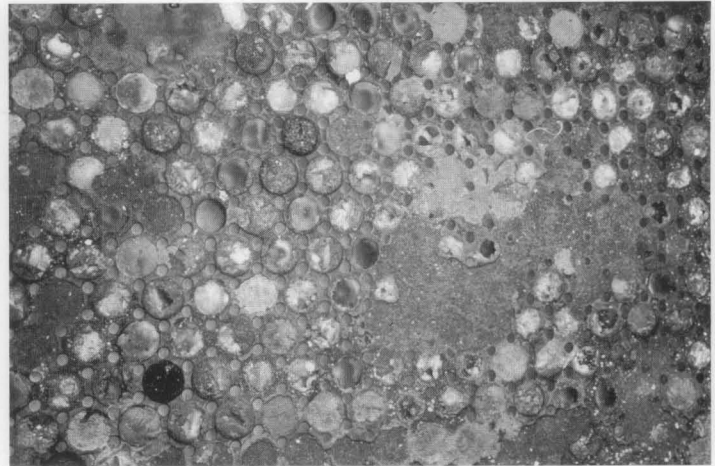
Figure 4. A detailed view of one of the panels illustrates the typical conditions prior to work. Although the original cast-iron knobs were still visible through the asphalt and concrete, many of the round openings were covered over or infilled. Nearly all of the remaining glass lenses were cracked.

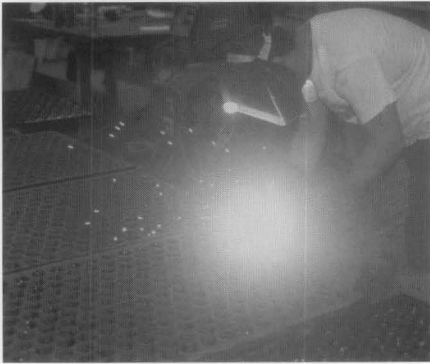
At the outset of the restoration program, six of the twenty-one vault light panels were found to be cracked. Rather than replace them with newly cast panels, the contractor chose to repair the damaged units using two different techniques: welding cracked sections and splicing in replacement

pieces. Due to inconsistent heating and the presence of impurities in the blast furnace mixture, historic cast-iron is a notoriously brittle material. This brittleness makes historic cast-iron susceptible to cracking and a challenge to weld properly.

The contractor had developed a system for repairing cracked or damaged vault covers. Primary considerations were to ensure that the pieces to be welded were correctly positioned and level and that the cast-iron was properly preheated. Then, using a wire-feed MIG (metal inert gas) welder, the two pieces were joined together (see figure 6). The welded seam was ground down to the level of the adjacent panel

surface so that the repair would not be visible after painting. The result was a strong, durable and complete cast-iron panel. When replacement sections were required, the contractor drew from a small stockpile of salvaged panels identical to those at 552-554 Broadway.

Figure 6. Cracked panels were repaired by welding in new material from a stock of salvaged panels maintained by the cast-iron contractor. The welded seams were then ground down before repainting.
