Tech Notes

HISTORIC INTERIOR SPACES

Preserving Historic Office Building Corridors

The Monadnock Building
Chicago, Illinois

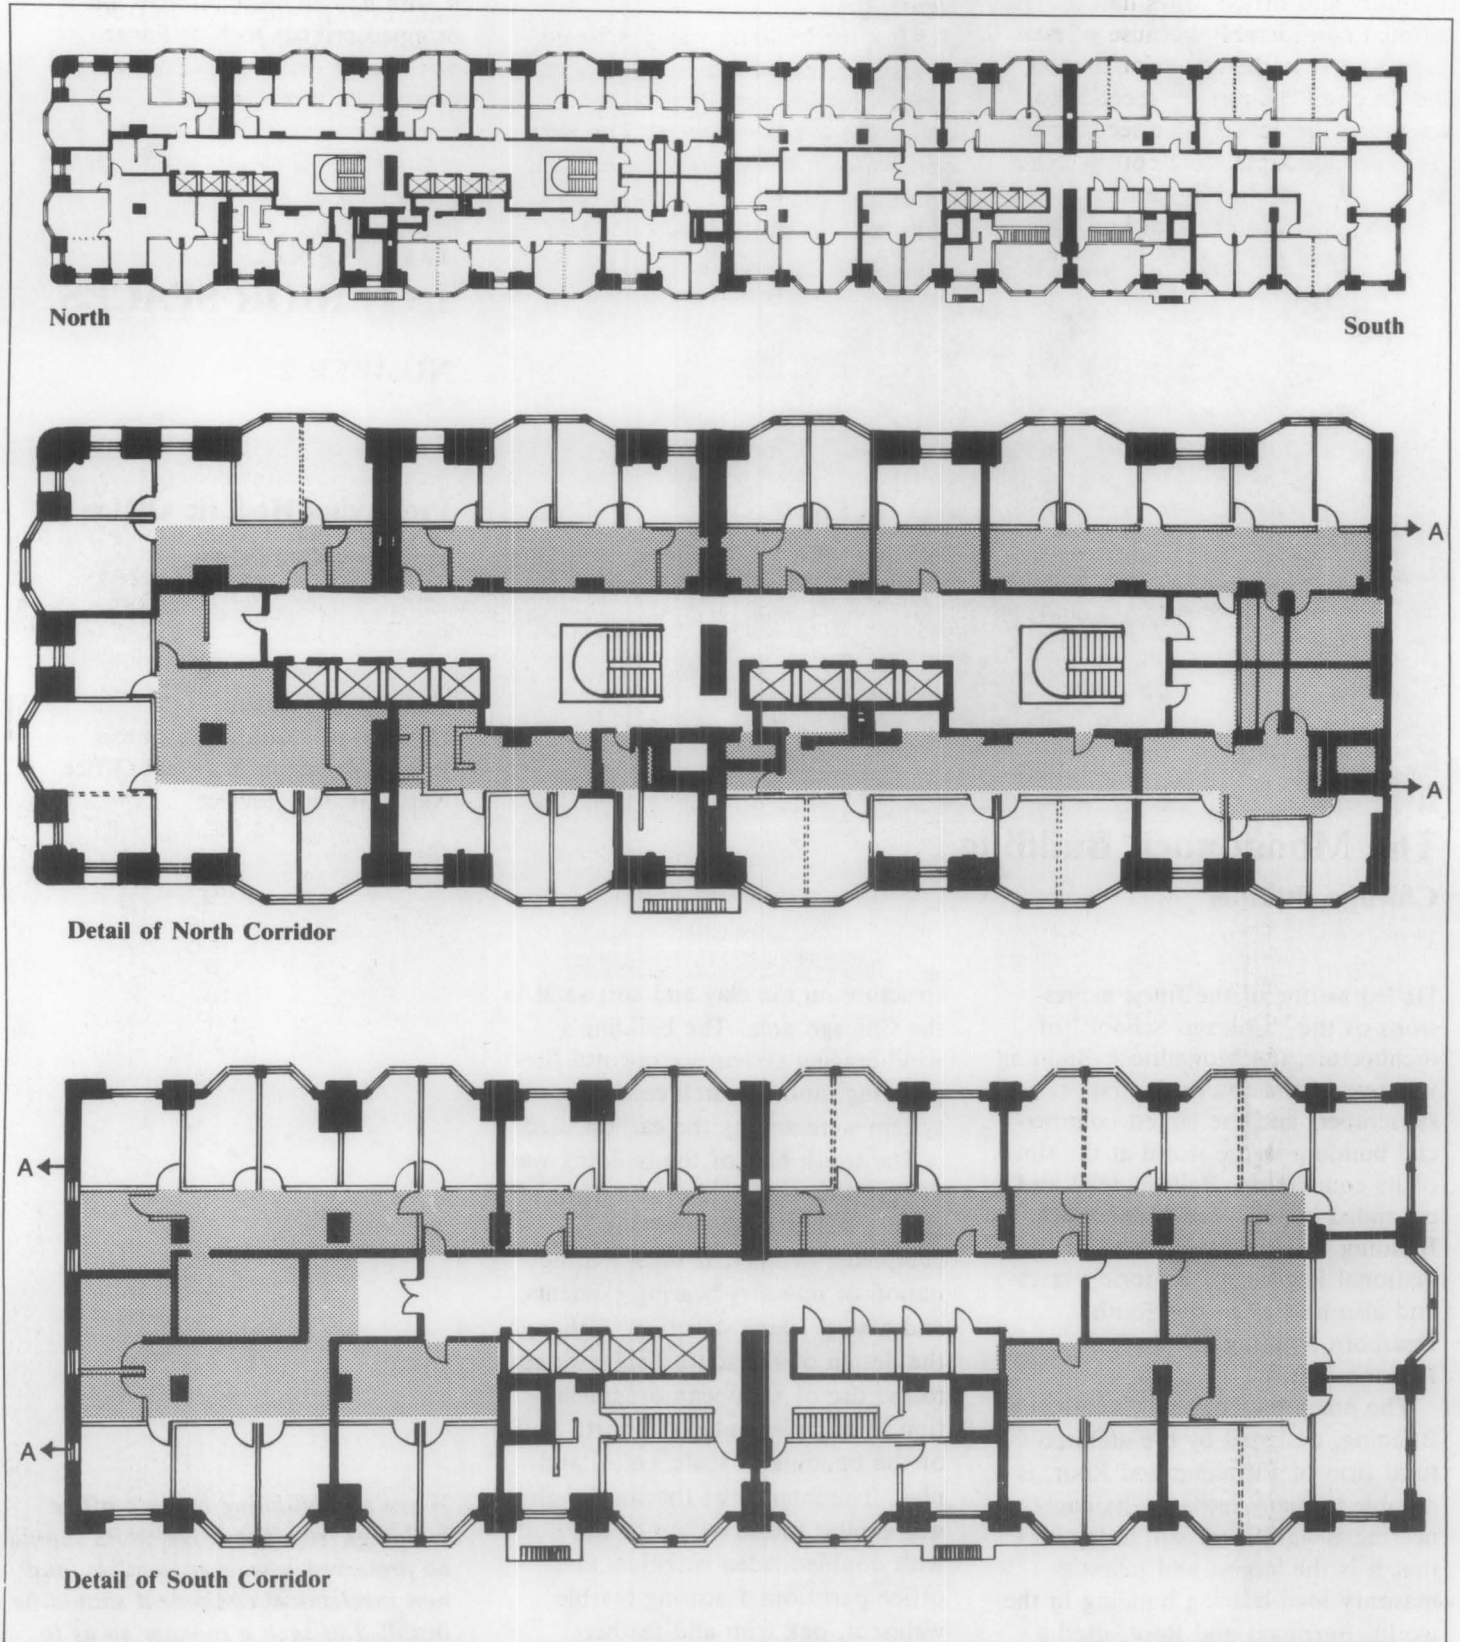
Figure 1. Both north and south building floor plan, showing double-loaded corridor system. Shaded area indicates dropped ceiling for mechanical chases in the non-public anterooms. Public corridors and private offices retain full ceiling height. Drawing: Neal Vogel

Typically, the ceilings in office building corridors are dropped to allow for mechanical chases to run longitudinally through the building. Retention of the Monadnock's historic plaster ceilings in the corridors was possible by locating mechanical systems above dropped ceilings in the non-public space adjacent to the corridors. These secretarial anterooms are located between the corridors and private office bays (See figures 1, 3, and 4).

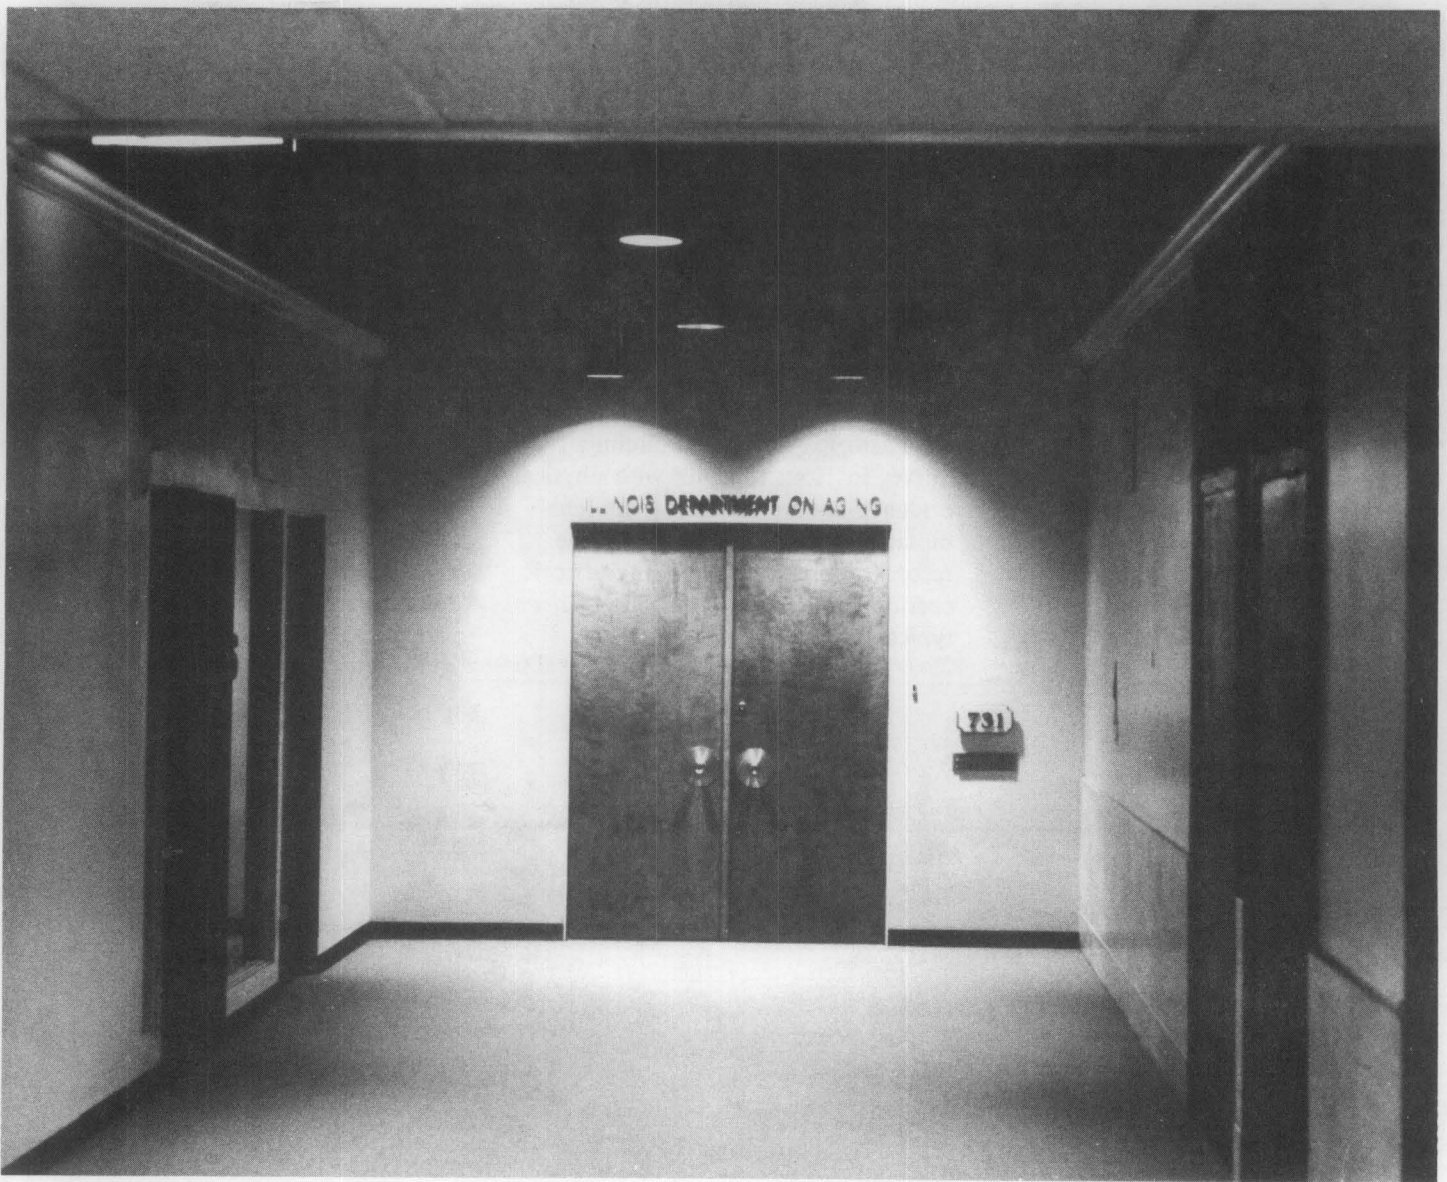
The Monadnock's historic interior corridors and office suites had suffered considerably because of past insensitive remodeling. Prior owners had dropped ceilings for mechanical equipment, removed large sections of the historic marble wainscotting, and painted over the ornamental cast-iron staircases and bronze door hardware. Almost all of the feather-chipped glass partitions, oak trim, and glass

office doors and transoms had been removed or covered over. On several floors the corridors had been entirely removed or shortened to accommodate open floor plan offices. (See figure 2).

Figure 2. Typical condition of public corridors prior to rehabilitation. Glass and oak corridor partitions and much of the marble wainscot was either removed or covered. Ceilings were suspended and sections of the corridor plan were shortened or removed. Photo: William S. Donnell

A third, more historically sensitive option was chosen. This option involved retaining the existing historic corridors and re-establishing corridors to match the historic ones on floors where they had been removed. The plans also called for smaller individual offices with a basic office module of about 600 square feet, which was close to the size of the historic office suites. (The marketing plan targeted lawyers and other professional businesses requiring smaller office spaces).

Historic drawings were used as the basis for reconstructing the missing corridors according to Burnham and Root's original design. Rehabilitation plans also included the repair and rebuilding of missing sections of the ornamental iron staircases. A few existing corridors, though missing some historic features, were left intact with plans to replace the missing historic elements sometime in the future. This allowed the building to remain occupied during the rehabilitation.

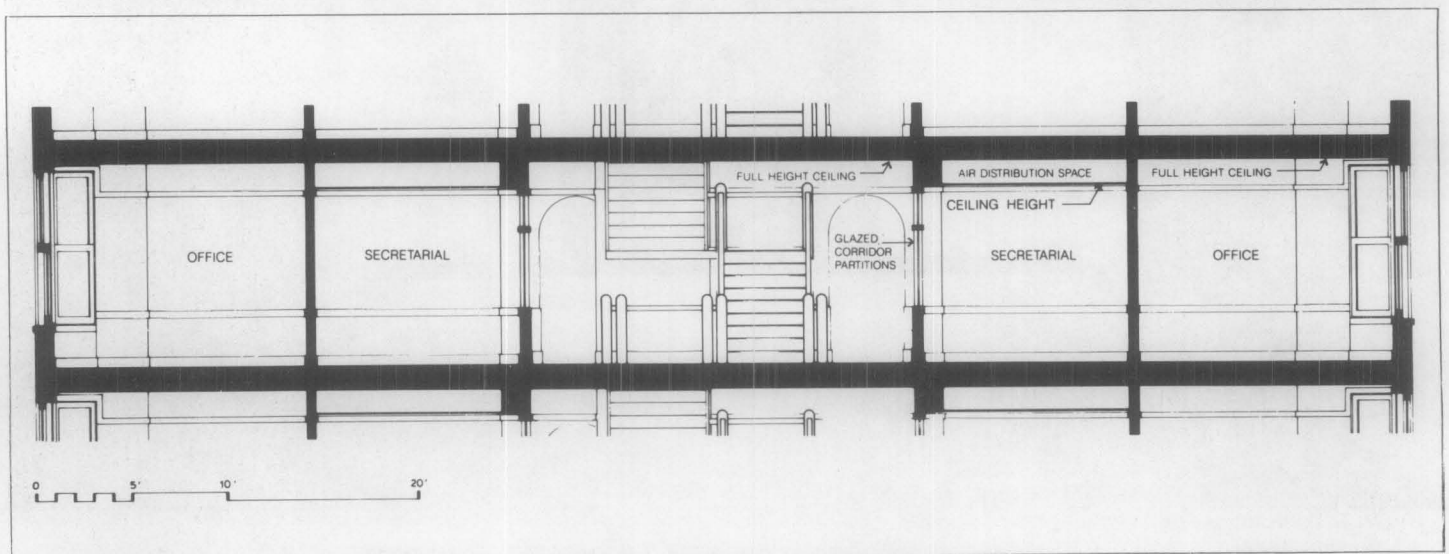
Figure 3. Building cross section showing open stairs and full height ceilings in corridors and private offices. Glazed corridor partitions are feather-chipped glass. Drawing: Montauk Company

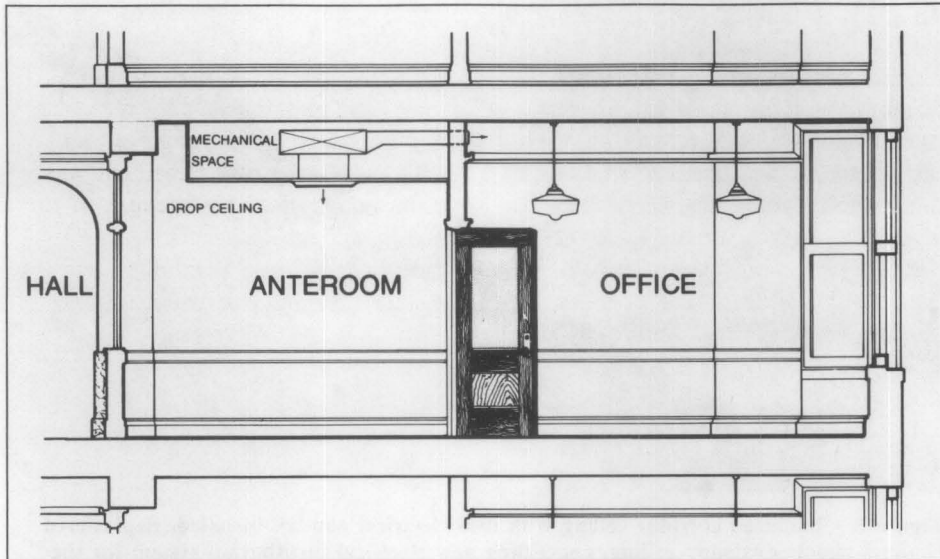
Figure 4. The innovative rehabilitation solution places dropped ceilings only in the anteroom, thus preserving the important historic features in the public corridors and private office spaces. The dropped ceiling area is large enough for future expansion of mechanical and electrical systems. Drawing: Neal Vogel

By breaking the air conditioning system into smaller components of individual heat pumps, and using the existing steam heat system, the amount of required mechanical space was reduced. By reducing the necessary mechanical space and evenly distributing the heating and air conditioning systems throughout the building, smaller mechanical chases could be located in anterooms, thus eliminating the need to lower historic corridor ceilings.

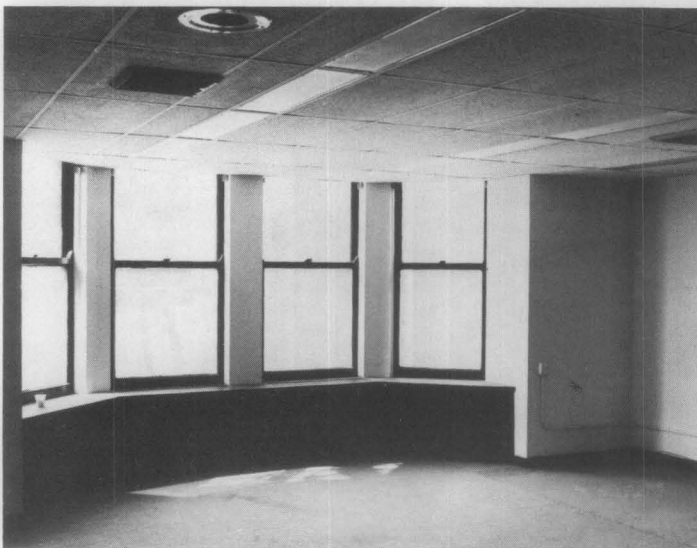
Figure 5. Typical pre-rehabilitation condition in private offices. Approximately 60 percent of all office interiors had suspended ceilings, blocked-down windows and radiator enclosures. Note inappropriate way dropped ceiling abuts windows. Photo: William S. Donnell

The Monadnock was purchased in 1979 by the current owners for \$5 per square foot. The original one-pipe steam heating system was still in place at the time. Rather than replace the existing system with a more costly forced-air unit, the steam system was repaired for less than \$1 per square foot. This included new boilers and controls, asbestos abatement, and new Ammark valves at the radiators.

The German Ammark valves are thermostatically controlled and regulate both steam and return condensation in one pipe. Considerable space was saved by using the existing steam system, and avoiding massive forced air duct work or piping for a new steam system (see figures 5 and 6).

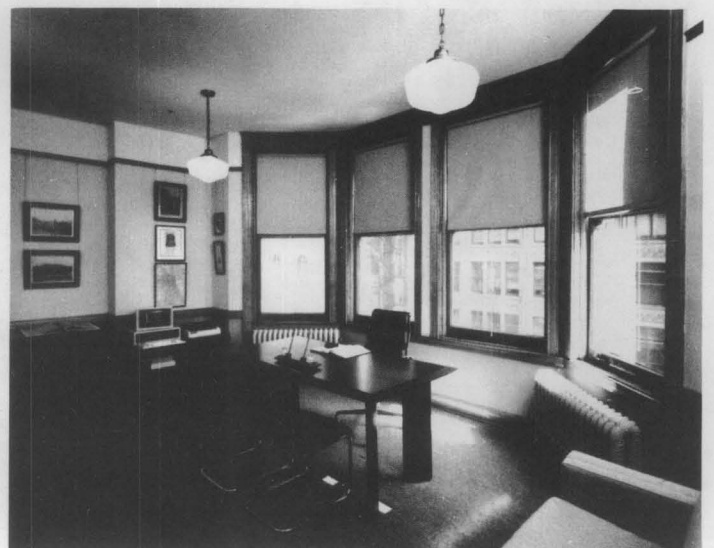
Figure 6. Typical 600 square foot office module after rehabilitation, with full ceiling height and one stand pipe radiator heat. Photo: Ron Gordon

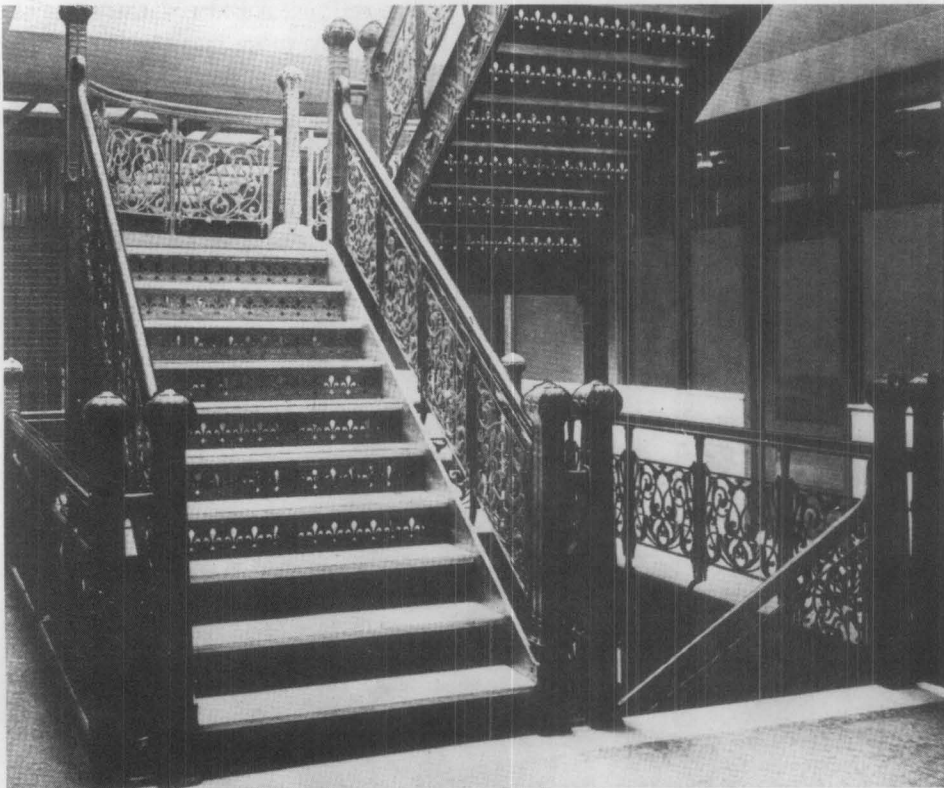
The ornamental open staircases are significant architectural features and a major focal point of the corridors in both the north and south halves of the building (See figure 8). Beyond their architectural significance, the stairs in the north half of the building from street level to the first floor are cast aluminum and represent the first use of this metal in a building. Upper flights are made of bronze-plated cast iron. These open stairs were allowed to remain intact under a provision of the Chicago Building Code that waives certain code requirements for buildings where

Figure 8. Burnham and Root's aluminum and bronze plated cast-iron stair remains the most notable architectural feature in the north half of the building. Minor repair work and a few missing elements have been replaced with cast aluminum. Favorable building codes allowed the open design.

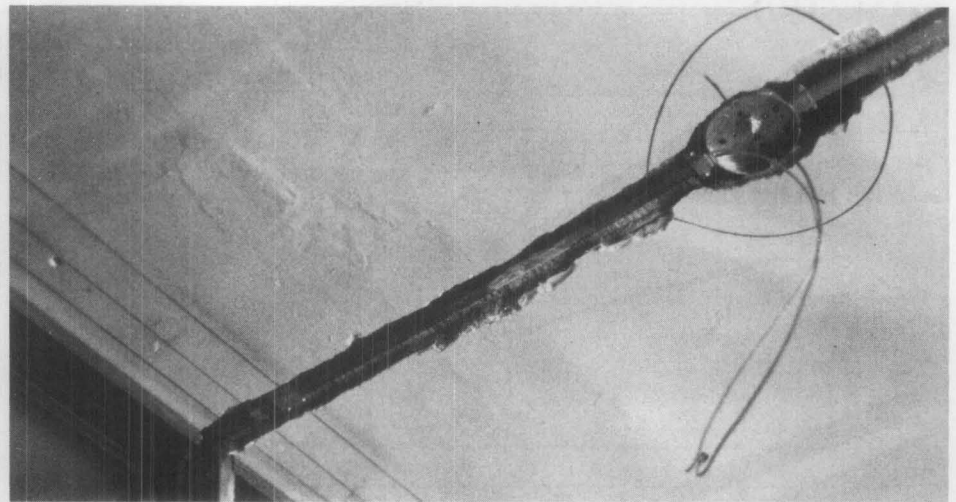
Figure 7. Channeled corridor ceiling with oval electrical conduit installed. Replastered channel matches existing ceiling, concealing new electrical distribution system for the entire building. Photo: William S. Donnell

installed in the building by carefully channeling the ceiling plaster and attaching 3/4-inch oval conduit to the hollow terra-cotta floor sections. The channels were then replastered to match the surrounding ceiling (See figure 7). Dropped ceilings in the anterooms also provided for electrical chases servicing secretarial and private office spaces.

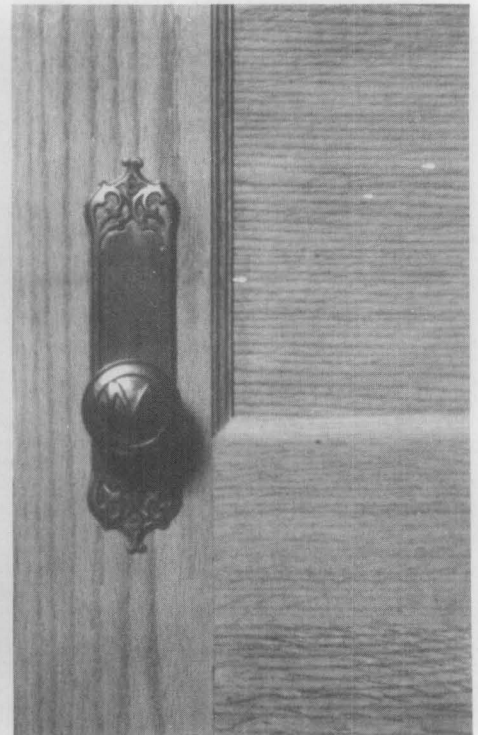
Figure 9. Original cast-iron door hardware retained in corridors. Photo: Ron Gordon

reheated in the manufacturing process to form a dark corrosion-resistant finish simulating cast oxidized bronze. During the course of the rehabilitation, missing and damaged hardware was replaced with actual cast oxidized bronze (See figure 9). As a result, these important historic features remain significant elements within the Monadnock's corridors.

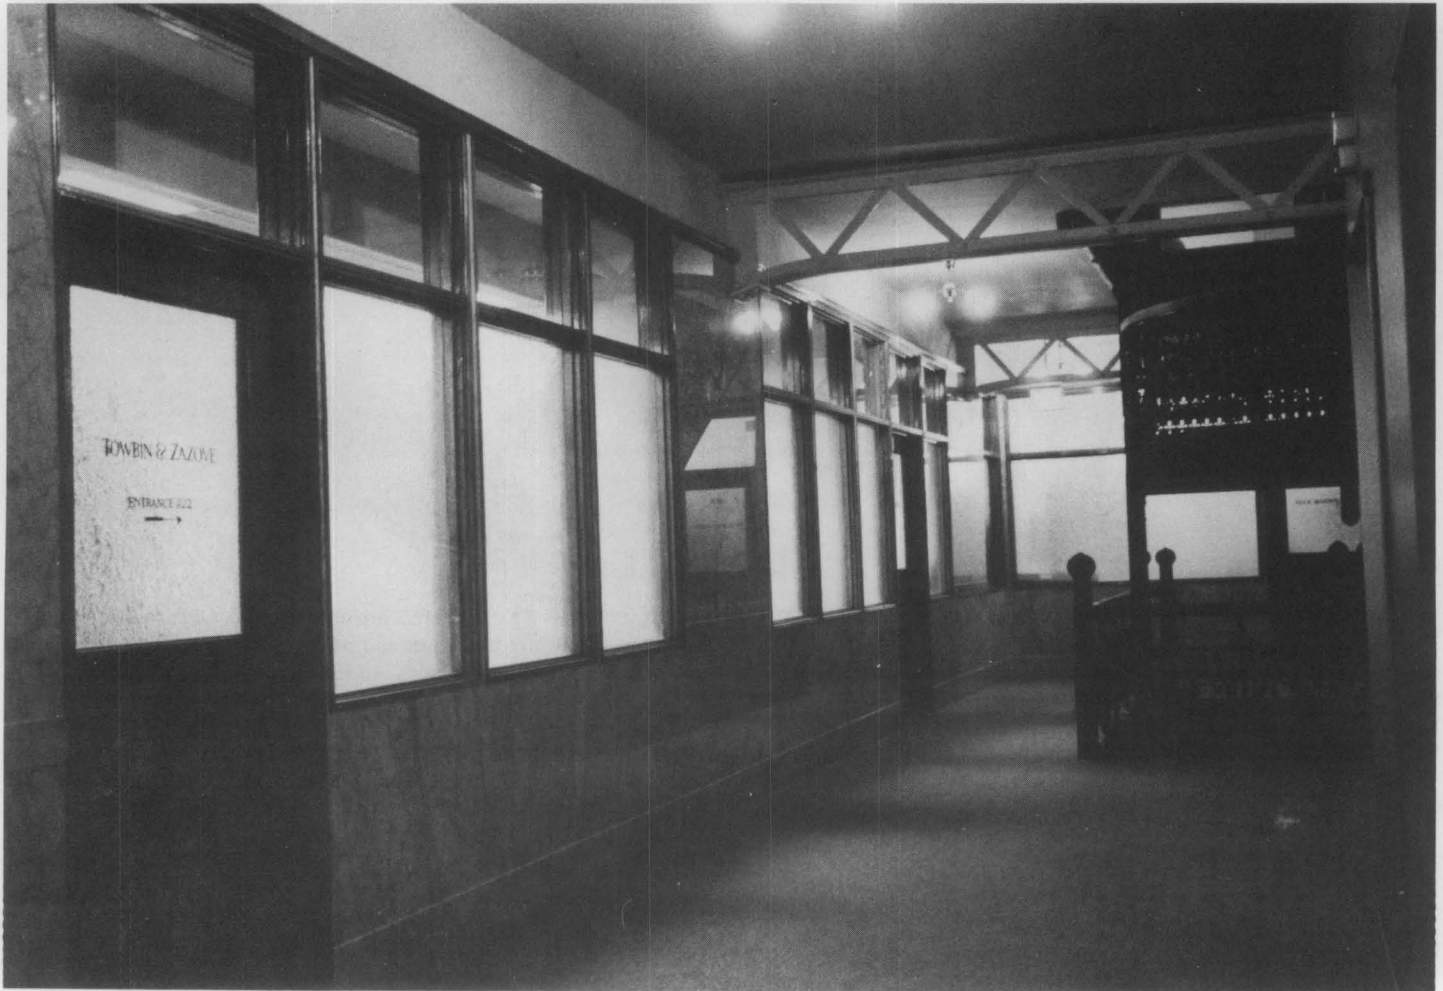
Figure 10. Rehabilitated corridor showing marble wainscot, oak and feather-chipped glass corridor partitions, full ceiling height and open ornamental stairs. Photo: Ron Gordon

The rehabilitation philosophy of retaining and repairing historic corridor fabric where possible and replacing missing elements to match the historic plans proved to have an economic advantage over comparable new construction. While typical office rehabilitations in Chicago require an average investment of \$100 per square foot, the rehabilitation of the Monadnock cost under \$50 per square foot (See figure 10).
