# Tech Notes

## MASONRY

#### Substitute Materials: Replacing Deteriorated Serpentine Stone with Pre-Cast Concrete

### SIX LOGAN CIRCLE Washington, D.C.

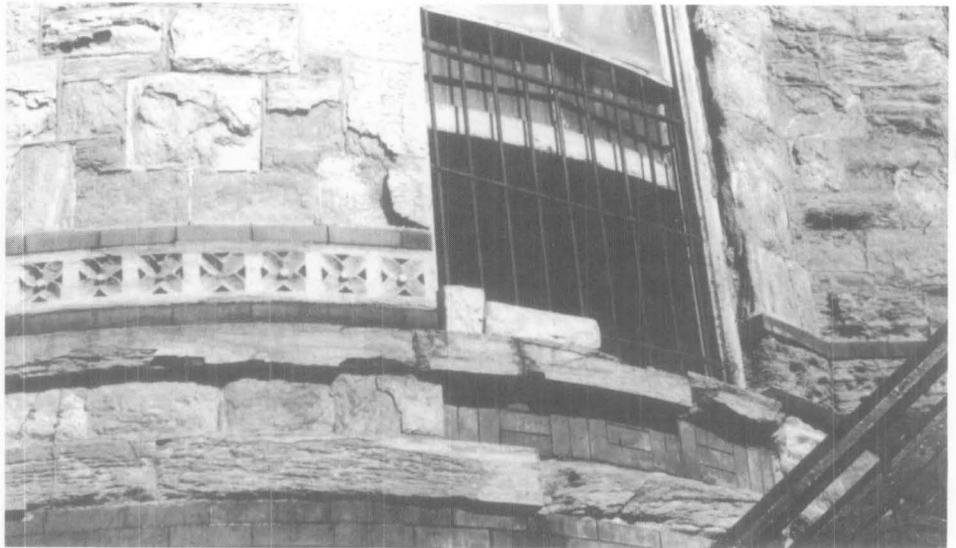
A stone consultant was retained to assess the condition of the serpentine stone and to recommend remedial work. The consultant conducted an in-depth visual inspection and evaluation and concluded that the serpentine stone was spalling extensively, due to the inherent softness and poor quality of the stone and the chemical forces interacting with the stone. The deterioration had been further exacerbated by the general lack of maintenance the building had received for the last forty years which had allowed large amounts of moisture to penetrate the stone. Moisture, laden with acids, had entered the stone through open mortar joints and the delaminated surface, accelerating the stone's deterioration. In this case, the problem was compounded by additional moisture spilling onto the surface of the serpentine from clogged, leaky, and inoperable gutters, downspouts and drains. Given the inherent problems with serpentine stone as an exterior building material and its overall advanced deterioration on Six Logan Circle, the consultant recommended that the serpentine stone, which was used as a veneer covering structural brickwork, be replaced rather than attempting a repair using traditional patching techniques. This conclusion was supported by a survey undertaken to determine how many of the stones

Figure 1. Close-up view of the deteriorated serpentine stone facade showing substantial surface delamination. Photo: Anne Grimmer

retained their integrity (i.e., how many remained substantially free of fractures and crumbling and retained their surface tooling, texture, and shape). The survey showed that 868 of the original 946 face stones which made up the facade no longer retained their integrity. In fact, many were so deteriorated that they could literally be pulled apart by hand (see figure 1).

Because only 78, or less than nine percent, of the stones remained intact, total replacement of the historic stone was justified in this particular case. However, the replacement material needed to closely match the historic stone in size, shape, dimension, texture and color in order to preserve the historic character of the facade. To meet these requirements, three replacement alternatives were considered:

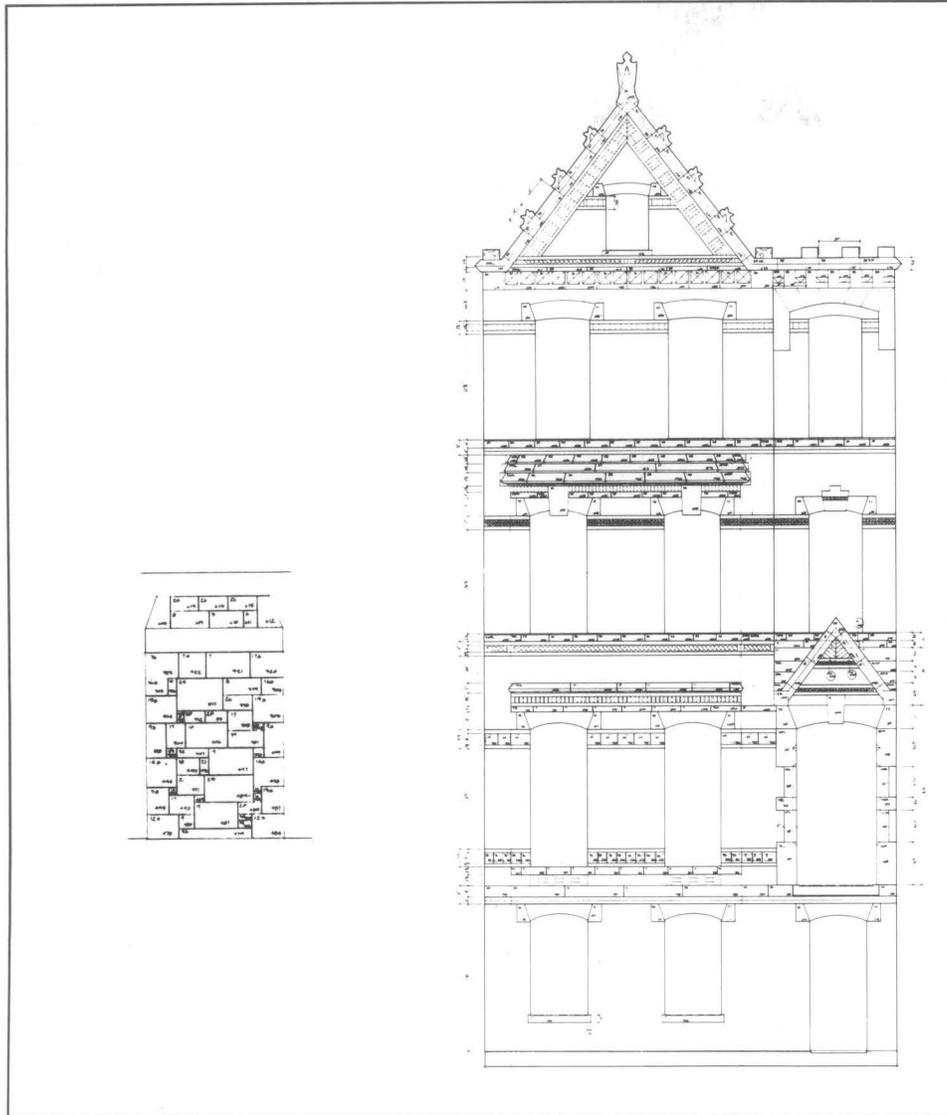
Figure 2. Two measured drawings were made of the facade, one showing the individual field and jamb blocks, and the other, the decorative trim stones. The identification number and the shape and size number of each stone were marked on the drawings. Drawings: Rich Layman

Before the new cast stone could be manufactured, the existing serpentine stone facade had to be recorded. An architecture student was hired to measure each existing stone on the facade and prepare precise drawings of the elevation, showing the size and location of each stone. Each stone was assigned two numbers—an individual identification number and a number indicating the stone's shape and size. These key numbers were marked directly on the measured drawings. Drawings were prepared for the plainer stones that made up the major portion of the facade as well as the decorative trim stones (see figure 2). From these drawings, a master list of all the stones and their sizes was compiled, which was used to guide the casting and manufacturing processes. Later, as each new stone was fabricated, it was noted on the drawings so that an up-to-date inventory could be maintained.

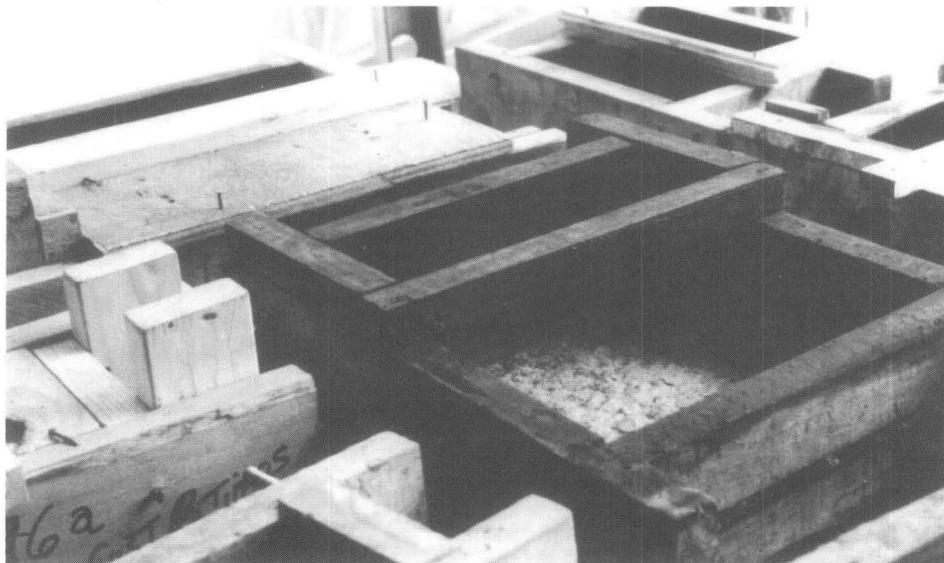
Figure 3. Concrete was poured into these wooden forms which were specially constructed, and reinforced with steel rods and bolts, to hold the built-up molds of the original stones. Once placed in the wooden forms, the built-up molds thus served as the casting models. Photo: Robert Powers

1. A release agent was sprayed on each stone of the facade to be reproduced.
2. Latex molding rubber was then brushed-on in layers to the surface of the stone, still *in-situ*, to obtain an impression of the stone's surface. From these latex molds, the surface qualities of the individual blocks of the serpentine facade could be faithfully reproduced in the casting process.
3. The latex mold was removed from the stone and in the workshop the mold was built up with plaster to increase the crispness of the details.
4. This built-up mold, when placed in a specially constructed wooden framework reinforced with steel rods and bolts, became the casting mold.
5. A release agent was applied over the formwork and the built-up mold. Then the concrete was poured into the casting mold (see figure 3).

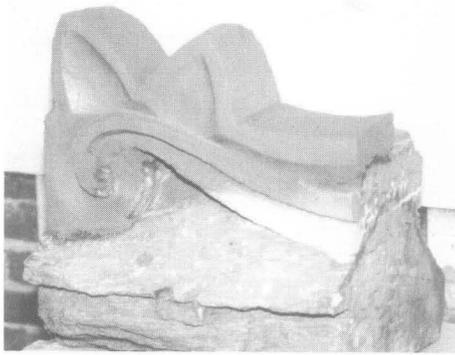
Figure 4. Most of the rubber castings could be made directly from stones still in place on the facade, but the more deteriorated stones first had to be removed from the wall. After their removal from the wall, a bonding agent was applied to the deteriorated stone surface, and a new stone surface was created replicating the original design details with concrete. Photo: James Smith

1. A bonding agent was applied to the surface of the stone to be reproduced.
2. Using the more intact stones as models, the stone's surface was built up with a mixture of portland cement and sand to approximate as closely as possible the stone's original surface, shape, and texture.
3. After the built-up stone was dry, the same process described earlier was followed to create molds of these stones (see figures 4-6).

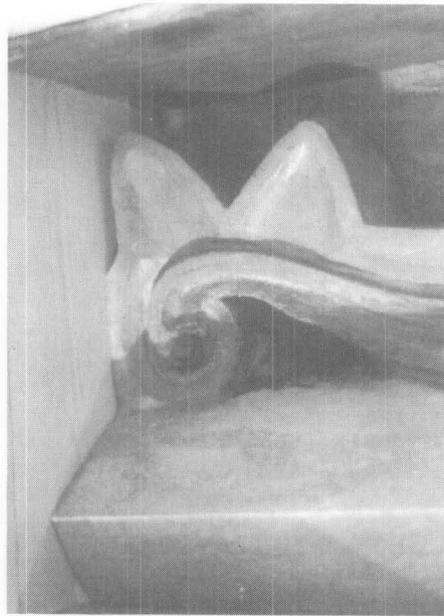
Figure 5. A latex casting mold was made from this recreated "built-up" stone surface by brushing on layers of latex molding rubber. Photo: James Smith

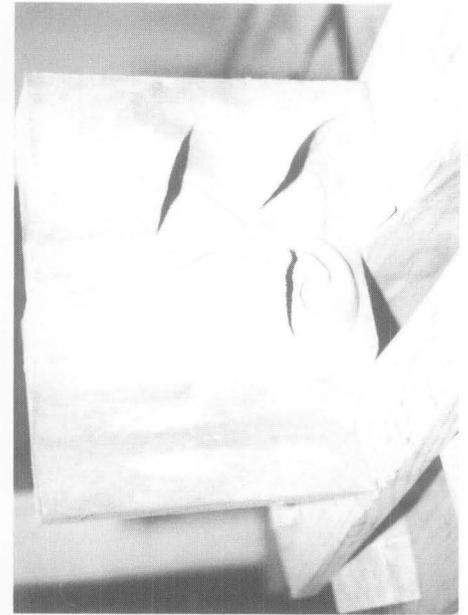
Figure 6. A rubber impression made from this latex casting mold then provided the mold into which the concrete was poured to create the new pre-cast units. Photo: James Smith

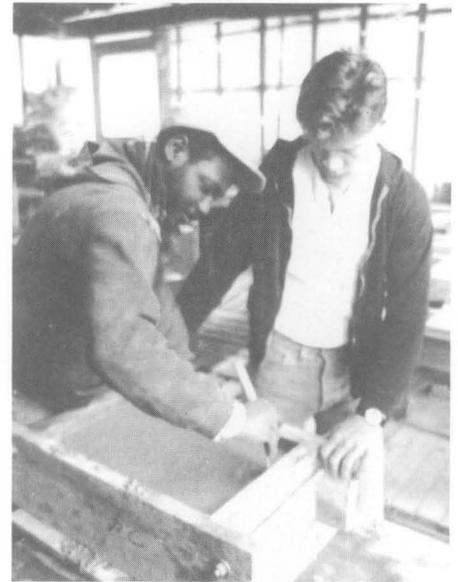
Figure 7. The workmen shown here are cutting the air bubbles from the sides of the mold using a cake spatula during the first 10 seconds of the vibration process. Photo: James Smith

The consolidated and homogeneous concrete mix was poured from the mixer into the specified mold which had already been placed on the vibration table. The vibrating process forces the entrained air and surface air out of the mold, eliminating in most cases the possibility of surface imperfections from air bubbles. Proper vibration of the newly poured concrete was extremely important to obtain a high quality pre-cast concrete. The vibration table operated at a rate of 2,600 vibrations per minute and could accommodate all the castings from a batch within thirty minutes after mixing. Small cast units required approximately sixty seconds of vibration and the larger ones required approximately ninety seconds. A cake spatula was effective in cutting many of the air bubbles from the surface of the sides of the mold during the first ten seconds of the vibration process (see figure 7).

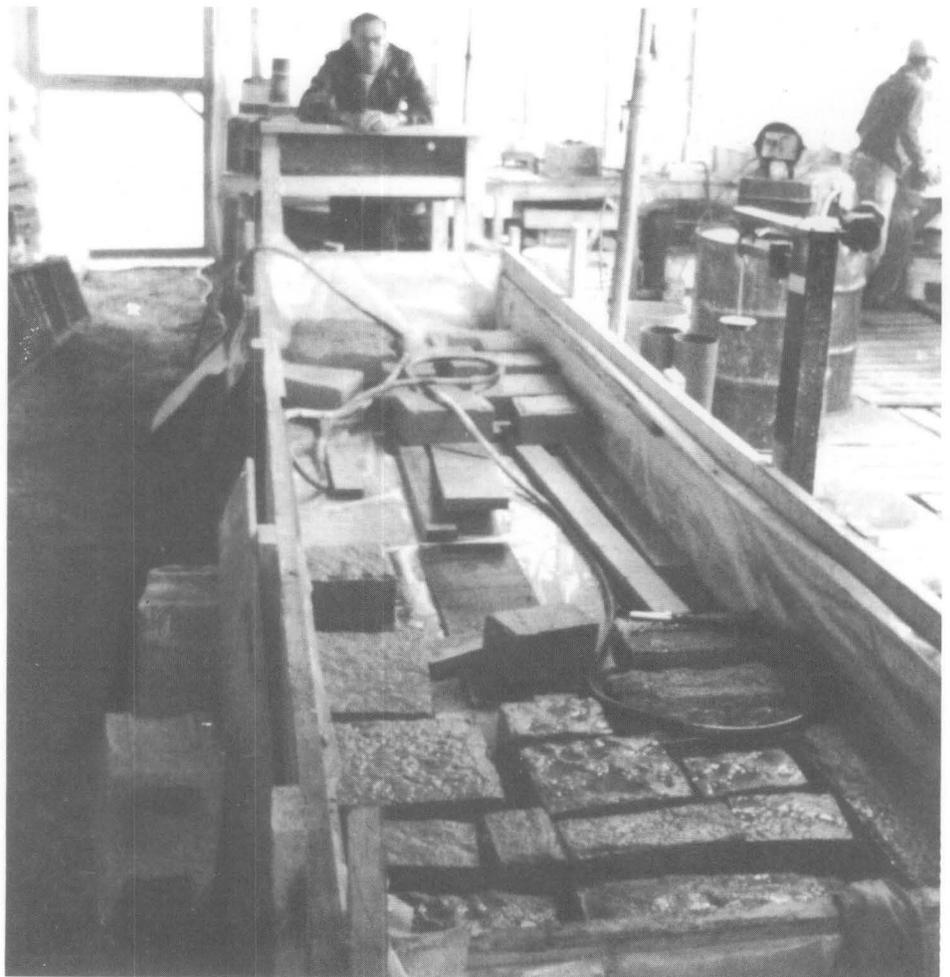
Figure 8. After soaking for 6 hours to remove soluble salts in a polyethylene-lined wood water tank, the pre-cast units were allowed to dry for another 6 hours. This process was repeated 3 times for each pre-cast unit. Photo: James Smith

The final step in the manufacturing process was essential to the successful outcome of the product. In this step, the stones were submerged in a water tank for a period of six hours, then removed and dried for six hours (see figure 8). The drying process forced soluble salts inherent in the concrete mix to the surface of the stone. An application of a weak solution of muriatic acid with a thorough water rinse was used to wash away the leaching salts. This procedure of soaking and drying was repeated three times for every stone. After completing this process, each stone was transferred to the base-ment for storage on wooden skids.

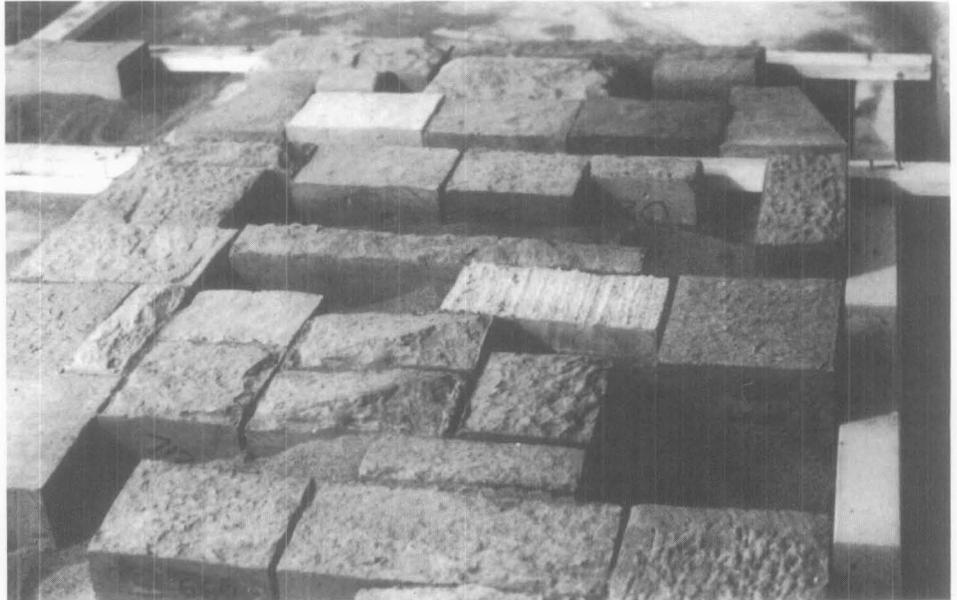
Figure 9. Using the measured drawings as a guide, the pre-cast units were assembled in the staging area on top of 4 inches of sand prior to their installation on the facade. Photo: Robert Powers

“staging area” in the basement. Using the measured drawings and numbering system prepared earlier, the blocks of cast stone were assembled on the basement floor on top of 4” of sand. Assembling them in the staging area allowed for a final inspection of the blocks and also allowed the master mason to arrange the new stones during a “dry run” prior to the actual installation on the building, thereby minimizing problems once the work on the building began (see figure 9).

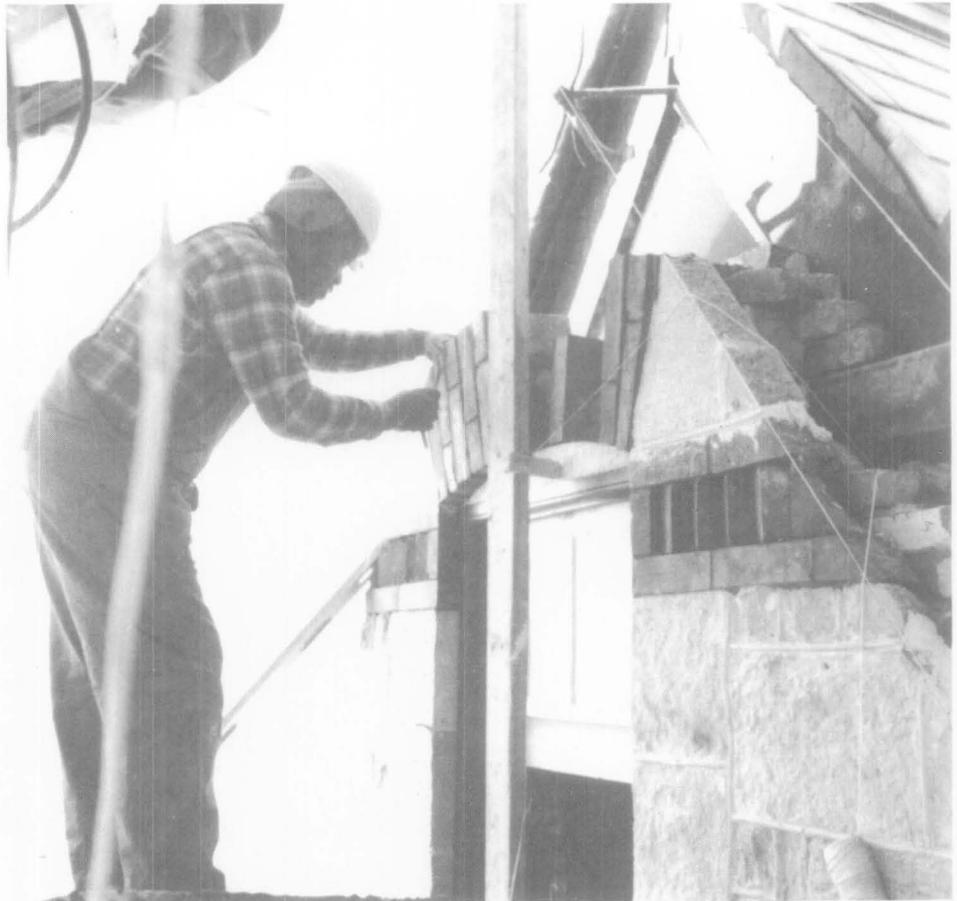
Figure 10. The new pre-cast units were hoisted up the scaffolding on wide belt slings with an electric winch, and installed in place using a portland cement-based mortar appropriate for cast-concrete. The original bricks were relaid with a more traditional lime-based, dark-colored mortar. Photo: James Smith

With the front elevation fully scaffolded, sections of the serpentine stone and ornamental brick were removed. Because the brick trim was in excellent overall condition and was to be reused in the new facade, it was carefully removed with hand tools, inventoried, and stored for reinstallation. With the serpentine and face brick removed, necessary repairs were made to the structural brick, and stainless steel anchors for the new pre-cast veneer were installed. The new cast stones were hoisted up the scaffolding on wide belt slings with an electric winch and installed in place (see figure 10).

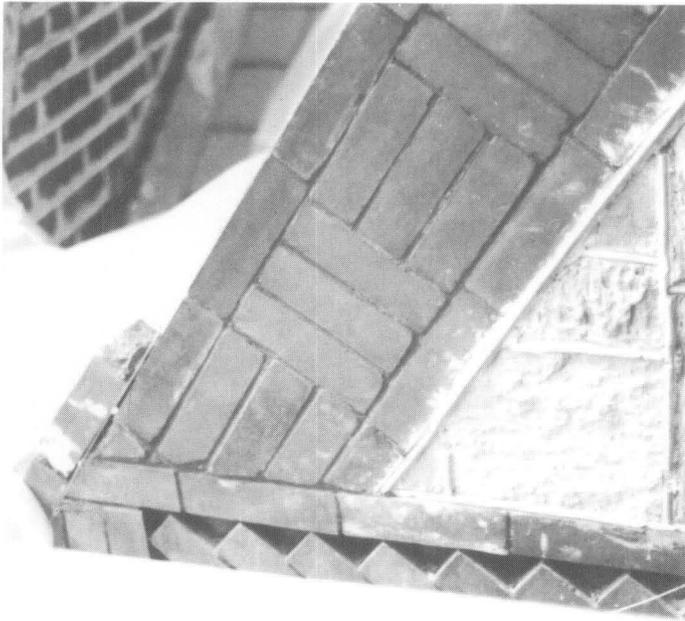
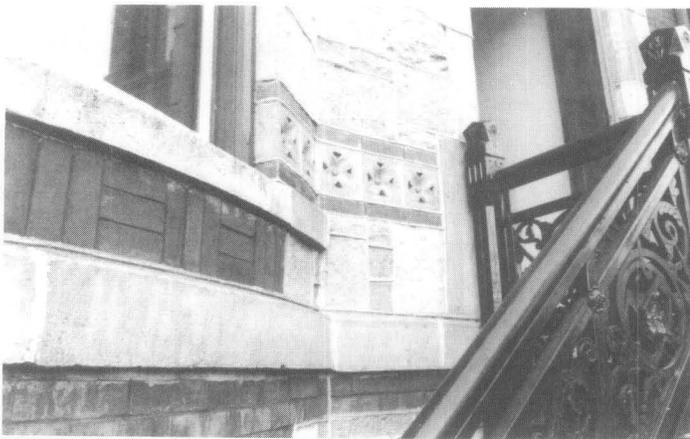
Figure 11. Close-up views of the newly installed pre-cast concrete units and the reinstated original brick. Photo: James Smith

The original bricks were individually cleaned with bristle brushes and water before being reset into the new facade. The new brick mortar was based on an analysis of the original, dark-colored brick mortar and matched it in composition, color, texture, joint width and profile. (see figure 11).

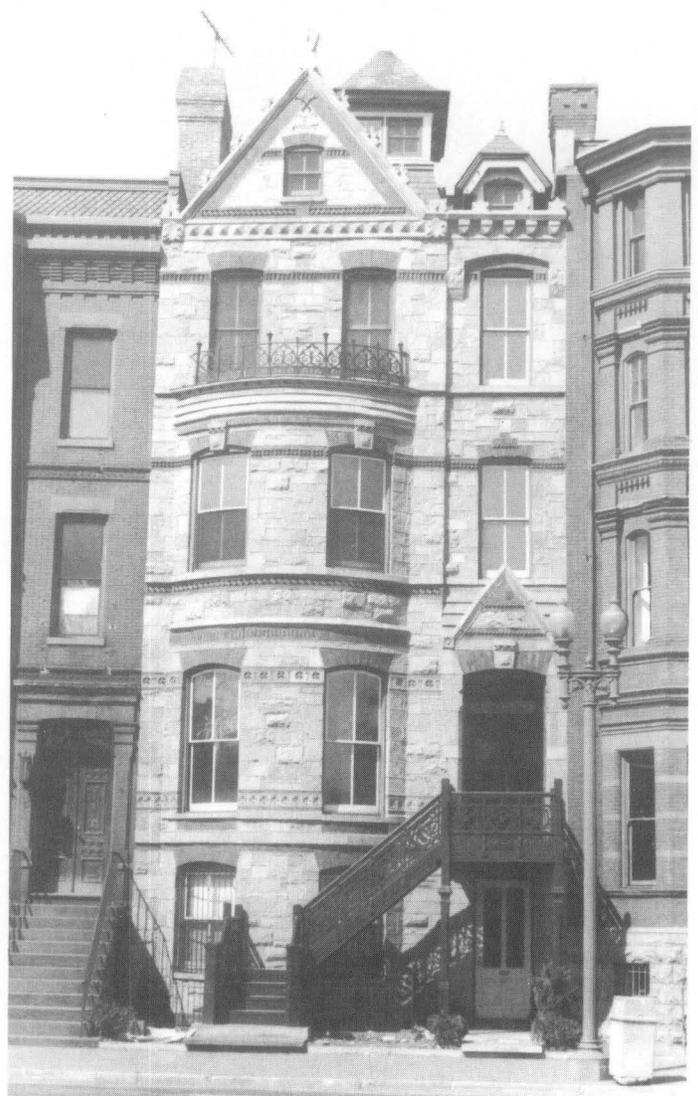
project was considered a success by all the participants; the stated goal of removing the crumbling serpentine veneer and replacing it with a new material that returned the facade to its original appearance was met. The building has a renewed presence with its pre-cast concrete units molded to match the form of the original stone, and exhibits a crispness of detail, texture and color that had been absent for many years (see figure 12).

Figure 12. The house after rehabilitation. Photo: Anne Grimmer
