THE LAND TITLE BUILDING Philadelphia, Pennsylvania

PRESERVATION Tech Notes

MASONRY NUMBER 2

Stabilization and Repair of a Historic Terra Cotta Cornice

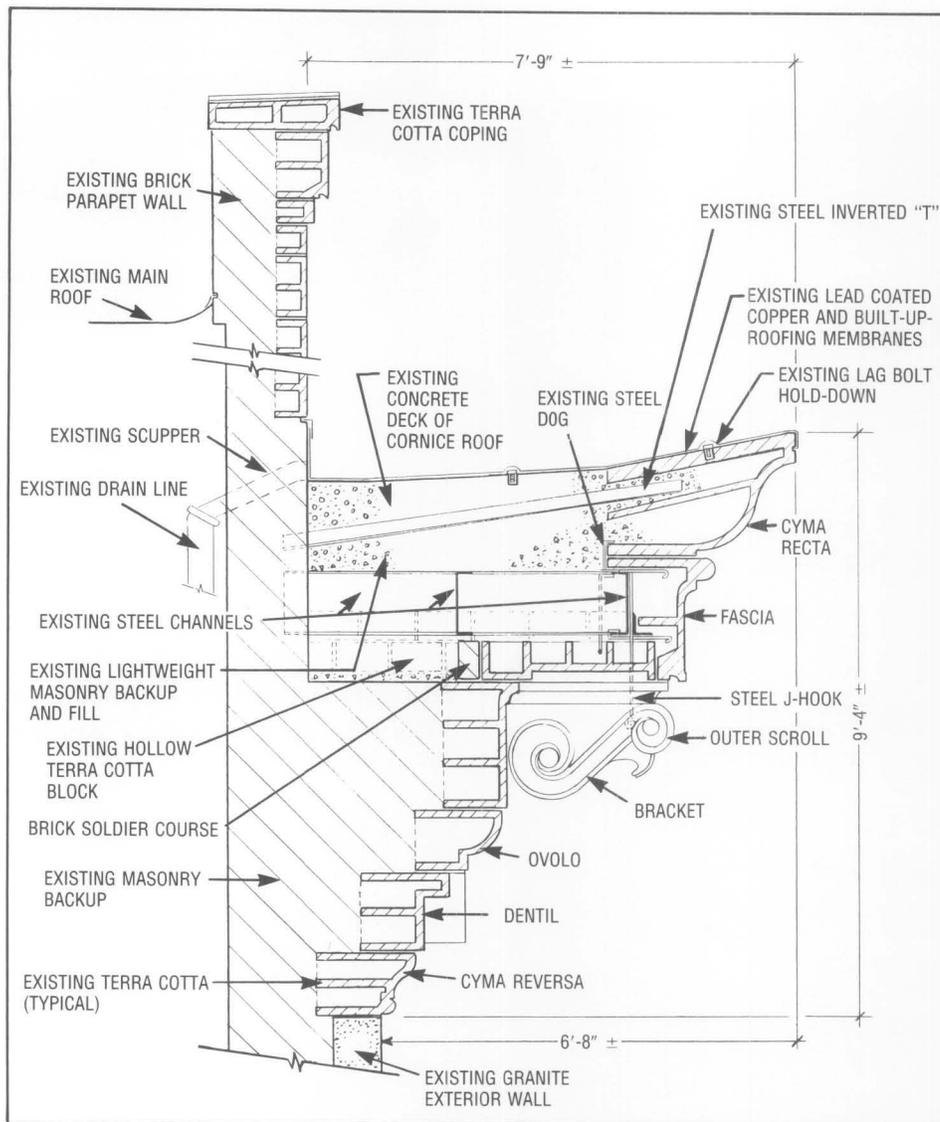
Figure 1. Section through the cornice and the parapet showing the structure's construction and attachment to the building. The inverted T's are embedded in concrete and act in friction to help support the cyma recta unit from rotating outward. The test openings did not penetrate below the soffit level of the cornice. Drawing by Jeffrey S. Levine.

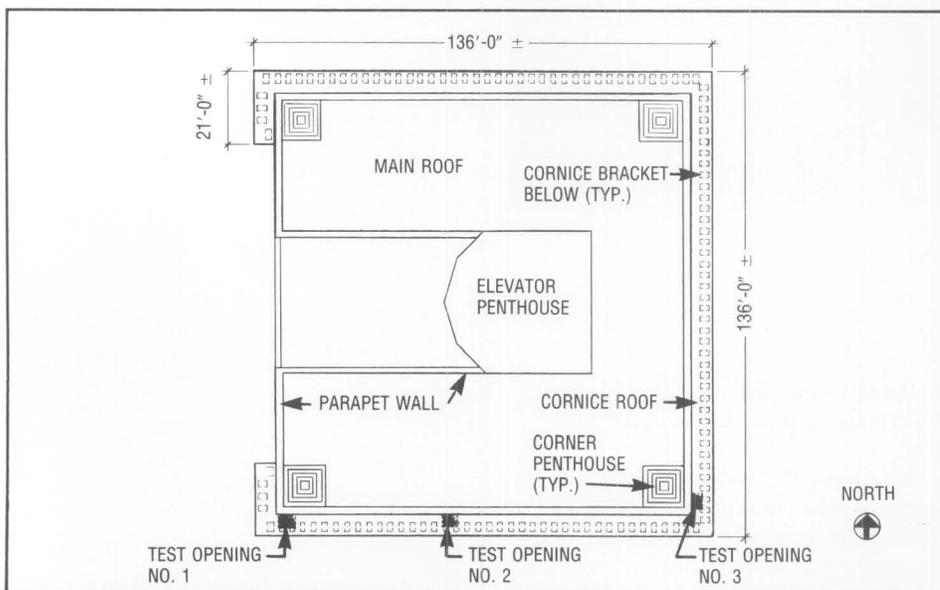
Figure 2. Roof plan of the 1902 tower showing the location of test openings in the cornice roof. Each bracket was later numbered consecutively so that easy reference could be made to a particular area of the cornice. Drawing by Jeffrey S. Levine.

Test openings made in the cornice roof revealed much about the construction of the cornice and the condition and integrity of the structural steel members which supported the terra cotta facing units. Light rust was seen on all steel members, including channels, outlookers, J-hooks, and dogs. Flaking and

scaling of the steel frame members appeared to be limited, except at the inverted "T" members where conditions were worse, but still not bad enough to warrant replacement.

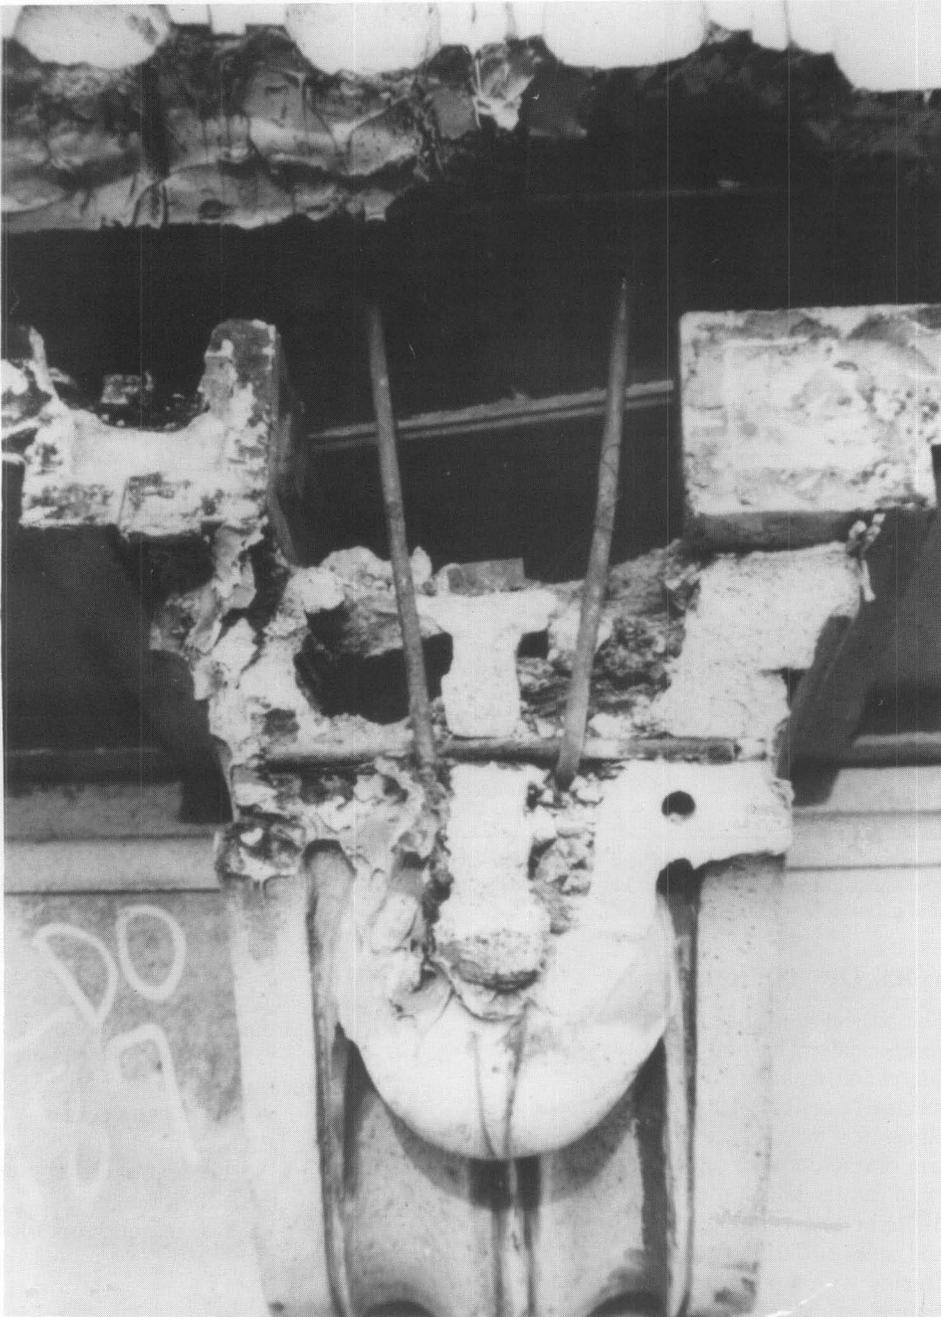
Visual inspection of the terra cotta revealed four common types of deterioration: spalls, glaze crazing, cracking, and open mortar joints. In addition, sounding the terra cotta units with a wooden mallet indicated that roughly 10% of the terra cotta units had cracked internal webs. Deterioration resulting in loss of material appeared with less frequency and was found principally at the outer scroll of the brackets (see figure 3) and at the scalloped fascia (see figure 4).

Figure 3. Numerous brackets were found to be missing their outer scrolls due to oxide jacking of the steel J-hooks, steel pencil rods, and temporary support wires located within the units that were used for installation. Cracking in the brackets whose outer scrolls had not yet broken off indicated potential for further loss of material if stabilization measures were not undertaken.

During the original construction of the cornice, the brackets were hoisted into place and temporarily supported by the wires cast into the nose of the bracket units. J-hooks were then dropped down from the outermost steel channel above into the upper and outermost cells formed by the unit's internal webbing. A steel rod was then inserted horizontally through holes cast into the exterior sides and internal webs of the unit such that, with minor adjustment in the length of the J-hooks, the rod sat in the trough of the J-hooks; the weight of the bracket were thereby transferred to the J-hooks (see also figures 1 and 5). Photo by Jeffrey S. Levine.

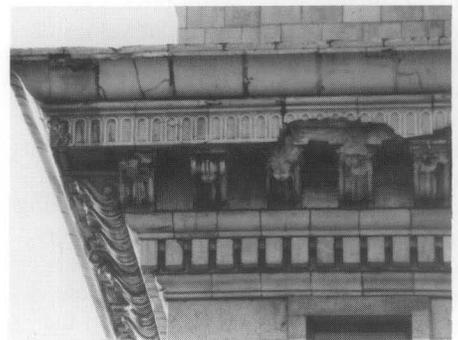
Figure 4. Extreme loss of material was noted in the scalloped fascia above the brackets at the south end of the east elevation of the cornice. This deterioration and corresponding cracking in other fascia units was due to rusting of the structural steel angle iron which supports the fascia units at their center webs (see figure 1). A likely point of water entry was a large open joint located immediately above the fascia, at the bed joint of the cyma recta units. Photo by Jeffrey S. Levine.

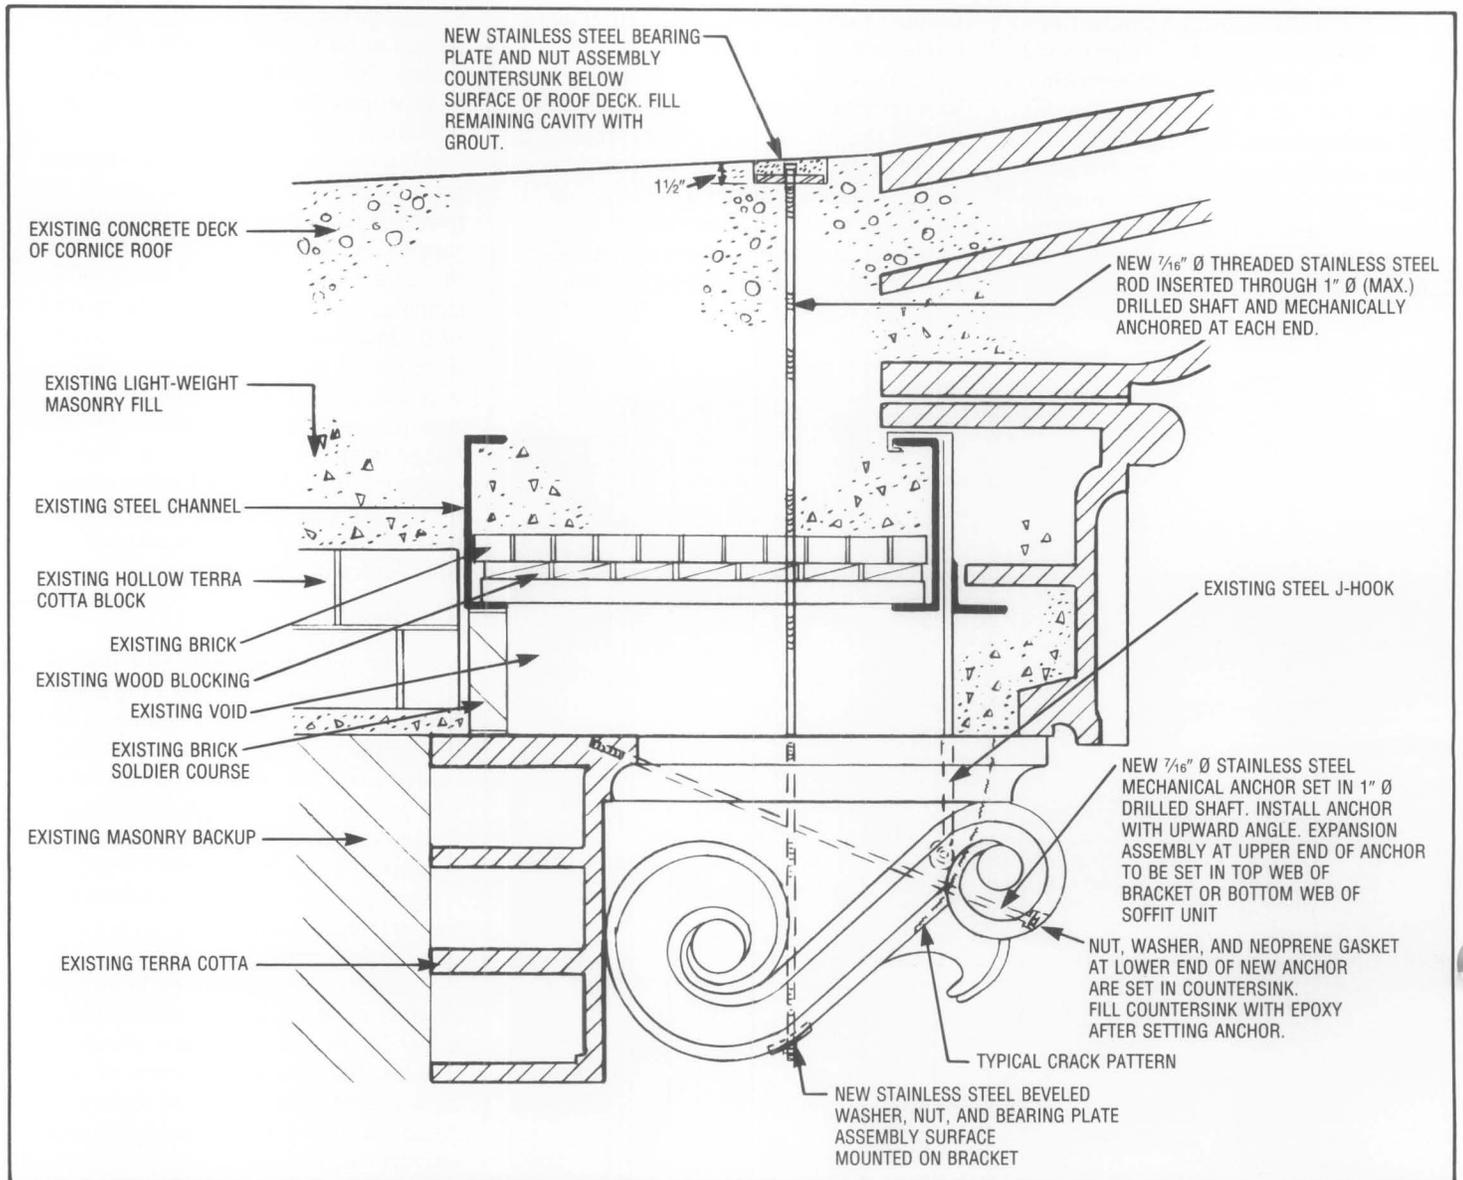
Figure 5. Detail section through the cornice showing the manner in which the vertical and angled outer scroll anchors were installed in the bracket units. The vertical hash-marks represent a typical crack pattern found in brackets which had not yet lost their outer scrolls. All 128 brackets received angled outer scroll anchors and about 80 received vertical anchors. Drawing by Jeffrey S. Levine.

to be suitable when set in brick backup or in structural steel. Pull-out values of from 500 to 1,800 psi were obtained in these materials, without any slippage or failure. These values were sufficiently high to provide a working safety factor of four times the weight of the terra cotta unit being supported. After making the decision to use mechanical anchors, drilling tests were conducted to determine anchor depths and backup materials at typical anchor locations on the cornice. Because the depth of penetration of the bracket units into the backup masonry could not be verified by non-invasive means, it was decided to anchor all brackets which had lost their outer scrolls or which had cracked internal webs. Given the condition of the light weight fill, this could only be achieved by extending vertical anchors through the roof (see figure 5).

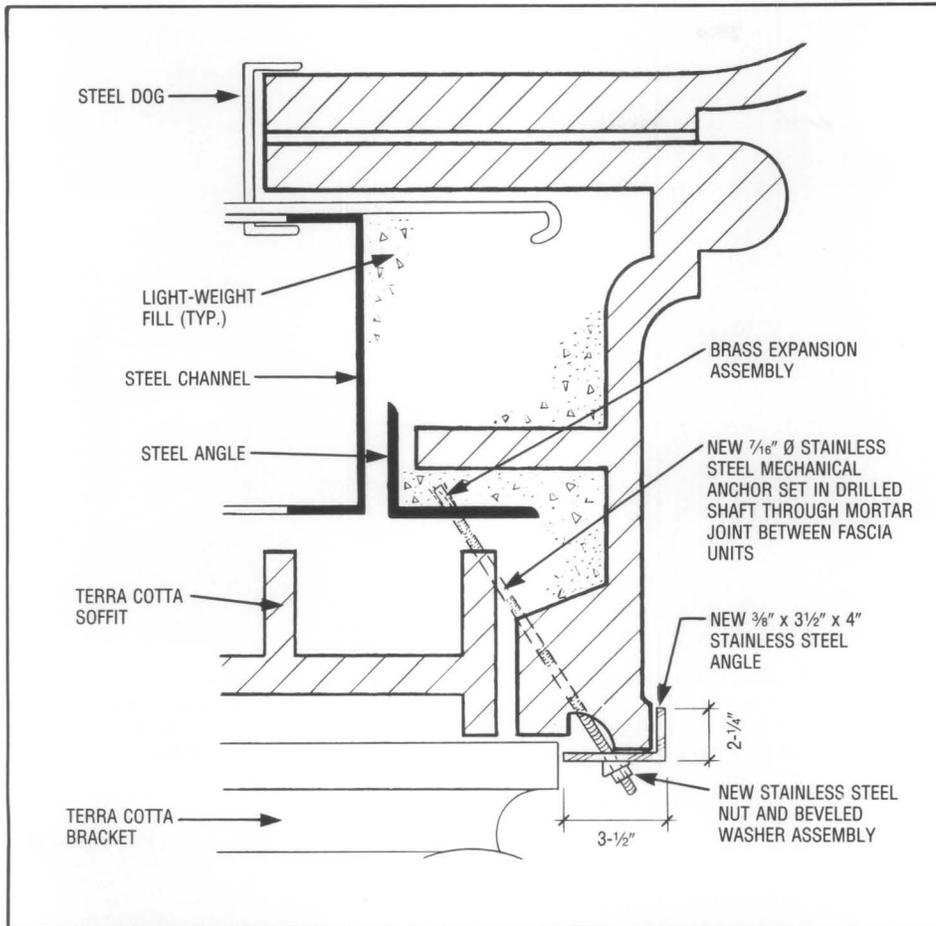
Figure 6. Detail section through the fascia of the cornice showing the installation of a fascia clip-angle anchor. Clip-angles were placed in the joints between fascia units—128 total. Drawing by Jeffrey S. Levine.

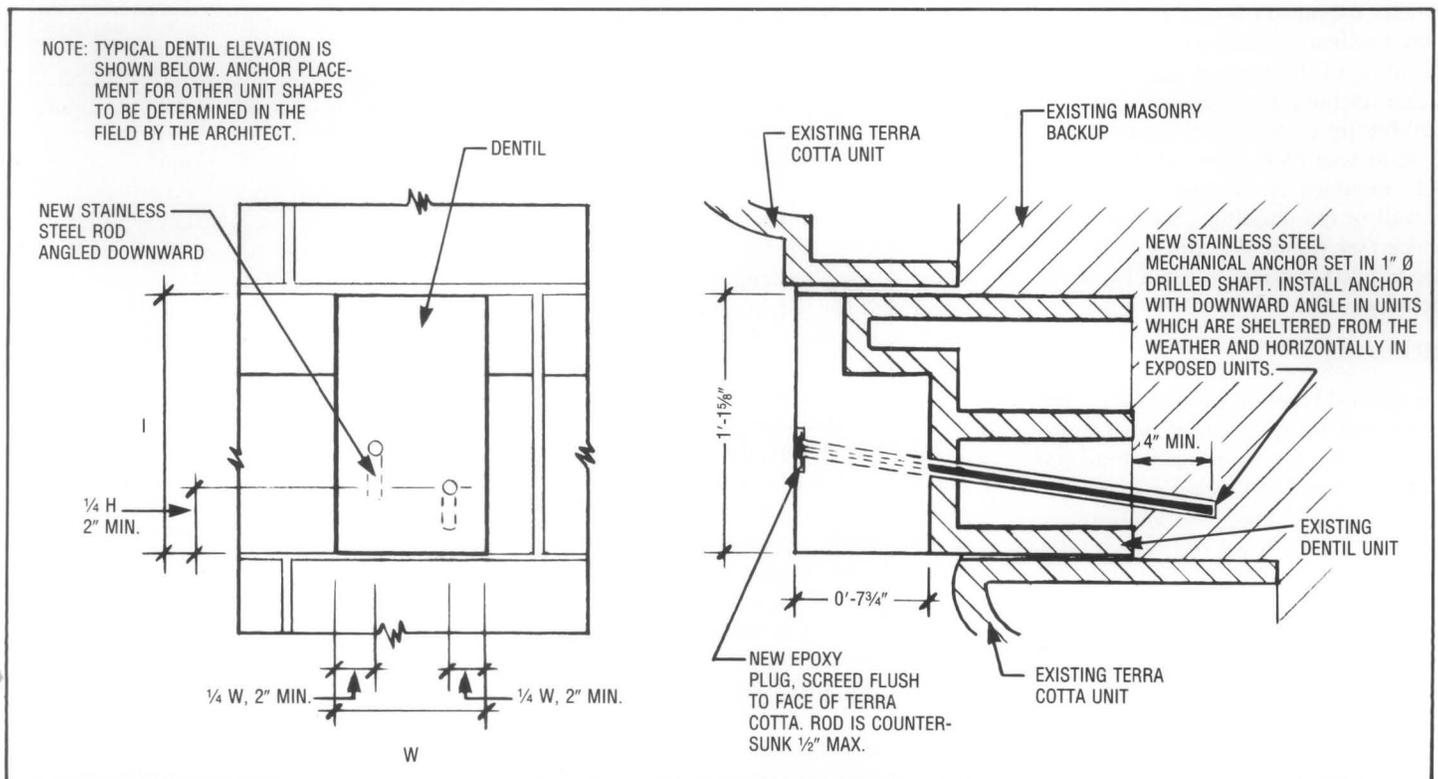
Figure 7. The typical terra cotta anchor detail is shown here for a dentil unit. Other terra cotta units with cracked internal webs were anchored in a similar fashion. Roughly 30% of all terra cotta units, exclusive of the brackets, were anchored in this manner. Drawing by Jeffrey S. Levine.

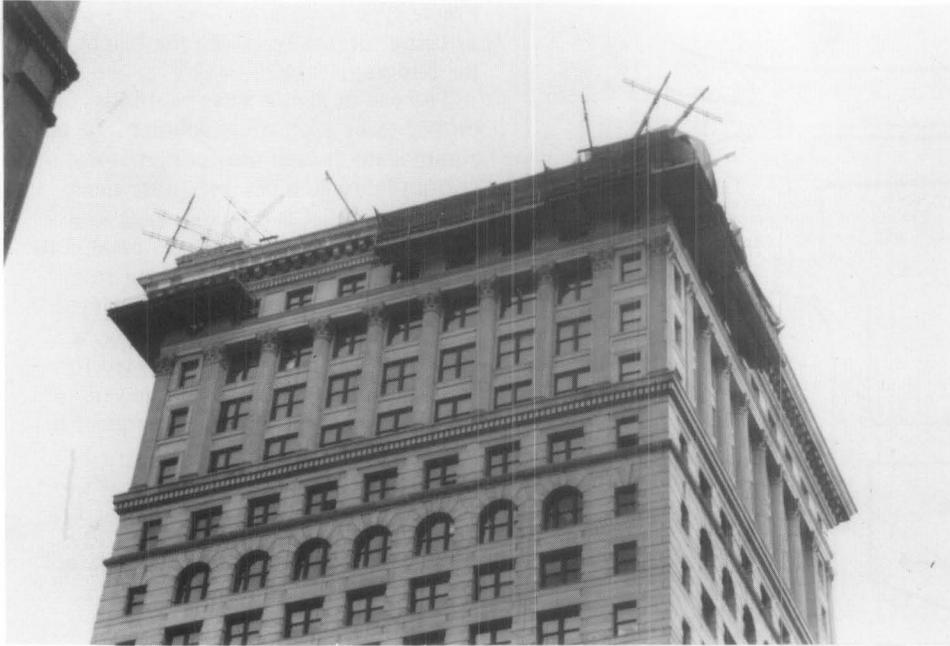
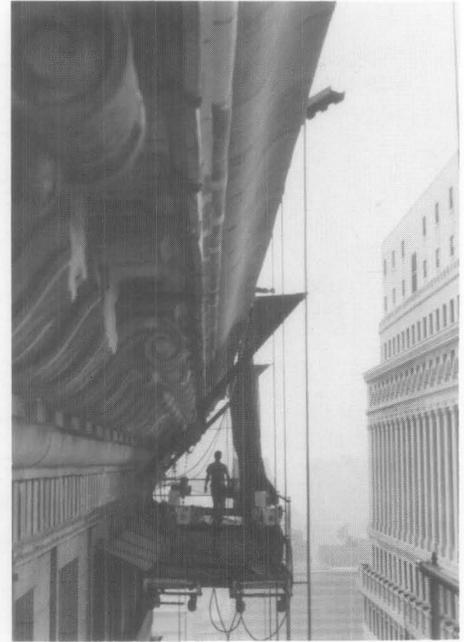
Figure 8. Access to the cornice was provided by cantilevered aerial scaffolds at the southeast and southwest corners of the cornice. All other locations were accessed by hanging two swing stages, side by side. The inner swing was hung off of a V-shaped bracket (shown) while the outer swing was hung from a steel deadman which projected horizontally across the cornice roof. Both the V-shaped bracket and the deadman were designed to transfer the weight of the swings vertically down through the center of the cornice. No load was placed on the outer edge of the cornice. Photos by Jeffrey S. Levine.

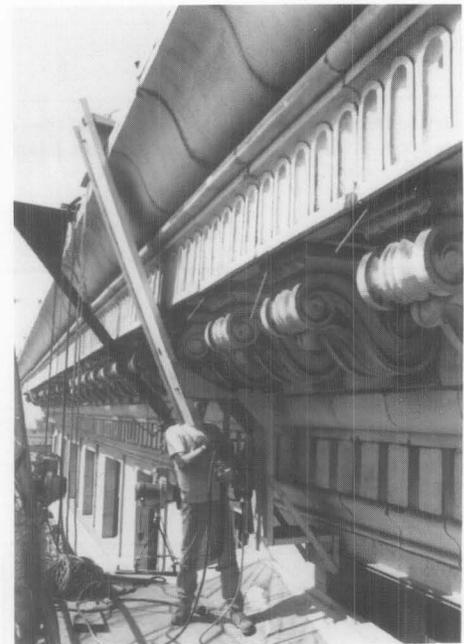
Figure 9. Drilling 6' long vertical holes through the cornice, in a variety of materials, was a delicate operation requiring great skill and specialized drilling equipment. The aluminum drilling jig provided the precise alignment needed to drill the holes for the vertical and angled bracket anchors. Drilling of a vertical anchor is shown. To create an angled outer scroll anchor hole, the drill was mounted on the angled portion of the jig, which passed directly in front of the bracket. Hand-drilled holes could be completed in 15-30 minutes, depending on the depth of the hole and the type of backup material encountered (e.g., brick, terra cotta, light-weight concrete, steel). Holes drilled with the jig required more time, 30-60 minutes, as alignment was more critical and it took time to set the jig in the proper position. Photo by Jeffrey S. Levine.

Drilling of the vertical and angled bracket anchors was accomplished using a drilling jig custom-fabricated out of $\frac{1}{4}$ " aluminum plate. The jig slid on tracks mounted on the roof deck and on the wall of the building, just below the cornice (see figure 9). All other holes were aligned and hand drilled by skilled mechanics.

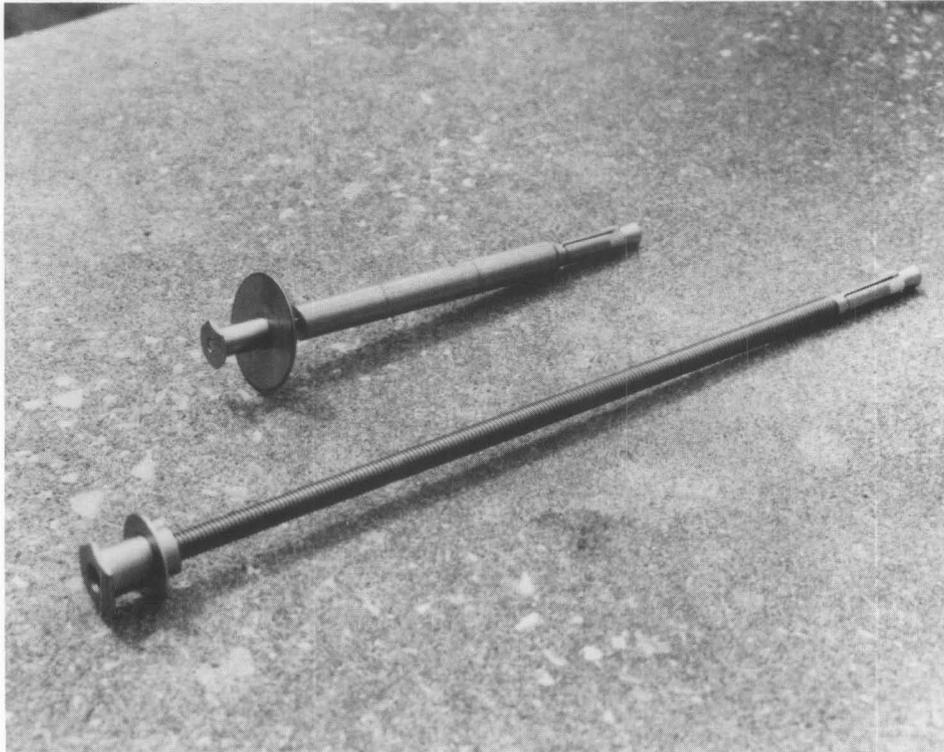
Figure 10. A standard mechanical anchor (top) and a variable length mechanical anchor. The variable length anchors were fabricated from 6' long threaded stainless steel rods, which were tapped at both ends to receive expansion assemblies (two anchors could be cut from each rod).

Stainless steel mechanical anchors, $\frac{7}{16}$ " in diameter and with bronze expansion assemblies, were employed for most other anchoring needs (see figure 10). Anchors of various lengths were special ordered from the manufacturer. The specified lengths were established in the planning phase by drilling test holes in the cornice at what were thought to be typical anchoring locations. A variable length anchor was also developed for use in unanticipated locations and in areas of the cornice where the original construction differed materially from the area in which test borings were conducted (see figure 10).

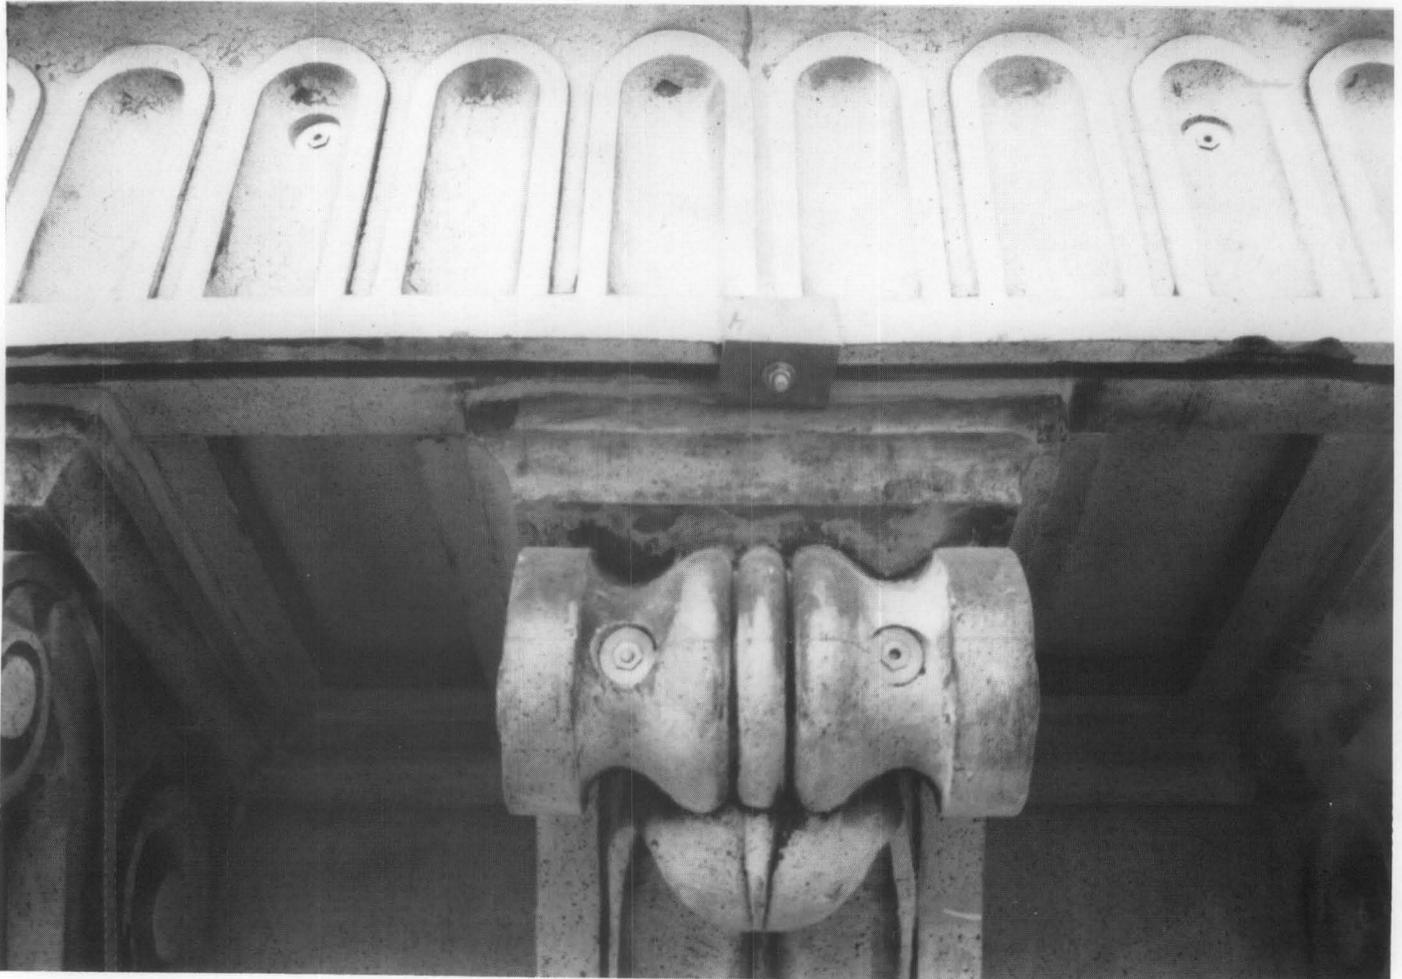
Figure 11. Completed anchor installations at a fascia and bracket. The countersink holes penetrate no more than half the thickness of the outer wall of the terra cotta and were filled later with epoxy.

As it turned out, the cornice construction was not very consistent and anchor placement varied according to the location of cracks. As soon as the initial order of fixed length anchors was used up, the drilling crew resorted to using all variable length anchors since these could easily be cut to the exact length required for any given situation (see figure 11).
