MASONRY

NUMBER 3

Water Soak Cleaning of Limestone

THE WIDENER BUILDING **Philadelphia, Pennsylvania**

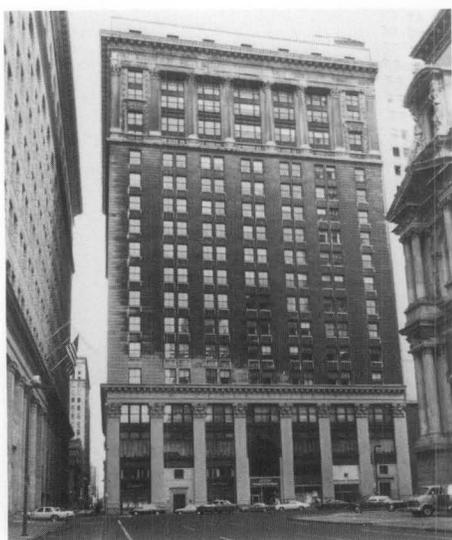
Figure 1. In 1989, just prior to the onset of the rehabilitation project, the Widener Building was showing the effects of 75 years of exposure to an urban environment. Note the lighter color of the left side of the building regularly washed by rain. Photo: John Milner Associates.

to seventy-five years of exposure to an urban/industrial environment and had never been cleaned, the masonry surfaces were heavily coated with typical deposits of air-borne particulates of soot, fly ash, tar and clay matter as well as localized areas of organic matter. These deposits in conjunction with sulfur oxides accelerate the decay process of the calcareous stones such as limestone by forming non-stable, highly soluble and chemically-reactive crusts that increase the stone's surface area and ultimately leave the stone more vulnerable to damage from continuing deposition attack.

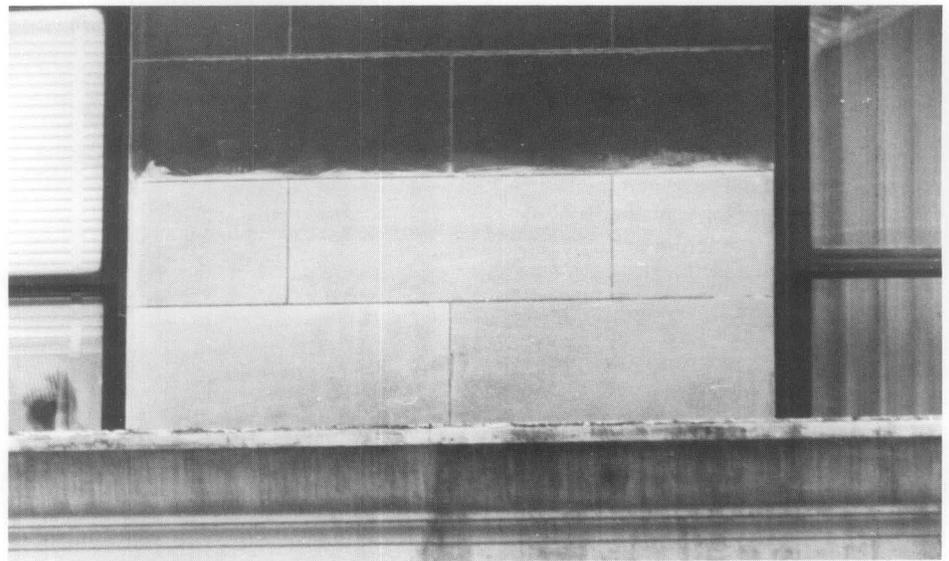
For this test, the limestone was soaked for 4 hours with low-pressure water from an oscillating sprinkler in order to dissolve and loosen the pollutant crust. After the 4-hour soak, the loosened crust and remaining particulate matter were rinsed off the stone surface by a pressure washer with a 45 degree fan tip nozzle at 400 pounds per square inch (psi) using approximately 5 gallons of water per minute (gpm) (see figure 2a).

Figure 2. The three test panels were carried out on the right side of the 4th floor of the South Penn Square elevation directly above the cornice that tops the 3-story storefront columns. (a) The completed panel on which the water soak method was tested; (b) the second completed panel after testing with the two-part alkaline chemical cleaner; and (c) the third completed panel after testing with the one-part alkaline chemical cleaner. Photos: John Milner Associates.

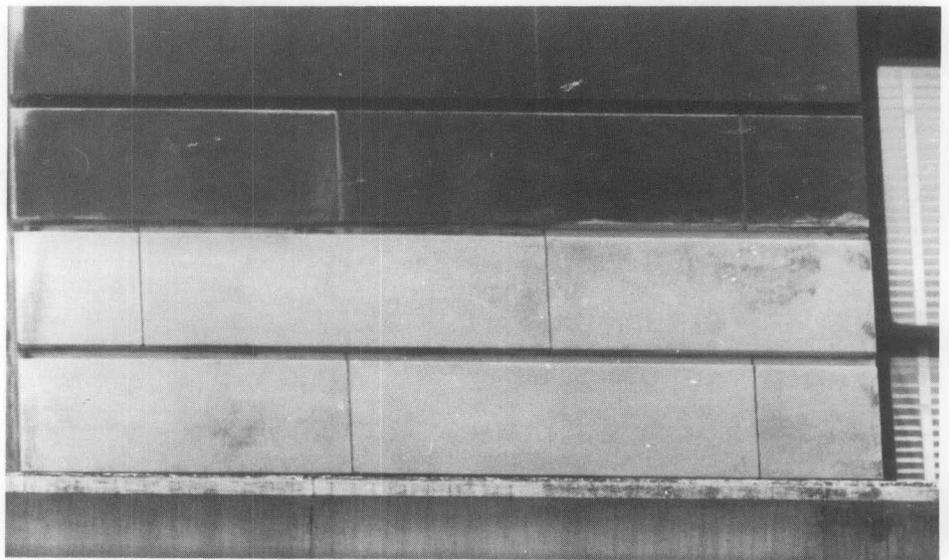
(b)

allowed to remain on the surface of the test patch for approximately 30 minutes. The treated area was then thoroughly rinsed at a pressure of approximately 400 psi at 5 gpm using a 30 degree nozzle. Immediately after rinsing, the acidic neutralizer was applied (diluted 1:1 with water), to the wet stone with a deep nap roller. The neutralizer was left on the surface for 3 minutes, and then the stone was fully rinsed with water (see figure 2b).

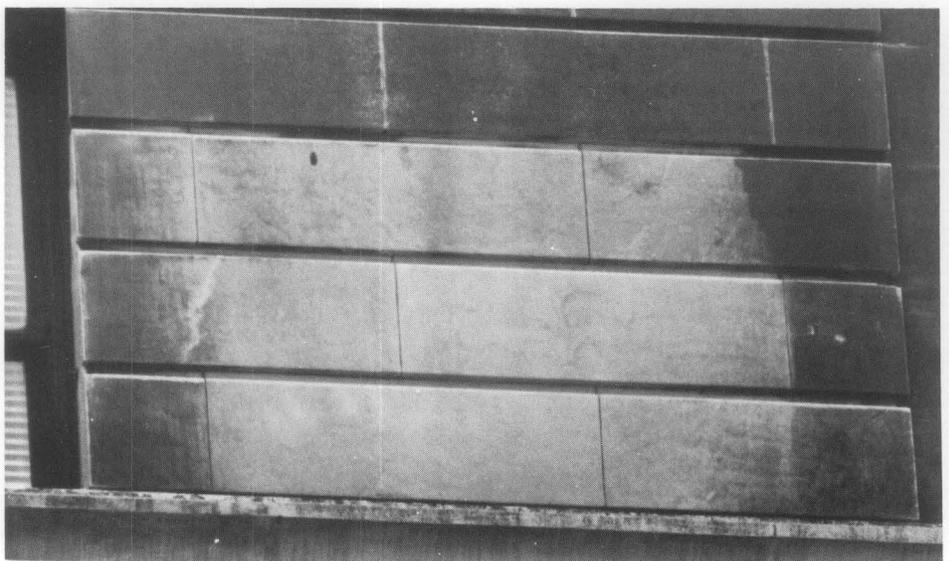
(c)

The second type of chemical cleaning tested was also an alkaline-based cleaner, and it too is intended to be used on limestone. It consists of a fluoro-chemical surfactant containing carbonate emulsifiers (pH of 10). It was applied full strength to the dry surface of the stone with a deep nap roller, allowed to remain on the surface for approximately 5 minutes and then rinsed with a pressure washer delivering water at 600 psi at 5 gpm (see figure 2c).

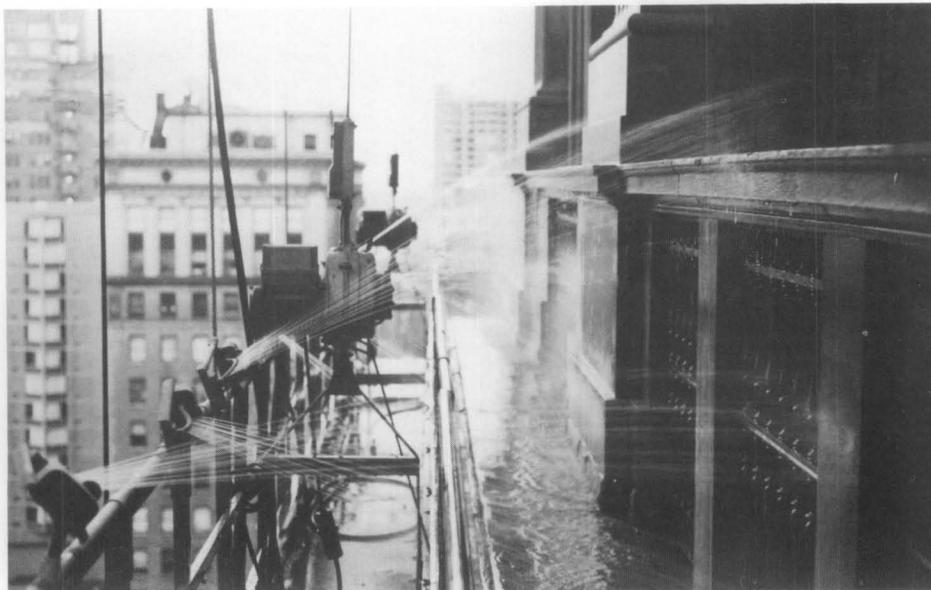
Figure 3. Close-up view of the oscillating sprinklers spaced 3 feet apart and connected to 1/4" PVC piping attached to the rear bar of each scaffold. Photo: P & R Masonry Restoration, Inc.

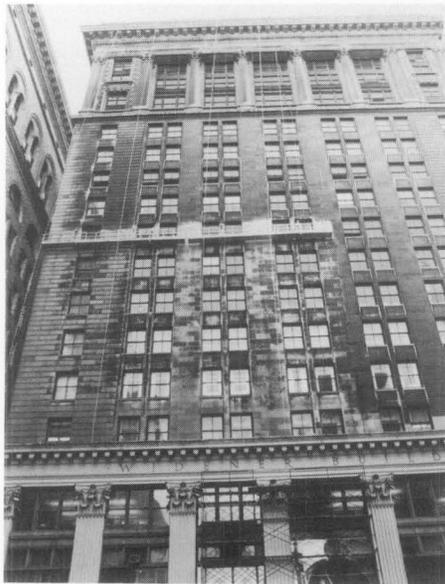
Figure 4. South Penn Square elevation after the completion of two drops from the 9th-4th floors of water soaking only, and prior to beginning the rinse process. Photo: P & R Masonry Restoration, Inc.

soaking had been completed on both drops (a "drop" is the amount of vertical wall surface that can be covered by one scaffold moving vertically up or down a building), the crew began the rinsing process this time moving down the elevation, starting from the 9th floor and proceeding to the 4th (*see figure 4*).

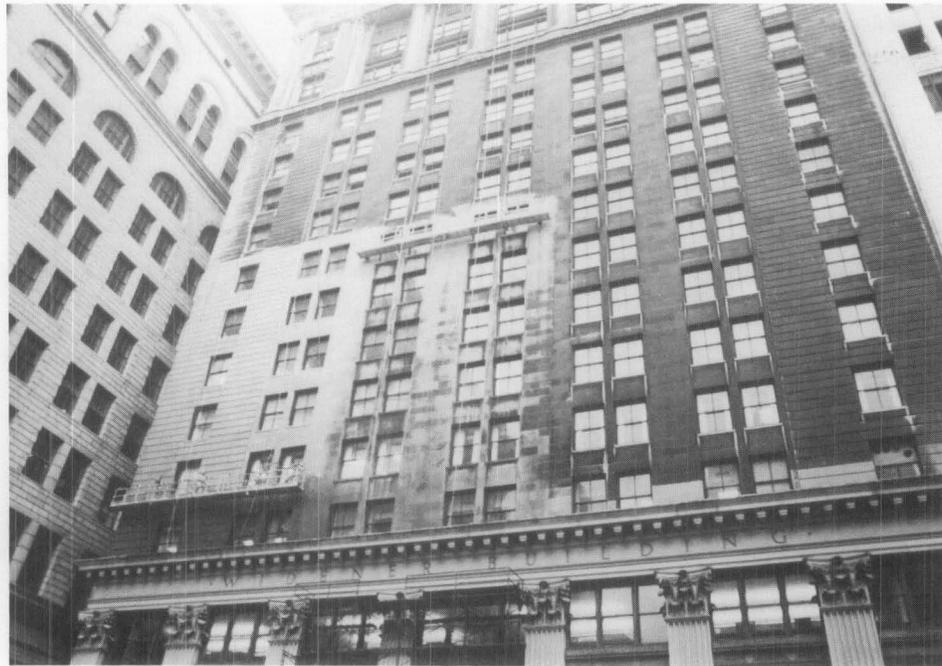
For the rinsing process, two pressure washers were placed atop the building with pressure hoses extending to the scaffolds. Each machine generated a pressure of 400 psi and 5 gpm. Throughout the cleaning, one worker per scaffold used a short-handled spray wand with a 30 degree nozzle to rinse away loose material and clean out the pores of the stone. The nozzle was kept a minimum of two feet away from the masonry surface at all times (*see figure 5*).

Figure 5. The drop on the left side of the building has been water-soaked and rinsed, while the drop on the right has been soaked only. Note the amount of soil that still remains on the right side before rinsing. Photo: P & R Masonry Restoration, Inc.

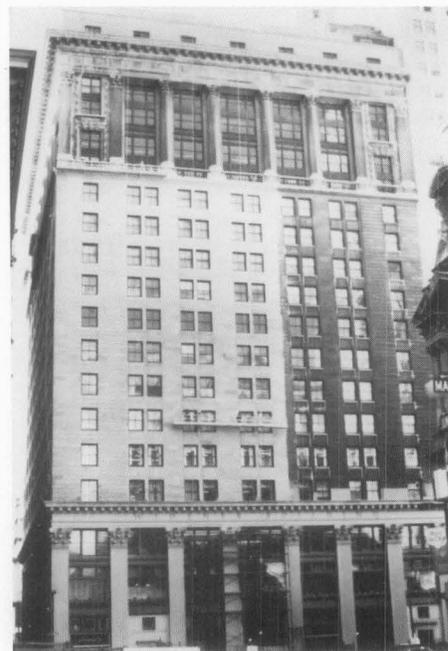
After cleaning (soaking and rinsing) the 4th through the 9th floors, both scaffolds were moved up to the 10th floor where the soaking process was begun again and was continued up through the 13th floor (*see figure 6*). This section was then rinsed, and the soaking process recommenced at the 14th floor and proceeded to the cornice at the top of the building.

Figure 6. The contrast between the cleaned and the uncleaned portions of the facade after completion of both the water soak and the washdown rinse of these two drops from the 14th-4th floors is dramatic. Photo: Robert M. Powers.

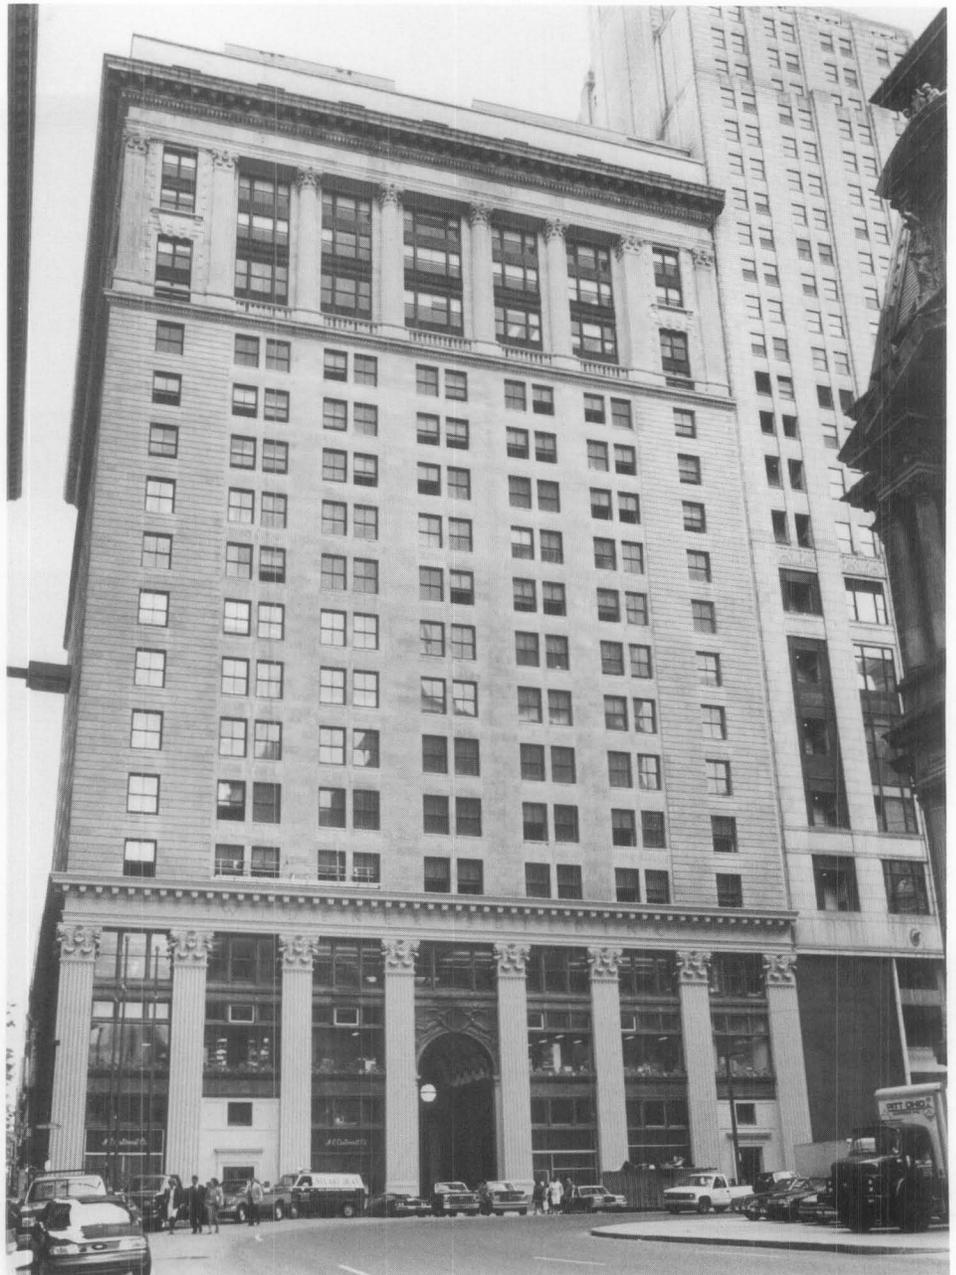
Water soaking is a cost-effective cleaning process for both large and small limestone buildings. The results of the cleaning of the Widener Building are startling, especially when compared to the appearance of the stone prior to the start of the project (*see figure 7*). Although the cleaning team was on the job site for a longer

Figure 7. The South Penn Square elevation after its successful cleaning using the water soak method. Photo: Faherty/Kelter Associates, Inc.
