## **THE HEXAGON (Ephraim Shay House) Harbor Springs, Michigan**

## **METALS:**

### **NUMBER 3**

## **In-Kind Replacement of Historic Stamped Metal Exterior Siding**

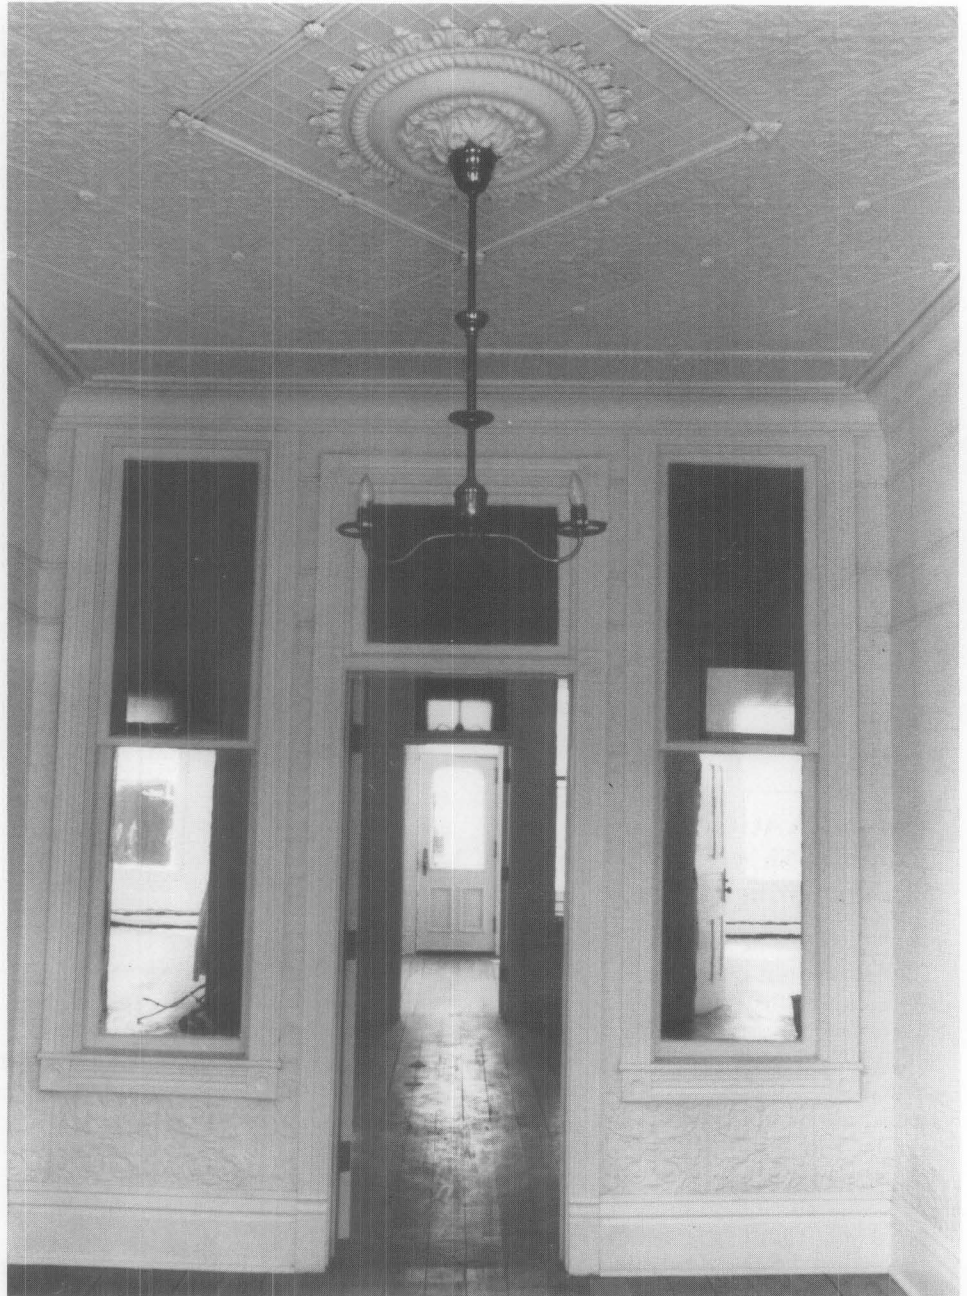
In contrast to the exterior metal siding, the interior stamped ceilings and walls remained in good condition. All of the interior metal was retained, with only isolated areas requiring patching due to minor rust. In addition, the exterior window hoods had not deteriorated like the siding and only routine repairs were necessary for their retention.

2. The walls and ceilings of each interior room are sheathed with stamped metal siding in a variety of decorative patterns. Photo: Brian Conway.
