## WILSON'S BRIDGE

Chester County,  
Pennsylvania

## Preservation Tech Notes

## Rehabilitating a Historic Truss Bridge Using a Fiber Reinforced Plastic Deck

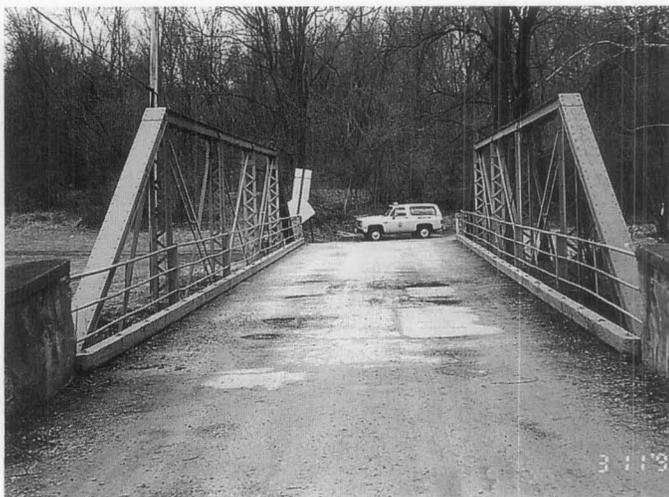
extensive cracking and was losing adhesion with the deck below (*see figure 2*). The thirty-five year old nail-laminated deck, made up of individual timber boards placed on edge and spiked together to form a 4-1/2" thick continuous surface, was uniformly soft and unable to support the wearing surface above. The steel stringers were also in poor condition (*see figure 3*). Though the full extent of their deterioration was not clear until the deck was removed, preliminary examination indicated that the I-beam stringers were severely corroded, particularly over the abutments where they had suffered approximately fifty percent section loss.

Figure 2. Before rehabilitation, Wilson's Bridge had an asphalt wearing surface that was delaminating from the deck below. Extensive cracks and numerous potholes were also present.

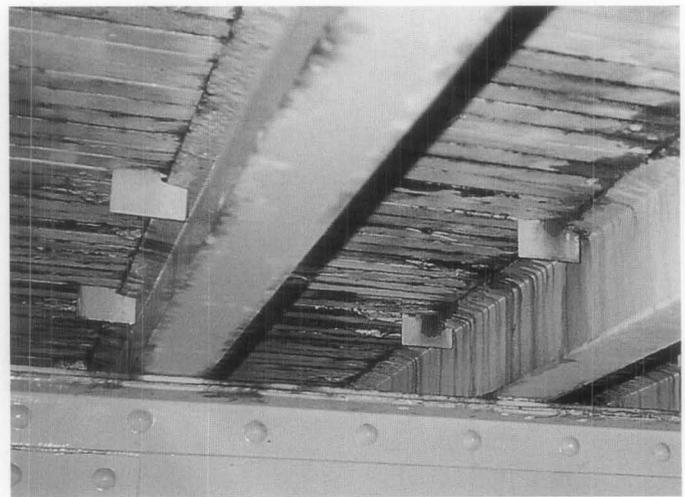
Figure 3. A view of the underside of Wilson's Bridge before rehabilitation. The timber nail laminated deck sat on steel "I-beam" stringers which, in turn, were supported by wrought iron floor beams. Failure of the wearing surface had allowed water to penetrate the laminated deck planks causing further deterioration to both the deck and the stringers below.

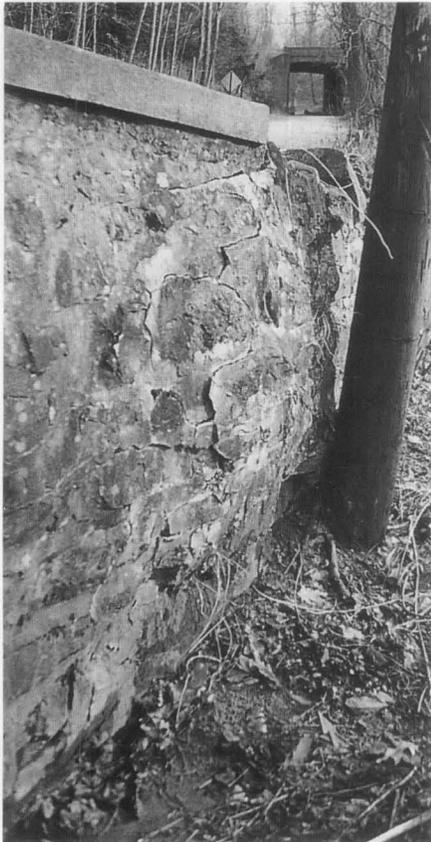
would need to undergo significant repair work, ways of increasing the allowable loads on the bridge would also be explored. In addition to these immediate concerns, the bridge was due for cyclical maintenance work including repainting the truss and repairing and repointing the stone abutments and wingwalls (*see figure 4*).

Figure 4. The Wilson Bridge wingwalls had loose and crumbling mortar joints. Much of the wall surface required removal of this deteriorated material and significant repointing.

While the deck was being fabricated in Delaware, the Chester County bridge team began work on the truss and abutments. Both the masonry abutments and wing wall approaches required significant repointing. Existing mortar from earlier patch jobs had separated from the joints in many locations. This deteriorated mortar was gently raked out with hand tools and a new mortar pointed into place. The existing asphalt wearing surface, nail-laminated deck, and steel stringers were all removed. Wrought iron U-bolt hangers, several of which had suffered impact damage, were known to be weak links in the structure. As part of the rehabilitation they were replaced with high-strength steel substitutes that had a higher structural capacity than the original hangers but were identical in appearance (see figure 8).

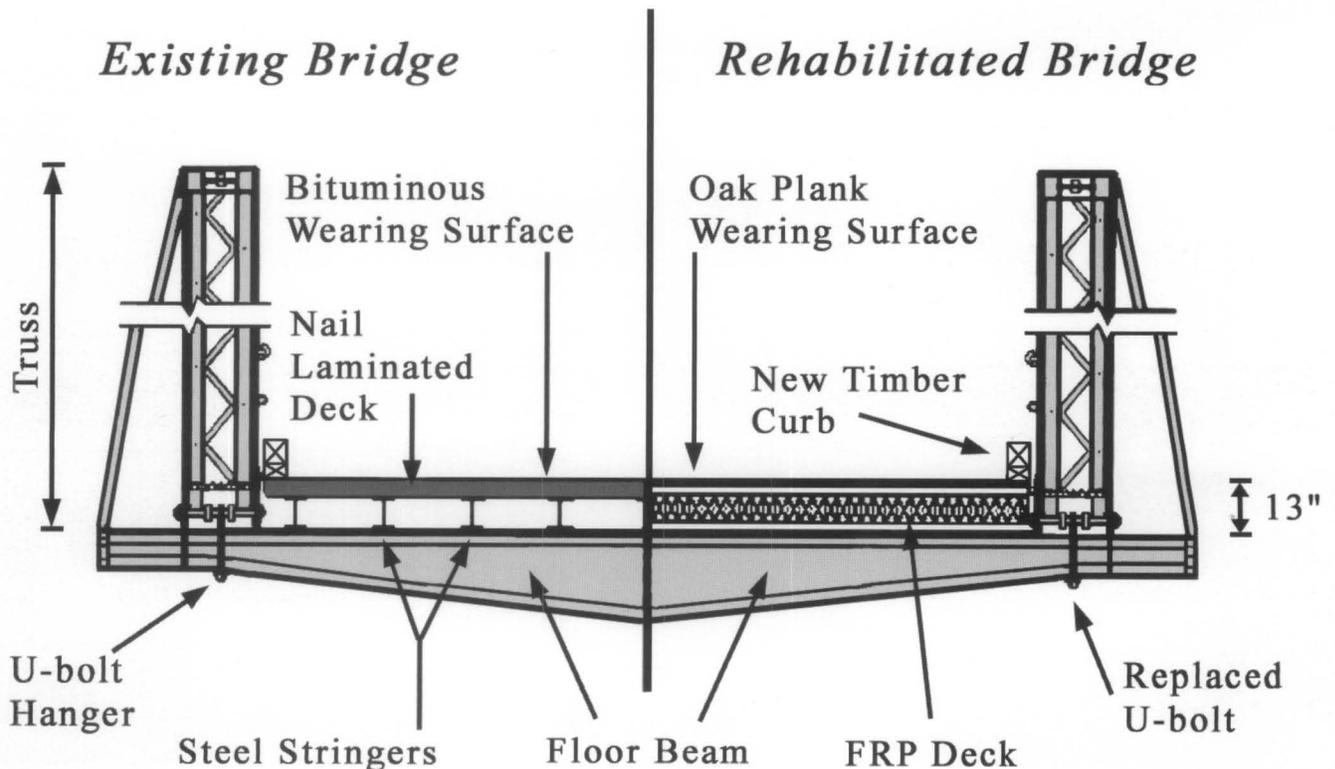
Figure 5. A section drawing of the Wilson's Bridge. The left side shows the construction of the span before rehabilitation, while the right side shows removal of the stringers and the installation of an FRP deck with a plank wearing surface. Both systems were approximately thirteen inches thick. Drawing: Chester County Engineering Department.

The characteristics of an FRP deck matched those sought by Chester County for Wilson's Bridge (see figure 5). Composite decks are chemically stable and resistant to deterioration caused by moisture, freeze-thaw cycles, chemicals and other forces that act on bridge surfaces. They also have a higher strength-to-weight ratio than conventional decks. This strength makes the use of steel stringers unnecessary. The reduced dead load of an FRP decked bridge allows a corresponding increase in the live loads the bridge is able to carry. Resins used in the FRP deck harden to a solid state so they can not leach or deteriorate, thus avoiding the release of any potentially harmful materials into the surrounding area, especially the creek below. Though the cost of a composite deck is somewhat higher than that of a nail-laminated timber deck, the estimated life span of the former is more than twice as long. Additional cost savings are usually realized in the short construction times and low level of required maintenance.

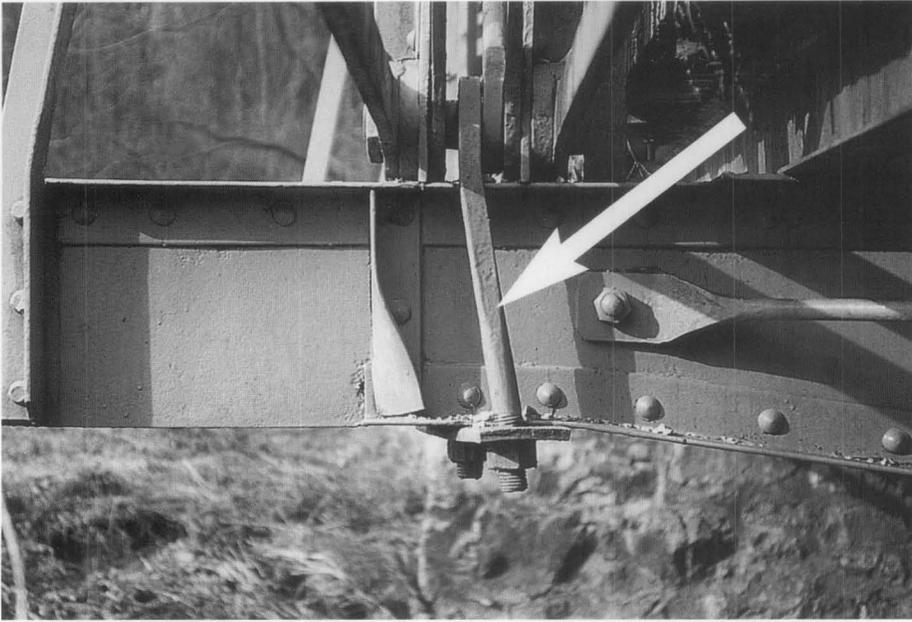
**Figure 8.** U-bolts connected each of the four floor beams to the superstructure above. Prior to rehabilitation, some bolts, like the one in the photo, showed signs of impact damage. The engineers determined that all of the wrought iron bolts were near the threshold of their stress level and called for replacement with high-strength steel U-bolts of the same dimensions.
