ALDRIDGE HOTEL Shawnee, Oklahoma

Preservation Tech Notes

METALS NUMBER 6

Repair and Reproduction of Metal Canopies and Marquees with Glass Pendants

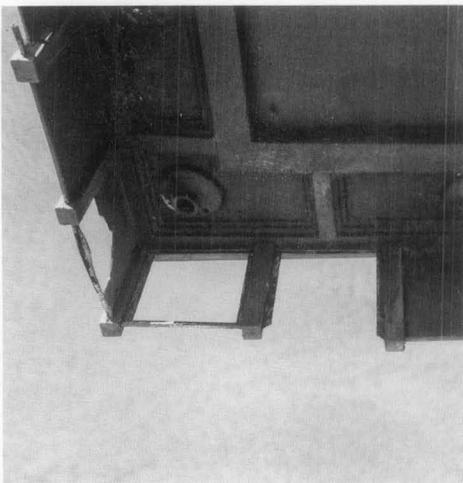
Figure 2. The underside of the main canopy's left corner, showing damage to copper pendant frames and missing glass.

By the time the rehabilitation work began, the main entrance canopy had suffered years of neglect and decay (see figure 1). The entire canopy had been painted green, masking the structure's original patina, ornate stamped ceiling, and colored glass pendants. Since the canopy was encased in copper, it was not possible to visually establish the condition of its internal structure. However, it was evident that the glass pendants located at the corners and along the sides were either missing or cracked. The pendant frames were also bent, twisted, or broken off (see figure 2).

meet code, as the existing glass was not tempered. Because of the extent of needed repairs, both the left and right corners and side sections, along with the ceiling panels, were completely dismantled and taken to the contractor's shop. Upon removal of these sections, it was discovered that the wood frame to which the copper was attached had rotted as a result of water seepage and needed to be replaced.

After transporting the dismantled canopy sections back to the shop, the sheet metal contractor took measurements of the existing pendants that were in good condition. Along with the canopy's original drawings, these measurements were used to create a pattern for the needed replacements. The design for the pendant, measuring 7 1/4" x 7 1/4" and made of 16 oz. copper, resembled a picture frame. At the bottom of the frame, a U-shaped channel provided a bottom receiver for the glass to help hold it in place. An extended U-channel was used along the top, providing extra room so the glass pane could slide up out of the bottom channel for replacement when broken. Affixed to the backside of the frame were four 1/2" copper clips, two on

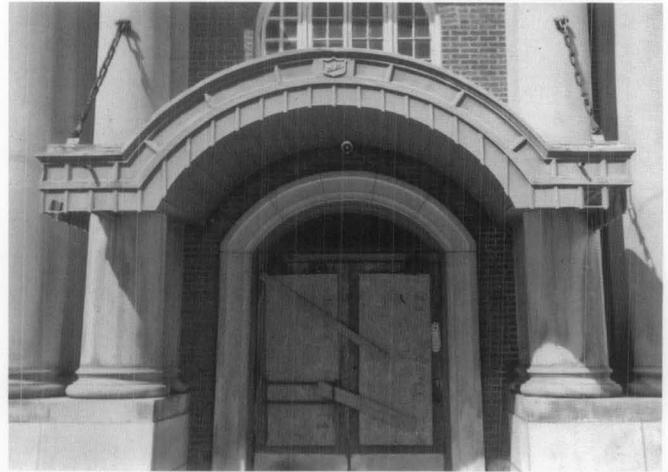
Figure 1. The Aldridge Hotel's south main entrance canopy as it existed at the start of the building's rehabilitation.

The initial task of the sheet metal contractor was to establish the condition of the canopy and determine what could be repaired and what needed to be replaced. The contractor began by surveying the copper cladding that covered the roof, sides and underside of the canopy structure. Since paint was covering the copper cladding, the decision was made to remove the non-historic paint to allow for a more thorough condition assessment.

Upon removal of the paint, it was evident that the archway and canopy roof were in sound condition. Ferrous armatures and attachments were inspected for rust since copper sheet is cathodic to iron. Approximately 40% of the glass pendant frames located along the canopy's sides required replacement and the canopy's galvanized metal ceiling needed to be repaired. It was also decided that all the glass panes would need to be replaced in order to

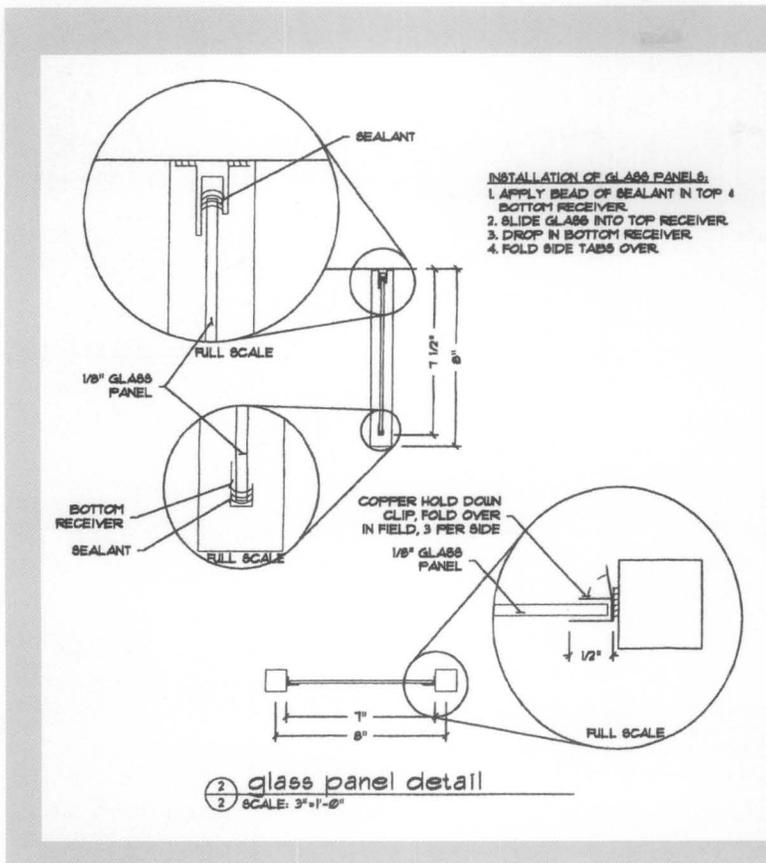
Figure 3. Details of the proposed replacement pendant frame, including how the pendant glass was to be installed. Drawing: The Hill Firm.

each vertical side, which when folded over the glass, helped secure the lights in place (see figure 3).

After cutting and shaping the metal pieces, the new pendant frame was soldered together. Each frame was then soldered to the dividing posts between each pendant. These 1" square copper posts served as the connector between each pendant and provided structural strength for the row of glass pendants. At the top of each pendant frame, the metal sides included a flange at the upper end that enabled it to be affixed with screws to the underside of the canopy. An additional section of copper panned over the flanges provided for a weather tight seal.

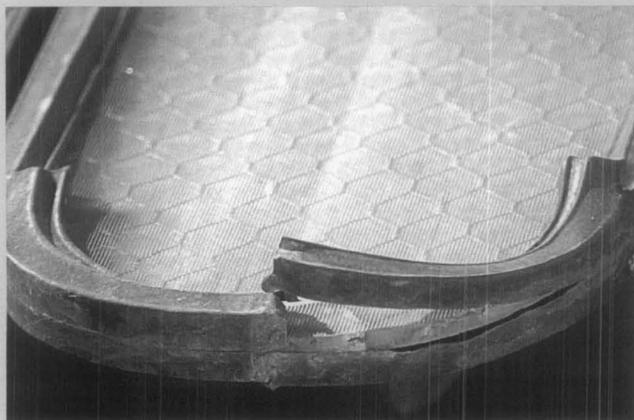
Figure b. In this double-faced pendant, the soldered joint on the outer face has failed where two adjacent pendant halves are connected.

Open joints: Metal joints connect individual pieces of the pendant frame. Where joints have opened up, water can seep inside and cause eventual rusting of the galvanized steel. In colder climates, metal deformation can occur from water freezing and expanding within the frame. Open joints should be cleaned, aligned, and re-soldered rather than simply filling voids with caulk or other sealants.

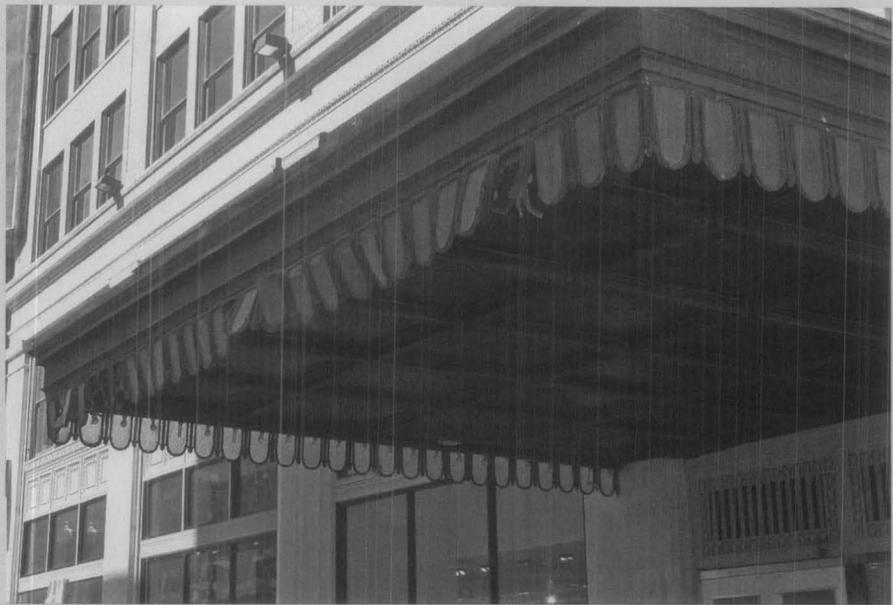
Figure a. Rust, paint failure, open joints, broken glass, or damaged and missing sections are indications that pendant frames are in need of repair.

Rust, paint failure, open joints, broken glass, or damaged and missing sections are indications that pendant frames are in need of repair. When the pendant frame is in reasonably good condition, it may be possible to make necessary repairs on-site. Where more extensive deterioration has occurred or where the wood substructure has deteriorated, sections of the canopy usually are removed and taken to a shop for repair or replacement work.

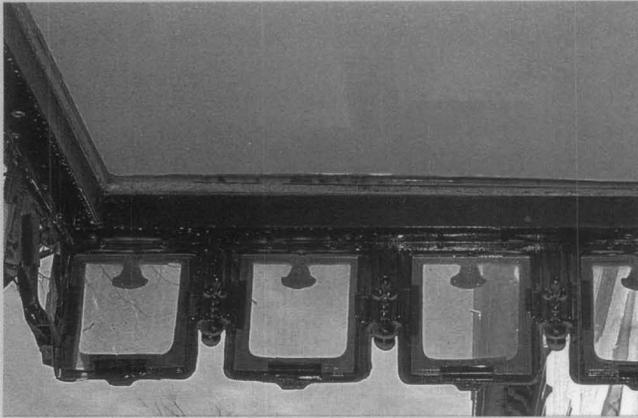
Figure c. Broken glass in single-faced pendants can be easily replaced from the back side, where the glass is held in place by metal tabs, as shown above, or by glazing putty.

Broken or missing glass: Glass breakage can result from stones and other airborne objects; deformation in the pendant frame from entrapped moisture that freezes and thaws; and impact from tall service vehicles or mechanical lifts. Glass in pendant frames that are open in the back are the easiest to replace since they are secured by exposed metal tabs. For most double-faced pendant frames, the glass originally was installed as the frame was soldered together. The recommended procedure is to detach the individual pendant frame from the canopy

and unsolder the connection with adjacent pendants. This allows for the individual pendant to be taken down, the old glass removed and measured, and new glass installed. With some pendants, the removal of individual ones is problematic and it may be possible to undertake the work in place. Alternately, it may be necessary to remove one or more pendants and replace them with new ones.

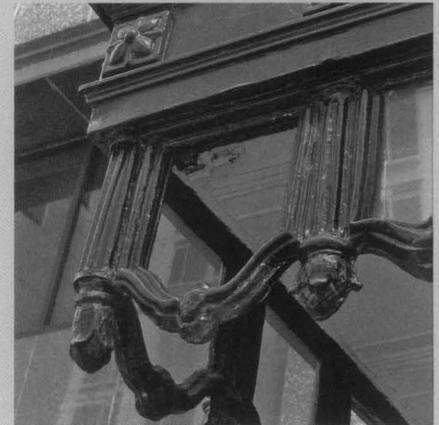
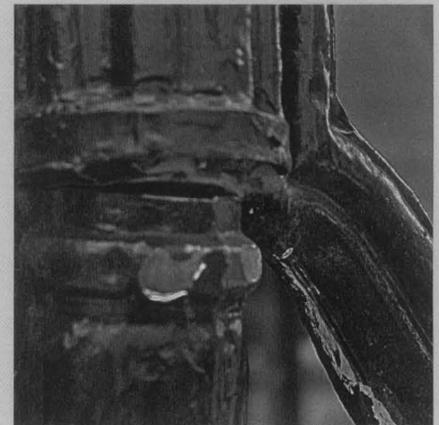
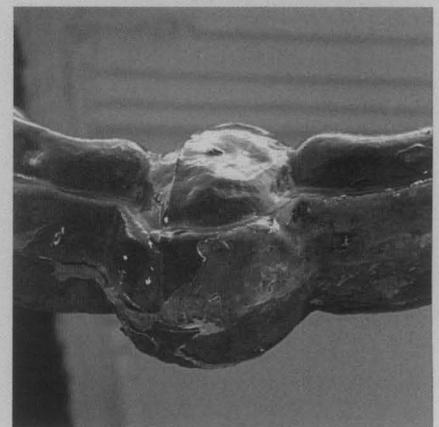
Figure d. Typical deteriorated conditions on pressed, galvanized metal pendants can include broken or missing glass (top); broken or misaligned elements (middle); and rust along the bottom of the pendant frames where water has collected (bottom). These conditions can usually be repaired.

Deteriorated, damaged or missing pendant frames: Depending upon their condition, it may be possible to remove old galvanized sheet metal elements to make repairs in the field or shop. Old stamped zinc is more difficult to repair. Long-term exposure to acid rain leads to deterioration, resulting in the zinc sheet being thinned and perforated. This tends to occur where water ponds, such as the bottom of the pendant frame. While new zinc sheet stampings may be bent or molded as needed to install, existing zinc stampings generally fatigue and fracture with a small amount of movement. As a result, when zinc pendant frames cannot be repaired in place, it usually will be necessary to replace them with new ones.

Where sections of the pendant frame are damaged or beyond repair, there are a number of possible steps that can be taken to correct this condition. Some of the old patterns of metal pendant frames are still manufactured so new matching replacement pieces may be available. Where various pendants are missing or damaged and matching new pieces are not available, it may be possible to purchase a similar pattern and group the new pieces on the sides back toward the building. Another alternative that works with some matching double-faced pendants is to scavenge needed sections by removing the backs of existing ones and using them

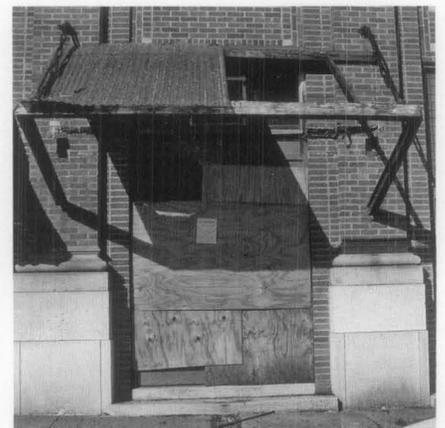
While a simple shed canopy existed at the east entrance at the start of the building rehabilitation, it was poorly constructed and in deteriorated condition (*see figure 5*). Physical evidence of the original canopy fortunately had survived. The pockets remained in the masonry wall that once carried the supporting beams and the historic overhead cables and anchors still were in use. The flat roofline of the original canopy clearly was evident against the building, cutting right below the transom over the doors. Furthermore, ghost marks on the brick wall helped to establish the height of the box canopy frame.

Figure 5. The east canopy entrance prior to the fabrication of its replacement. The original canopy had been replaced long ago with a simple covering that had deteriorated as well.

The new canopy consisted of a metal sub-frame, upon which a wood frame made of exterior grade plywood was attached. For the canopy cladding,

16 oz. copper was used along the top and sides. To match the patina of the existing canopy on the main entrance, the new canopy was chemically treated.

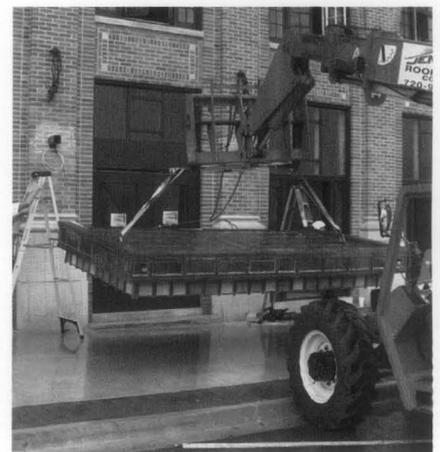
Figure 6. The installation of the new canopy required the use of a Sky Track and a special harness to ensure the protection of the copper frame. Photo courtesy of Thad Jennings, JENCO Roofing & Sheet Metal.

the structure safely to the building. The contractor then used a lift to set the canopy into place (see figure 6). The entire process had to be handled with care, given the vulnerability of the canopy's soft copper skin and the hanging pendant frames.

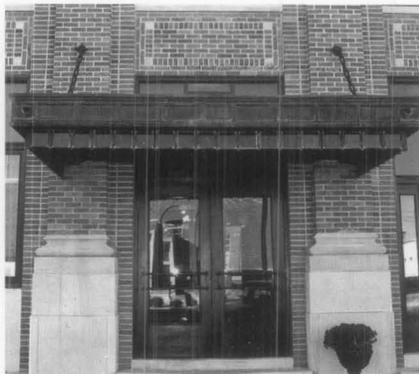
Figure 7. The new copper canopy on the east elevation of the Aldridge.
