WORTHINGTON HOUSE Monocacy National Battlefield Frederick County, Maryland

WINDOWS NUMBER 10

Temporary Window Vents in Unoccupied Historic Buildings

PTN-11

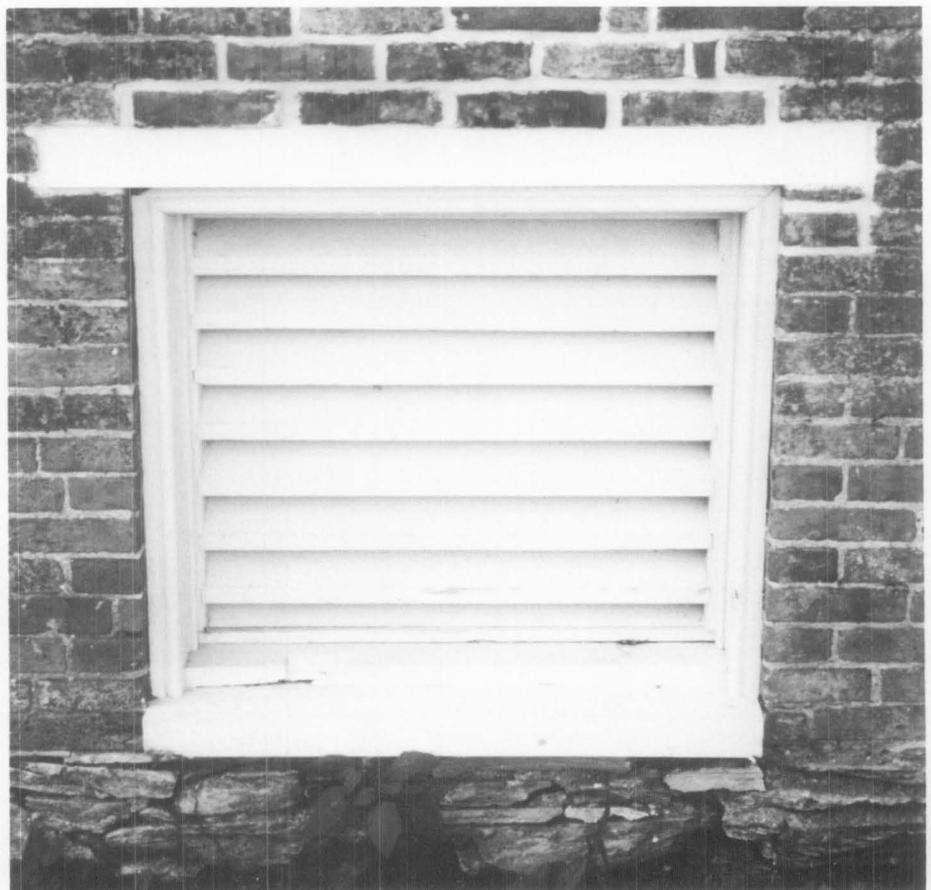
Figure 1. Full louvered vents were installed in all single-sash openings in the basement because of the more severe moisture problems present in that location. Photo: Charles Fisher

Wooden fixed louver vents were custom-made and installed. The easily fabricated louvers were sized to fit the lower sash opening — 34½" wide by 34¼" high on the first floor, while those for the smaller second floor windows were only 25¼" high. Full units were installed in all single-sash basement windows, since the window area was much less and the moisture problems more severe (see figure 1). At the same time, the three attic windows were also replaced with full louvers to encourage thorough multi-level ventilation.

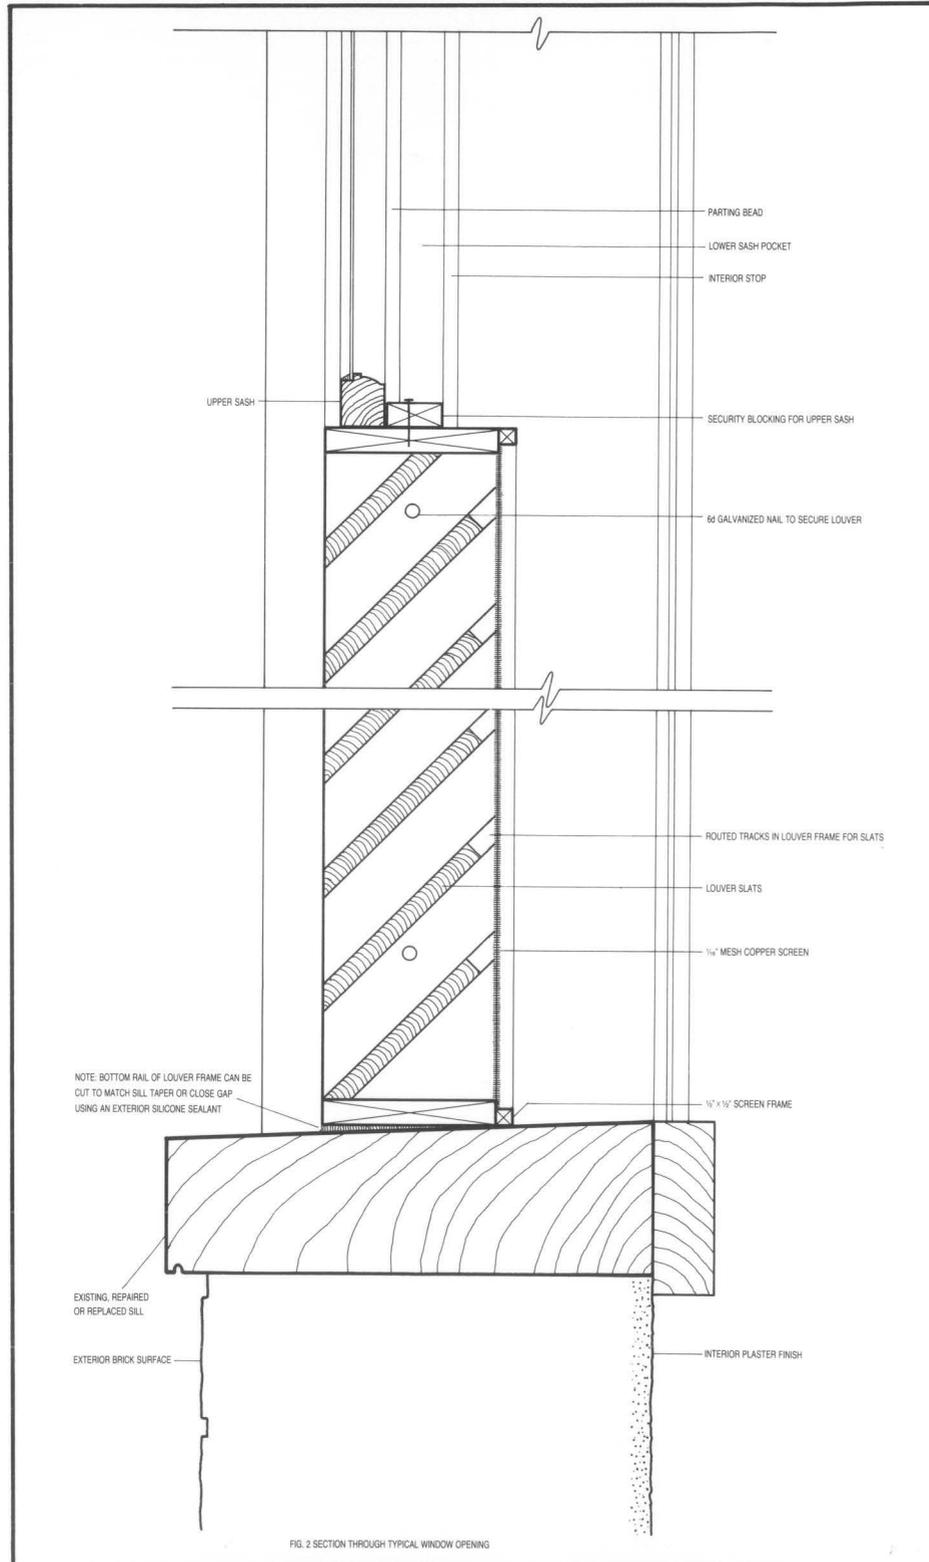
Figure 2. Section of the wooden louvers shows the simple manner in which they were made and assembled. Drawing: Thomas Vitanza

The louver frame was designed to fit snugly into the existing sash tracks and simultaneously to secure the glazed upper sash. An added benefit of the 6" stock width is that it provided a fairly rigid — and thus secure — louver frame. The louver frame was constructed of 1" x 6" shelf grade northeastern white pine; the louver slats were

made from 1" x 8" pine (see figure 2). The spacing of the louver slats did not exceed 4" in order to provide additional lateral strength (and security) to the frame. The relative closeness of the slats also would make it more difficult to kick out the grade level units. The slats were set into the frame at a 45 degree angle by routing a ¼" deep dado

cut into the jamb of the louver. The exposed edges of the slats were plumb cut in order to create a water drip on the exterior.

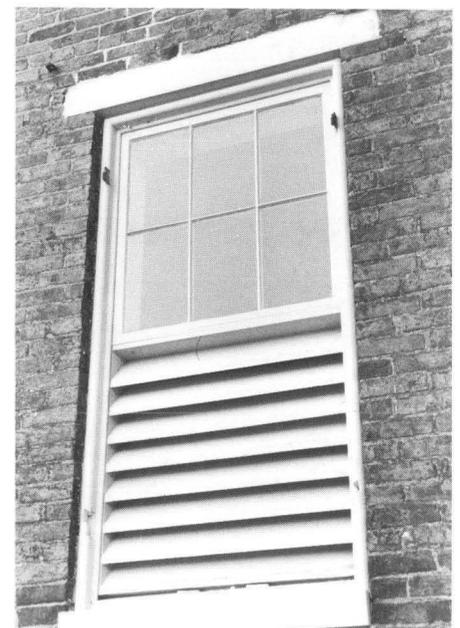
Figure 3. The exposed edges of the louver slats were plumb cut in order to create a water drip on the exterior. For aesthetic reasons, the louvers were painted the same color as the sash and trim. Photo: Charles Fisher

Prior to assembly, the louver members were primed using an alcohol base paint in order to get at least one protective coat on all surfaces. After assembly, they were given one shop coat of oil base exterior house paint. A final coat was applied after installation. For aesthetic reasons, the paint color used on the sash and trim was selected for the final coat on the louvers (see figure 3).

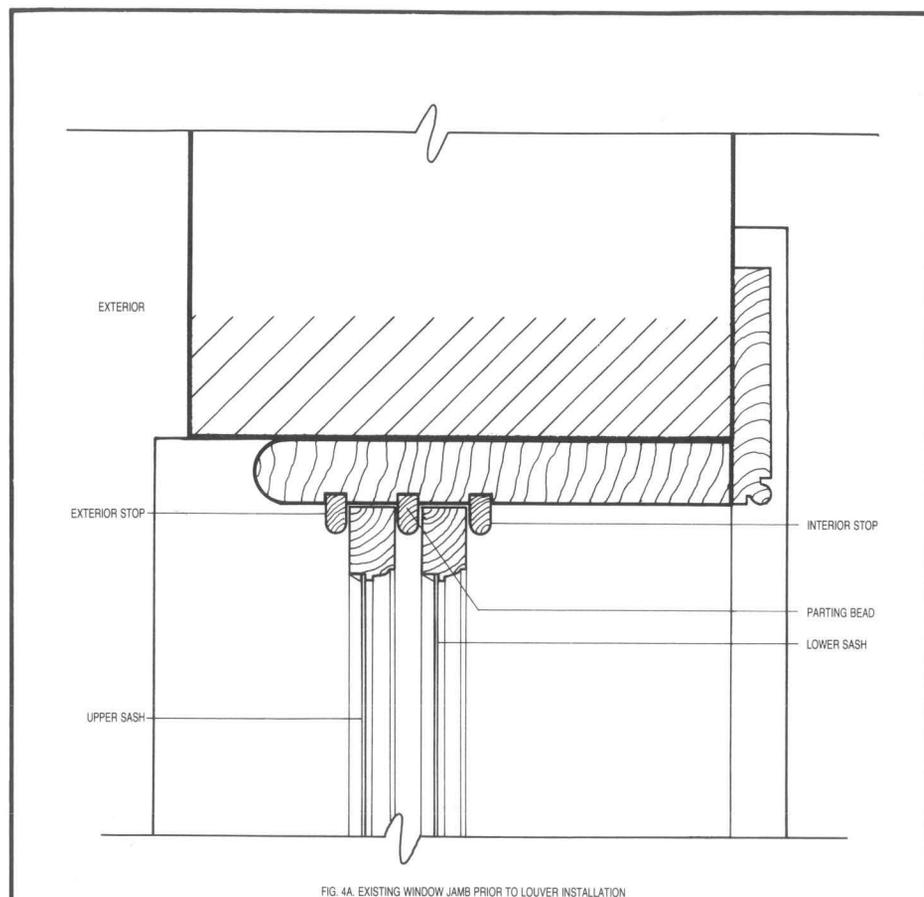
FIG. 4A. EXISTING WINDOW JAMB PRIOR TO LOUVER INSTALLATION

Figure 4. The lower sash (Figure 4a) were removed to permit installation of the louvers. To minimize damage to historic fabric in installing the louvers, temporary blocking was set between the parting bead and stops prior to nailing the units in place (Figure 4b). Drawings: Thomas Vitanza and Christina Henry.

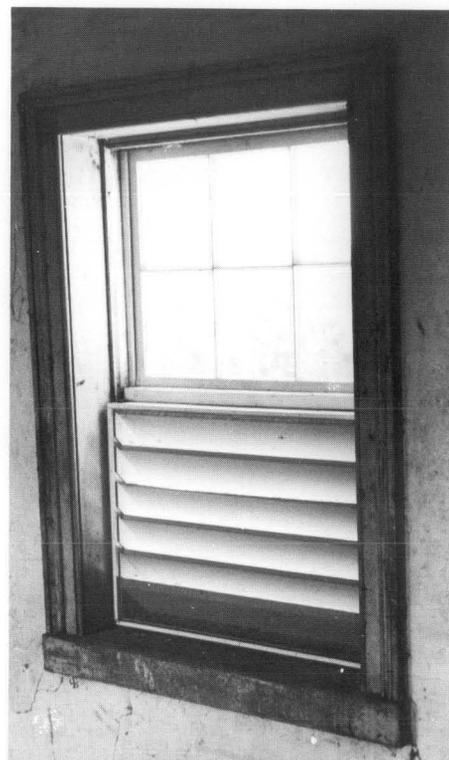
Figure 5. Screening was attached to the back side of the louvers to prevent the recurrence of insect, bird, and rodent infestation. Photo: Charles Fisher

After the louvers were secured in place, 1/16" mesh copper wire screening was installed on the interior of the louver frame using a 1/2" square wood frame. The screening is an integral part of the louver design. This seemingly minor detail was necessary to prevent the recurrence of insect, bird, and rodent infestation (see figure 5). The 1/16" mesh was specified to keep out the ever-present mud-dauber wasp, whose hive-building instincts have no regard for historic plaster or paint.

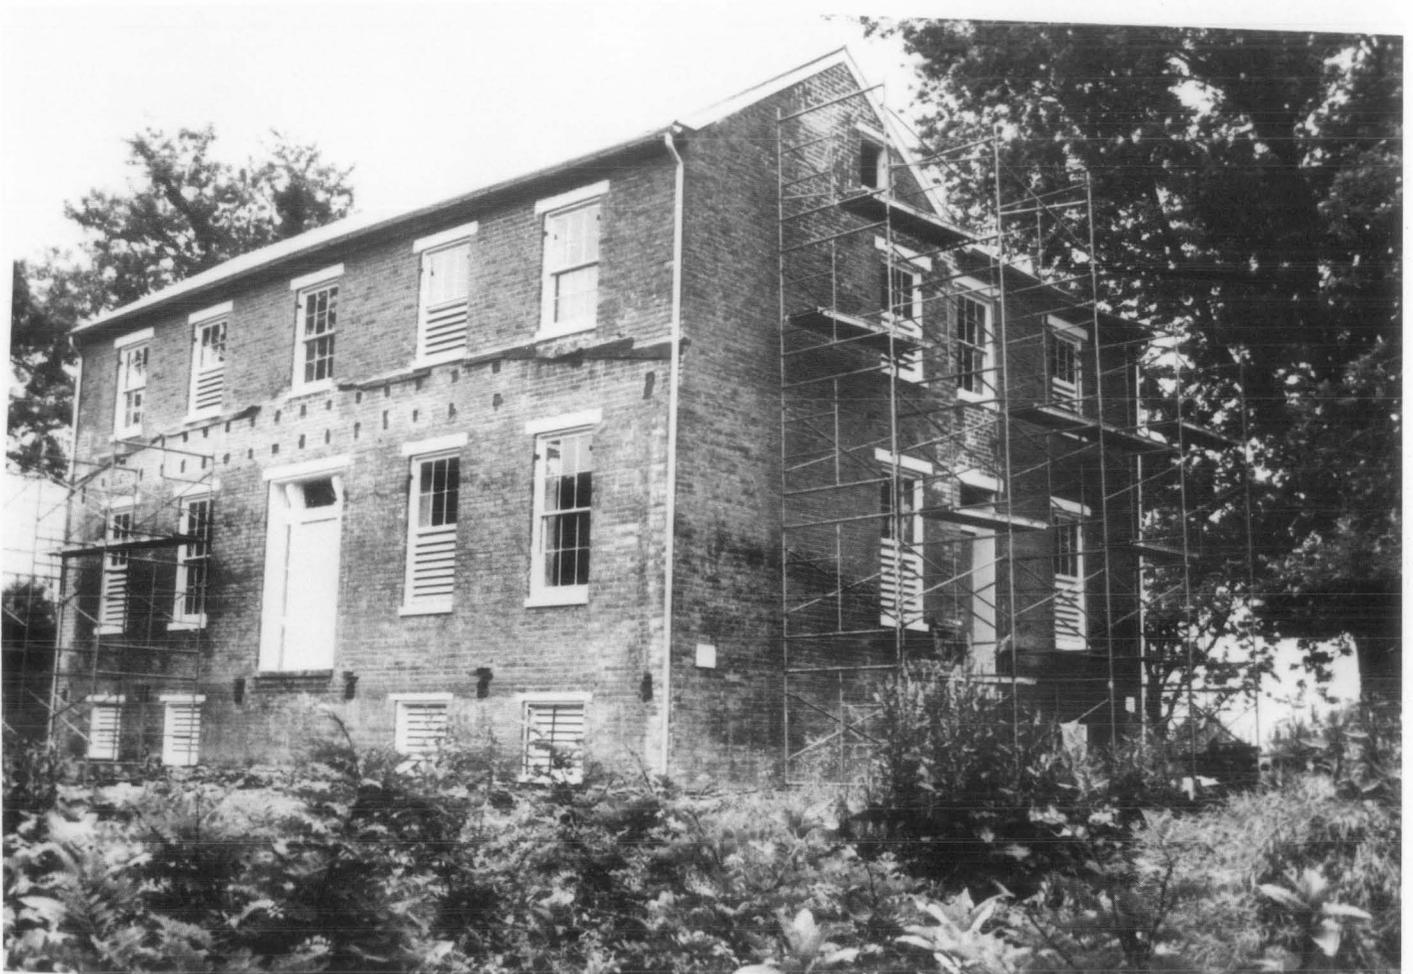
The window louvers installed in the Worthington House have proven effective over the past two years in providing the necessary ventilation for the building (see figure 6). Neither fungal attack nor condensation damage has recurred, and the interior air lacks even the typically humid, musty odor typically found in many older buildings. The louvers provide for good air movement within the building and a greater equilibrium between interior and exterior humidity levels and air temperatures, thus helping to protect the historic plaster and the significant interior finishes. The installation of the louver system in conjunction with the other sash work, and the overall exterior stabilization work has stimulated an interest in finding a use for the structure. As a temporary solution to a complex set of problems, the louver vents in the Worthington House have resolved a variety of issues. When used together with additional weatherproofing measures, this venting solution can be adopted for use in other buildings being mothballed.

Figure 6. The window louvers installed in the Worthington House have proven effective over the past two years in providing the necessary ventilation for the building. Photo: Tom Vitanza.
