Tech Notes

WINDOWS NUMBER 11

Installing Insulating Glass In Existing Wooden Sash Incorporating the Historic Glass

DELAWARE BUILDING

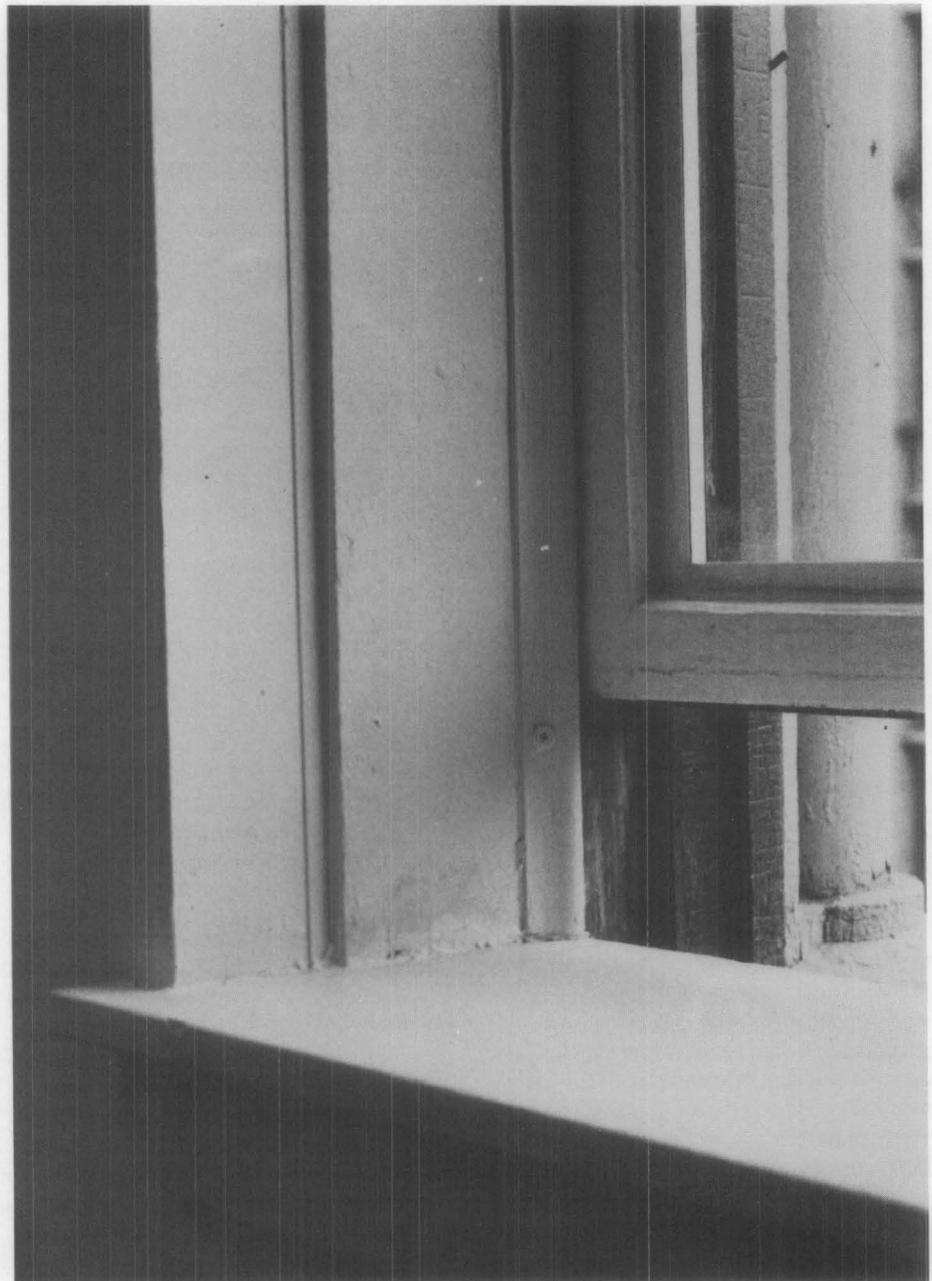
The technique used for double glazing the windows, incorporating the existing glass, was developed in Europe and in use there since the mid 1970s. This technique uses only one additional sheet of glass, placed off the inside edges of the rails and stiles, to create a sealed insulating unit. Since the metal spacer placed between the glass sheets is set slightly off the edges of the rails and stiles, the retrofitted insulating unit reduces the historic glass exposure by about 1/2" along all sides. This tends to limit the applicability of this technique for double glazing to upper floor windows with large lights since at such distances the reduction in exposed glass area is not readily visible (see figure 1). At the third floor level and

above, the 1/2" encroachment along the edges of the glass on the large sash at the Delaware Building was determined not readily visible from the street. The architect felt that the additional expense to avoid any sight encroachment was not justified for an alternate approach entailing the routing out the 2 1/4" thick sash on the inside putty rabbet to a greater depth in order to accept an all new sealed insulating unit. Such an alternative, however, might have been appropriate had the interior moldings along the inside rail and stile been more decorative, since the added

Figure 1. Since the metal spacer placed between the glass sheets is set slightly off the edges of the rails and stiles, the retrofitted insulating unit reduces the historic glass exposure by about 1/2" along all sides. This change on large windows is hardly noticeable particularly once the flat trim piece is glued in place. Photo: Charles E. Fisher.

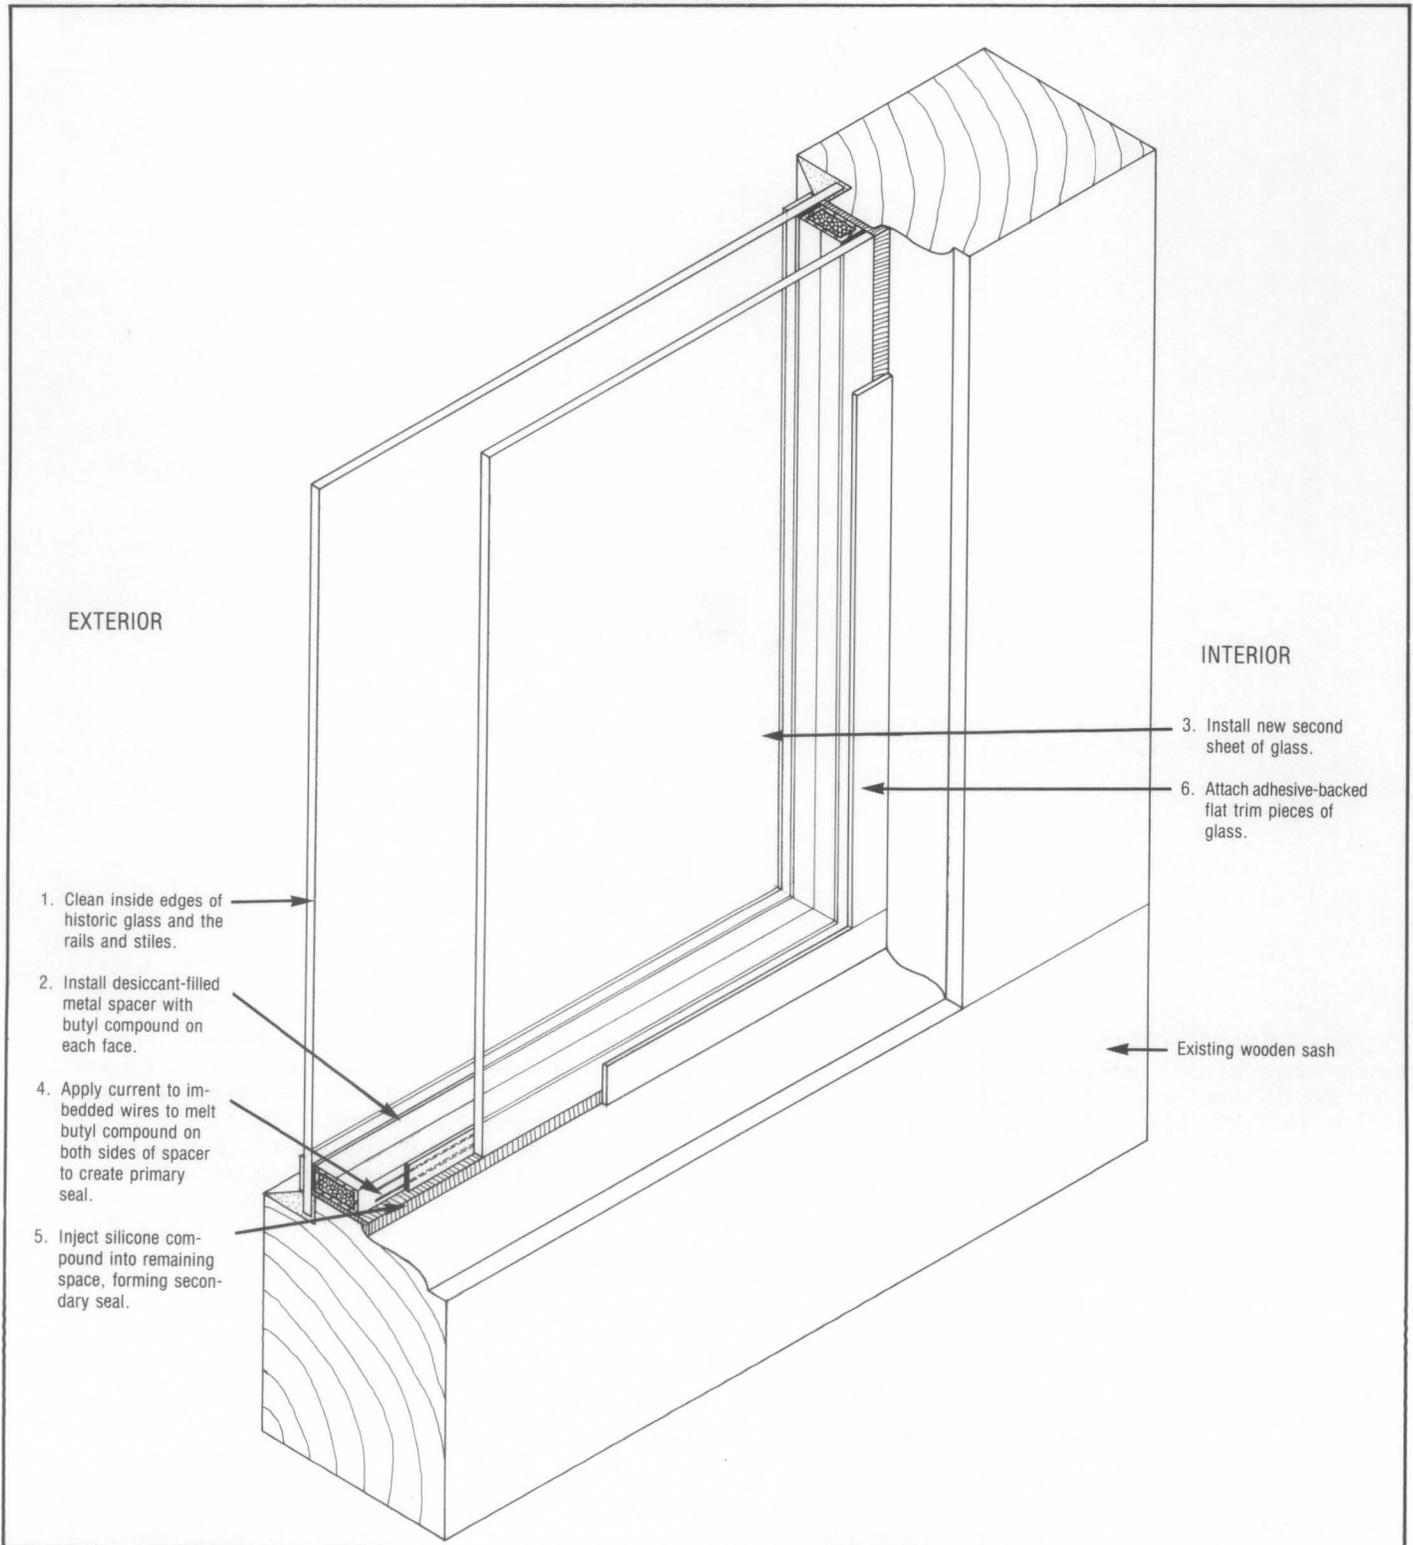
Figure 2. The isometric drawing of the window shows the manner in which the insulating glass units were created utilizing the existing glass without any damage to the wooden sash. Drawing: Christina Henry.

lene. The polyisobutylene strip on the room side also had two parallel copper wires running the entire length, terminating through one corner (see figure 2). With the sash lying flat, the spacer was set snugly up against the inner surface of the existing glass, then the sheet of new glass was placed upon it. Small setting blocks

The primary seal for the insulating unit was then created by applying an electrical charge for about 5 to 10 minutes through the two copper wires. The wire-resistant heating melted the butyl compound on both sides of the spacer since the aluminum spacer easily conducted the heat generated by the wires to the polyisobutylene strip on the opposite face. As a secondary seal to retard moisture collection between the glass and help secure the new glass in the sash, a silicone compound was applied in the space between the wood frame, the old glass and the edge of the new glass and the metal spacer (see figure 2).

To complete the glazing work, a flat piece of 5/8" wide painted aluminum trim was adhered with silicone along the inside perimeter of the light as trim to cover the spacer (see figure 2). A similar trim piece, normally applied to the outside, was judged not to be necessary in this instance.

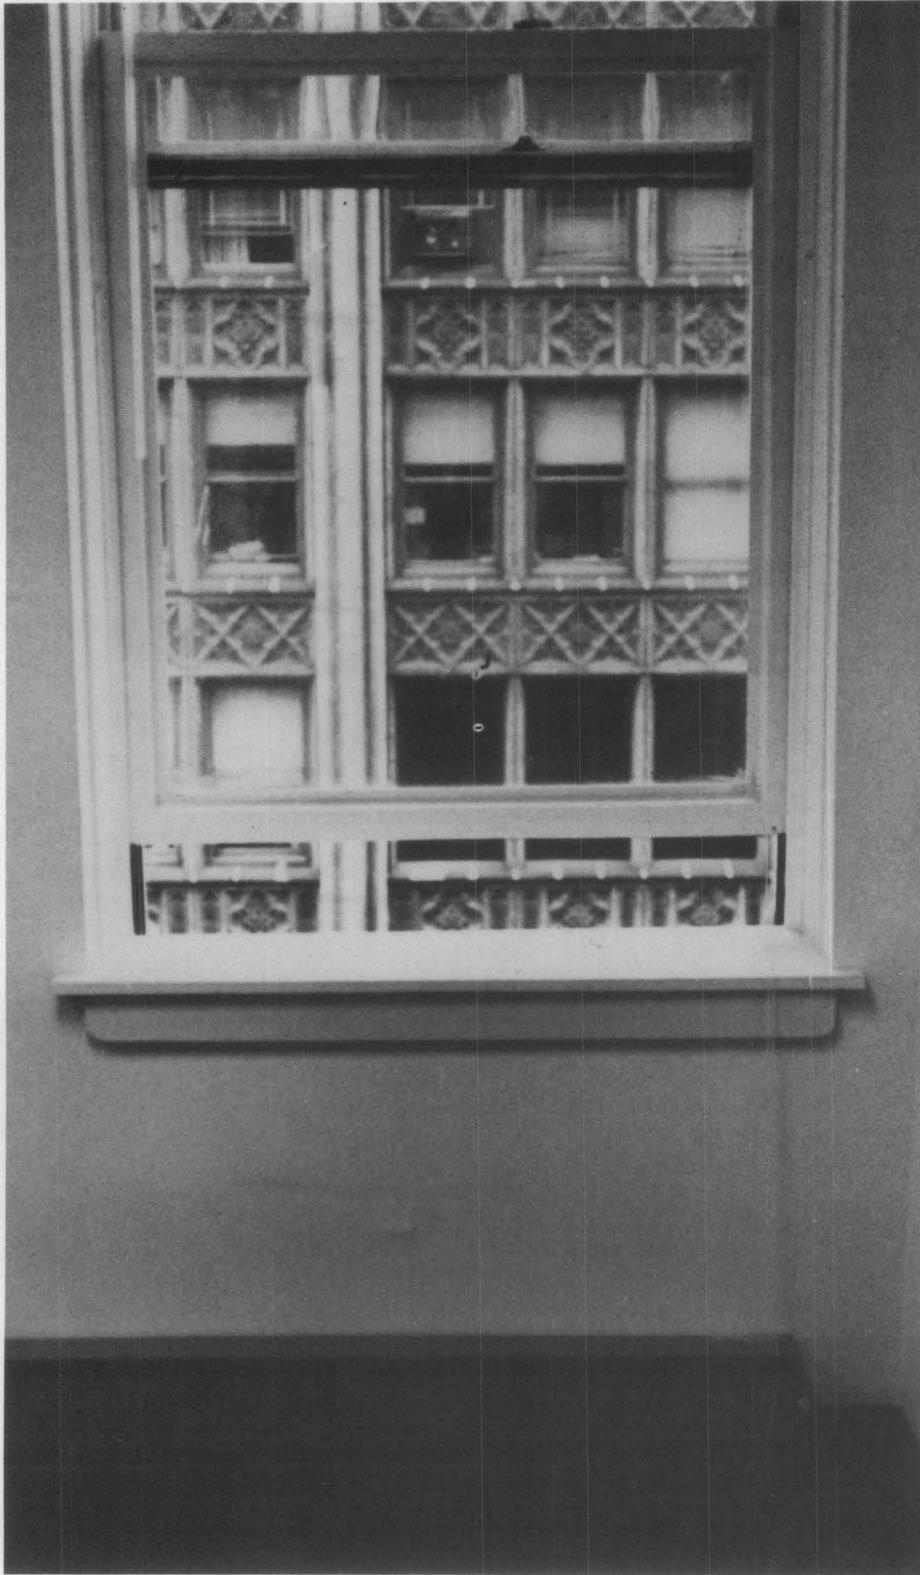
Figure 3. View of the window with the lower sash partially raised following completion of the work. Due to the large size of the sash, the small flat aluminum trim piece covering the spacer had little noticeable effect on the appearance of the windows as viewed from the typical office area. Photo: Charles E. Fisher.

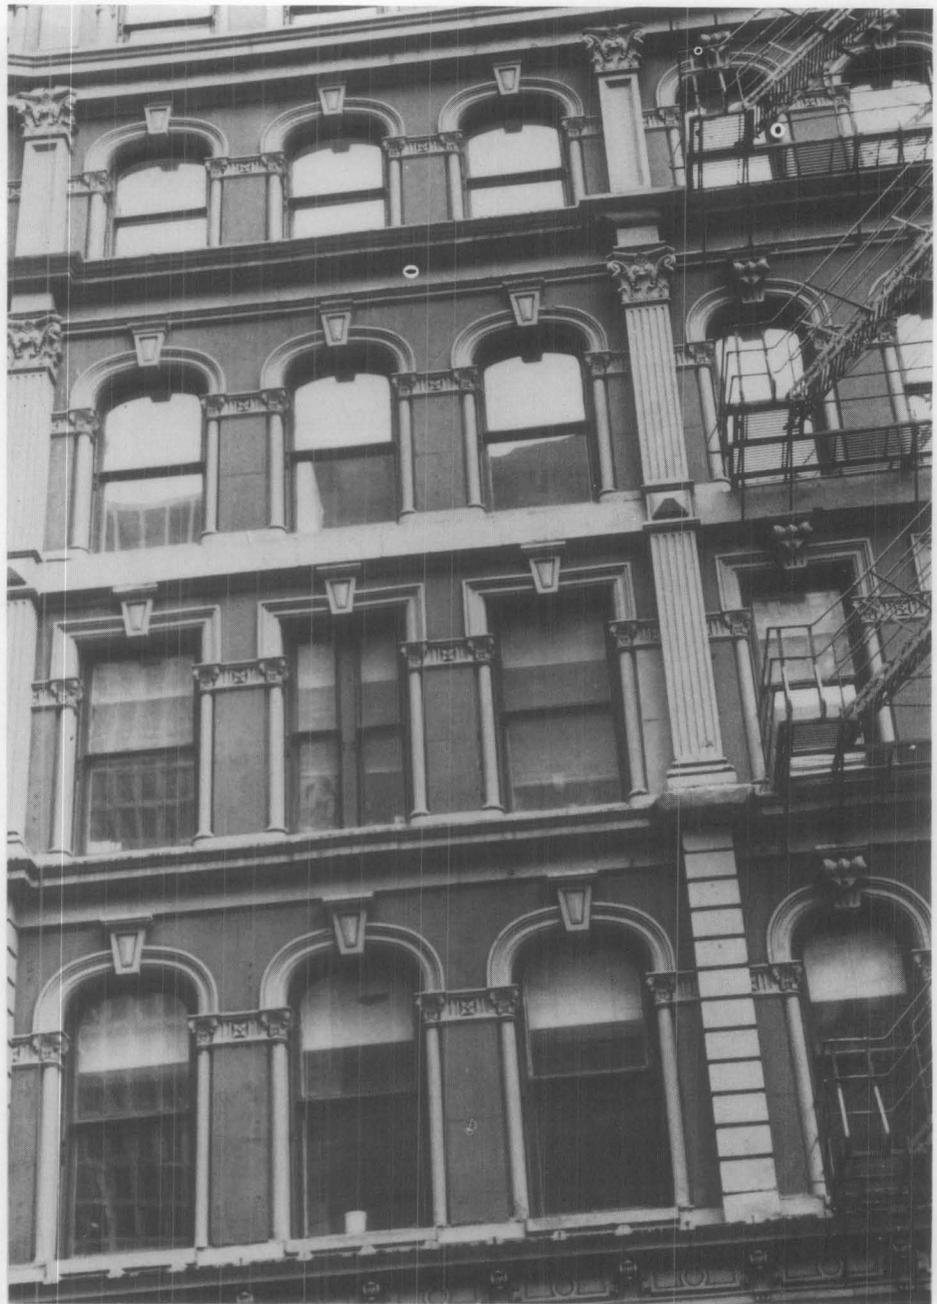
The incorporation of the existing glass into a sealed insulating unit was accomplished in the Delaware Building without any damage to the historic sash and without any loss of historic material (see figure 4). The retrofit work, which is easily reversible, has performed well since its completion in 1982.

Figure 4. View of the windows on floors 3 thru 6 shows that the technique used for creating sealed insulating glass units in the existing wooden sash had no noticeable impact on the historic appearance of the windows as seen from the street below. Photo: Charles E. Fisher.
