## CHALMERS UNITED CHURCH

### Kingston, Ontario

# Tech Notes

### Reinforcing Deteriorated Wooden Windows

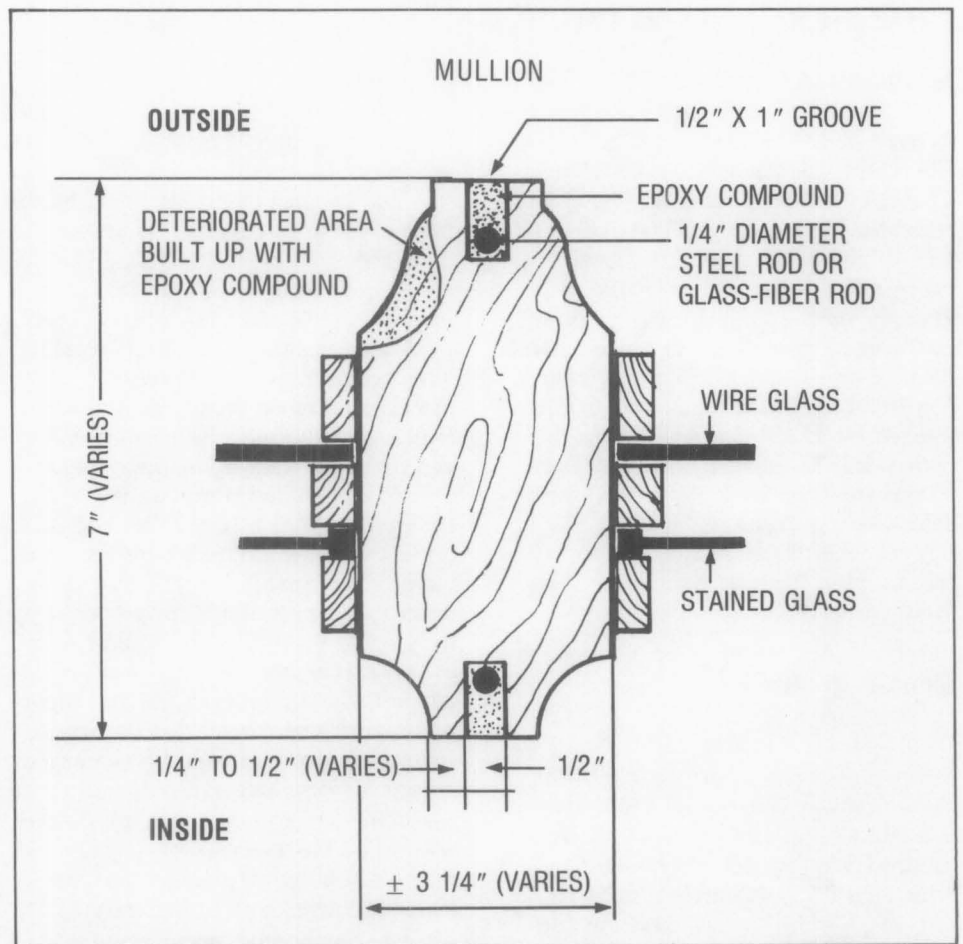
**Figure 2.** Cross section of the historic mullion shows the manner in which the pre-formed steel reinforcing bars were inserted in order to strengthen the windows. The grooves that were cut for the steel bars were filled with an epoxy compound.

For reinforcement, 1/4" diameter steel bars (the same type used to reinforce concrete) were painstakingly bent to match the curves of the mullions. The shape of the bars had to be accurate, within a tolerance of 1/8" in any direction, in order to fit comfortably in the 1/2" wide grooves which followed the complex curves of the windows (see figure 5). Because of the deteriorated condition of the wood, the steel bars could not be forced into the grooves without the danger of splitting the frames apart. In a few instances where the steel rods could not be suitably shaped, braided fiberglass strands were used instead.

With the reinforcement in place, the grooves were filled with an epoxy compound, thus completely embedding

the steel in epoxy. The epoxy used for this project — the high-modulus, thixotropic Sikadur gel in which some Union Carbide phenolic microballoons had been added for more firmness and improved workability — had the consistency of a stiff paste. This mixture had the advantage of remaining in position and retaining its shape wherever it was placed. If a fluid epoxy had been used on these vertical windows, special molds would have had to be fabricated and positioned to prevent the liquid from spilling out before it hardened. After this paste epoxy cured, it achieved a strong adhesive bond with the wood of the mullions and the reinforcing steel bars, creating a sturdy composite window frame.

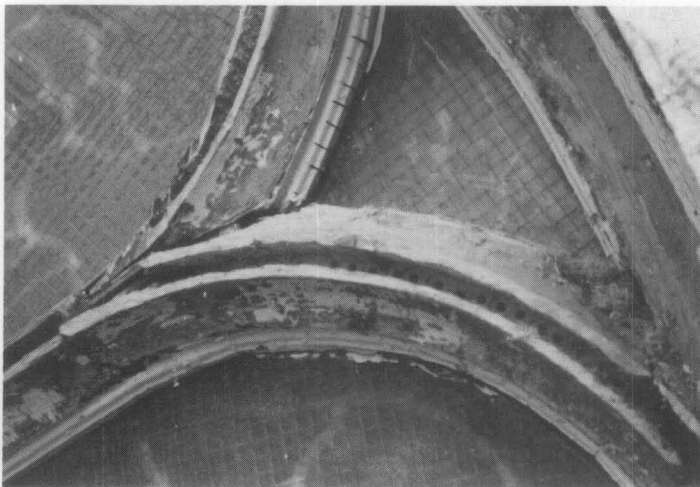
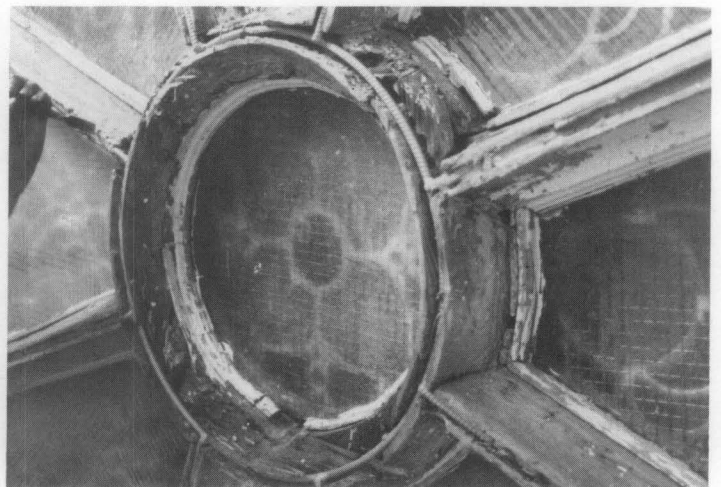
Figure 5. Details of the mullions as the strengthening process was carried out. Left: The grooves had to be carefully cut both because of the deteriorated condition of the wood and due to the relative thinness of the outer edge of the mullion. Right: Reinforcing bars are positioned in the grooves prior to being encased in an epoxy compound.

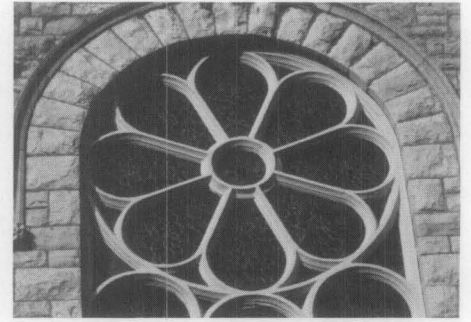
**Figure 6.** Repairing the historic frames resulted in a 25% savings over fabrication of new ones. The work included paint removal, reinforcing of the mullions, consolidation of the deteriorated wood, and repainting.

paste like modeling clay. Skillful hands of the craftsman sculpted fill-ins which blended perfectly into the curvature of the wooden mullions. After the epoxy paste hardened, only the color was different from the wood; the shape and the texture were the same. To complete the work, the windows were then primed and painted (see figure 6).
