Tech Notes

NUMBER 15

Interior Storms for Steel Casement Windows

THE DRAKE HOTEL (DRAKE TOWER) Philadelphia, Pennsylvania

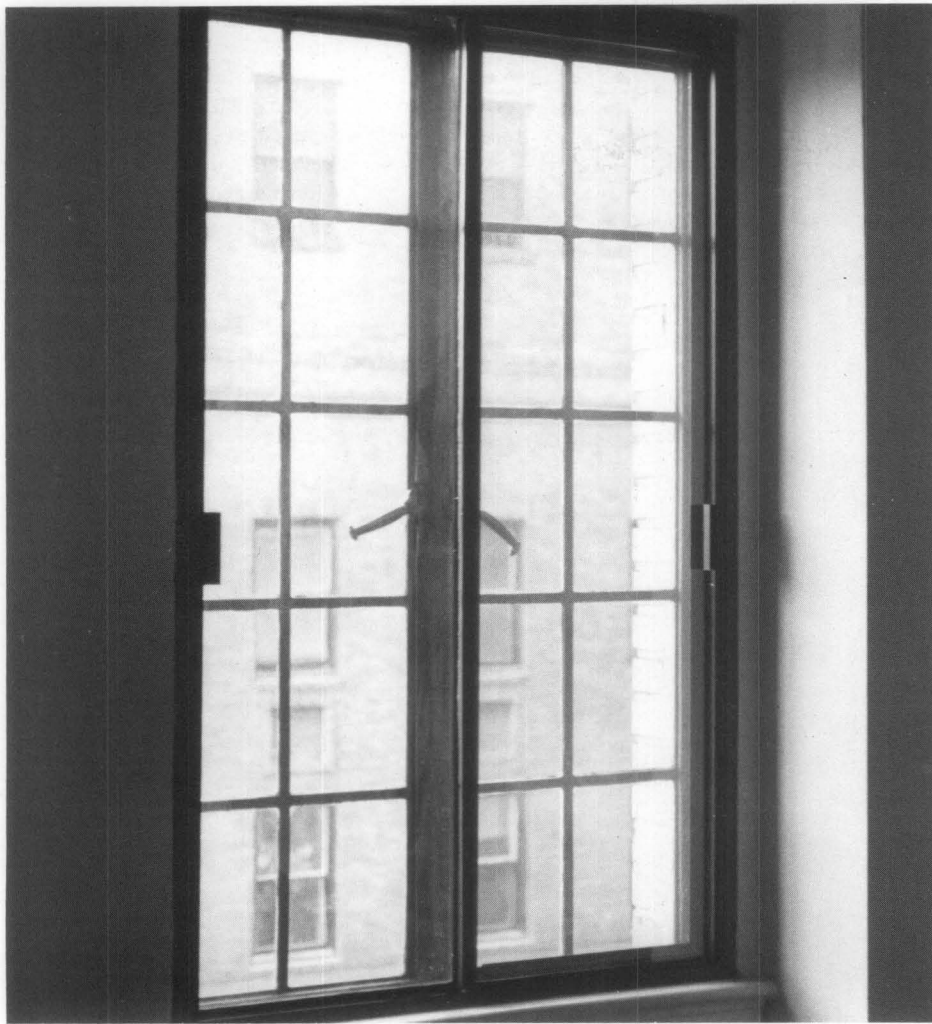
Figure 2. A horizontally sliding storm window unit was installed on the inside of the casement windows for improved energy performance. Photo: Christina Henry.

A system to improve the energy performance of the windows was developed by the architect, based on an approach that the firm had specified for other similar projects. It involved the installation of a new horizontally sliding storm window unit, mounted on the interior of the window jamb. The 2 storm panels would run the full height of the opening and would slightly overlap to allow for an effective weather seal (see figure 2). The intersection of the 2 storm panels thus would align at the vertical mullion of the existing paired casement windows. Since the interior face of the steel mullion was 2¼ inches wide, the visual impact on the windows of the intersection of the frames of the two storm panels would be minimal. For insect control, especially on the lower floors, a screen panel half the width of the opening was specified, set within a third track of the aluminum subframe (see figure 3).

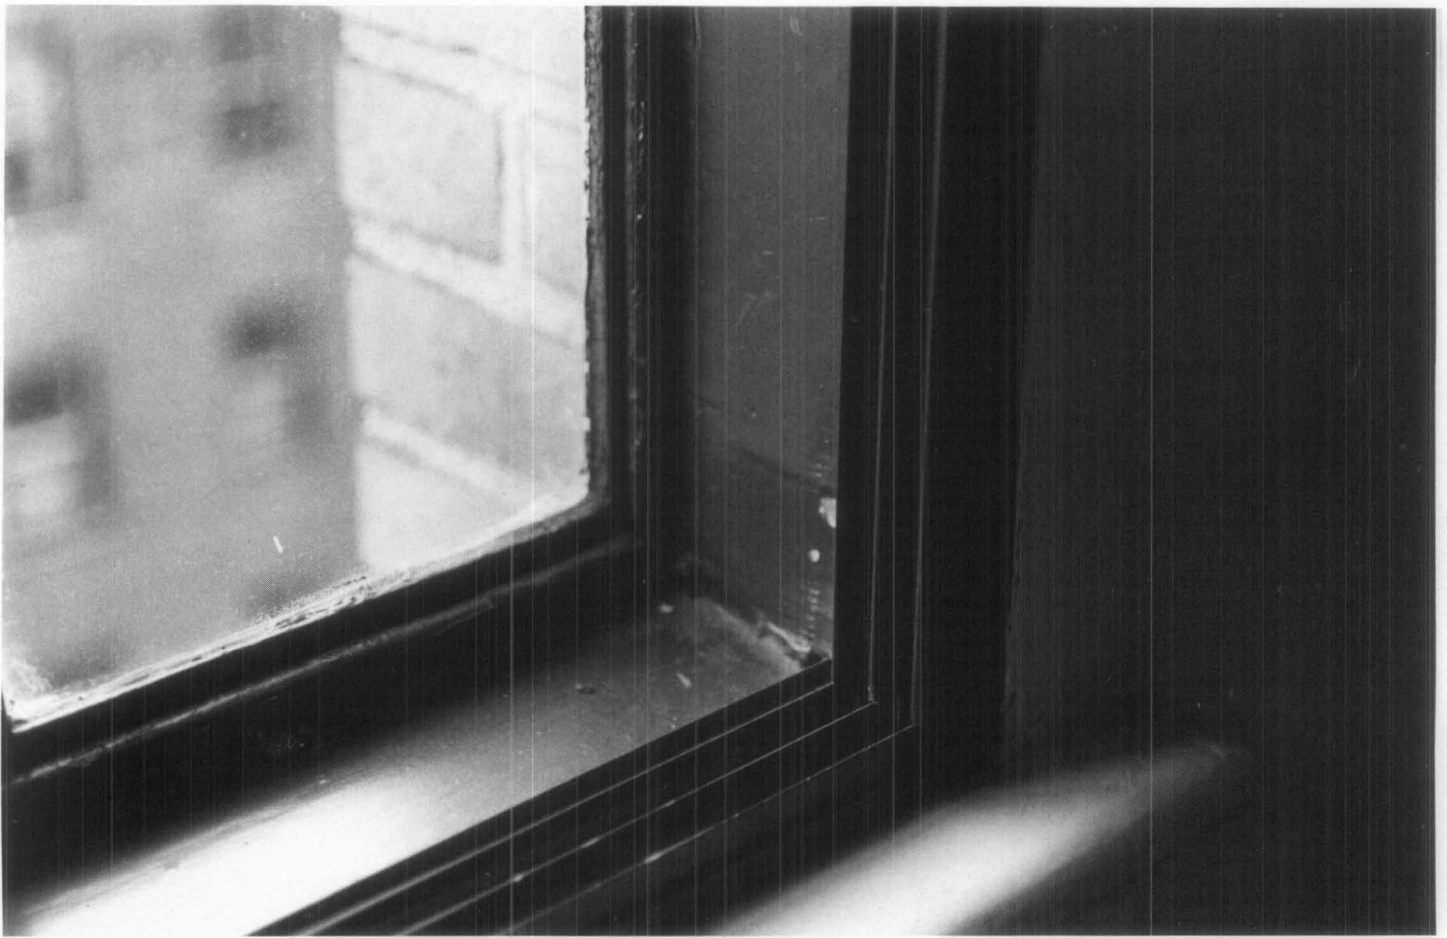
Figure 6. The subframe had to be squared off when installed in each window opening to prevent racking of the sliding panels.
Photo: Christina Henry.

Several important factors were taken into account to ensure the successful installation and operation of the storm windows. First, care was taken to make sure that the aluminum window section was thick enough to prevent racking of the sliding sash. For the 3' by 4¾' opening, a 5/8" thick sash frame was used, set into an aluminum 1⅜" subframe screwed to the existing jamb (see figure 5). Openings larger than these may require thicker frames. Second, correct installation procedures were essential to ensure that the slider unit functioned properly. This required that each subframe be squared off when installed in the existing jamb, since changes in alignment may have

occurred to the window opening over the years (see figure 6).
