Tech Notes

NUMBER 16

Repairing and Upgrading Multi-Light Wooden Mill Windows

SAWYER MILLS Dover, New Hampshire

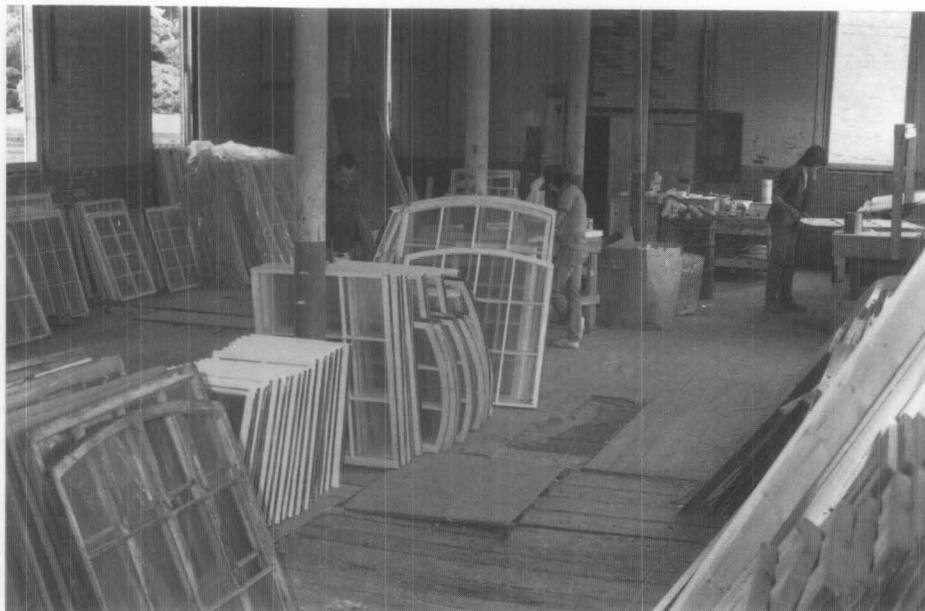
Figure 1. Window repair shop in operation. Photo: Christopher Cross

labor force in a logical sequence (see figure 1). The decision was made to undertake the work on the site and to establish a mobile millwork shop adjacent to the window repair shop so that the former could continuously supply the latter (see figure 2). The shops had to be relocated only once during construction. A key factor making the on-site window repair approach feasible was that the millwork shop's variable workload from window repairs was supplemented by specialty orders from outside contracts, eliminating costly down-time.

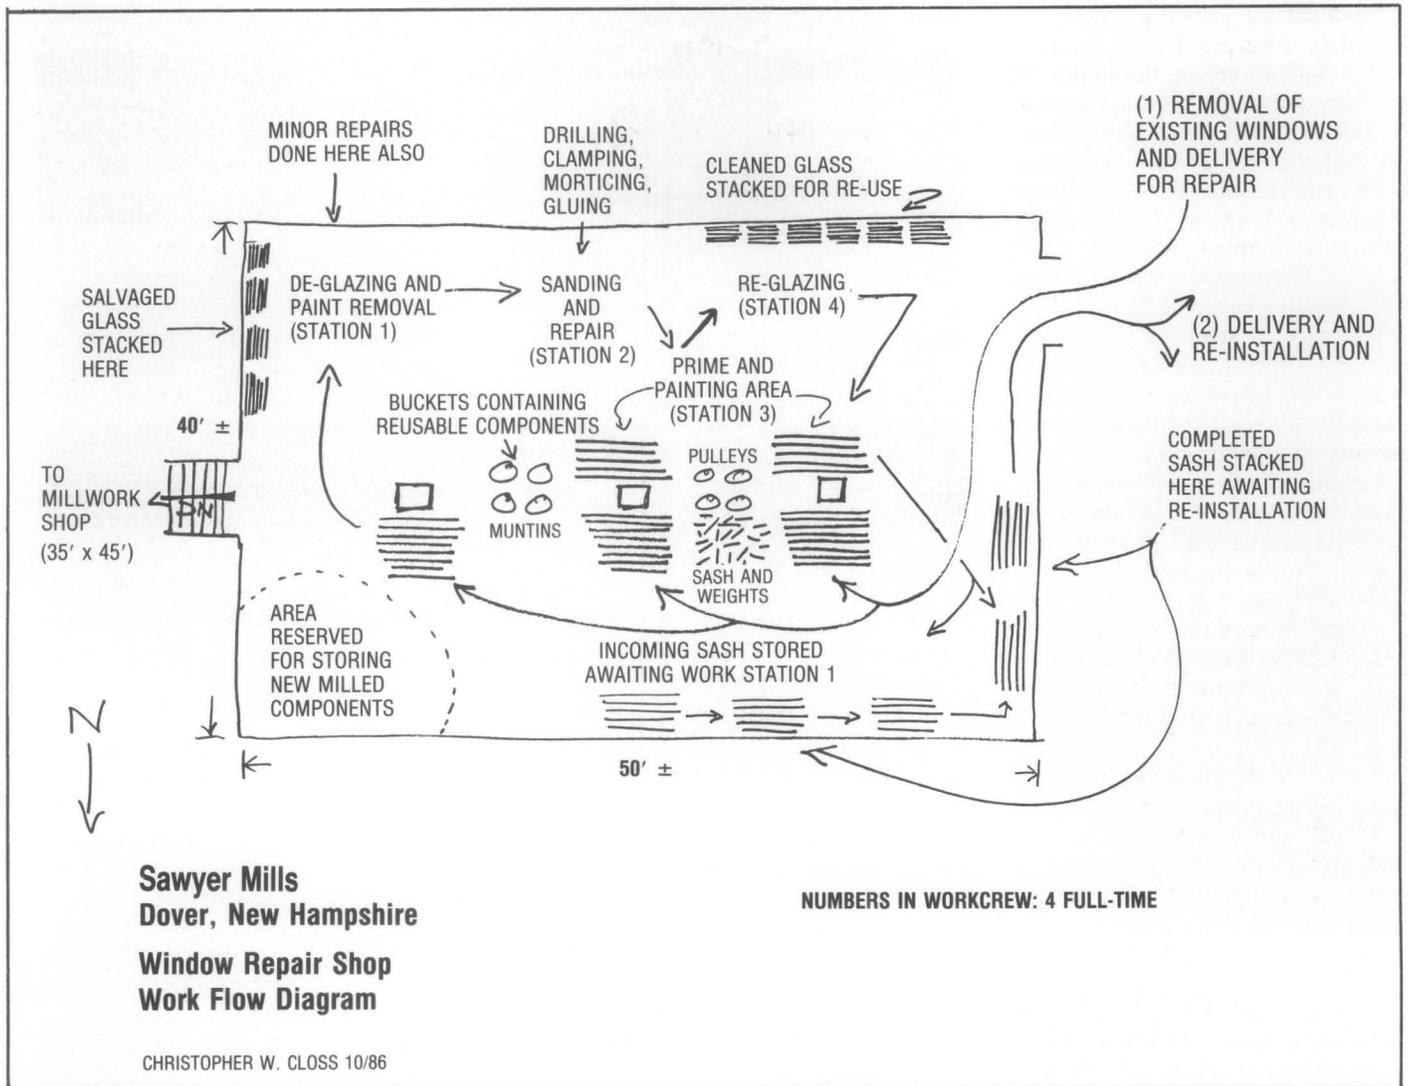
Figure 2. Drawing shows the plan of the window repair shop set up within Sawyer Mill during renovation work. The mobile mill-work site was located in a room immediately to the left of the repair shop. Drawing: Christopher Closs

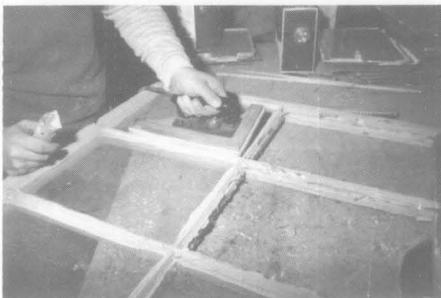
Figure 3. Electric deglazing irons were used to remove hardened putty so glass could be removed and the sash frames repaired. Photo: Christopher Closs

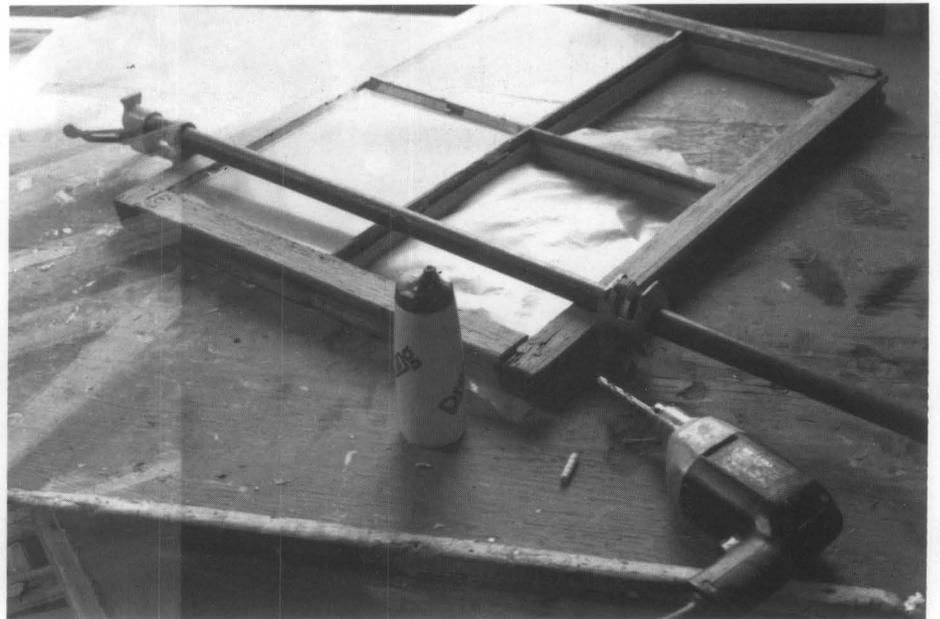
The most typical problem encountered was loose or failed mortise and tenon joints; this was remedied by drilling out the old pegs with a slightly oversize bit and then drawing the sash frame together tightly with pipe clamps (see figure 4). Fluted,

Figure 4. The basic repair: cleaning sash frame and drilling out pegs to tighten corner joints. Glue purchased in bulk was transferred to squeeze-bottles for ease of application. Oversize bit and new hardwood dowel shown ready for use. Glazing has not yet been completely removed. Photo: Christopher Closs

hardwood cabinet dowels, liberally coated with waterproof glue, were then driven in to secure the joints. To allow for natural movement, the mortise and tenon joints were not glued. In some instances, deteriorated tenons were cut off and bored out, and new tenons installed, using glue to secure the tenons in their seats but not inside the joints. This worked well providing the receiving mortises were sound. If muntins required selective replacement, this was done before clamping. It was critically important to "true" each sash square before re-pinning the corner joints.

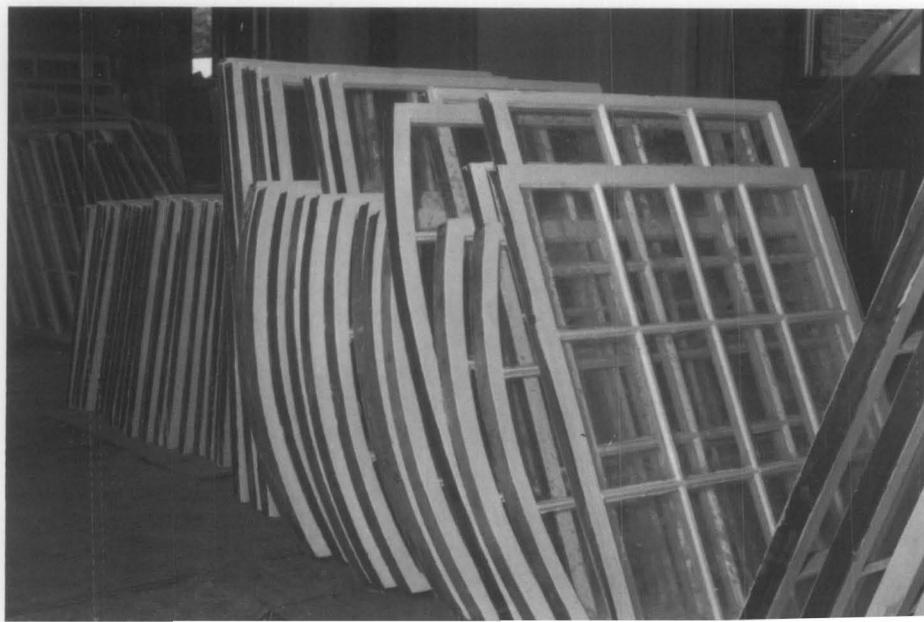
Figure 5. Repaired sash primed and awaiting reinstallation. Glass was cleaned of smudges after final installation. Photo: Christopher Closs

Once the sash for a complete window were made structurally sound, frames were hand-sanded and fully primed with a shellac-based sealer. Sash were then reglazed in conventional manner and stacked to await final finish with two coats of exterior-grade, oil-based paint (see figure 5). The wood edges of the sash were left

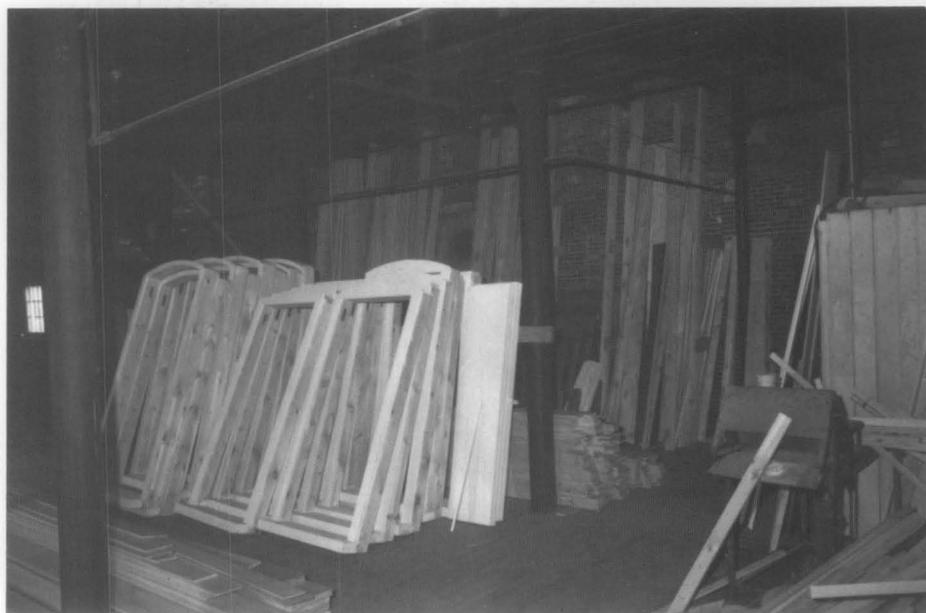
Figure 6. Newly milled replacement window frames awaiting installation. Photo: Christopher Closs

New matching wood sash, manufactured in Springfield, Massachusetts, were required to fill three hundred openings where the originals were missing or beyond repair (see figure 6). Deliveries of the new sash were scheduled to match the installation

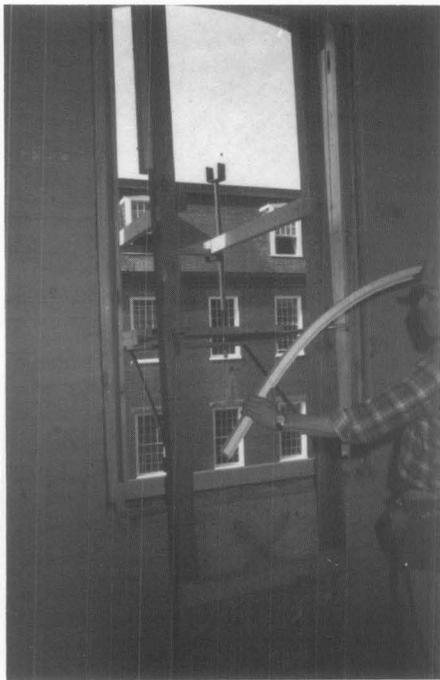
Figure 7. "Gun carriage" (scaffolding) in use by the window re-installation crew who are preparing to replace missing brickmold with replacement made by the millwork shop. Note saw kerfs used to create arc in molding for use in the window head (same method as used in the original molding). Photo: Christopher Closs

The re-installation crew was responsible for repairing or installing new frames, mounting brickmolds and installing repaired and new sash. Two "gun carriages" were constructed to facilitate frame installation and to ensure safety for the crews (see figure 7). Each carriage served as a cantilevered work platform (if fitted with dolly wheels they would have resembled a naval gun carriage). They permitted the installation crew to work safely on the exterior of the window opening without staging (much of this work had to be done over the river). The carriages had stops on the interior, were counter balanced, and were moved from opening to opening as frame repairs and brickmold work proceeded.

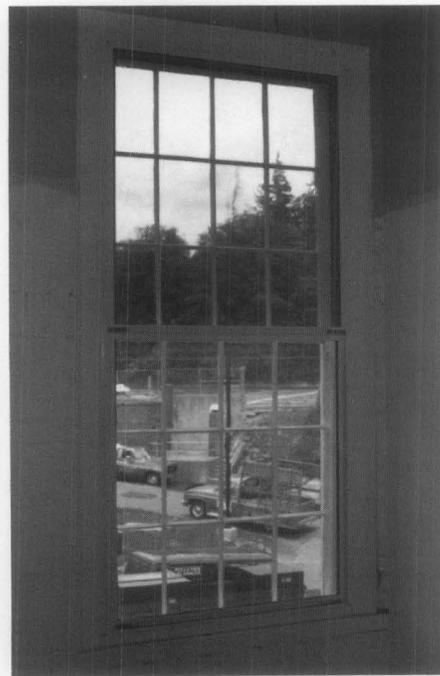
Figure 8. Typical interior aluminum combination storm window unit with insect screen shown at top. Beveled stops around the perimeter were added and the windows were caulked to provide for a good energy seal. Photo: Christopher Closs

The installation of the aluminum interior storms occurred after the primary windows were in place (see figure 8). Installation of the storm windows was monitored carefully to ensure that aluminum frames were set in a continuous bead of silicone caulk to provide a tight weather seal. This was made easier by the absence of decorative casing on all of the windows; storms were simply screwed fast to the flat, three-inch weight pocket covers (see figure 9). A new beveled 1" wooden strip was applied around the outside perimeter of the weight pocket covers and the heads, and caulked forming an uninterrupted seal with the brick masonry wall. Weight pockets were not insulated since the counterweights remained operable.

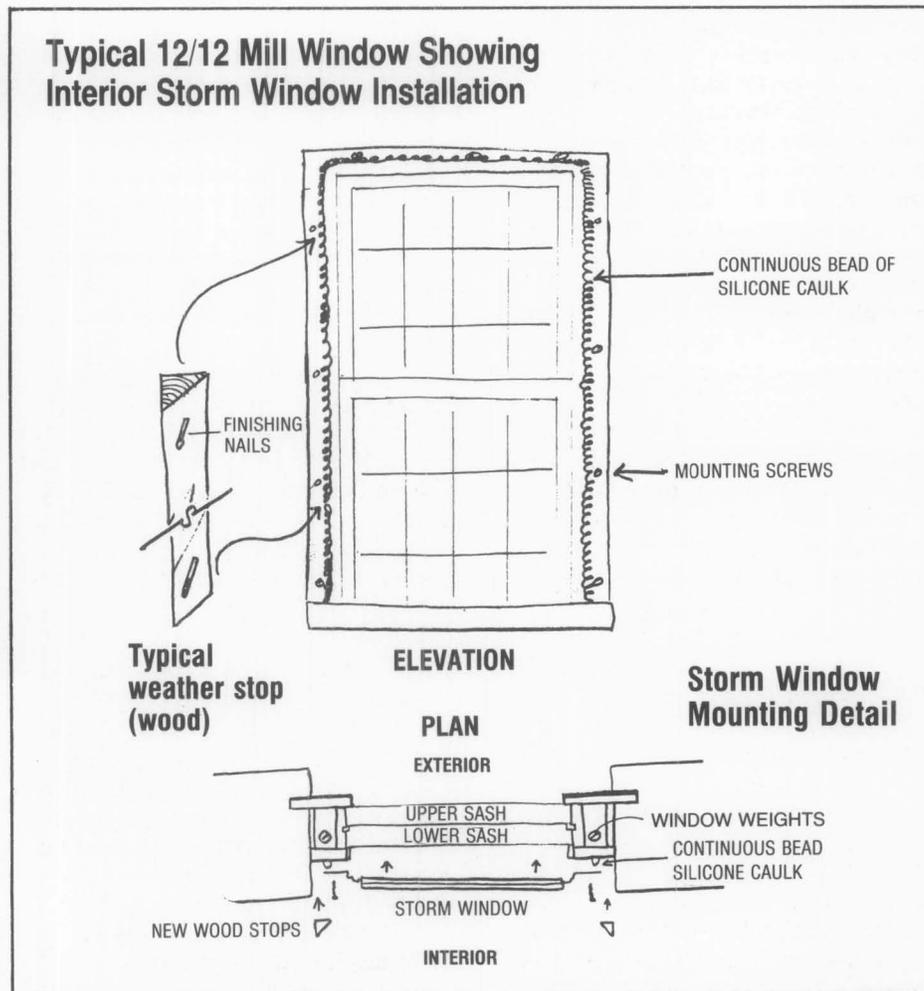
Figure 9. Drawing showing installation of the interior storm window. Drawing: Christopher Closs
