Tech Notes

WINDOWS NUMBER 17

Repair and Retrofitting Industrial Steel Windows

LIPPINCOTT PRESS BUILDING Philadelphia, Pennsylvania

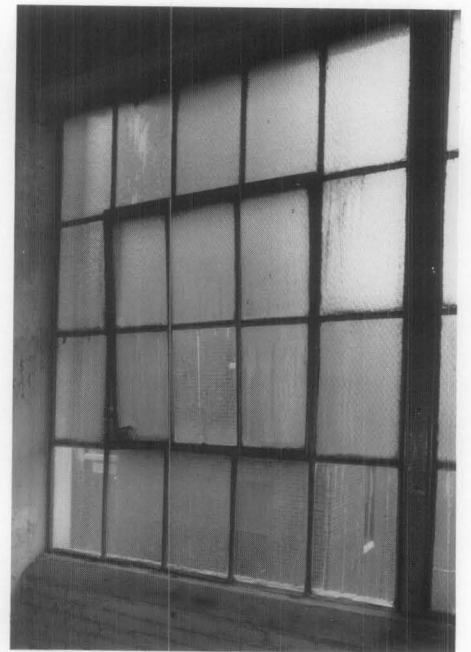
Since the Lippincott Building was used for a long time as a storage facility, the windows had not been painted, oiled, reglazed, or caulked, nor had missing or damaged parts been replaced in well over twenty years (see figure 1). Naturally, many of the windows exhibited problems typically found on inadequately maintained steel windows, including corrosion, bent and bowed metal sections, non-operable ventilators, missing or non-functional hardware and broken glazing. Furthermore, some of the original windows had been removed and replaced with double-hung aluminum windows, and other window openings had been infilled with glass and concrete block, metal louvered air vents, ductwork and other mechanical equipment (see cover photo).

Figure 1. Typical multi-light steel window with ventilator as seen from the interior. This window exhibits typical pre-rehab conditions including sill corrosion, missing hardware and a poorly operating ventilator. Photo: Clio Group.

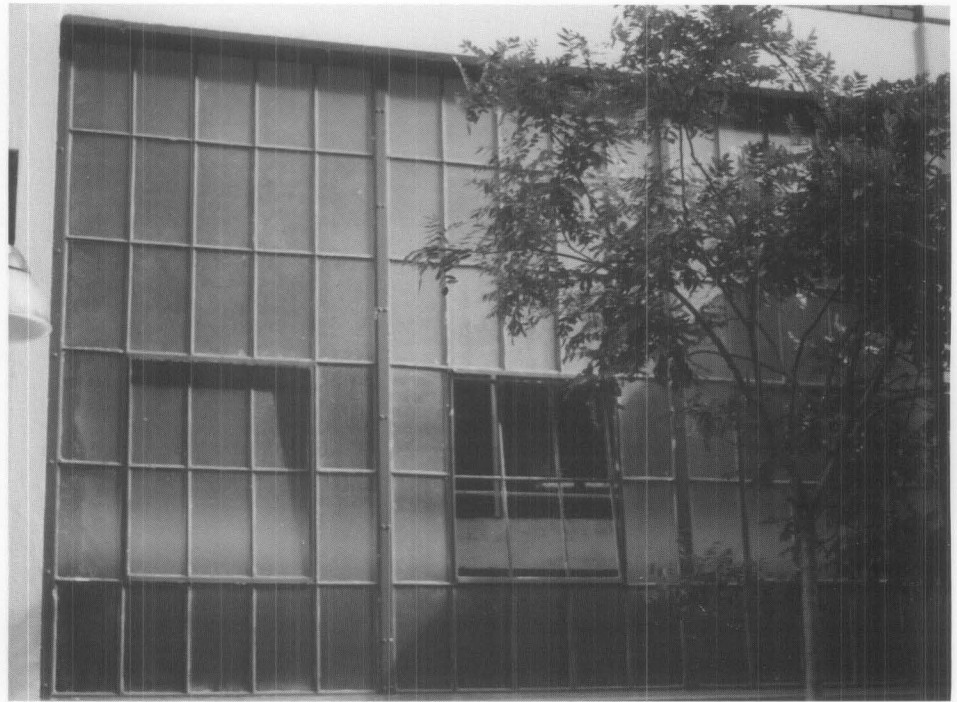
Figure 4. First floor, garage level showing the frosted glass and the center ventilator without glazing. Photo: Robert Powers.

To accommodate the first floor lobby and parking garage, the decision was made to repair and reglaze with frosted glass the existing steel windows in the garage area, and to install new windows in the newly created lobby area where no windows previously existed. The garage windows retained their operable pivoting sash, since compliance with energy requirements was not applicable. To provide for adequate garage ventilation, glazing was omitted from a number of the ventilators (see figure 4).

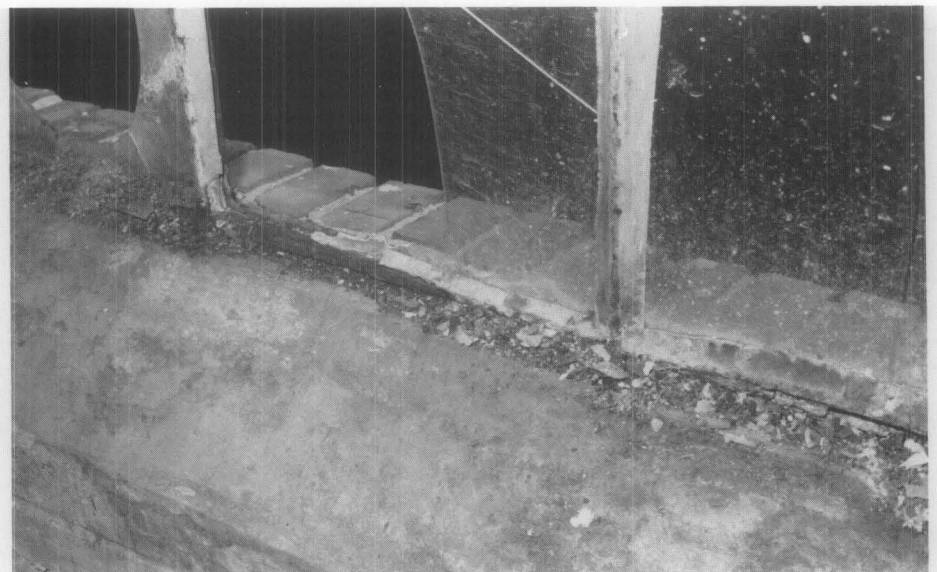
Figure 5. Sill corrosion typically found on 95% of the windows. Photo: Clío Group.

Generally employing three crews of three to four men, each contractor began by cutting out all the severely corroded and/or heavily bent metal sections from each window. Severe corrosion occurred primarily in the sill areas where the original steel sill section was embedded in concrete—a condition existing in approximately 95% of the window sills to be repaired (see figure 5). The spalled concrete and the corroded metal sill sections were chopped out with a portable band saw. In addition to the corrosion in the sill areas, extensive deterioration typically extended up the window muntins approximately three to six inches. These members were cut at a 45 degree angle with a five-inch grinding wheel using a five-inch disk, usually at a point four to seven inches from the sill or where the steel was no longer corroded.

Once the muntins and mullions were set plumb, the final steps in the steel repair process began. In most of the sill areas, lengths of new steel sections were installed to replace the original corroded members. The new cavetto-shaped steel sections did not match exactly the bullnose profile of the historic windows (see figures 9 and 10). However, the original profile was no longer available and the new profile was close enough so that the overall proportions, profile, and shadow lines were compatible with the historic window appearance. The new steel sections at the sill and the lengths

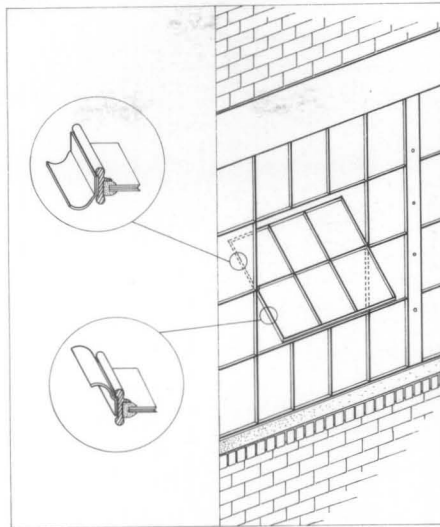
Figure 6. Pivot ventilators prior to retrofitting on the upper floors. Bullnose trim pieces to be modified as part of the retrofitting from pivot to projecting ventilators. Drawing: Martha Raymond.

Concurrent with the cutting out of the window's corroded steel members, each of the existing pivot window ventilators on floors two through six were cut from their jambs, labeled and brought to an on-site work station. At the work station, the pivoting ventilators were modified to operate as projecting windows (see figure 6). This was accomplished by cutting off the bullnose outside face of the side and bottom rails on the sash and riveting a new water-shed steel angle at the same locations. To allow the ventilators to swing out, two 16", heavy duty, 6 bar, zinc chromate plated steel, TRUTH hinges were screwed to each ventilator (see figure 7). New right-hand, cast iron, bronze lacquered, locking handles were installed on the bottom rail by face-mounting and screwing to each ventilator.

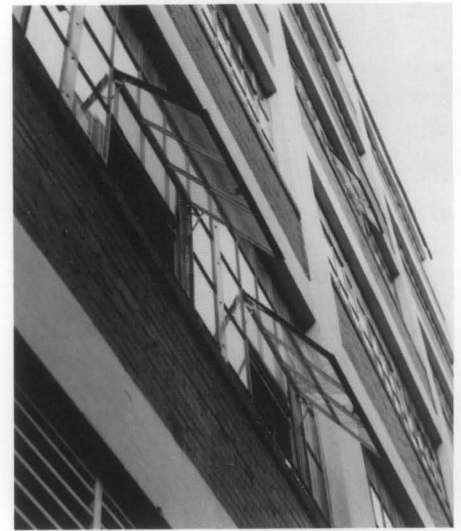
Figure 7. Retrofitting projecting ventilator with the TRUTH hinges. Photo: Robert Powers.

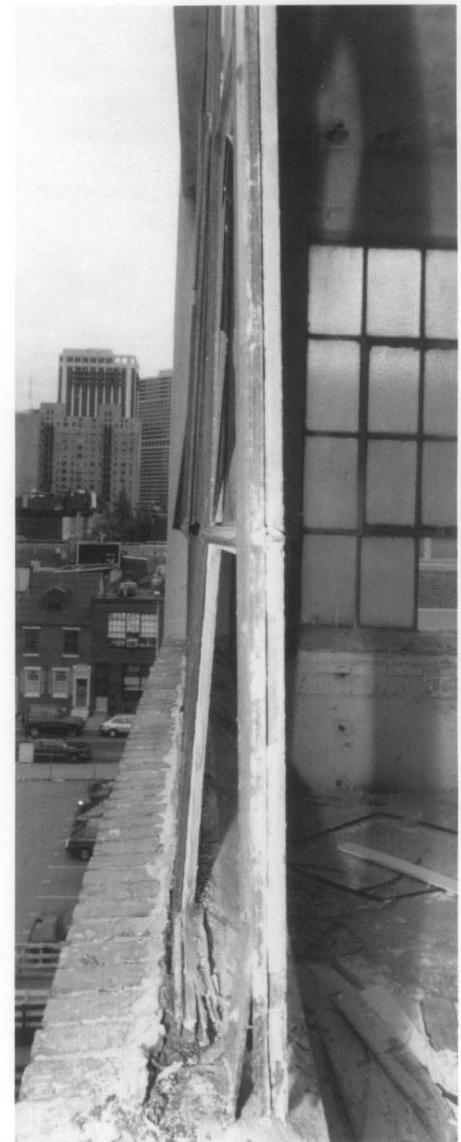
In addition to the retrofitting of the ventilators, many of the window muntins and structural mullions needed to be straightened, patched and repaired (see figure 8). Members that were seriously bowed and could not be adequately straightened were cut off using grinding wheels and salvaged;

Figure 8. Bowed and corroded window during construction. Photo: Clío Group.

replacement members were welded into place. Two relatively simple techniques were used to straighten the less seriously bent and bowed steel members. With mullions, a wooden brace (usually a two-by-four) was attached to the mullion; a wire cable was wrapped around the wooden brace and the mullion; and slowly the cable was pulled with a "come-along" winch hooked to the ceiling of the building. Since the mullions had typically bowed toward the exterior, the member was pulled in the direction opposite its bowing, towards the inside of the building. To straighten out bent and bowed muntins, the contractor applied constant pressure through the use of 14" bar-type clamps on the muntin. All indentations and gouges left in the steel members were filled with an auto-body patching compound containing steel fibers and an epoxy binder, sanded smooth and primed with a rust-inhibiting primer.

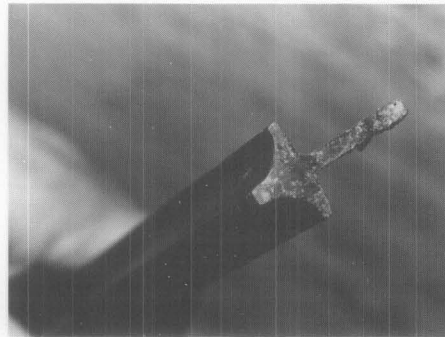
Figure 10. Replacement steel window section used primarily in the sill areas. Photo: Clio Group.

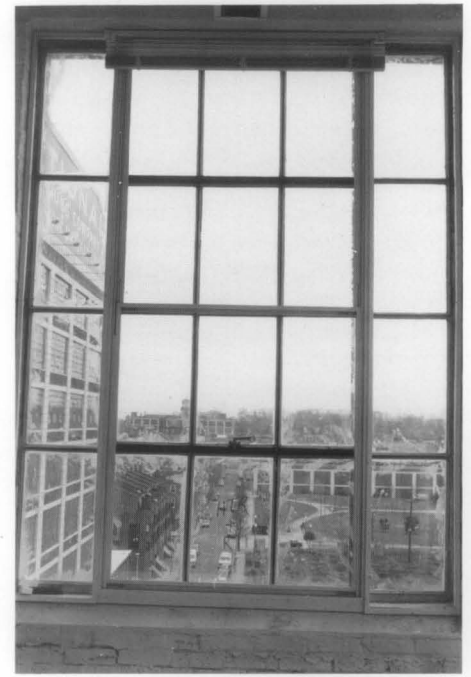
Figure 12. Installed interior triple-track storm window with fixed sidelights. Photo: Clio Group.

the existing steel windows in and of itself was not sufficient in bringing the windows up to code. The development of an interior storm window system provided the additional thermal performance for code compliance. The solution involved an aluminum, triple-track, interior storm unit with flanking, fixed "sidelites" (see figure 11). A major consideration in the development of this storm system was the desire to minimize the outside visibility of the storm unit by aligning as closely as possible the meeting rails and other aluminum members with the steel window members (see figure 12). The exterior face of the storm windows was painted the same color as the steel windows so as to be as inobtrusive as possible (see figure 13). Although, the aluminum members do not match exactly the width of the opposite steel members, the storm windows were not readily visible from the exterior.
