BOOTT COTTON MILLS (The Boott Mills) Lowell, Massachusetts

Tech Notes

NUMBER 18

Aluminum Replacement Windows With True Divided Lights, Interior Piggyback Storm Panels, and Exposed Historic Wooden Frames

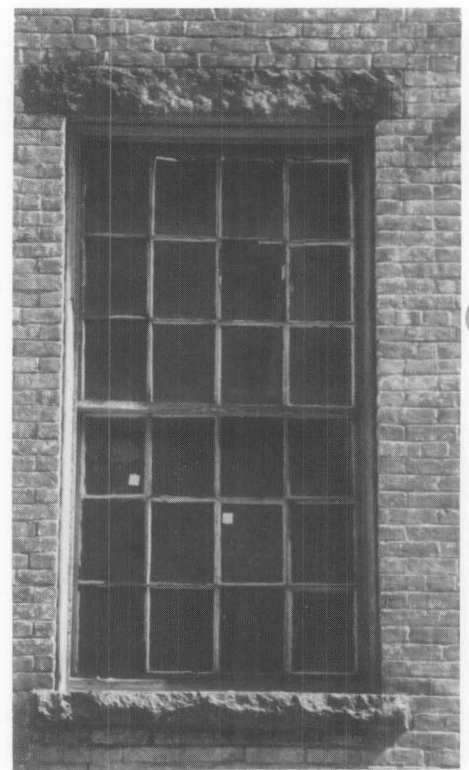
Figure 2. Because of the historic character and significance of the complex, replacement sash needed to have true divided lights and the dimensions and profiles of visible elements needed to be close copies of the originals. Photo: Courtesy of Huygens DiMella Shaffer

The projected three-phase, \$63 million rehabilitation of the Boott Mills involves 700,000 square feet of space. An appropriate window treatment was foremost among several important preservation design problems. The developer and the historic review commission agreed that one-over-one aluminum replacement windows with exterior muntin grids were not desirable. Because of the significance of the complex, it was established that the windows needed to have true divided lights and that the dimensions and profiles of all visible elements would be near copies of the originals (see figure 2).

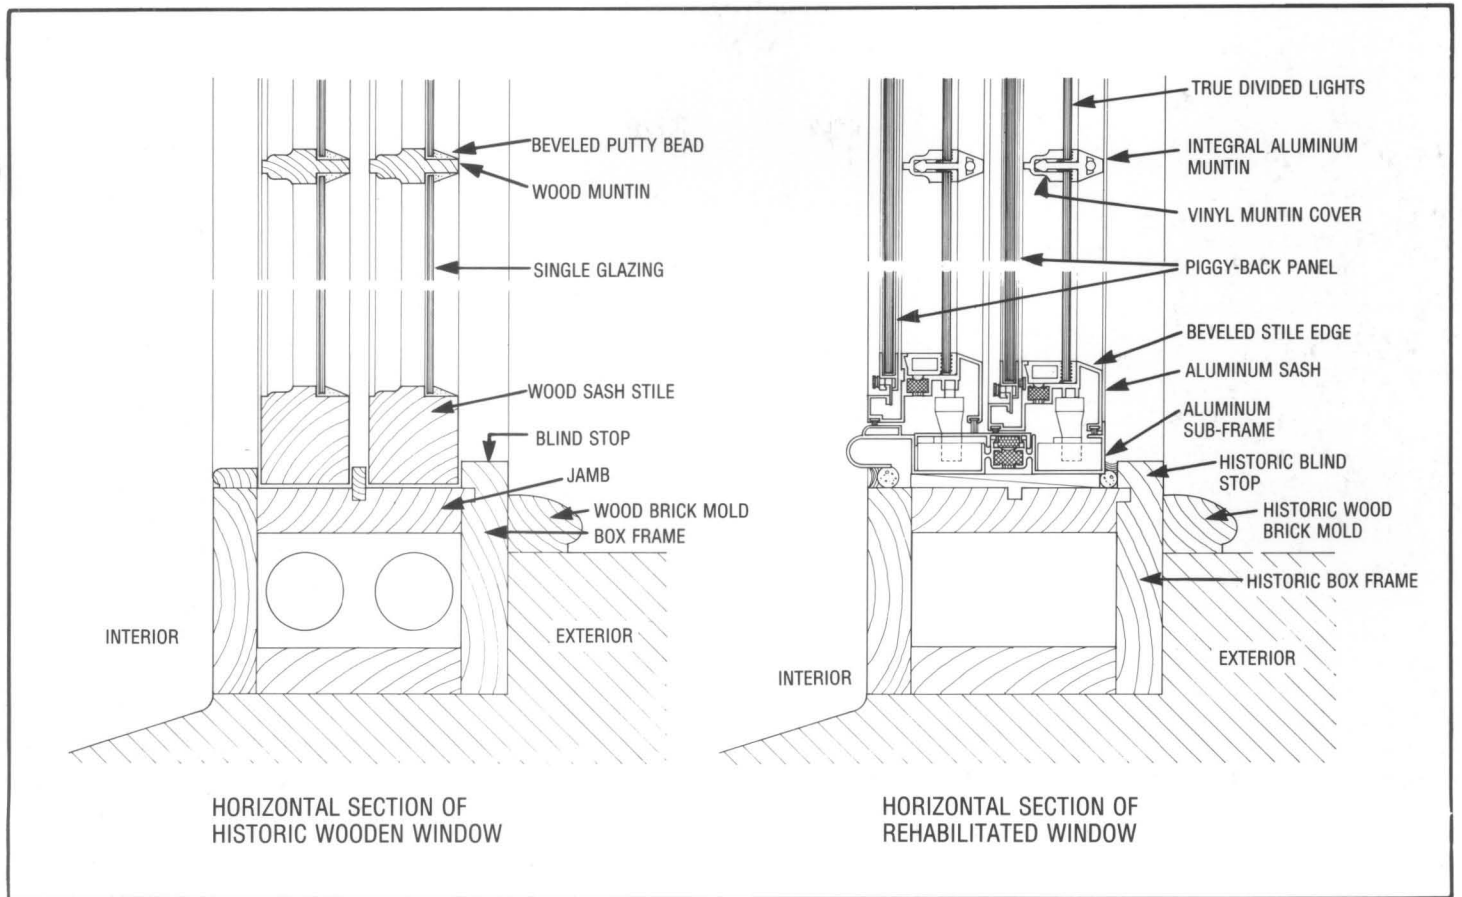
Figure 3. Horizontal section of the window shown with old and new sash. Drawing: Timothy Buehner

Boott Mills, it was necessary to limit the muntin-supported glass panes to single glazing, as in a historic window, and to achieve double glazing with a secondary window system (see figure 3). This secondary window consisted of a "piggy-back" interior glazing panel, which left exposed on the exterior the multiple facets of the true divided lights so characteristic of historic multiple-pane windows. The interior glazing panel was attached to the room side of the sash. It was also decided that the existing wooden frames would be retained and used to receive the aluminum sub-frame for the new window. Finally, new aluminum extrusions were to be made for all members to ensure a very close match to the historic units.

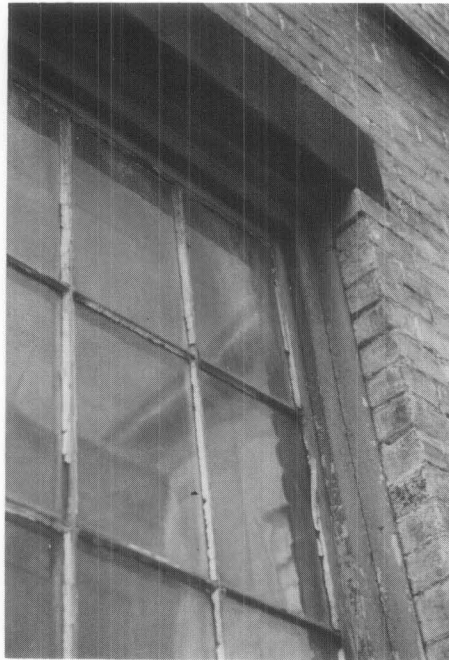
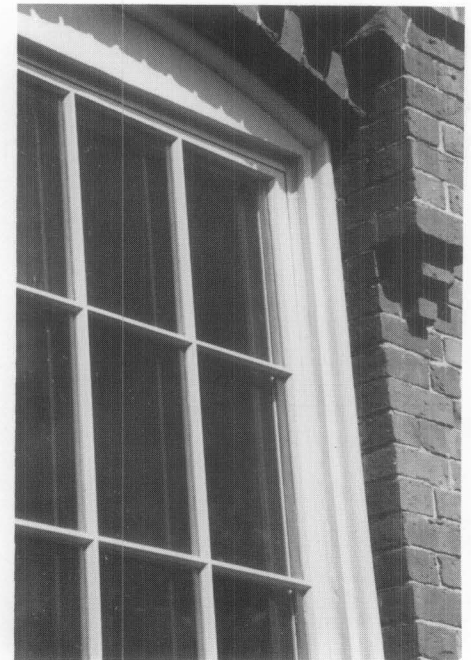
Figure 4. The decision to use an integral muntin for the outer glazing and a piggy-back interior glazing panel was an important component of the successful window solution. Sash shown before and after rehabilitation. Photos: Charles Parrott

was narrowed and profiled to approximate the beveled glazing bead and sticking of the historic wooden muntins. However, it was found that the technology of the 1985 three-piece muntin system could be reduced only to about $\frac{7}{8}$ " in thickness. A new two-piece true muntin was then developed by the manufacturer that met the general dimensions and profile of the putty-glazed historic muntin; it provided the needed strength and proved to be simpler in design and less expensive to fabricate. This muntin consisted of an aluminum tee extrusion with a trapezoidal flange and a web terminating in a triangle-shaped point over which a profiled cover of extruded rigid PVC was snapped to hold the glass panes in place. Plastic was used for this cover to provide the flexibility needed to remove the cover in case of glass breakage and to provide the thermal break to insulate the aluminum tee member. The snap cover extrusion was to be made in the pre-selected custom color chosen for the window (see figure 4).

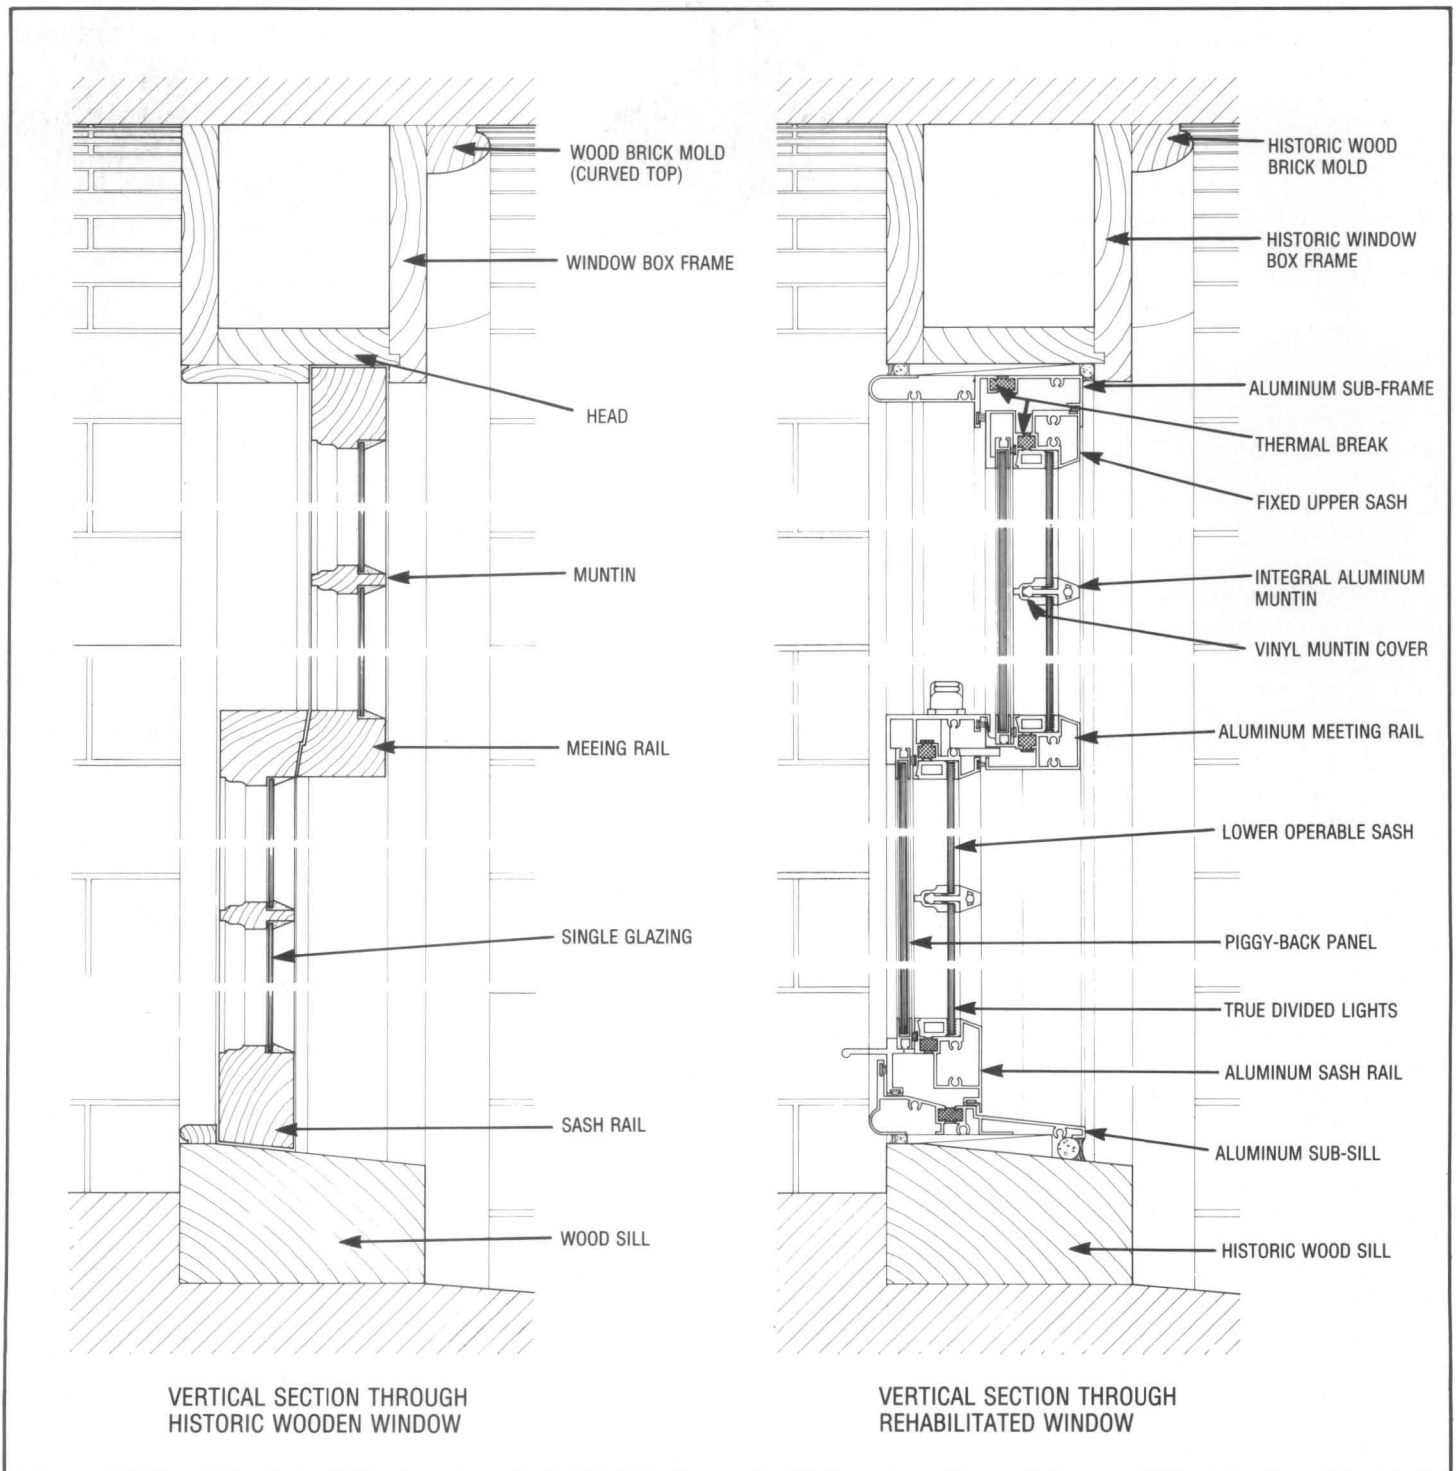
Figure 5. Vertical section of the window shown with old and new sash. Drawing: Timothy Buehner

On the sub-frame, a drip edge that broke the sight line at the head was eliminated as unnecessary. The detailing of the sub-frame was also revised to facilitate installation into the existing frame from the building interior. This resulted in a cleaner interior finish; however, it also increased the height of the sub-sill, making it somewhat more visible on the exterior. The overall depth of the early design was also reduced, resulting in a final depth only about $\frac{1}{2}$ " larger than the historic window. Because the muntin had to clear the piggy-back panel behind it, the overall muntin depth was to be $1\frac{1}{16}$ ", just $\frac{3}{16}$ " less than the historic ones (see figure 5).

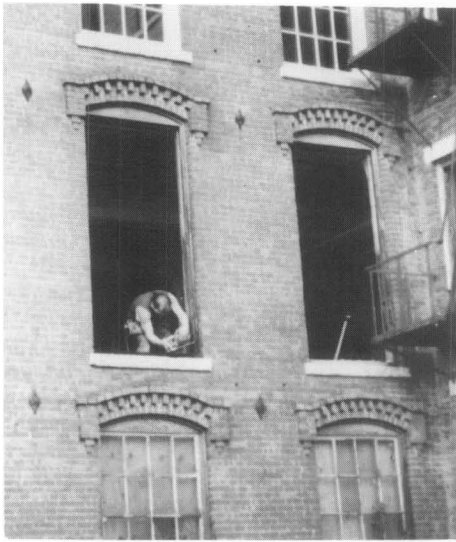
Figure 6. Work on the frames consisted largely of making dutchman repairs to the pulley stiles where required; renailling or replacing brick moldings; replacing some sills; and surface preparation. Photo: Charles Fisher

The exterior of the wooden frames were not to be panned or covered in aluminum. Thus it was important both for aesthetic consideration and good paint performance that the wood frames be repaired and surfaces properly finished. Work on the frames consisted largely of making dutchman repairs to the pulley stiles where required; renailling or replacing brick molding; replacing some sills; and scraping, filling and sanding wood surfaces. Painting consisted of priming and two coats of alkyd oil paint (see figure 6).

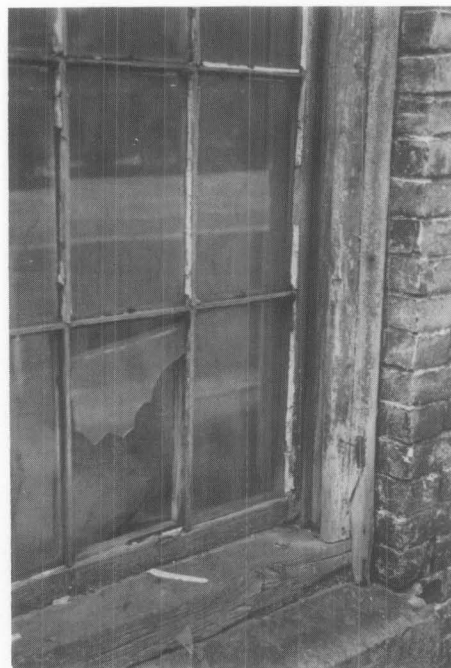
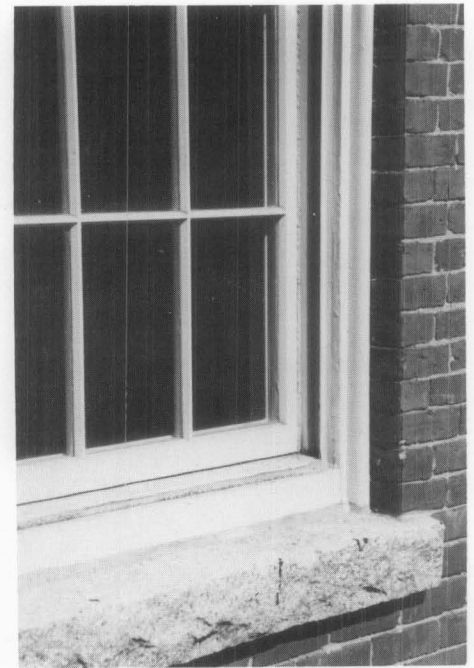
Figure 7. The retention of the exposed outer face of the historic wooden frame and the sill detailing were important qualities of the window treatment. Before and after photos: Charles Parrott

Installation of the new sash went quickly and smoothly. First, the sub-frame was inserted in the prepared opening from the room side, shimming to plumb, line and level before attaching screws through the head and jambs into the old frame. The sash were then installed and the windows were caulked on both the interior and exterior to complete the work (see figure 7).

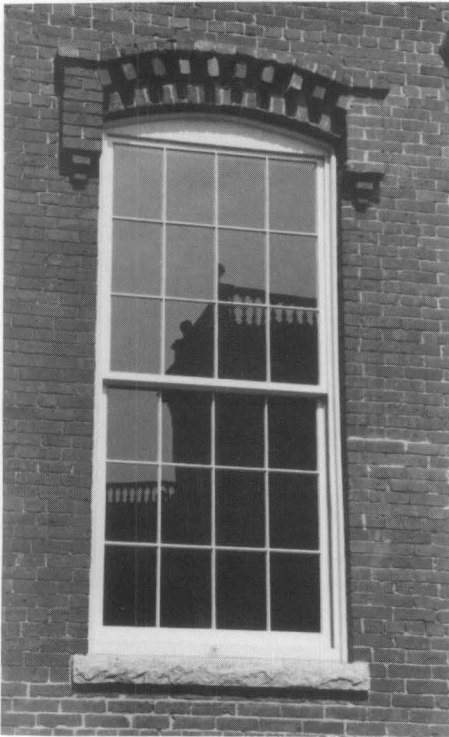
aesthetically pleasing and that retained many of the important historic qualities of the original windows (see figure 8).

Figure 8. Replacement window sash after installation. Photo: Charles Parrott

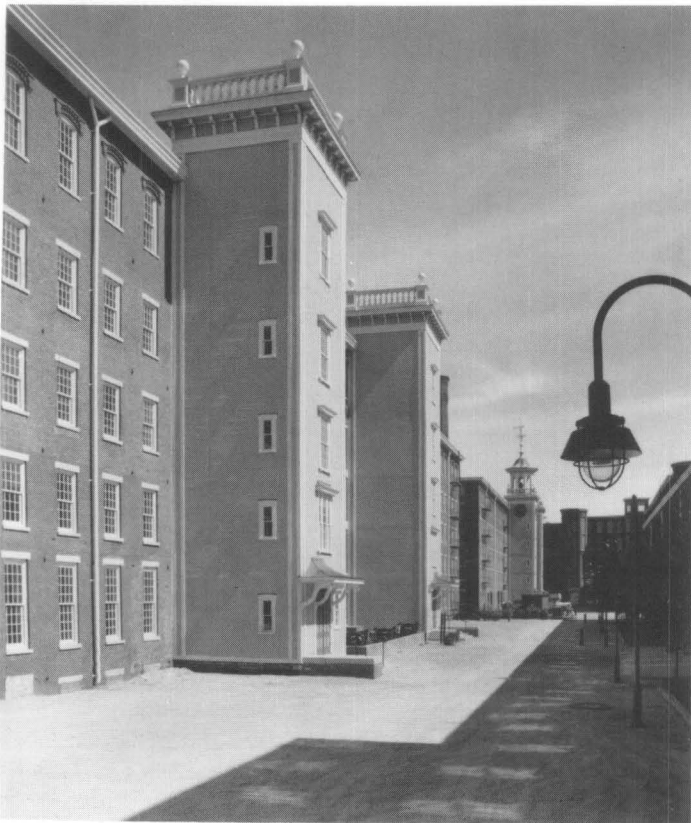
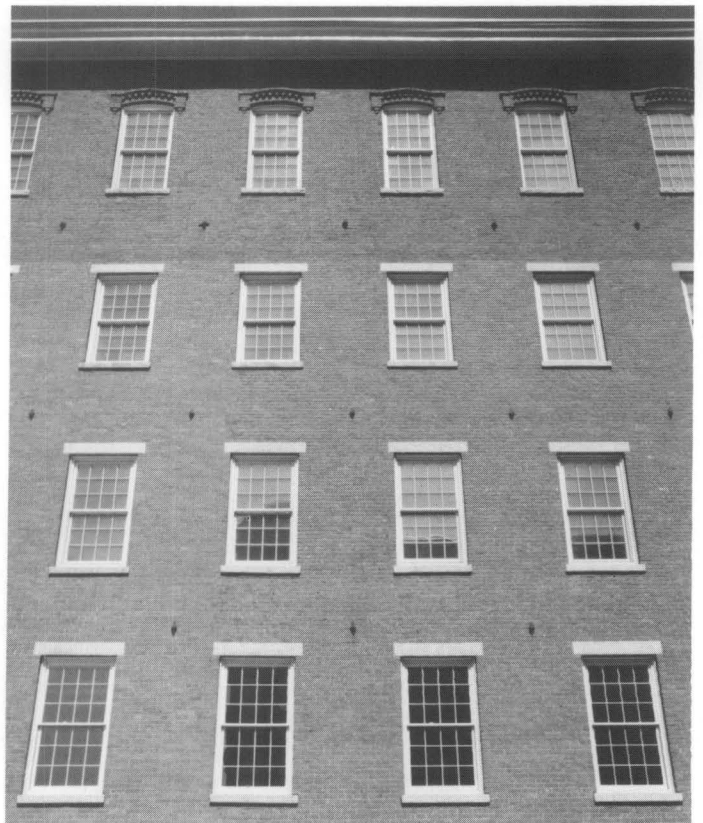
Figure 9. The window solution represents an important advance in the way in which aluminum windows can be designed to capture more fully the appearance of historic windows in larger buildings. Right photo shows wood sash in bottom row and aluminum in the upper three rows. Photos: Jim Higgins ©
