9 ROXBURY ROAD SCARSDALE, NEW YORK

NUMBER 19

Repairing Steel Casement Windows

Technical Preservation Services
National Park Service

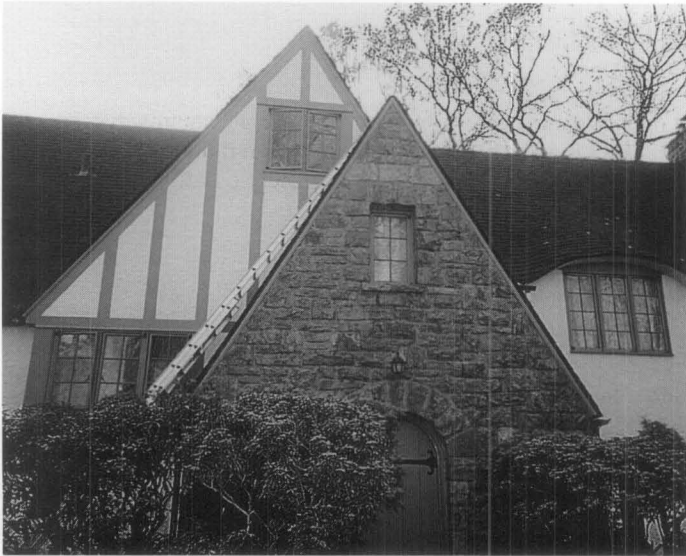
Figure 1. Steel casement windows were placed in various configurations throughout the house. Grouped windows open in opposite directions from each other, assuring that breezes can be captured, and a sash opened during rainy weather, regardless of the wind direction.

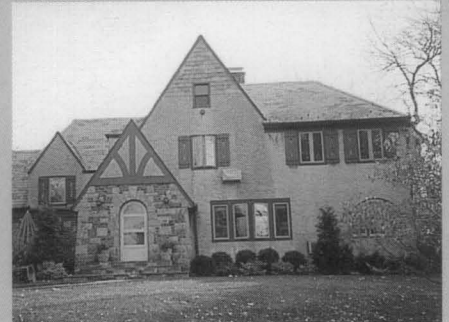
Inappropriate replacement windows dramatically affect the appearance of a historic home that once featured steel casement windows.

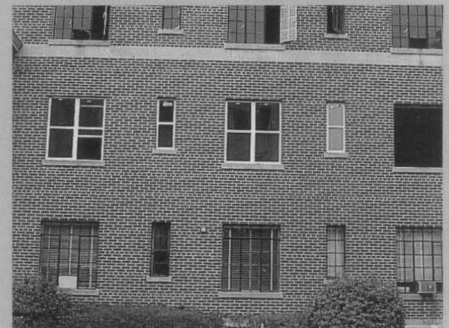
Historic steel casement windows are in the process of being replaced with new units that compromise the character of this building facade.
