Tech Notes

WINDOWS

NUMBER 2

Installing Insulating Glass in Existing Steel Windows

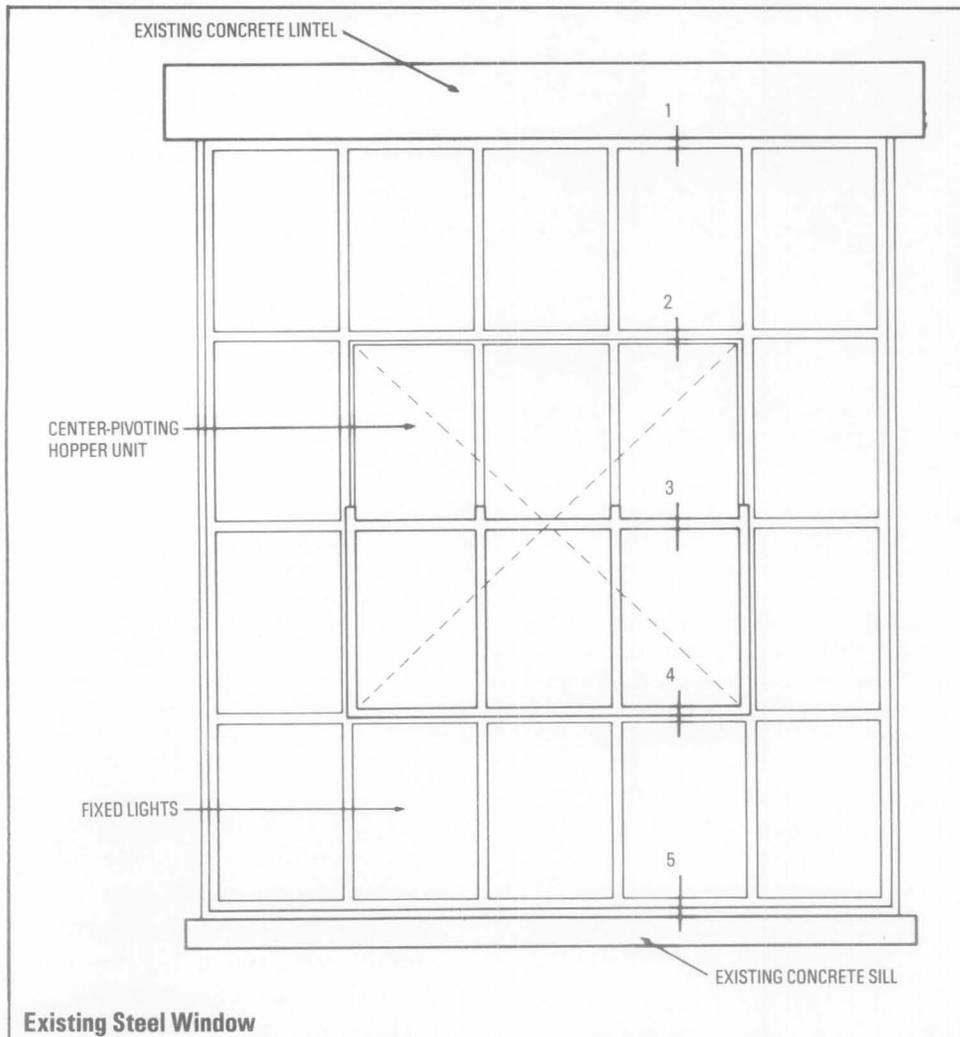
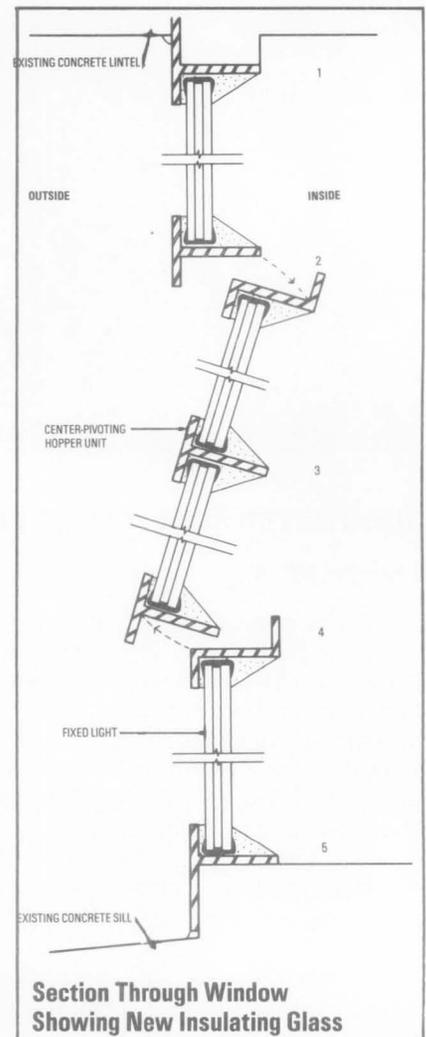
Figure 1. Insulating glass was installed without changing the appearance or operation of the steel window. Drawings: Martha L. Werenfels

Only about half of the glazing cost was directly attributable to the use of insulating glass since from the outset, the residential use of the building tended to dictate from a marketing perspective that the existing wire glass be replaced. Thus it was decided that in lieu of only repairing and reglazing with clear 1/4" glass, which would have been the cheapest of the four identified window options, sufficient benefits could be derived by using double glazing to improve the window's energy performance (see figure 1).

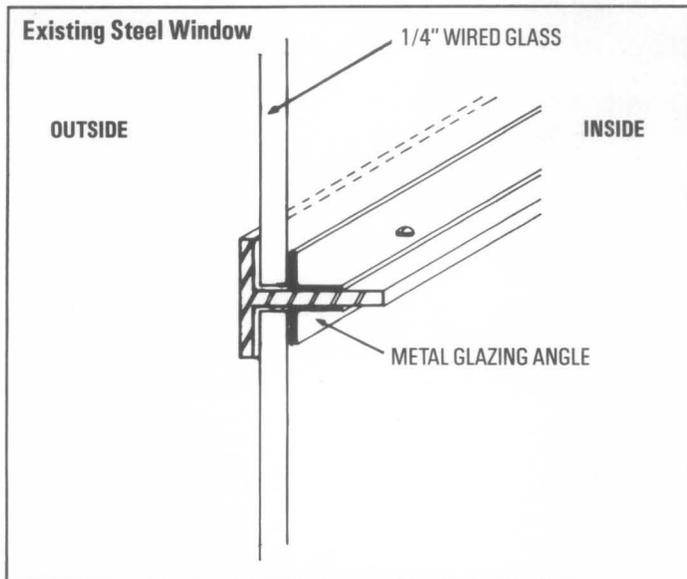
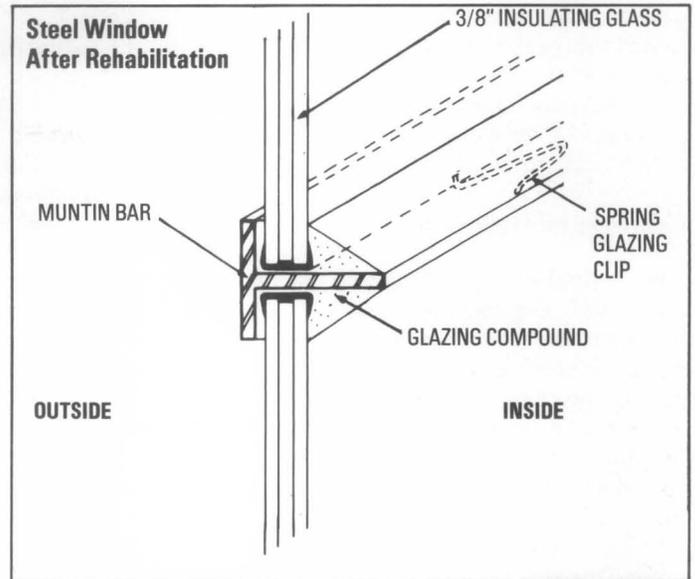
Figure 2. Spring glazing clips and face putty were used instead of the original metal glazing angles in installing the new glass. Drawings: Martha L. Werenfels

The original wire glass had been held in place by glazing angles bolted to the muntin bars. In removing the glass it was decided, due to deterioration of the glazing angles and the labor-intensiveness of reinstallation, that new spring glazing clips and steel sash glazing compound would be used instead (*see figure 2*).

The insulating glass had been delivered to the site, vacuum sealed and with a continuous glazing edge. After the bed putty was applied to the sash, the insulating glass was installed with glazing clips and face putty.

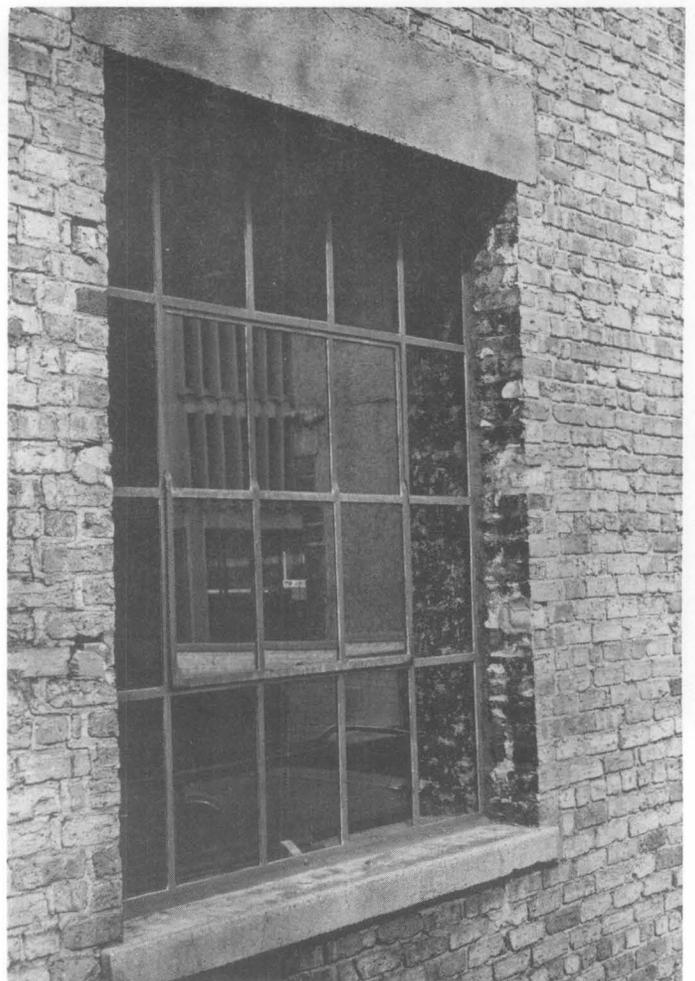
The architect for the project, Kenneth Schroeder, AIA, with the Chicago firm of Kenneth Schroeder and Associates, was confronted with a series of problems in dealing with the steel windows. As is commonplace, lack of routine maintenance had led to rusting and mild corrosion of portions of the windows. Some of the sections, especially the hopper units, were bent, bowed or racked and a number of the 1/4" wire glass panes were broken.

Figure 3. The historic steel windows were repaired and then upgraded through the addition of insulating glass. Photo: Charles E. Fisher

After the metal glazing angles and glass were removed, the old frames were scraped off and existing paint layers and rust were removed using sand under air pressure. After cleaning, sections from several old windows that had been removed were welded into the remaining windows to replace missing

or deteriorated metal pieces. At the same time, racked metal sections, especially the center-pivoting hopper units, were realigned by applying heat and pressure. All the metal was then painted with an anti-corrosive paint.

On the whole, the reconditioned windows are performing well and are providing the desired improvements in personal comfort (*see figure 3*). There was no real problem in marketing the condominiums and residents have capitalized on the interior design opportunities provided by the large windows and the loft space.
