Preservation Tech Notes

NUMBER 21

Replacement Wood Sash Utilizing True Divided Lights and An Interior Piggyback Energy Panel

BEATTY'S MILL (CORAL STREET ARTS HOUSE) Philadelphia, Pennsylvania

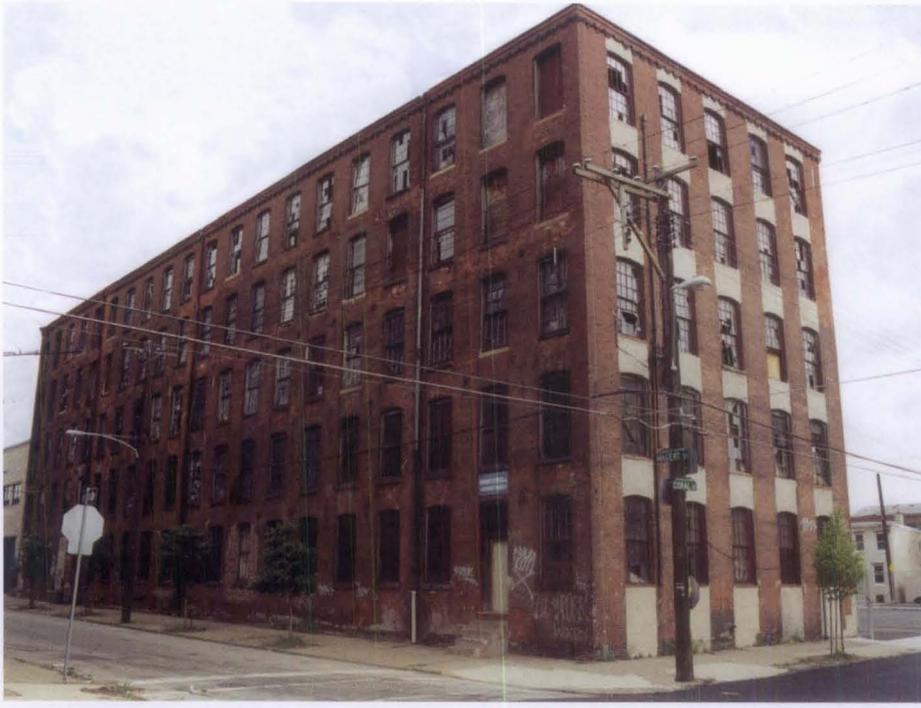
Figure 1. Constructed in 1886, the Betty's Mill is located at a street intersection. The segmental arched windows are a distinguishing feature of the building.

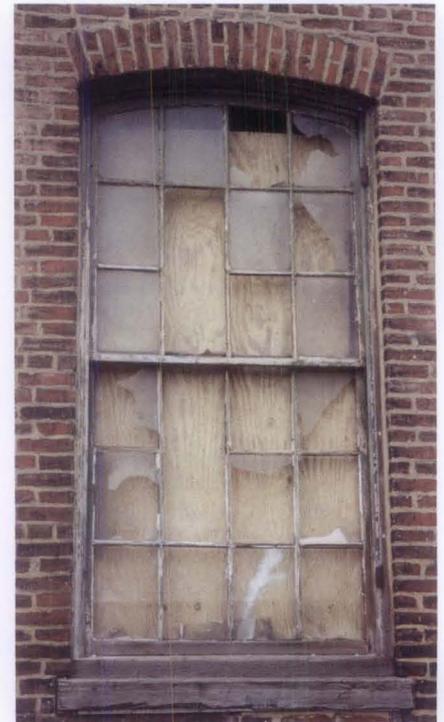
The large double-hung wood windows were one of the most prominent features of the mill. Each measured 48" by 96" with 12 lights of glass in both the upper and lower sash. Characteristic of many mill windows of the time, the sash frames were set in the masonry walls so as to minimize frame exposure on the outside. This provided for more light on the interior. It also enhanced fire safety through minimizing exposed wood on the outside, thus reducing the risk of flames spreading from an adjacent building fire (see figure 2). The outer face of the meeting rail was quite narrow.

The building had suffered many years of neglect, which was reflected in the condition of the windows. A condition survey determined that 40% of the sash were in poor condition; 45% were in fair condition; and only 15% were in good condition. Based on the window survey, the development team elected to replace the

Figure 2. The historic double-hung wood windows had narrow sash and frame members that contributed to the distinctive qualities of the windows.

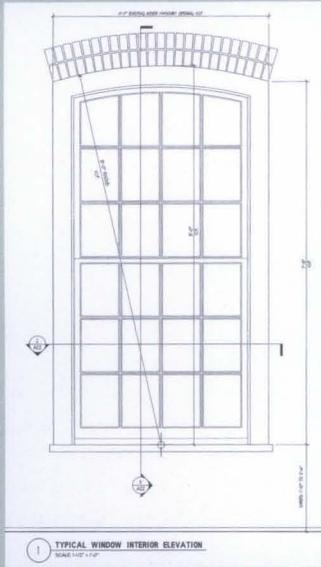
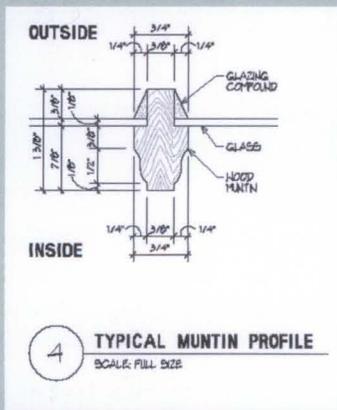
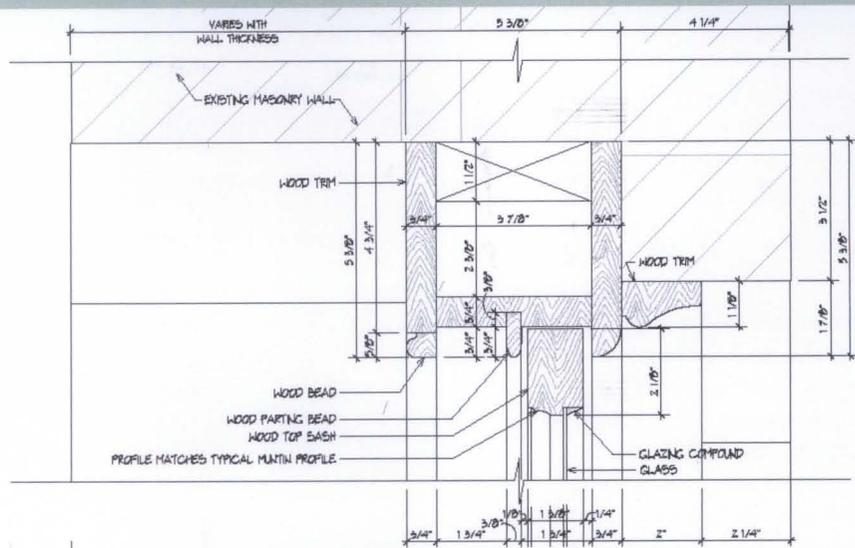
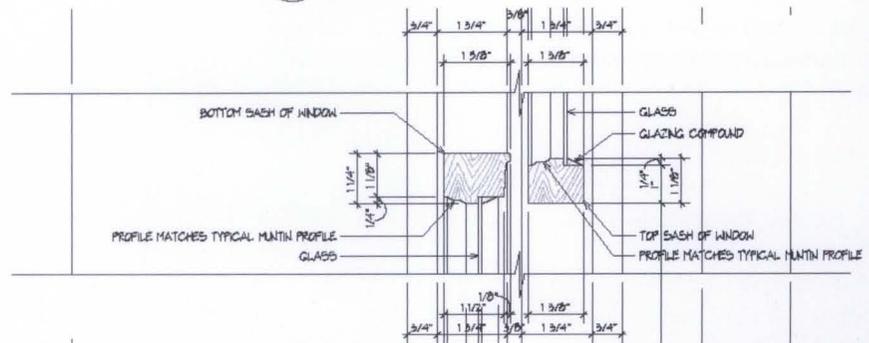
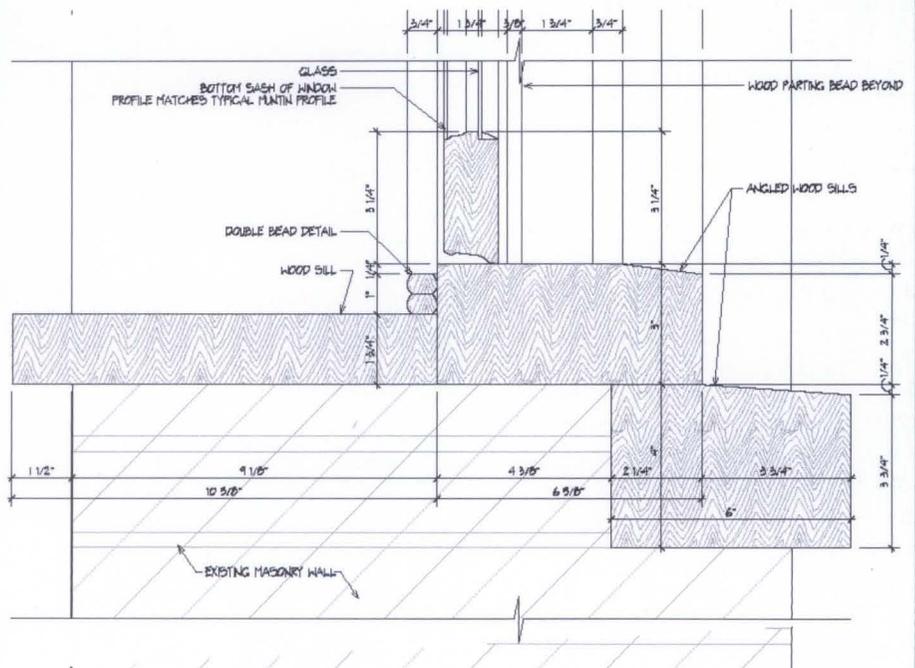
Figure 3. Drawings of the historic windows were prepared by the architectural firm based on field measurements to assist in devising an appropriate replacement window. Drawings: Courtesy of Kitchen & Associates Architectural Services.

The location of this building right on a street corner and the importance of the windows to the historic character of the building led the project team to select a window solution that closely matched both the detail and appearance of the historic windows. By selecting a new custom wood window, the narrow site lines of the historic windows could be closely replicated, the historic glass to wood ratio readily maintained, and other historic details easily reproduced (see figure 3).

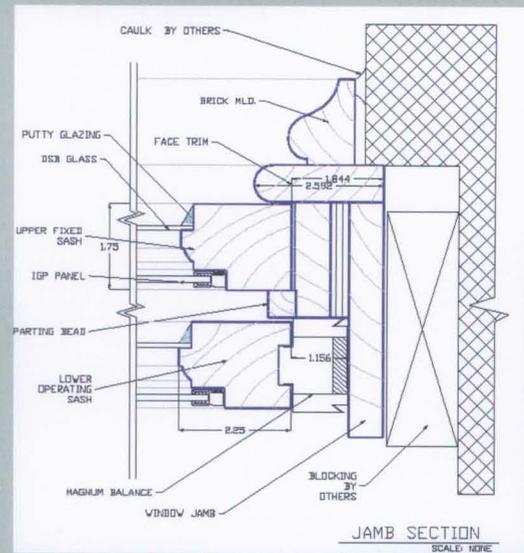
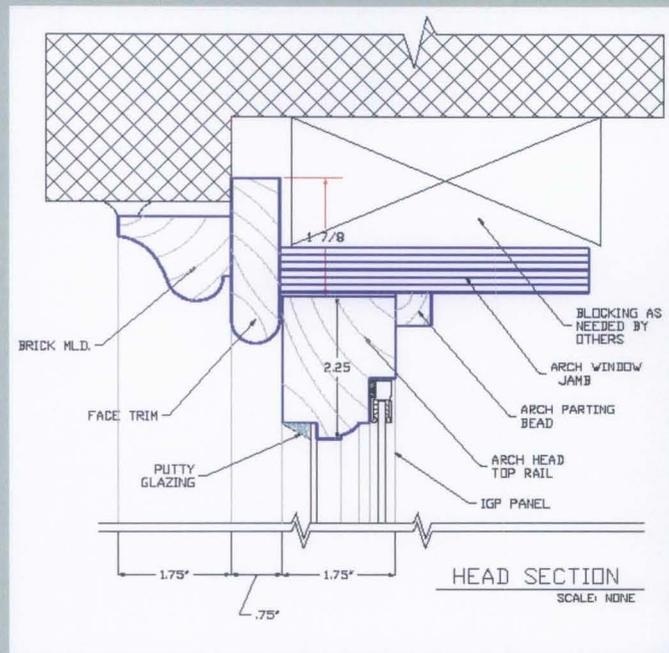
Figure 4. While using contemporary sash balances, the wood replacement windows had many traditional features such as putty glazing for the true wood muntins. Note the sash is rabbeted on the room side to a depth that permits the glazing panel to be set flush. Drawings: Courtesy of Seaquay Architectural Millwork.

To help retain the historic sightlines, the deteriorated frames were removed, permitting the new frames to be set close to the masonry (see figure 4). The alternate approach of retaining the existing frames, abutting new frames to them, and covering the outer face of the exposed portion of the older frames would have resulted in reduced glass exposure and a beefier frame appearance to the finished windows.

Several features of the new window were different than the historic windows in order to accommodate the dual glazing. The inside of the rails and stiles of the sash were rabbeted on the room side to a depth that permits the glazing panel to be set flush. To retain the depth of the original muntin and to accommodate the glazing panel on the inside, the thickness of the sash was increased to 1 3/4". In the bottom rail, weep holes were provided between the glazing panel and the outer glass, to allow water to drain from condensation that might on occasion develop between the two layers of glass.

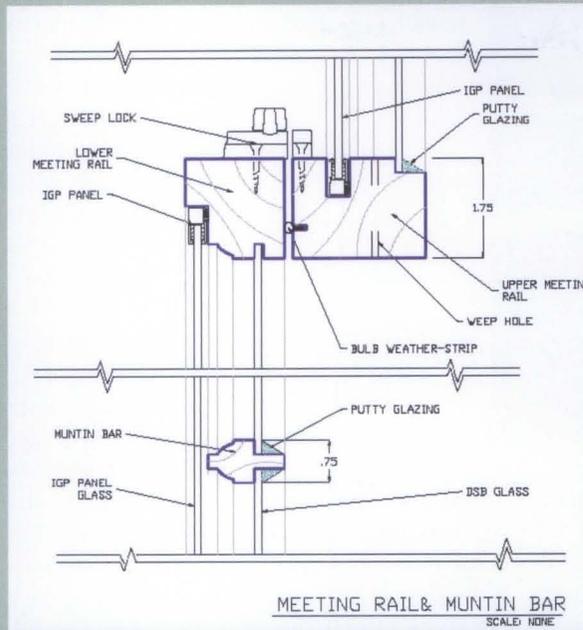
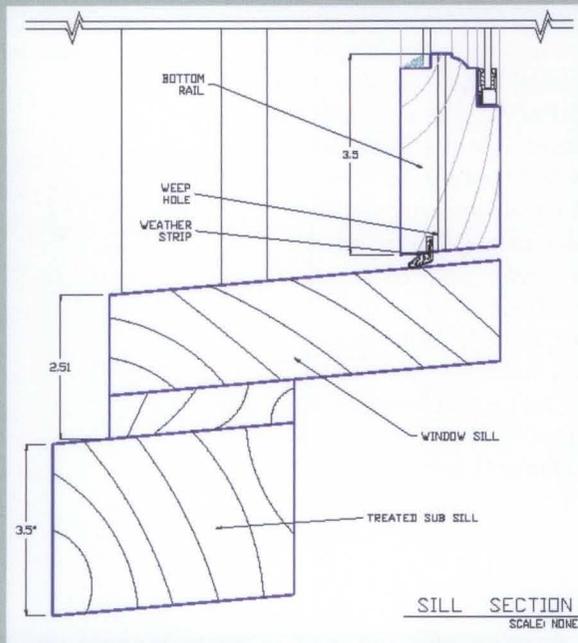
Figure 5. For the new windows to meet ASTM Standards, the face width of the meeting rail was increased 1/2 inch. To both accommodate the piggyback energy panel and match the historic muntins, the thickness of the wood sash was increased from 1 3/8" to 1 3/4". These two changes had minimal visual impact, considering the size of the windows. Drawings: Courtesy of Seaquay Architectural Millwork.

Somewhat more problematic was how close the bottom rail (meeting rail) of the new upper sash could match the narrow width of the existing window. Specifications for the project required that the replacement window meet three ASTM Standards: ASTM E283, the standard test for determining the rate of air leakage through an exterior window; ASTM E331, the test of water penetration; and ASTM E330, the standard test for structural performance of an exterior window. To meet ASTM E330 with the design pressure rating for the window set by the architect, a 1 3/4" wide meeting rail was needed (see figure 5). This was an increase of 1/2 inch over the historic sash. Fortunately because of the size of the window, this increase was considered acceptable, as the meeting rail still appeared relatively narrow even with the 1/2 inch increase.

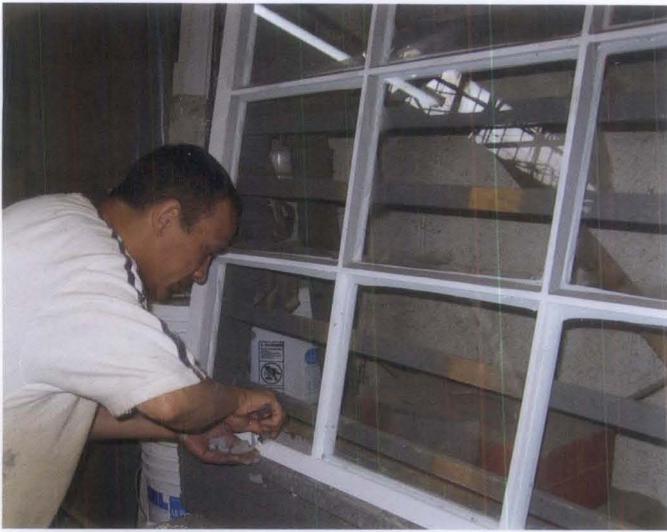
Figure 6. The outer glass was installed in the traditional manner, using exterior glazing putty. Photo: Charles Fisher.

The windows were then assembled and sanded. The outer glass was installed in the factory after the assembled sash were primed. Exterior glazing putty manufactured by C.R. Lawrence was applied in the traditional manner (see figure 6). Since the upper sash were to be fixed in the operable windows, weatherstripping and block and tackle balances were provided only for the lower sash. Each window was provided with two sweep locks and two sash lifts for the operable lower sash. Of the 188 replacement windows, 111 were single hung and 77 were fixed (see figure 7).

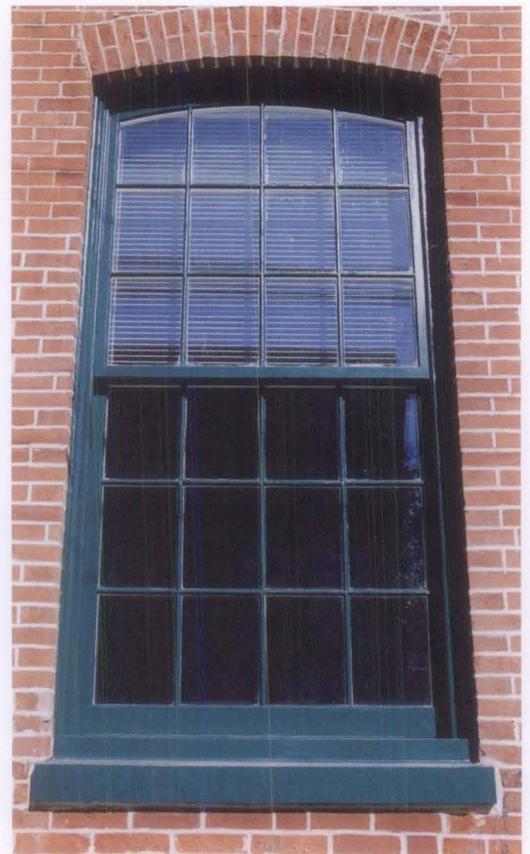
Figure 7. The new window's joinery, individual glass lights, reflective qualities, and painted wood finish all help to capture the appearance of the original units.

The new windows in Beatty's Mill successfully matched the historic units while providing enhanced energy conservation. There is little difference between the new and historic windows in terms of the characteristic features (see figures 2 and 7). The integral wood muntins, individual panes of glass, reflective qualities of the glass, glazing putty, and painted wood surfaces, along with the benefits of using a custom-wood window manufacturer that could duplicate

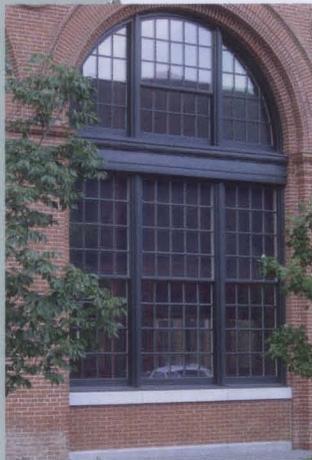
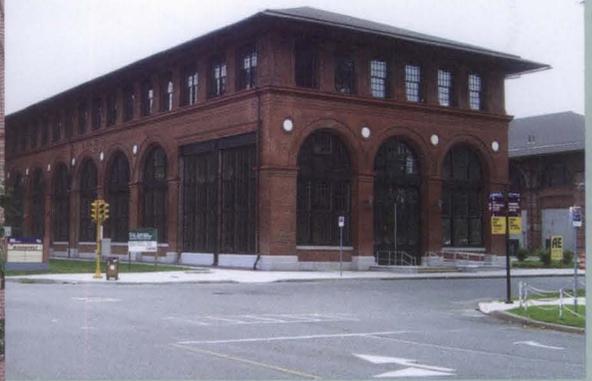
Figure A. Building 10 (headquarters of Urban Outfitters), former Philadelphia Naval Shipyard. New wood windows were made to match the original units, including true divided-lights, while incorporating a piggyback interior energy panel. Photos: Seaquay Architectural Millwork.

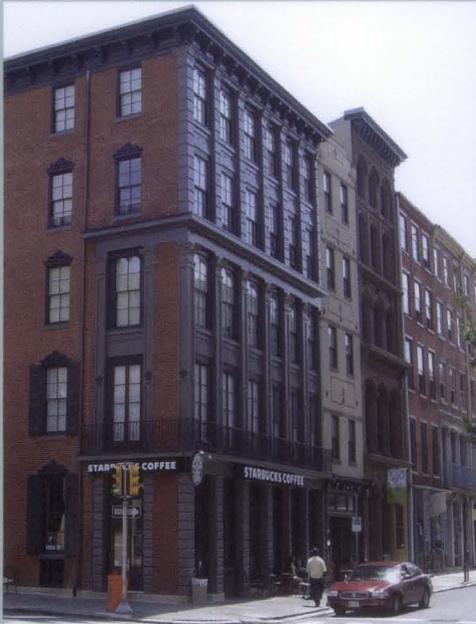
Figure B. 61-63 North Arch Street, Philadelphia (commercial and residential). Most of the historic windows were missing or severely deteriorated prior to the rehabilitation of this corner building. Based on surviving units, new non-clad wood windows were milled with matching true divided lights and piggyback energy panels. Photo: NPS file.

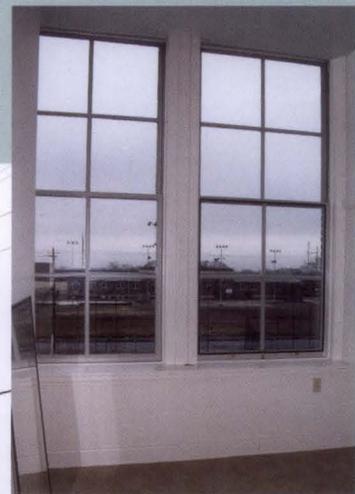
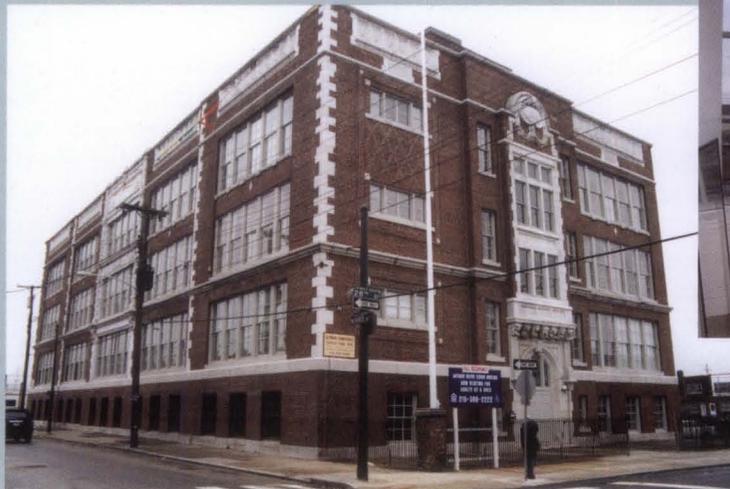
Figure C. Anthony Wayne School (affordable senior housing), former Philadelphia school. The predominant window type is a wood unit with four-over-four glass lights as shown in the lower right-hand photograph. The replicated wood window on the right is shown with the energy panels installed, while both sash in the left window have yet to receive the panels shown in the left forefront.

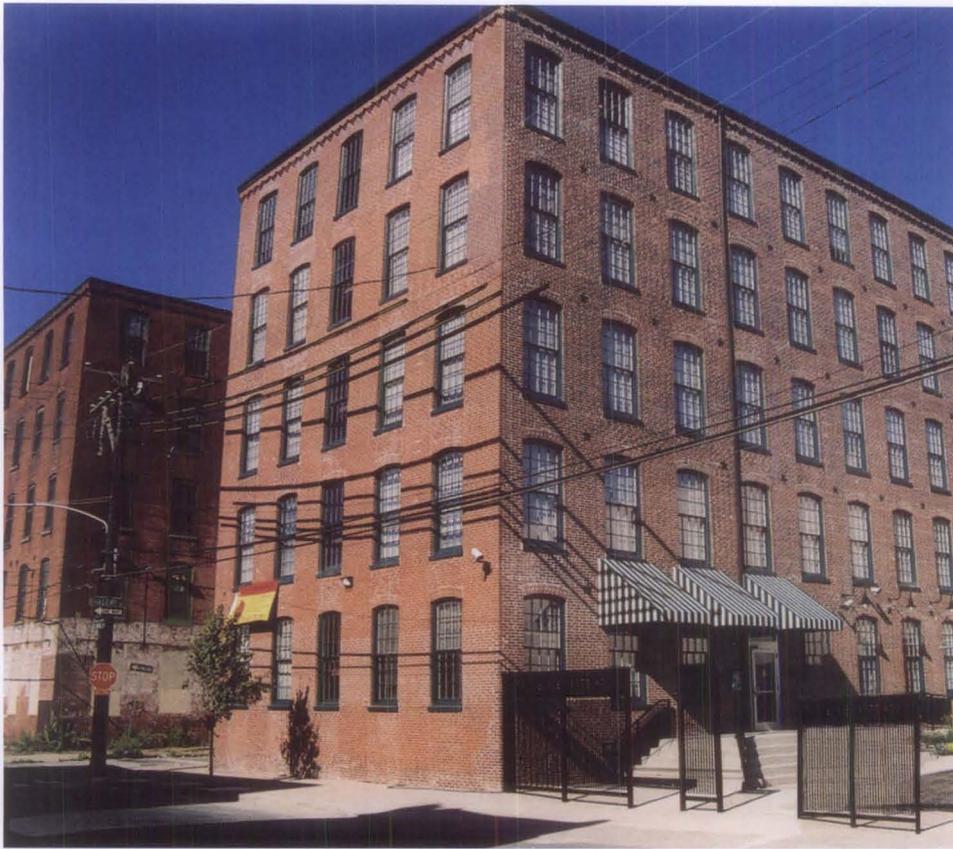
Figure 8. Upon completion of the work, the former mill now serves as low-income housing and artist live/work space. The new wood windows provide improved energy performance and enhance the visual qualities of the historic building.
