# Preservation Tech Notes

## WINDOWS NUMBER 22

### Maintenance and Repair of Historic Aluminum Windows

**Kaaren R. Staveteig**  
Technical Preservation Services  
National Park Service

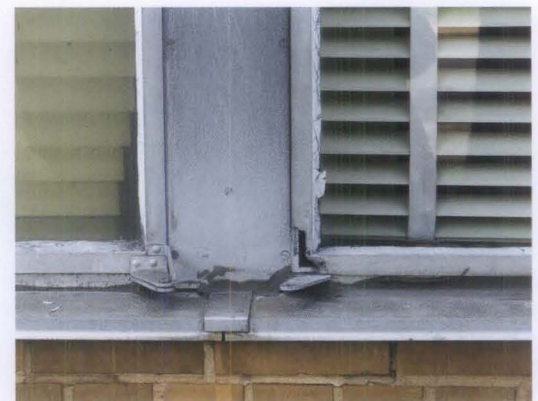
Figure 6. Deferred maintenance can result in a series of problems, such as broken hardware, cracked or missing glazing putty, and missing perimeter caulk (all shown above). All of these problems can be corrected. Note the uneven nature of the surface deposits of pollutants and grime on the mullion and sill of this window due to weathering and lack of cyclical cleaning.

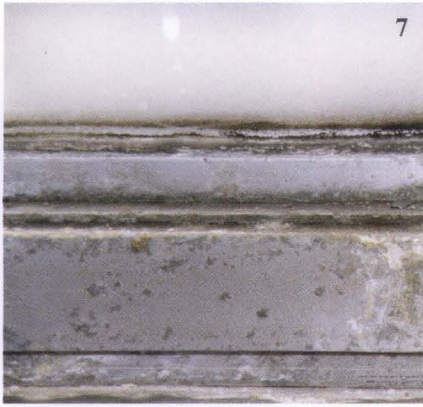
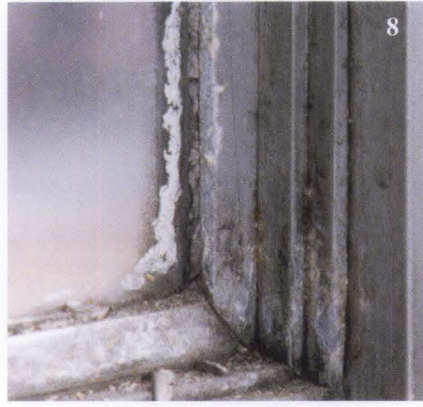
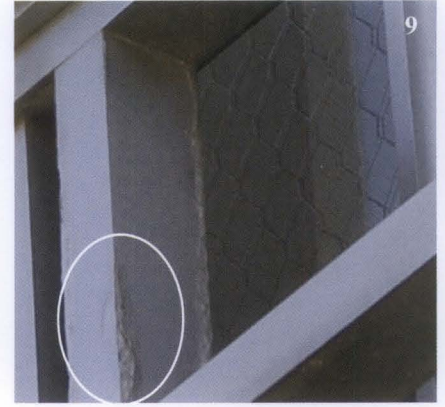
Figures 7 and 8. Aluminum corrosion can appear as a white discoloration and forms on the surface as the protective oxide film breaks down, as seen in these 60 year old windows in the PSFS Building, Philadelphia, before they were replaced. The small dark bumps are where surface dirt, grime, and pollution particles collect. Over time, pits form beneath these dark areas as the surface continues to corrode. This corrosive action is further encouraged by foreign particles, such as dirt and chlorides, which hold moisture next to the surface. (Photo: Powers & Company Inc.) Figure 9. Some aluminum alloys are less corrosion resistant than others. Delamination, as seen on this aluminum railing in front of a window at the Folger Shakespeare Library, can occur when an aluminum-copper alloy is introduced and used in an outdoor setting. The original specifications called for aluminum and chromium, but were not followed.
