Tech Notes

OLD WATKINS NATIONAL BANK

WINDOWS

Interior Metal Storm Windows

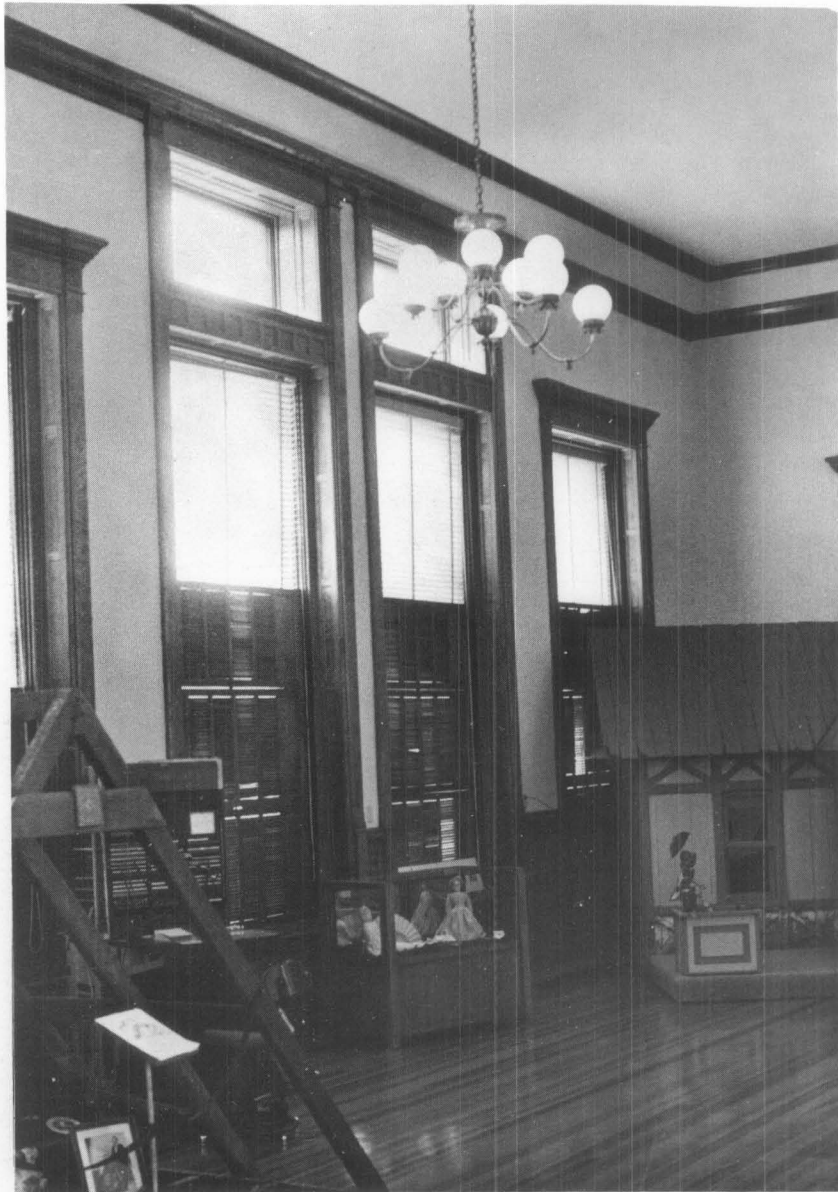
Figure 1. The monumental windows are elegantly detailed on the interior and contribute to the grandeur of the spacious banking rooms. The original interior shutters are still being used for comfort and light control. Photo: Charles E. Fisher

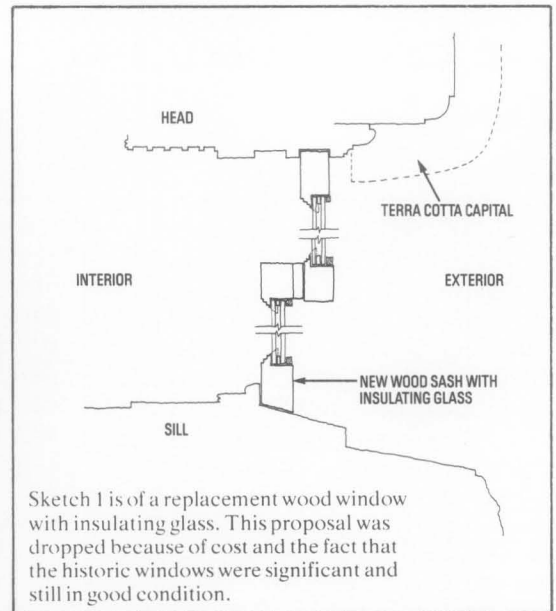
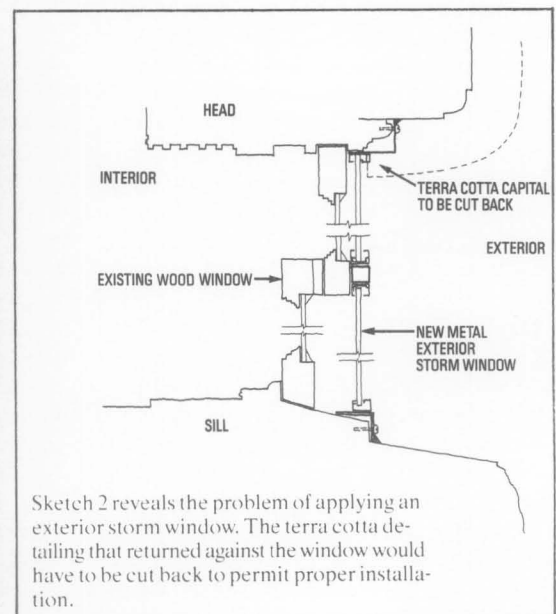
Figure 2. As part of the planning, the architect prepared sketches of 4 possible window treatments to improve the energy performance of the windows.

Use of exterior storm windows was initially explored both for energy conservation purposes and as a way to extend the useful life of the original windows (*see figure 2*). Unfortunately, the prices quoted for exterior storm windows by local contractors were around \$65,000, nearly double the budgeted amount. In addition to the high cost of exterior storm windows, one further problem with an exterior storm application arose when it was discovered that the decorative terra cotta capitals adjacent to the upper level window openings returned against the original frames. As a result, the proposed exterior storm windows could not be easily installed in these locations without cutting back or covering portions of the terra cotta (*see figure 3*).

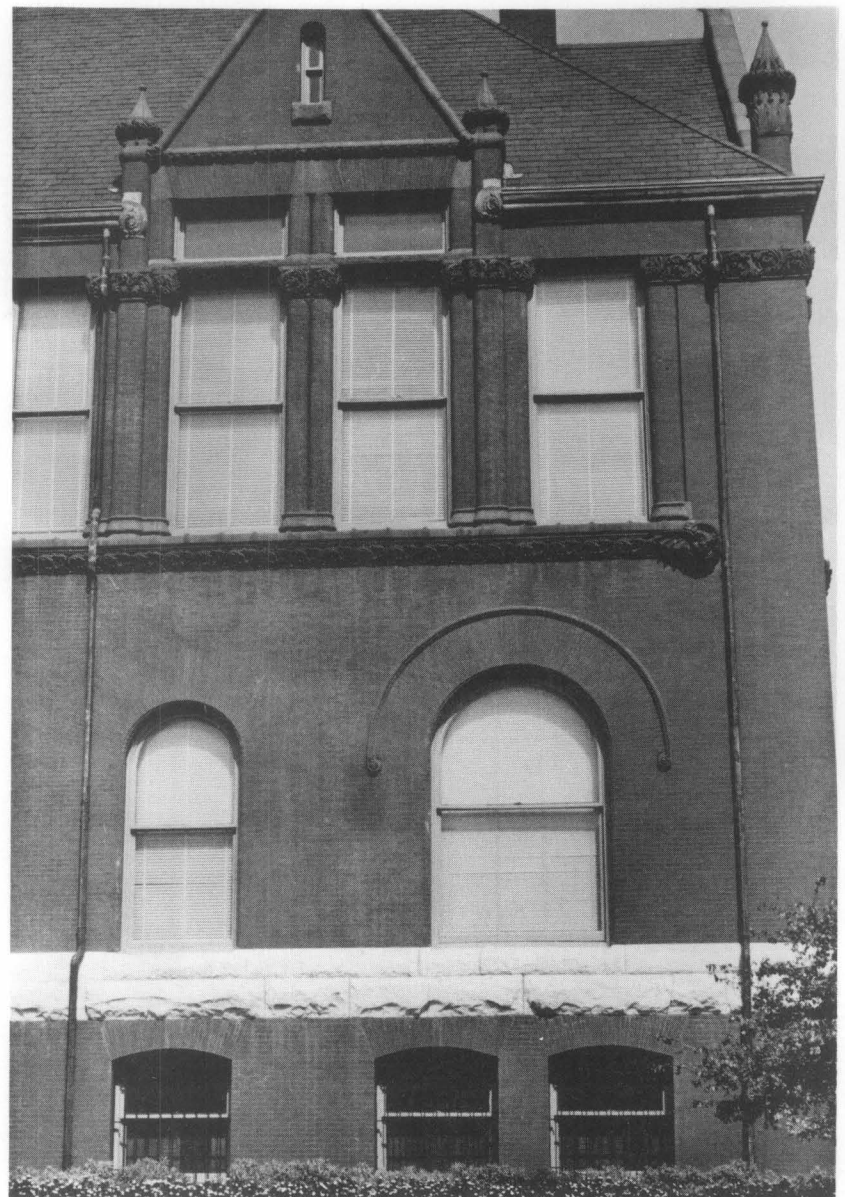
Figure 3. Exterior storm windows were initially considered but presented several problems. The terra cotta capitals on the pilasters returned against the windows, making normal installation difficult without damaging the terra cotta. Many of the windows also had round heads which would require additional custom work—these same windows on the interior had square tops. Photo: Charles E. Fisher

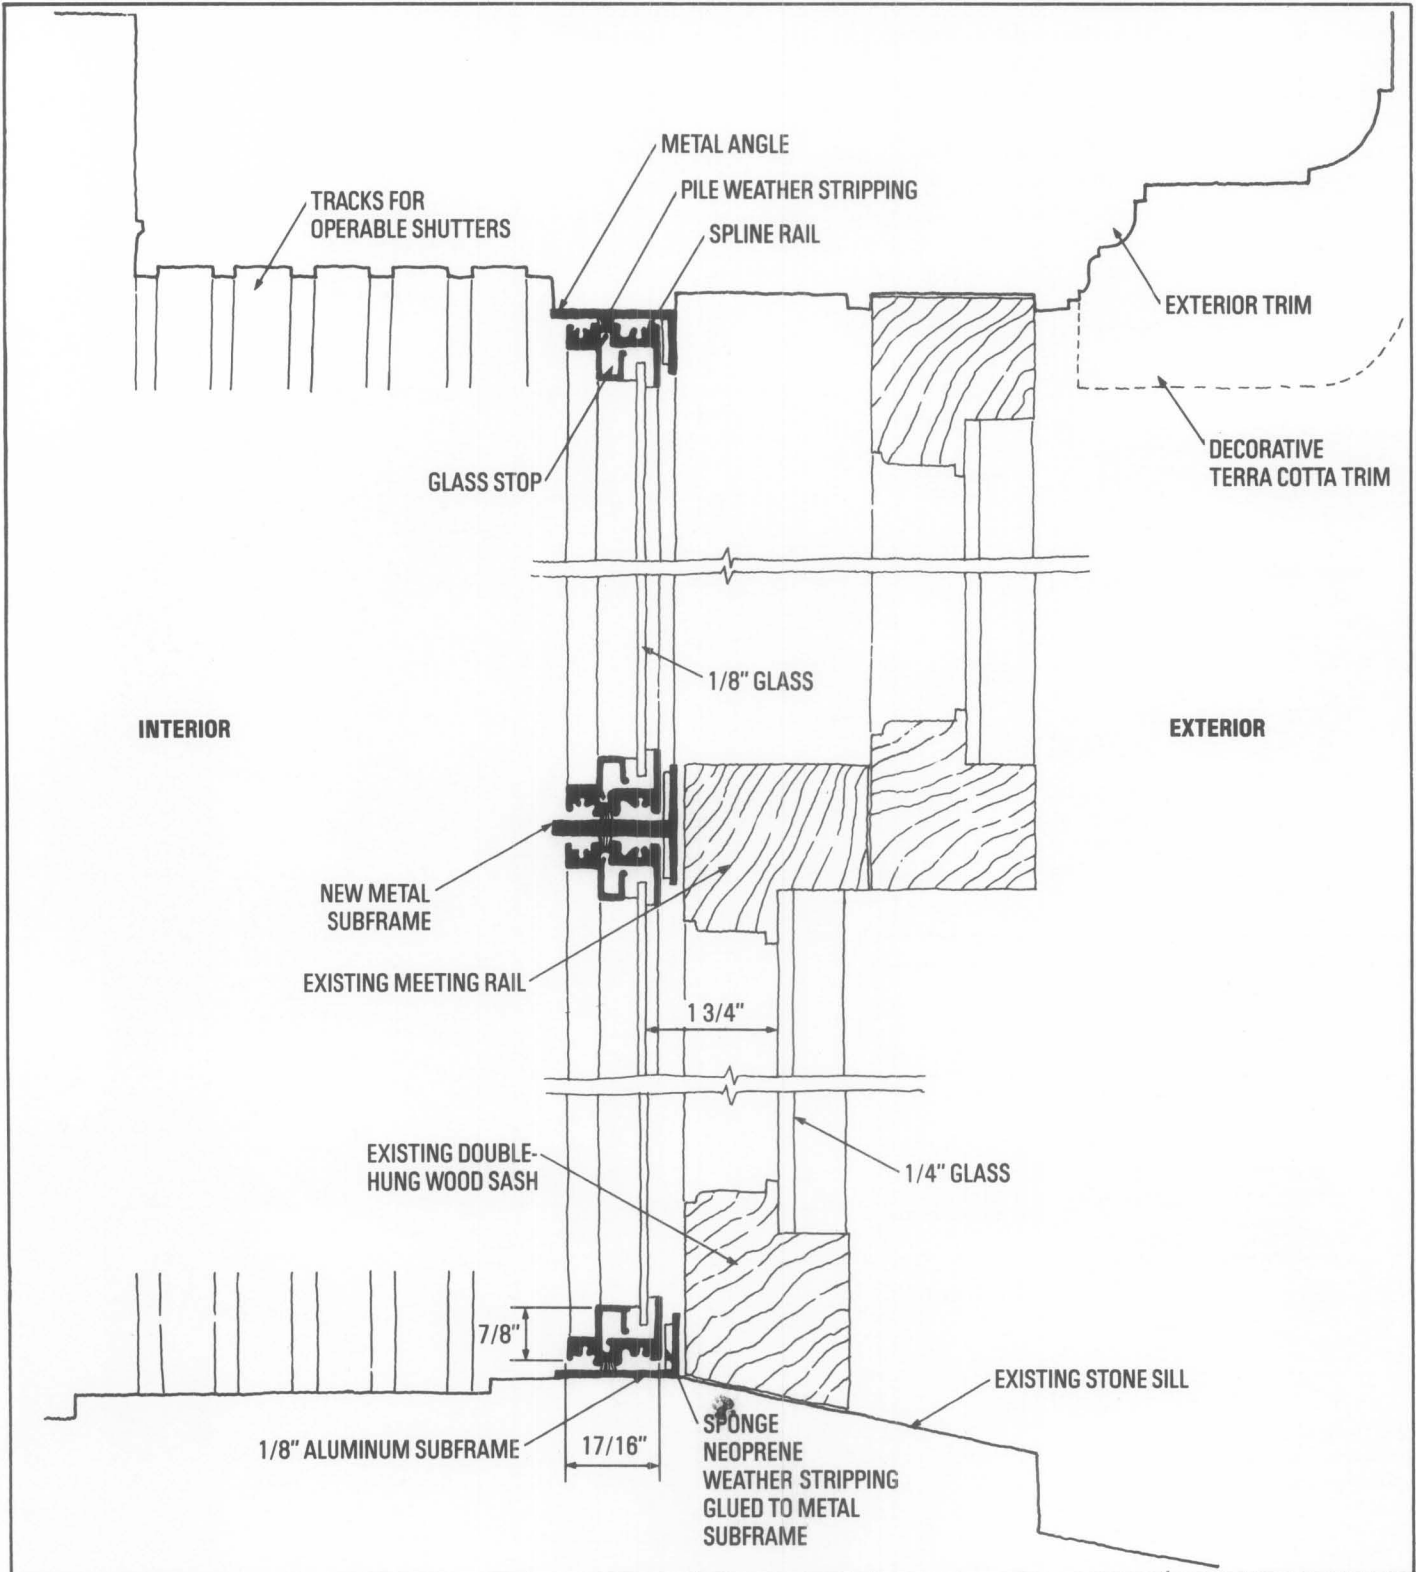
Mounted on pivot pins, the storm window relied on the pile weather stripping which ran continuously along the edge of the frame to serve as the seal between the metal subframe and the metal storm (see figure 4). Neoprene weather stripping was also added to the surface of the subframe to serve as a compression seal with the storm frame. Clear silicone caulk between the wood jamb and the subframe completed the seal.

Figure 4. Section showing the new interior metal storm window set behind the historic wood sash. Drawing: Martha L. Werenfels

In searching for an interior storm window that met both the functional requirements and the concerns about visual qualities, the architect chose a commercially available metal storm window system. The storm window was designed to fit within the existing wooden jamb, thus resulting in minimal damage to historic material (see figure 4).

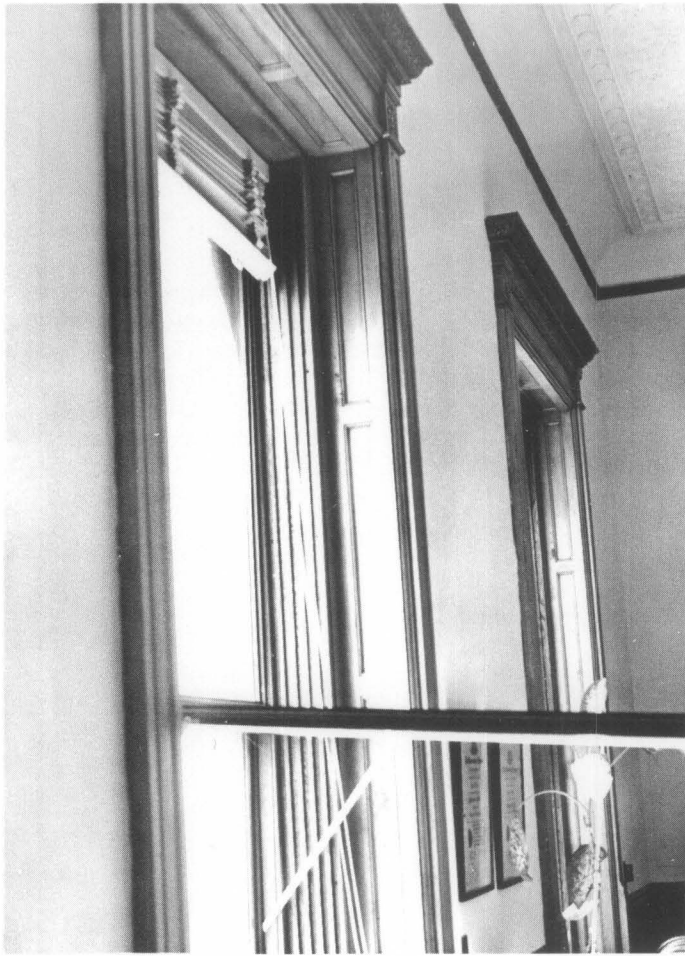
Figure 5. The interior storm window was designed to fit within the existing wooden jamb. The large size of the windows necessitated the use of operable storm panels, intersecting at the historic meeting rail. Here the lower storm panel is in an opened position for cleaning. Photo: Charles E. Fisher

The thin aluminum storm window frame ($\frac{7}{8}$ " wide, $1\frac{1}{2}$ " deep) was attached to a small new subframe by two pins that allowed the windows to pivot open for cleaning and venting in case entrapped condensation was ever a problem (see figure 5).

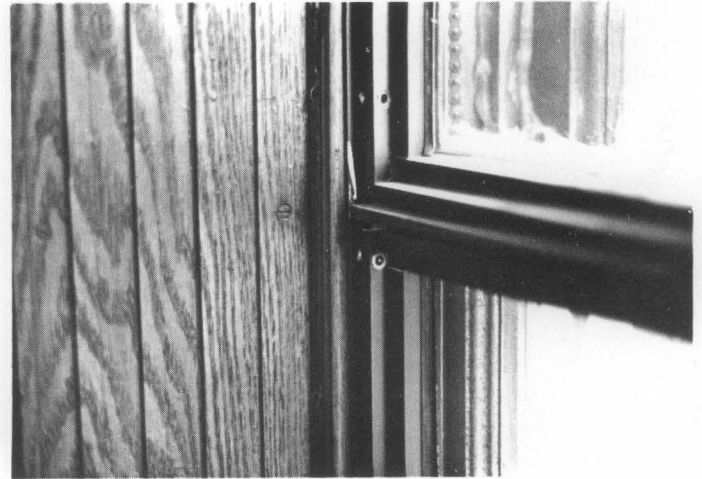
Figure 7. Continued use of the unique shutter system required that the frame of the interior storm window be narrow. The storm windows are set between the shutters and the historic sash. Photo: Charles E. Fisher

vided a sufficiently wide dead air space for energy conservation purposes, yet still allowed the interior shutters to remain operable (see figure 7).

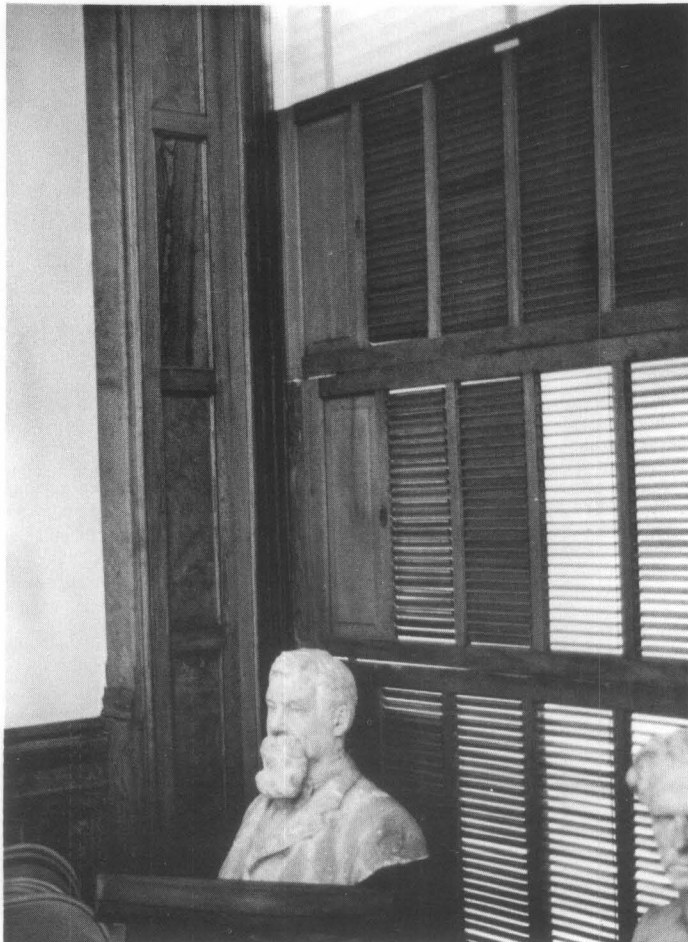
Figure 6. The windows were too large for only a single storm panel, necessitating the use of a structural subframe at the mid-section of the window. Both the upper and lower storm panels are operable and come together opposite the historic meeting rail. This element of the storm window is sufficiently thin that is not readily discernible from the outside. Photo: Charles E. Fisher

The subframe consisted of a $\frac{1}{8}$ " thick metal angle screwed to the wood jamb, serving as support and as a stop for the storm sash. On the large windows, the metal angle was paired to form a horizontal muntin, in line with the historic meeting rail, to accommodate an upper and lower storm panel, both of which pivoted (see figure 6). The frames were mounted in a location that pro-

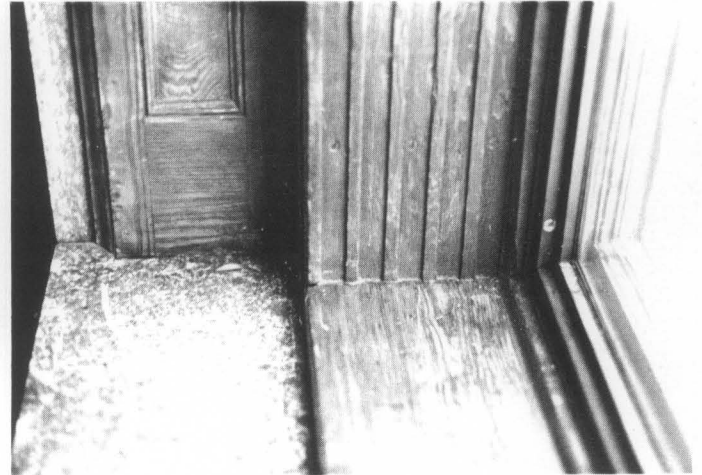
Figure 8. The decorative jamb panel on the left and the interior shutter tracks were unaffected by the installation of the interior storm window shown on the right. Photo: Charles E. Fisher

In summary, the interior storm window solution not only provided the owner with initial cost savings in installation, but it also reduced fuel consumption, met all functional requirements, and carefully addressed historic preservation concerns (*see figure 8*). The thin frame storm window, set within the existing jamb and mounted so as to pivot, was a sensitive solution which is also being used on other projects involving rehabilitations of historically important commercial buildings.
