Darrah Hall

Historic Structure Report

Reconstruction Era National Historical Park

Beaufort, South Carolina

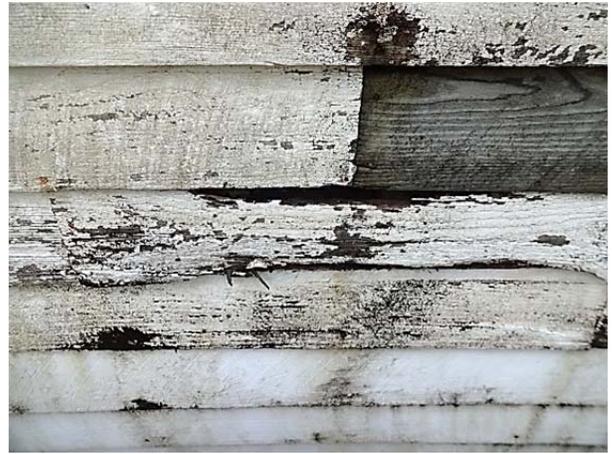
- Deterioration of the wood siding was observed in several locations, particularly on the north elevation (Figure 68 and Figure 69).
- Paint failure at the wood siding and trim was observed throughout the exterior of the building (Figure 70).
- The scalloped shingle siding at the east gable end is deteriorated, with displaced and missing shingles (Figure 71).

FIGURE 68. Deterioration of the wood siding along the north elevation.

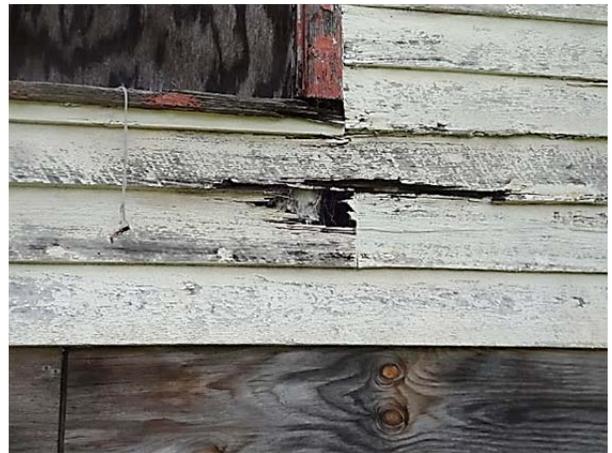
FIGURE 69. Deterioration of the wood siding at the west elevation.

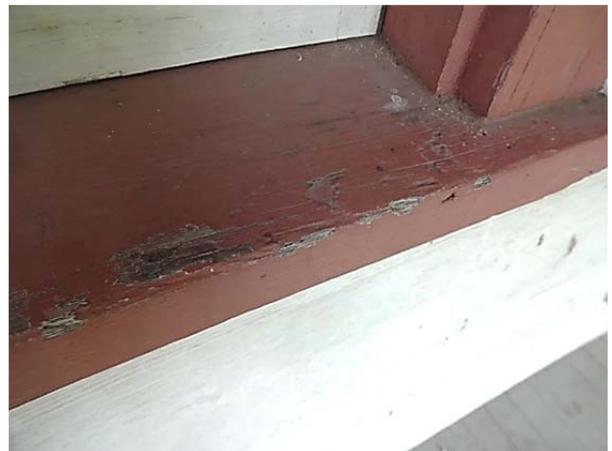
FIGURE 70. Paint failure at a window sill.

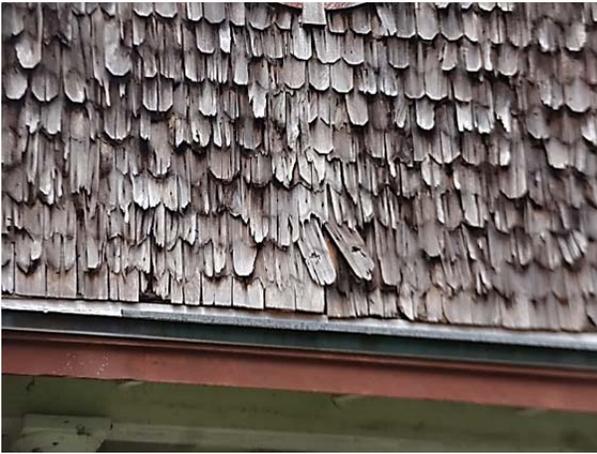
FIGURE 71. Deterioration of the wood scalloped shingle siding. Note the missing and displaced shingles.

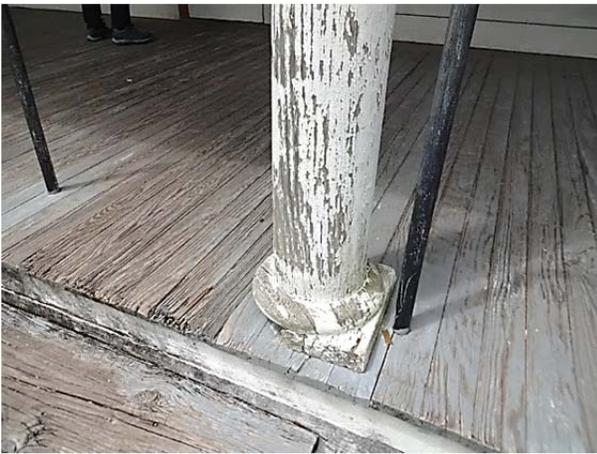
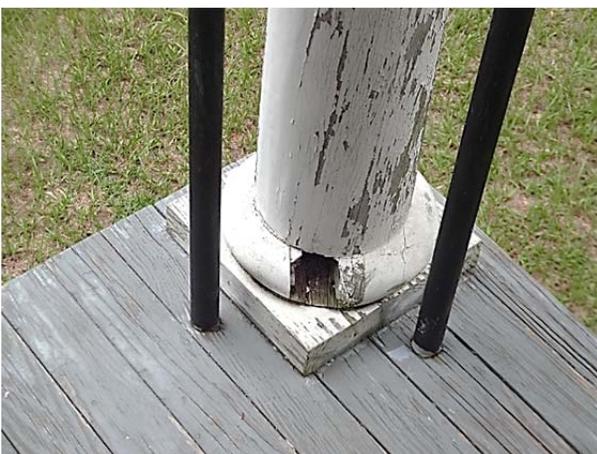
FIGURE 72. Portions of the wood columns on the east porch are missing.

FIGURE 73. Portions of the wood columns on the east porch are missing.

- Portions of wood at the base of the columns on the east porch are missing (Figure 72 and Figure 73).
- Paint failure was observed at the wood columns on the east porch (Figure 74).
- The stair leading to the east porch exhibits wood deterioration and paint failure (Figure 75).
- The stair at the south porch is deteriorated, with paint failure also observed (Figure 76).
- The railings at the stairs on the west elevation are damaged and deteriorated (Figure 77).
- The metal railing at the south porch stair is damaged, with portions of the railing detached from one another (Figure 78).

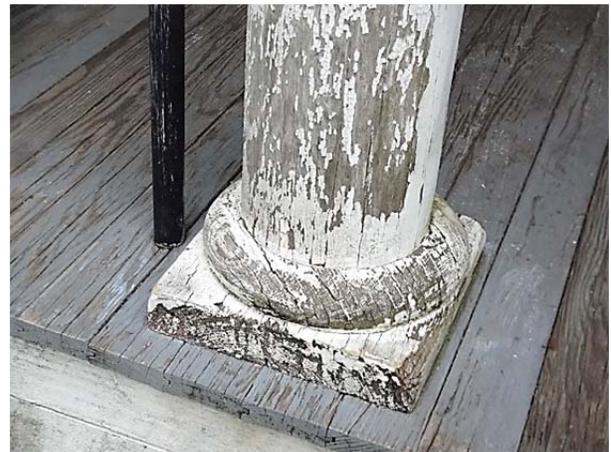
FIGURE 74. Paint failure was observed at the columns on the east porch.

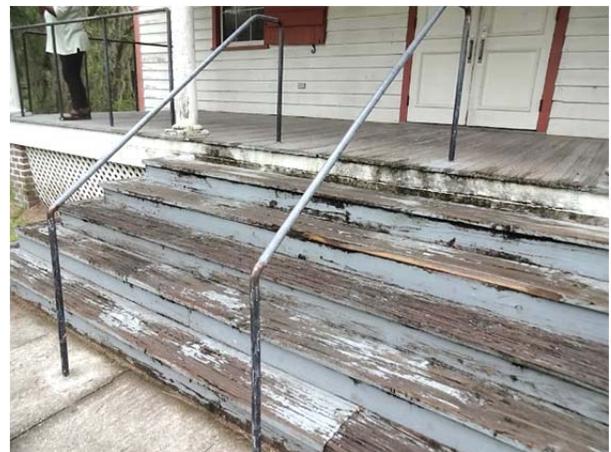
FIGURE 75. Paint failure and deterioration was observed at the stair leading to the east porch.

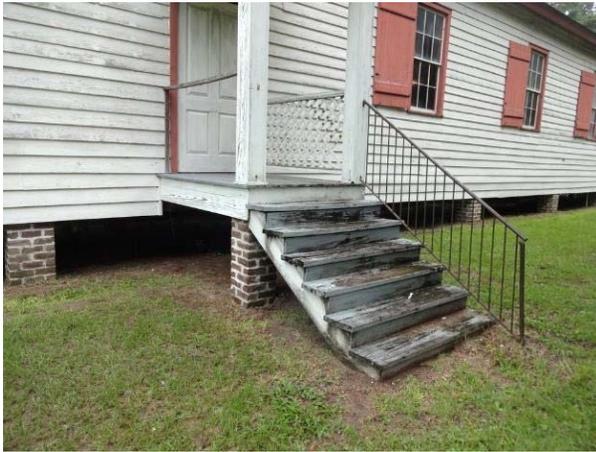
FIGURE 76. Deterioration of the south stair. Note the extensive paint failure at the stair.

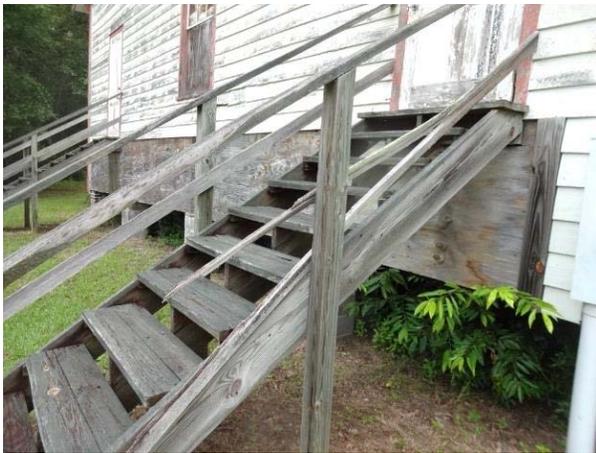
FIGURE 77. Railings along the west stairs are damaged and deteriorated.

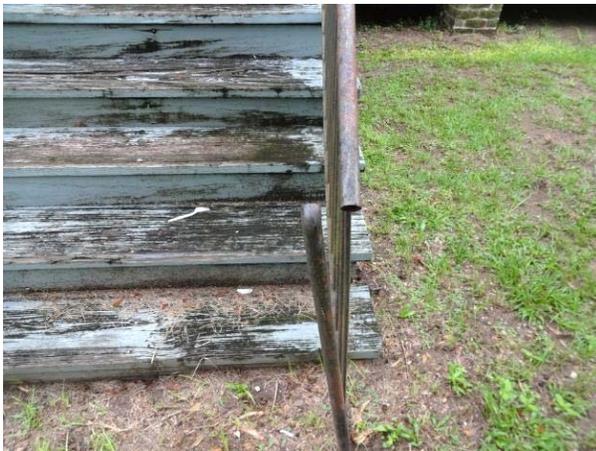
FIGURE 78. The metal railing at the south porch stair is damaged.

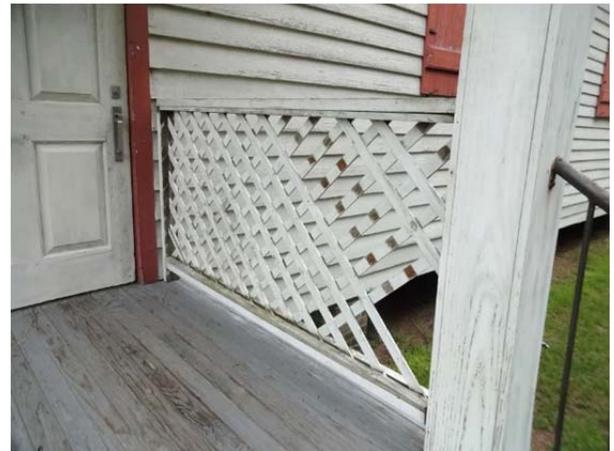
- The wood lattice panels are damaged in several locations, with pieces of wood missing at the porches and accessible ramp (Figure 79).
- The wood stair at the north covered porch is deteriorated (Figure 80).
- Staining and paint failure were observed at the deck and railings of the accessible ramp on the north elevation (Figure 81).
- Widespread failure of the glazing putty was observed at the double-hung windows (Figure 82).
- Isolated glazing units were found to be cracked (Figure 83).

FIGURE 79. Portions of the wood lattice panels are missing at the south porch. This condition was also observed along the accessible ramp.

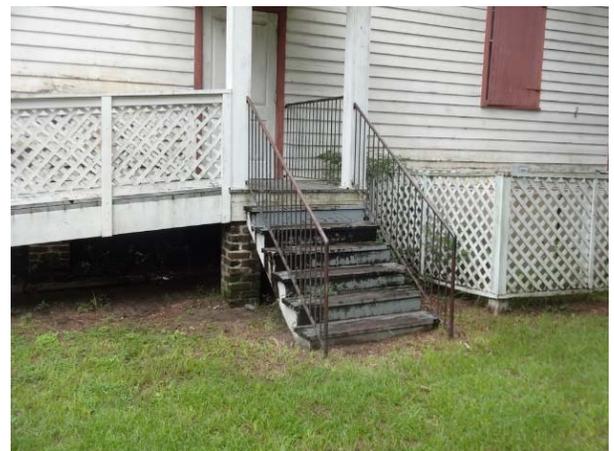
FIGURE 80. Deterioration of the north stair was observed.

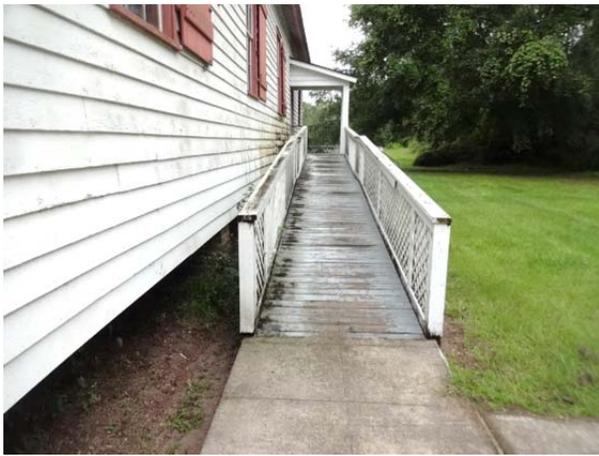
FIGURE 81. Staining and deterioration was observed at the accessible ramp.

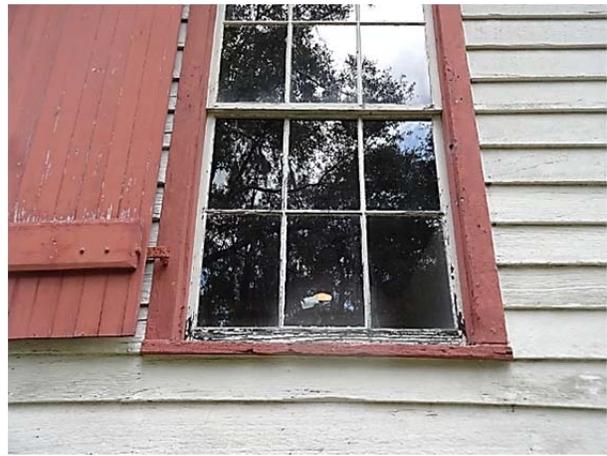
FIGURE 84. Paint failure was observed at several window sash.

- Paint failure was observed on the wood sash of the double-hung windows (Figure 84).
- The lower sash at the window centered on the west elevation is missing (Figure 85). A piece of plywood has been installed to cover the opening.
- Paint failure at the wood doors was observed, particularly on the west elevation (Figure 86).
- Both wood doors on the west elevation are cracked at the upper panels, with tape applied over the cracks (Figure 87).

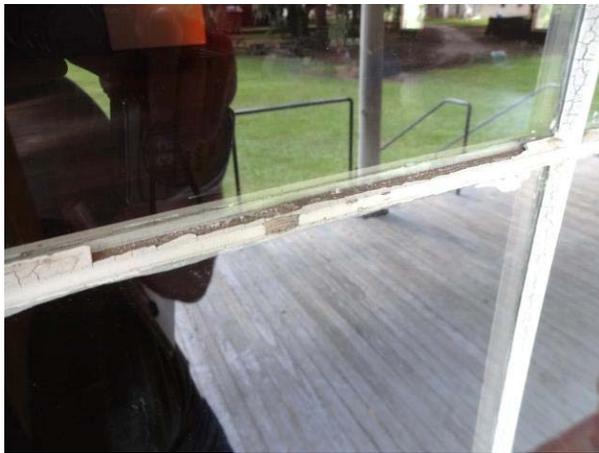
FIGURE 82. Deteriorated and missing glazing putty was observed at several of the wood windows.

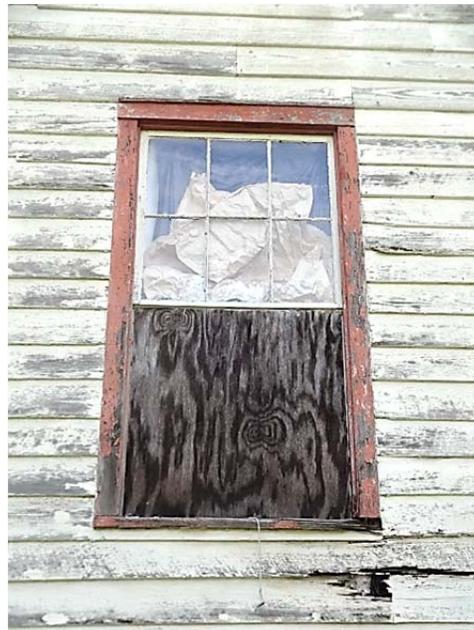
FIGURE 85. The lower sash at the central windows at the west elevation is missing.

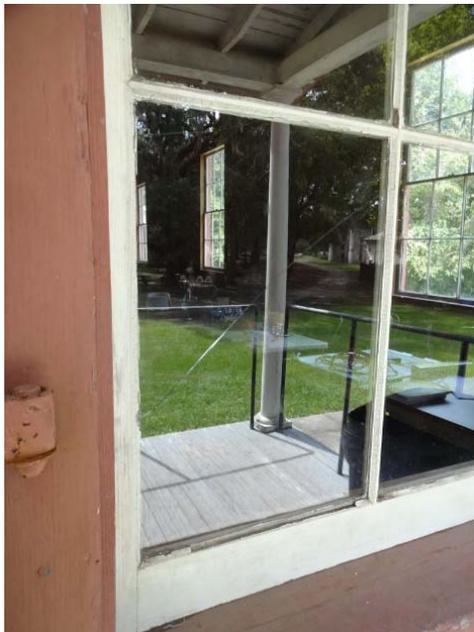
FIGURE 83. Cracking of glazing units was observed at several windows.

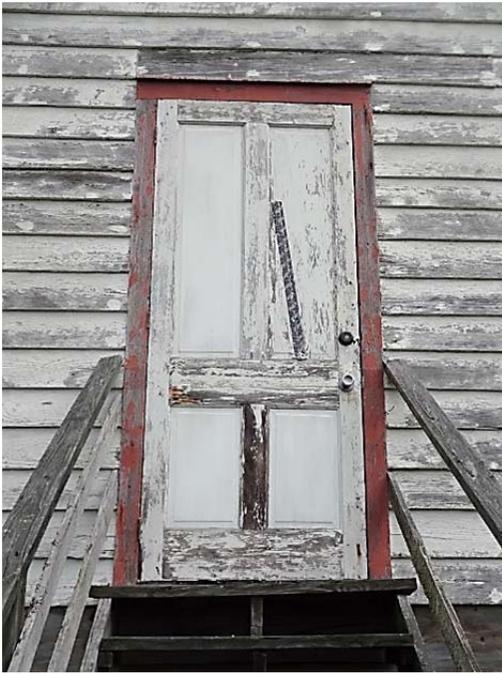
FIGURE 86. Cracks were observed at both doors at the west elevation.

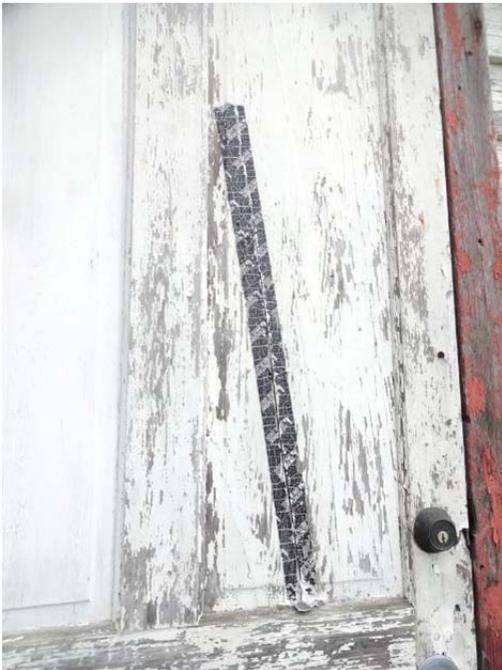
FIGURE 87. Tape was applied over the cracks at the doors at the west elevation.

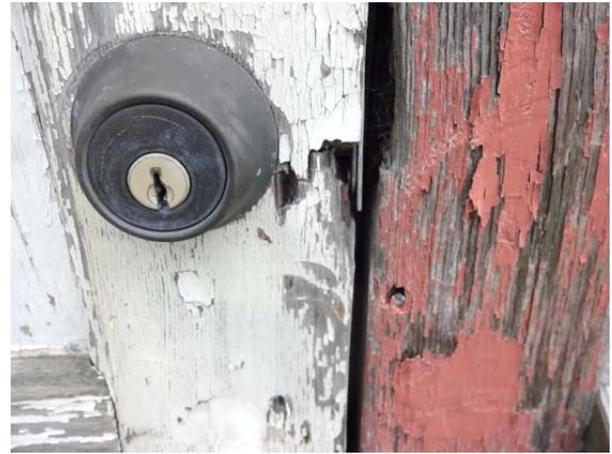
- Isolated deterioration of the doors on the west elevation was noted (Figure 88).
- Staining of the roof over the north covered porch was noted.

FIGURE 88. Isolated deterioration of the doors at the west elevation was observed.

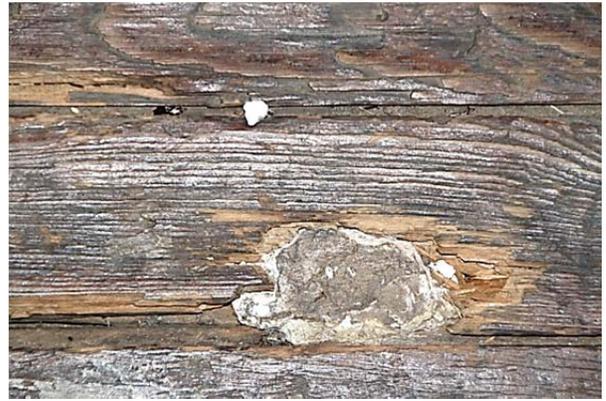
The original flooring is worn, with widespread cracks and splits and numerous holes and gouges (Figure 101). Previous attempts to patch some holes were observed (Figure 102).

FIGURE 102. Hole repair in the floor.

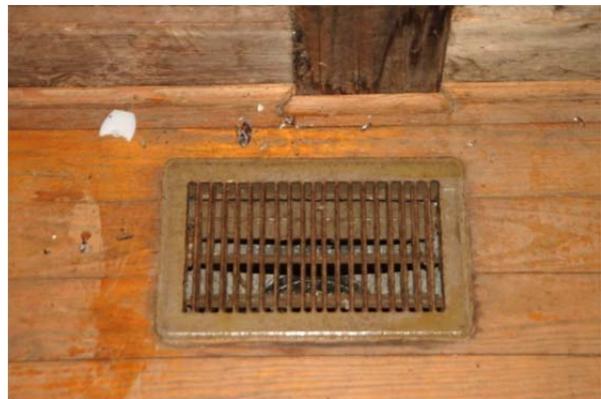
FIGURE 114. Floor register. Note rusted metal grille.

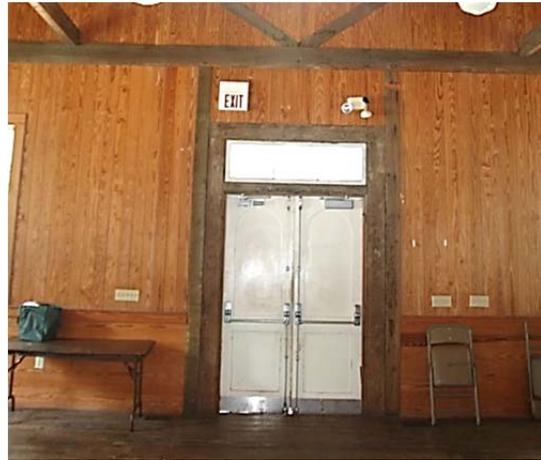
FIGURE 122. Exit sign and emergency light above main entrance. Note broken emergency light.
