Old Firehouse Beaufort, South Carolina Historic Structure Report

Old Firehouse

Reconstruction Era National Historical Park

Historic Structure Report

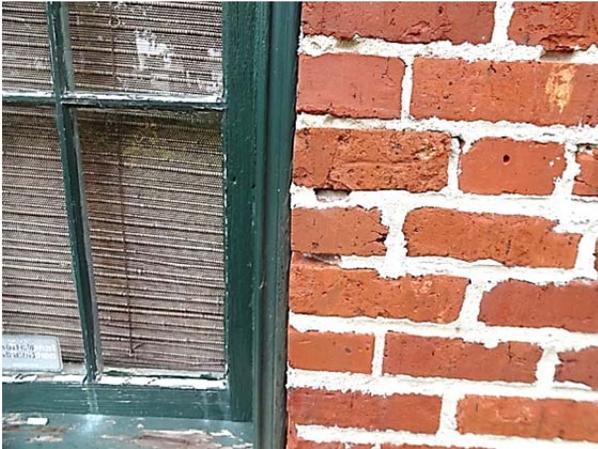
- Cracked and missing mortar was observed in mortar joints throughout the brick masonry facade (Figure 40).
- Isolated cracked brick masonry units were observed particularly adjacent to window openings (Figure 41).

FIGURE 40. Cracked and missing mortar was observed throughout the facade.

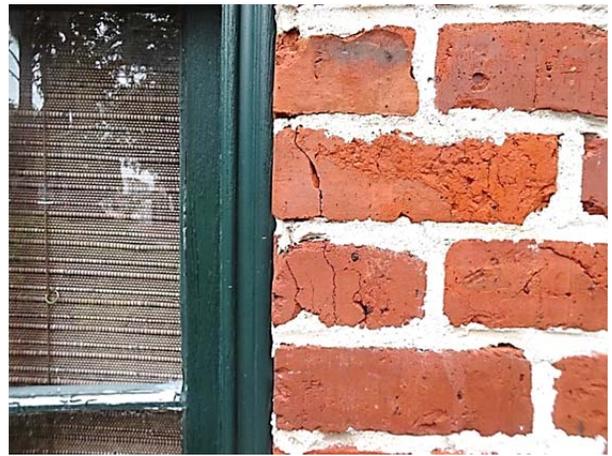
FIGURE 41. Cracked brick units were observed adjacent to window openings.

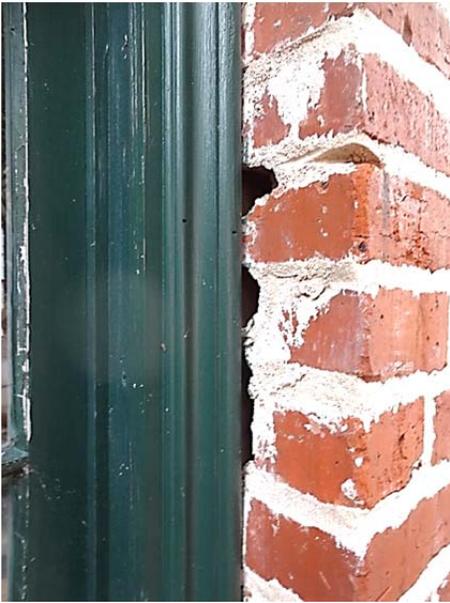
FIGURE 42. Missing and deteriorated mortar was observed adjacent to window openings on the east and south elevations.

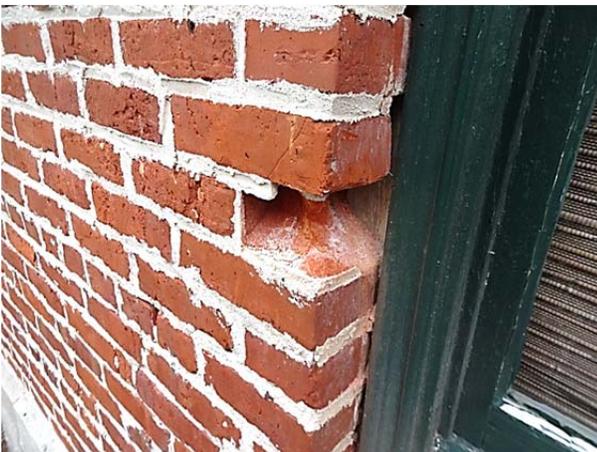
FIGURE 43. A deteriorated and missing brick unit at the edge of a window opening.

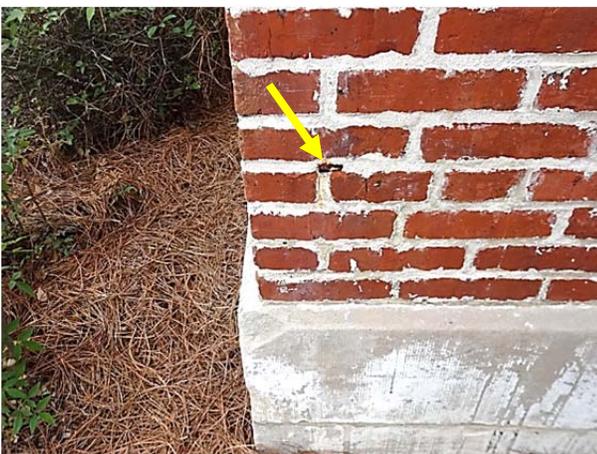
FIGURE 44. Remnant metal anchors were observed at the northwest corner of the building.

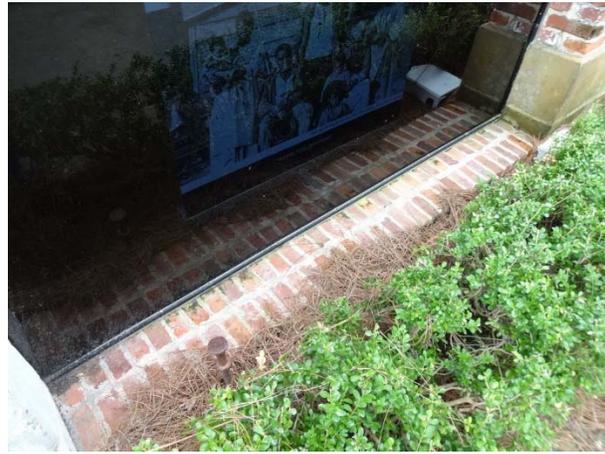
FIGURE 45. Biological growth was observed at the brick sills below the storefront windows.

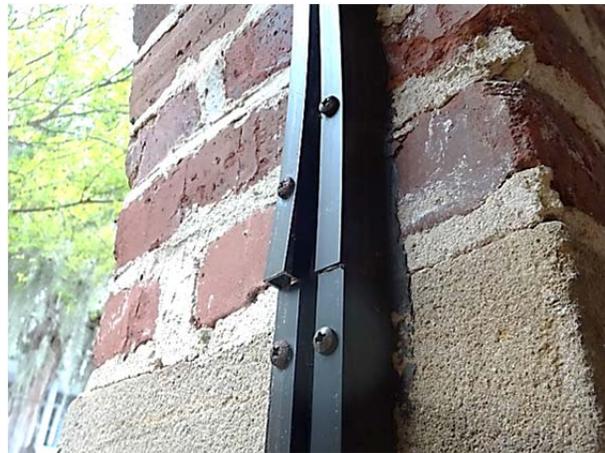
FIGURE 46. A portion of an aluminum frame is displaced.

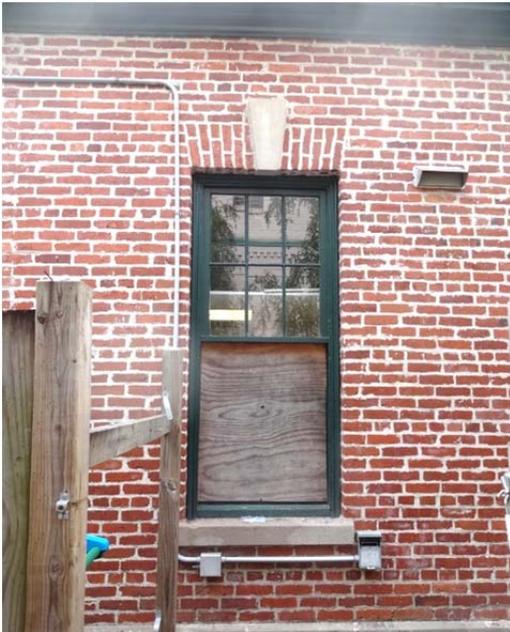
FIGURE 47. The lower sash is missing at the northernmost window on the east elevation.

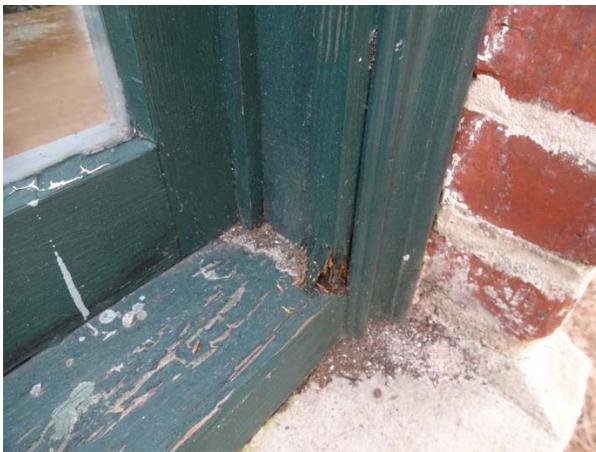
FIGURE 48. Deteriorated wood was observed at many of the wood-framed windows.

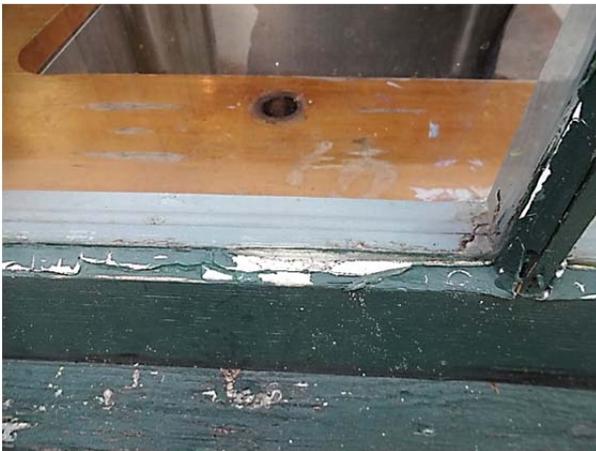
FIGURE 49. Paint failure was observed at the wood windows.

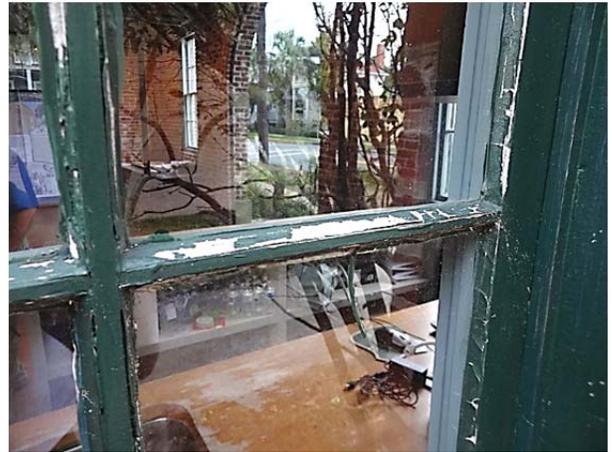
FIGURE 50. Deteriorated glazing putty was observed at the wood-framed windows.

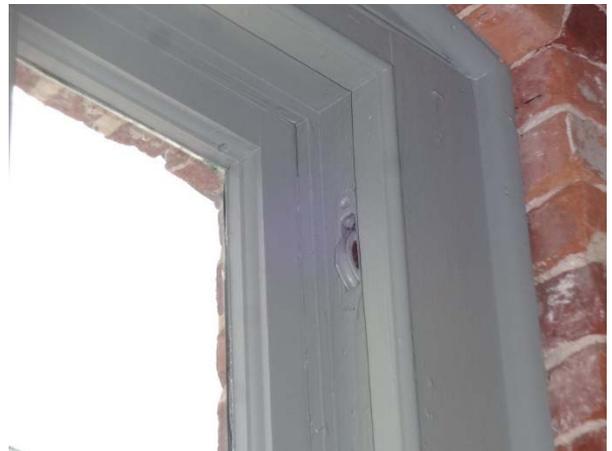
FIGURE 51. Rope and / or chain was missing from the wood double-hung windows.

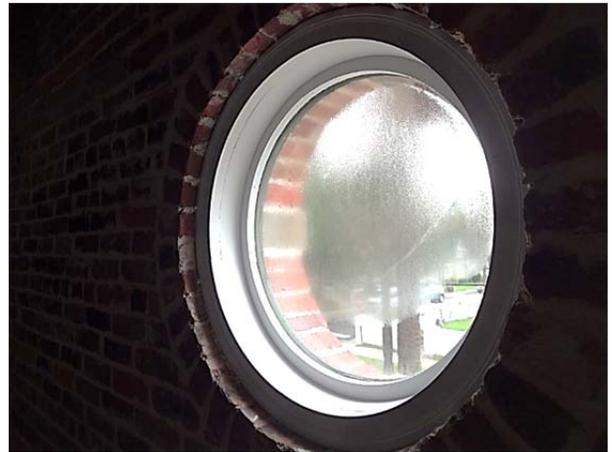
FIGURE 52. The seal of the insulated glazing unit at the north circular window was broken.

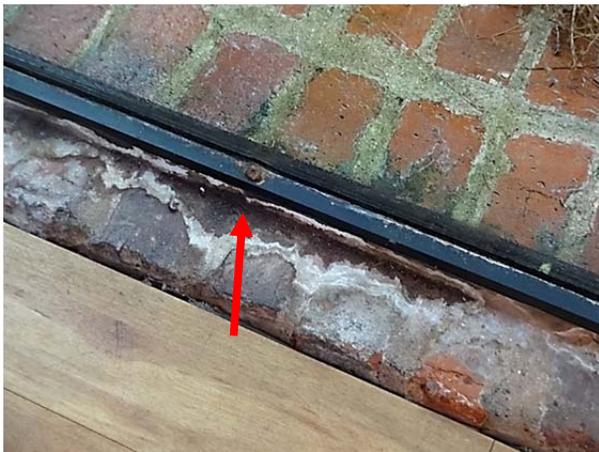
FIGURE 53. Signs of water infiltration were observed at the aluminum-framed windows.

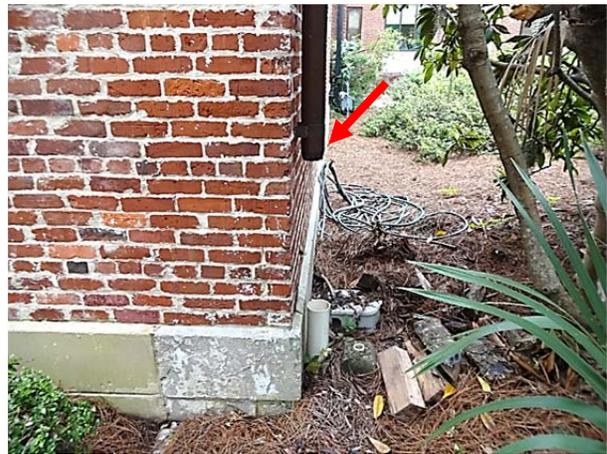
FIGURE 54. A portion of the southwest downspout was missing.

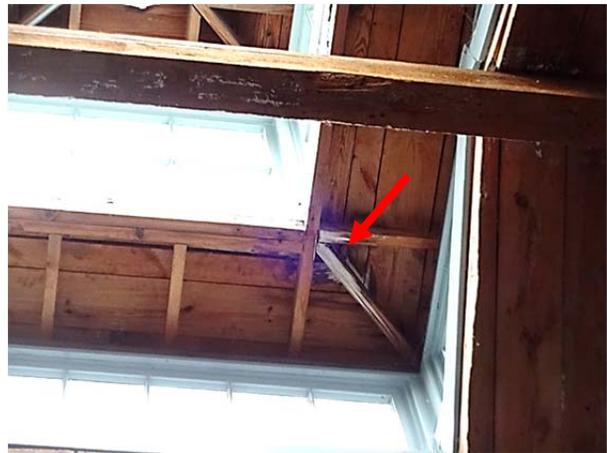
FIGURE 55. Staining was observed at the underside of the cupola at the center of the roof.

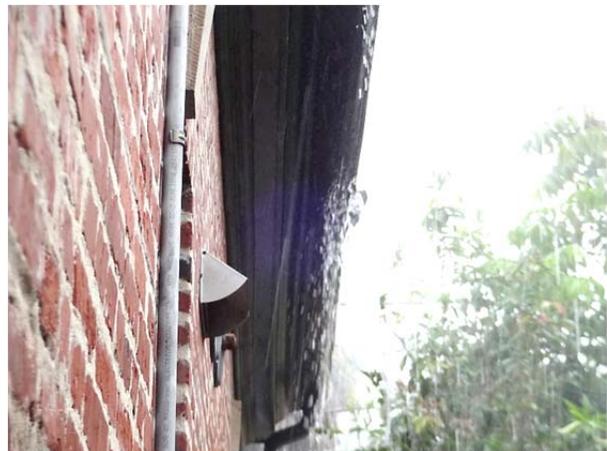
FIGURE 56. Gutters were overflowing with water during a rain storm.

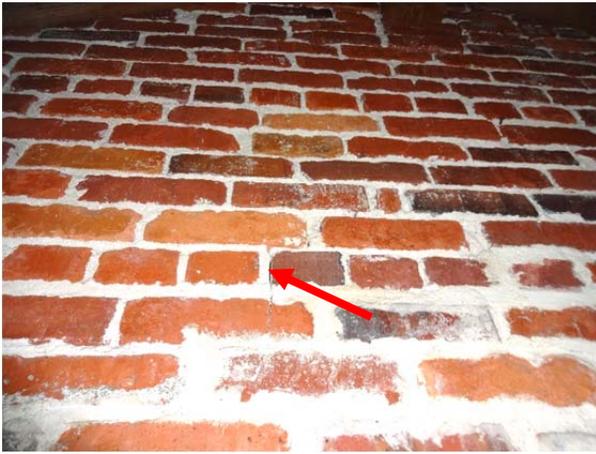
FIGURE 111. A visible crack at interior masonry wall.

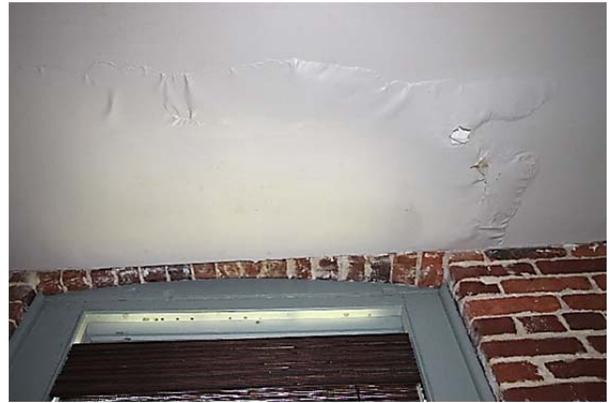
FIGURE 112. Water damage at ceiling in restroom.

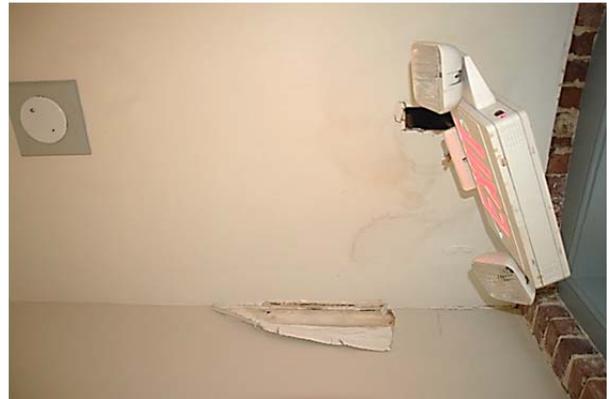
FIGURE 113. Water damage and peeling paint at ceiling in rear exit hall. Note exit sign hanging from conduit.

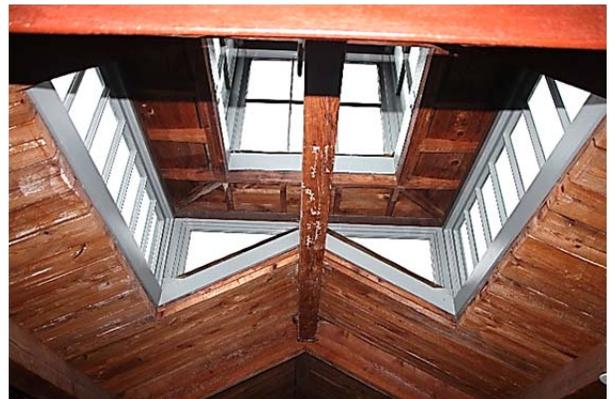
FIGURE 114. Water stains on wood structure at cupola.
