Antram – Gray House

Historic Structure Assessment Report Roger Williams National Memorial

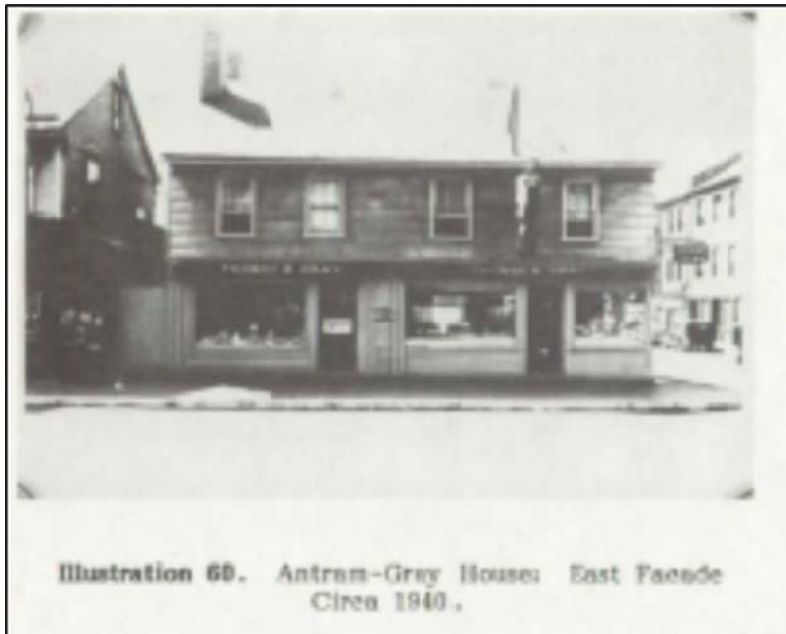
According to the NPS *Historic Structure Report*, this ca 1940 image is the earliest known photo of the Antram-Gray House.

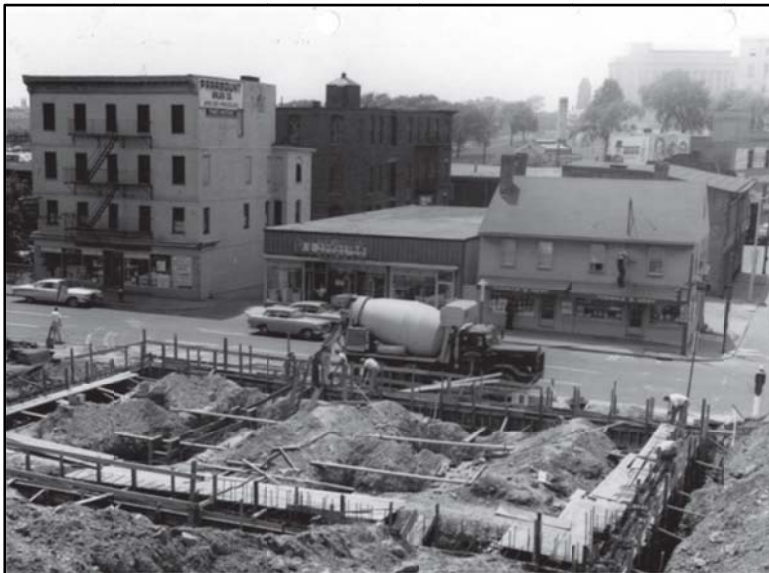
An early image of the Antram-Gray House (ca. 1963) at its original location on the corner of North Main and Smith Street. In the foreground is the foundation for the under construction St. John's parish house. *Figure 1.41 from the Cultural Landscape Report.*

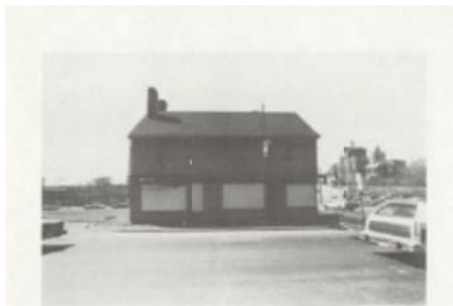
Illustration 68. Antram-Gray House: East Facade.

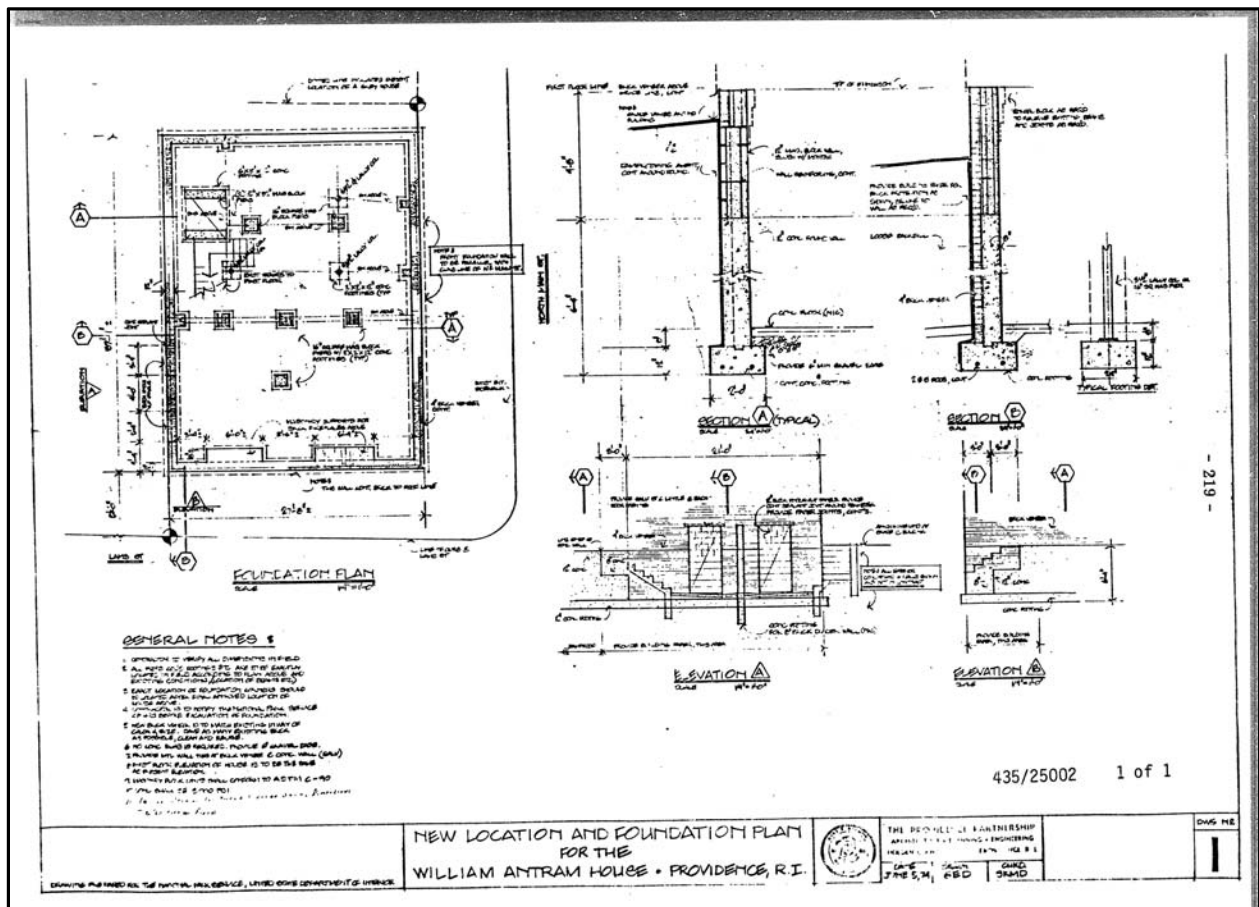
1974 NPS drawing for New Location and Foundation Plan for the William Antram House (Antram-Gray House), 435/ 25002.

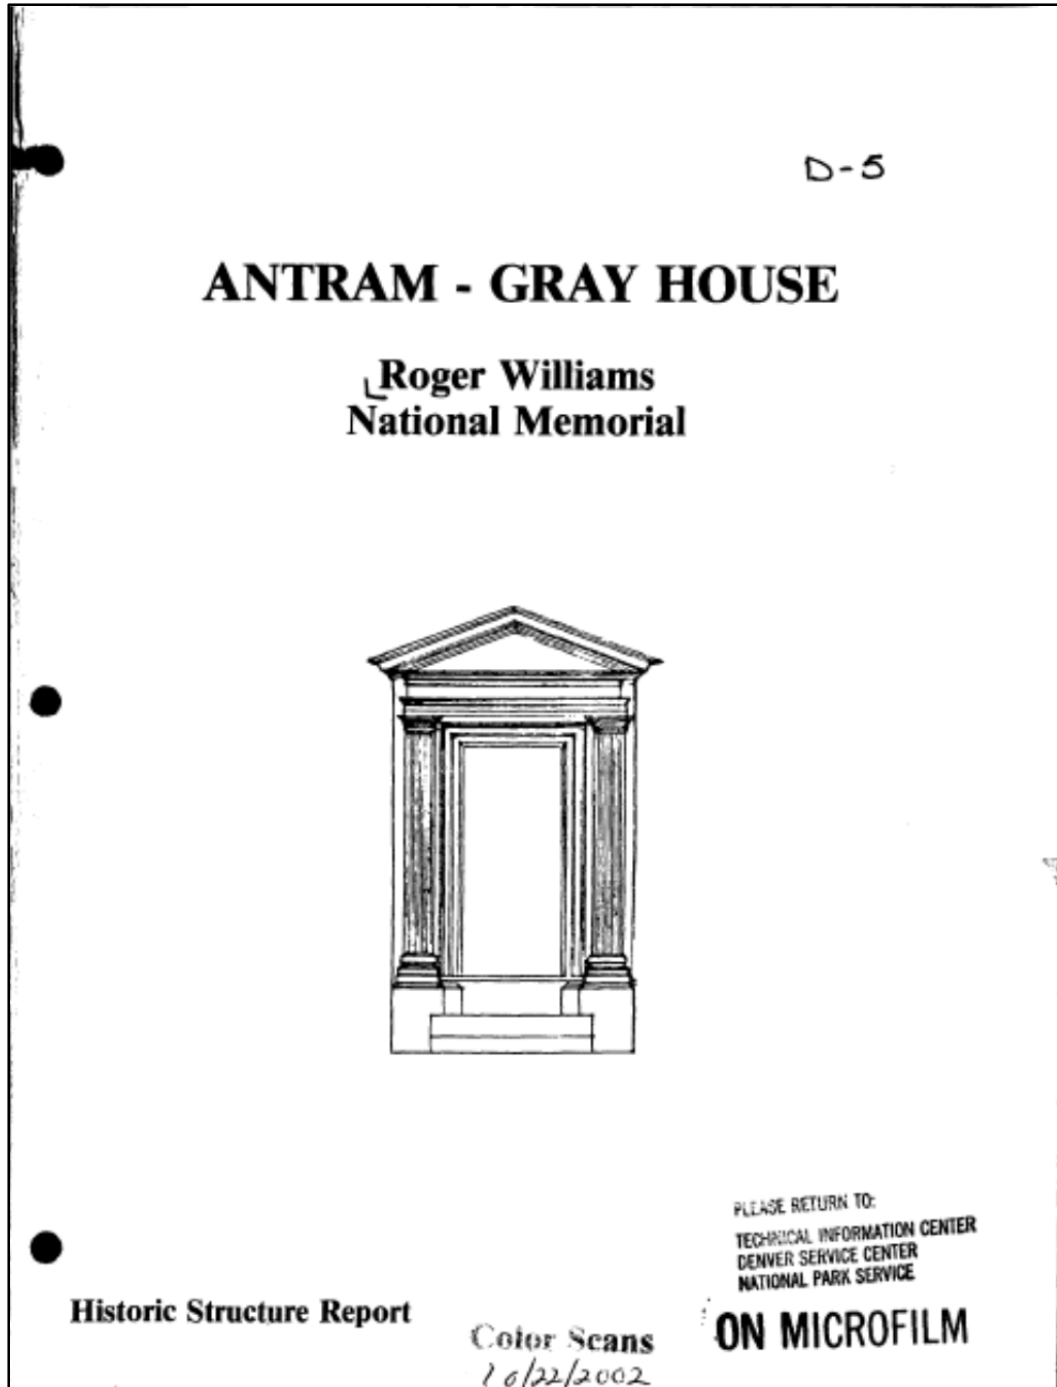
Much of the institutional knowledge of the early history of the Antram-Gray House is captured in the 1981 NPS *Historic Structure Report*, [NPS document number ROWI, 435-D5 (DSC-eTic)]. While thorough for its time it does not present an adequate description of the building frame components, their method of fabrication, or an indication of original (or evolution of) exterior cladding materials. An update to the HSR is one of the recommended management tasks made by this HSAR.

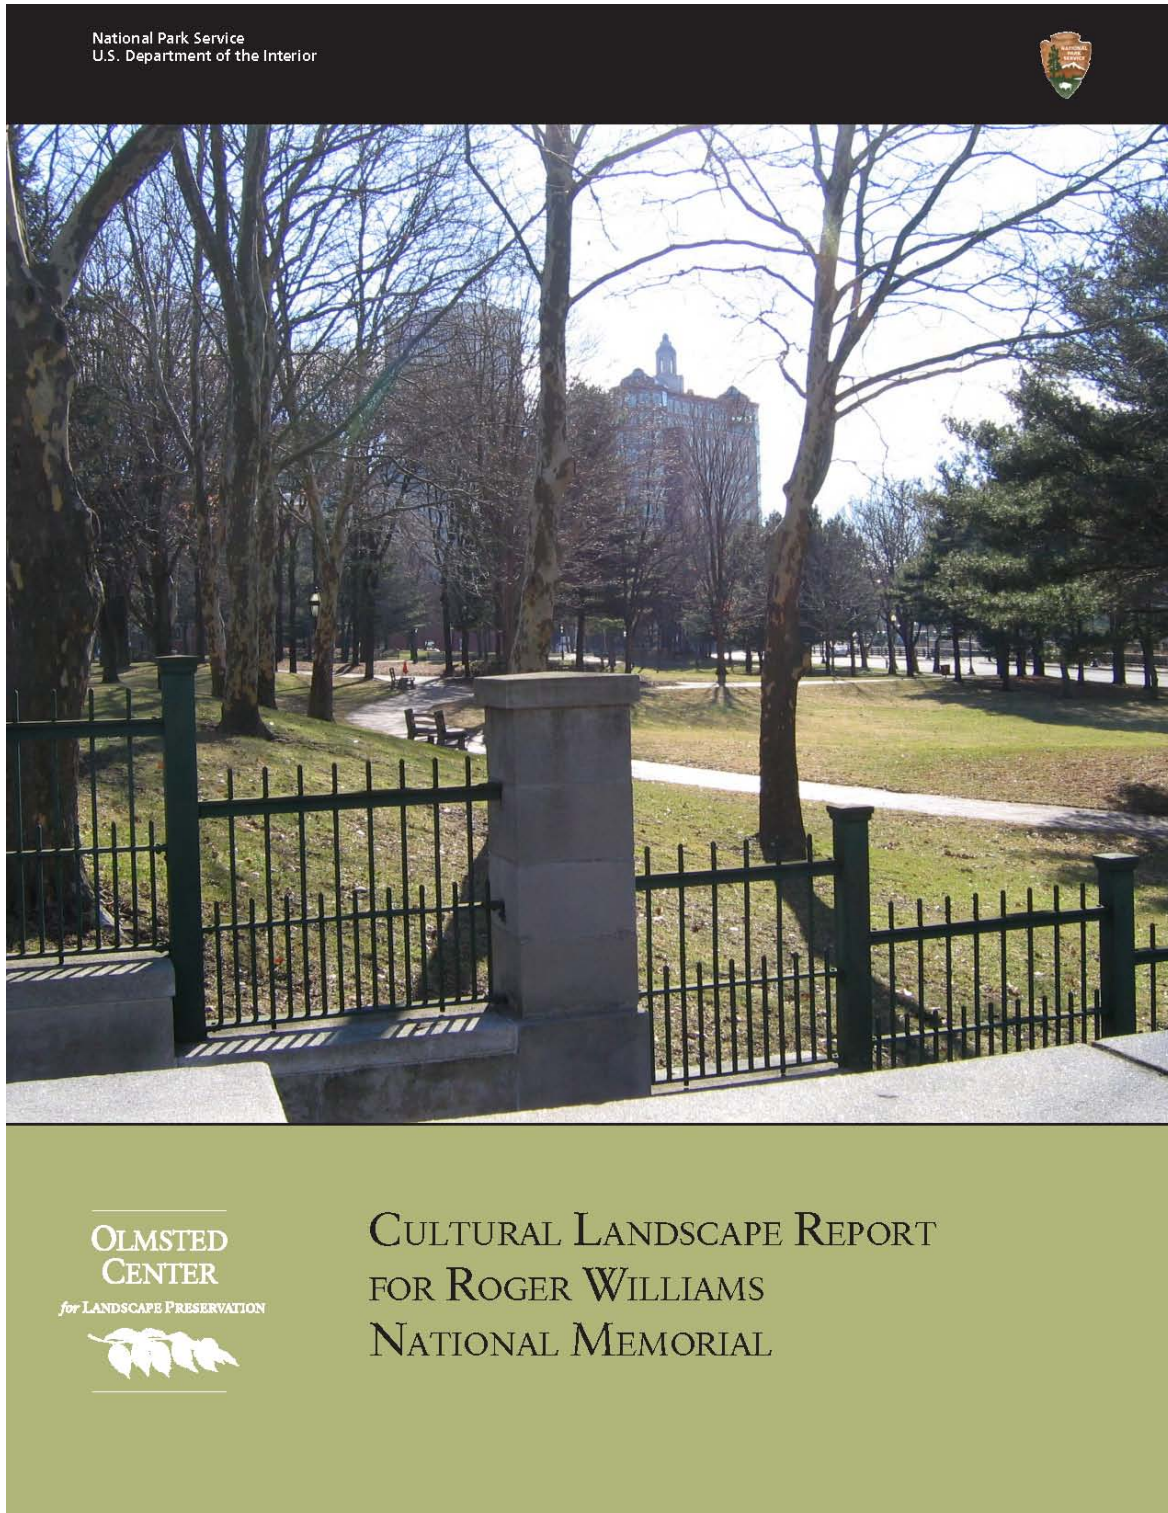
PMIS 53765: Develop a Memorial Cultural Landscape Report with Treatment Recommendations – work completed between 2007 and 2010 by the State University of New York for the NPS Olmsted Center for Landscape Preservation.

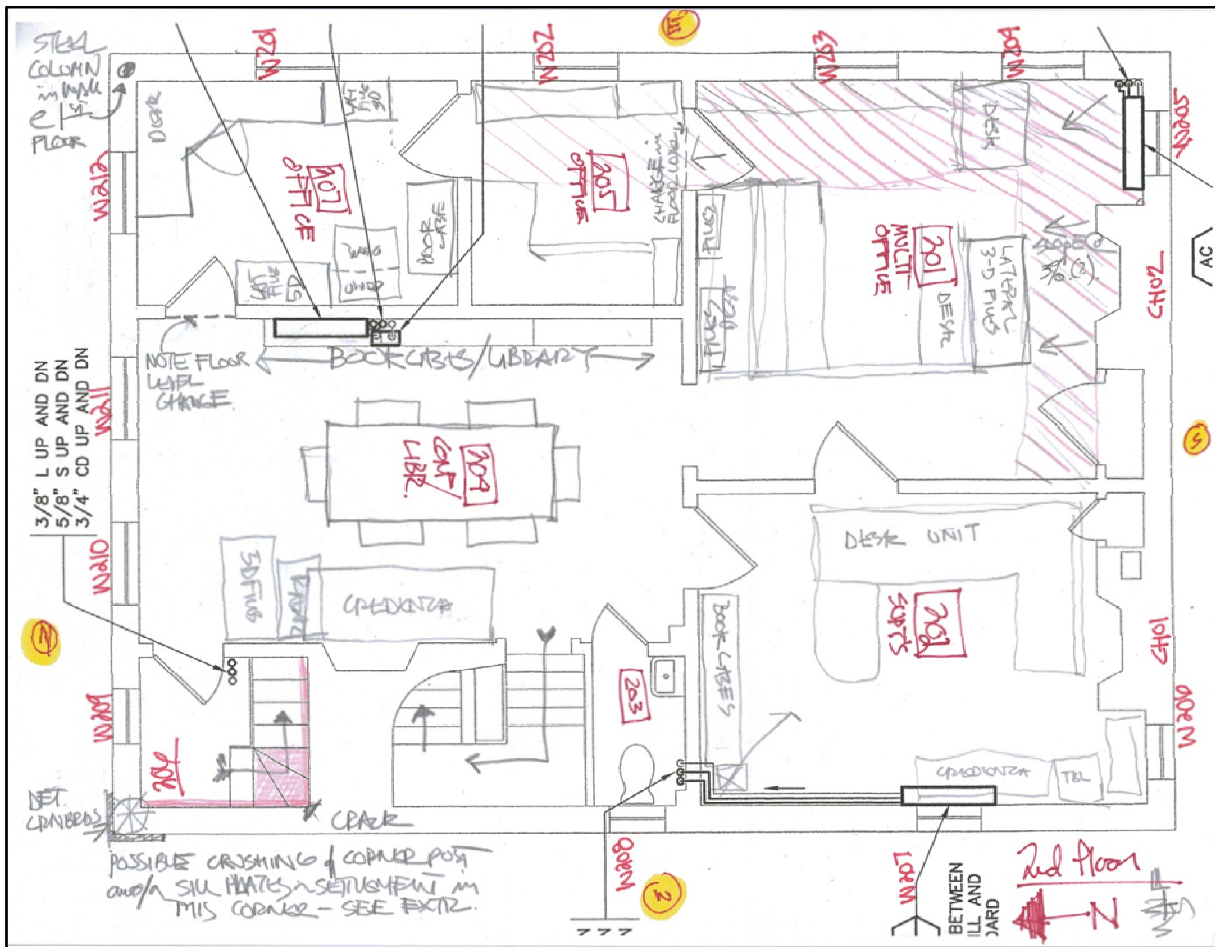
Example of HPTC field notes taken as part of HSAR project (July 2014).

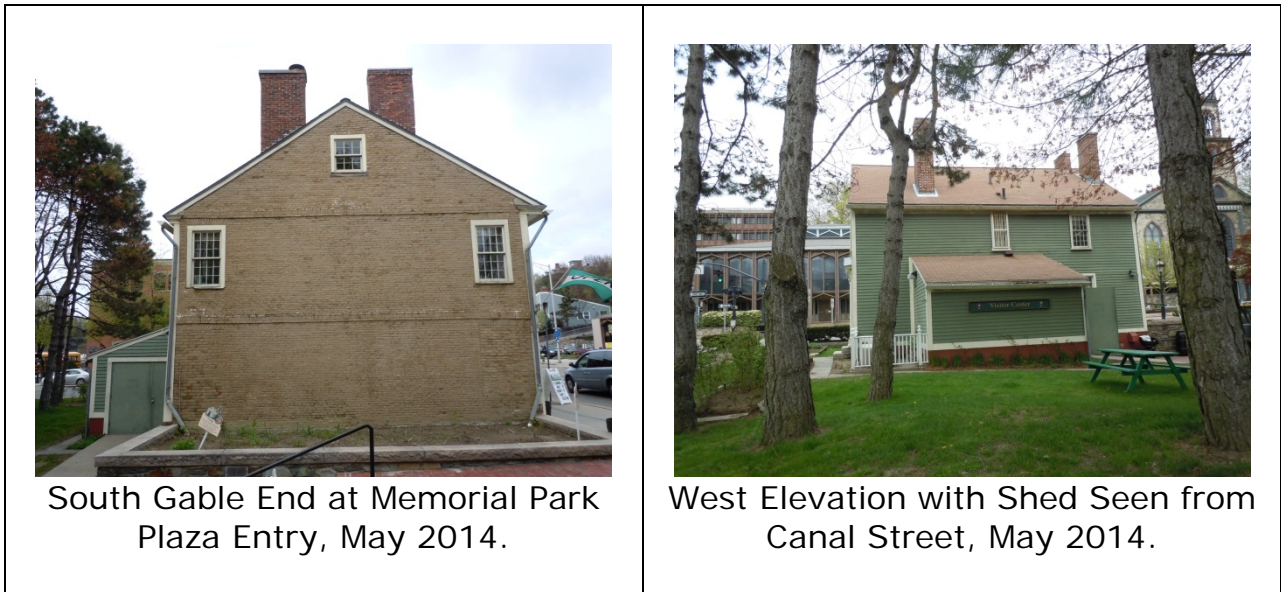
The HSR goes on to fully describe the architectural characteristics in later sections of the report, not repeated here.

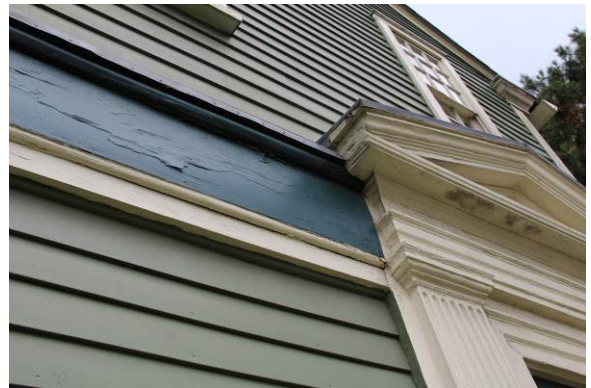
The triangular pediment supported by fluted doric style pilasters is the oldest surviving exterior architectural feature found on the Antram-Gray House.

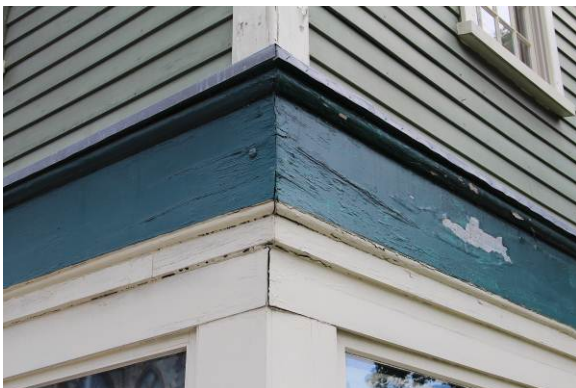
Late 19th- early 20th C. fascia board ties together later 20th C. storefront detailing.

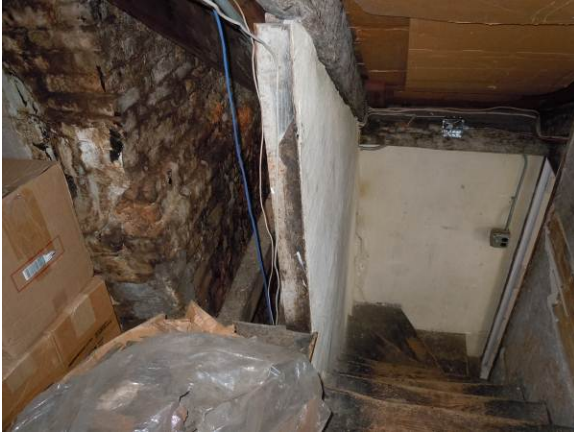
Historic interior plaster (c.1798) and winder stair between 2nd and attic floors, chimney shaft to left of image.

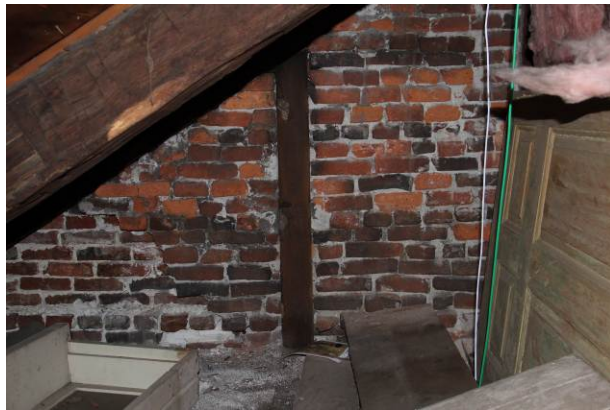
Unpainted (repaired) interior wall surface of south gable wall from attic.

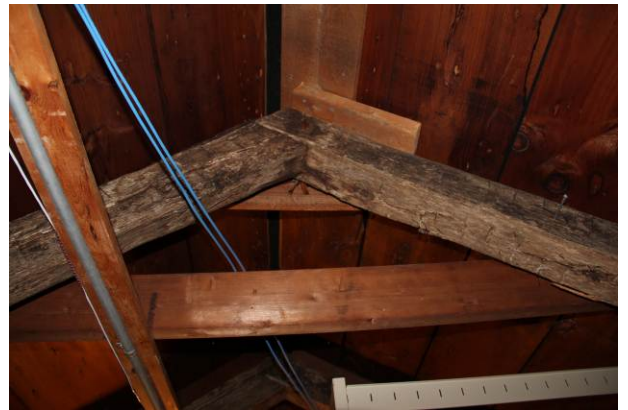
View of roof rafters pinned at ridge with replacement roof sheathing and supplemental bracing to support roof frame.

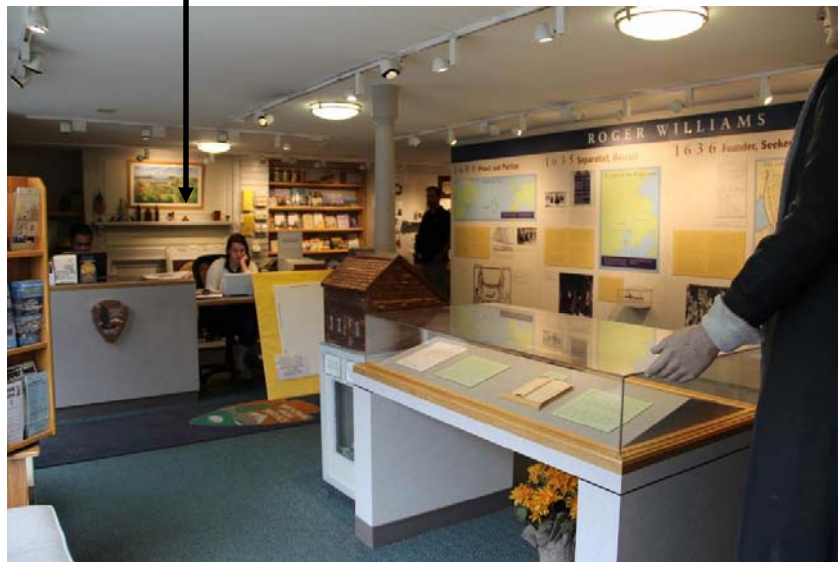
Historic fireplace partially visible behind visitor contact desk and east of book sales shelves (arrow). Other significant architectural woodwork is completely hidden behind interpretive panels at north elevation.

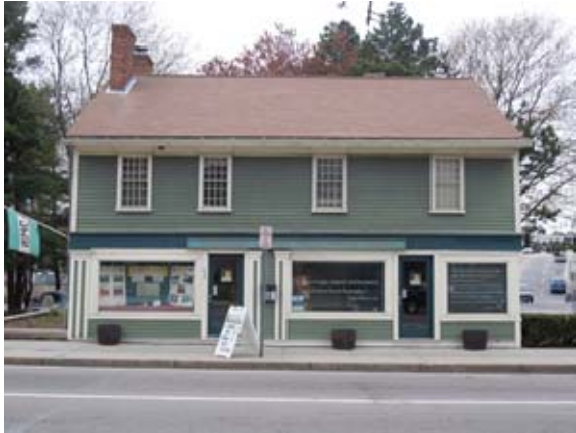
East Elevation at North Main Street. Fiberglass shingle roof lacks texture and color of traditional character-defining wood shingle roof.

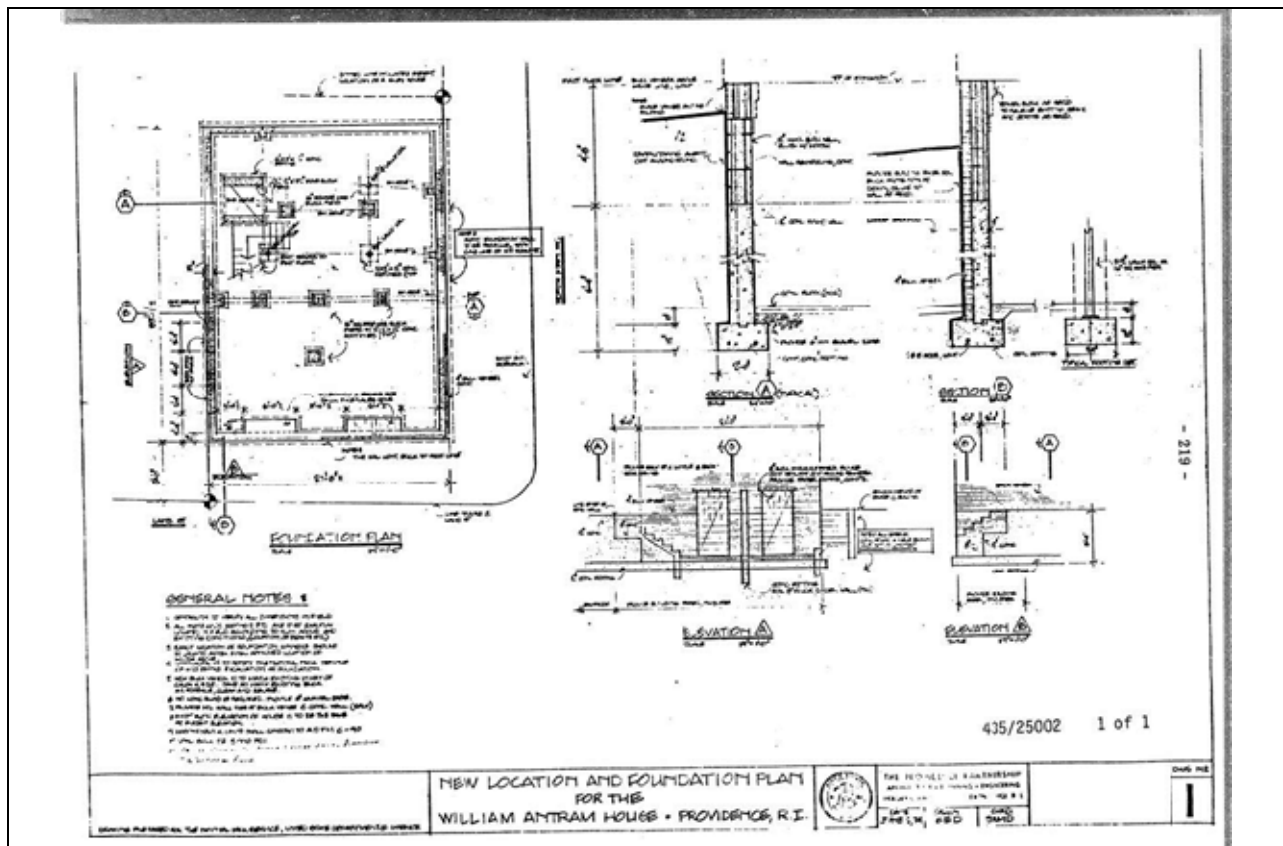
An early treatment of the Antram-Gray House was its relocation and the construction of a new foundation ca. 1974-75.

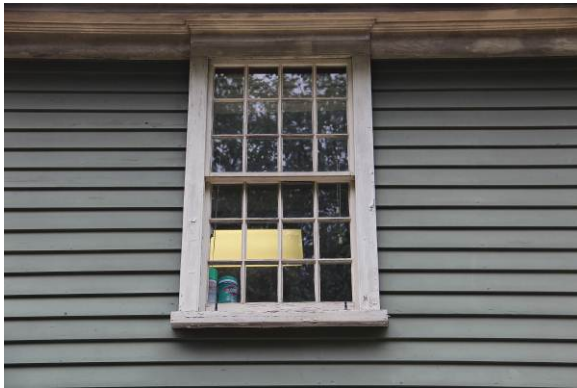
Typical deteriorated exterior window condition, July 2014.

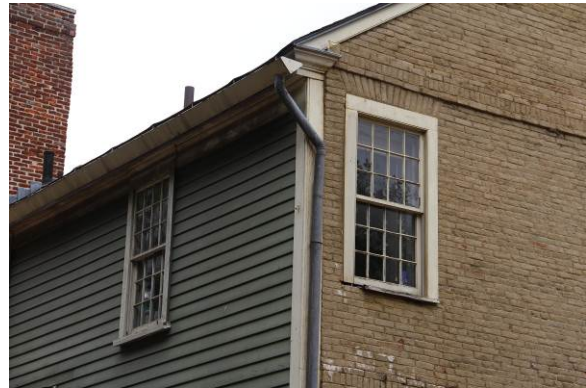
Accelerated deterioration of exterior window components, July 2014.

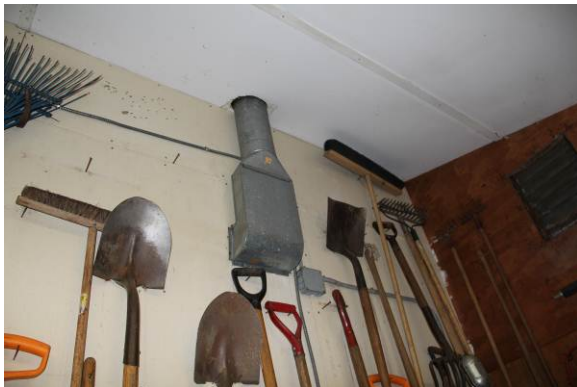
Penetrations in shed ceiling negate any fire separation offered by rated materials. According to NPS construction drawing it is 1/2 inch gypsum board; this assembly does not achieve a 1 hour fire resistant rating.

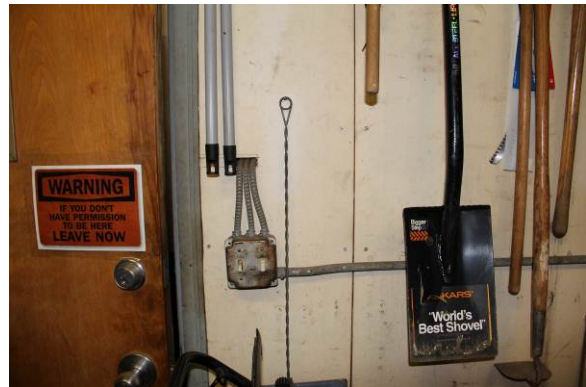
Penetrations through Type X wall board (1 hour fire rated material) are deficiencies in the fire resistant rated enclosure of the maintenance shed and void the 1 hour rating.

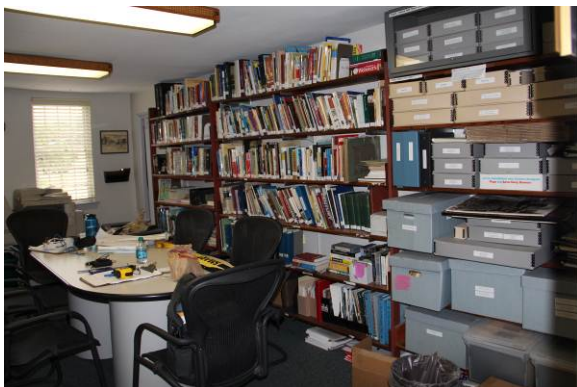
Possible over-stressing of historic post and beam structure due to overloading of interior spaces.

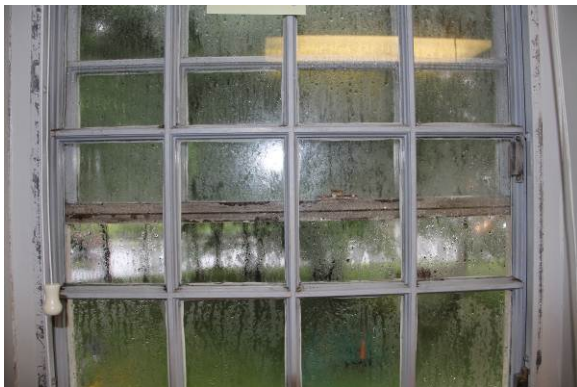
Typical non-historic replica interior window condition with interior storm window frame.

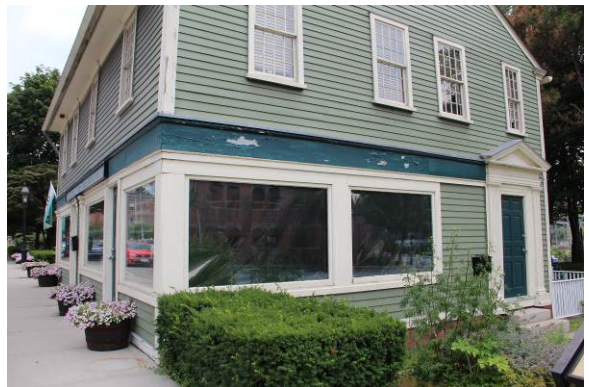
Condition of exterior painted surfaces, July 2014.

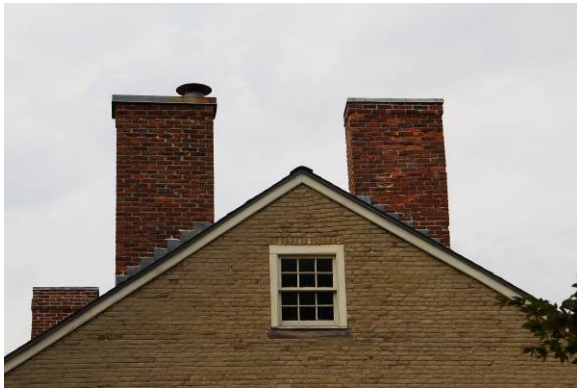
Capped and sealed chimneys at south gable elevation.

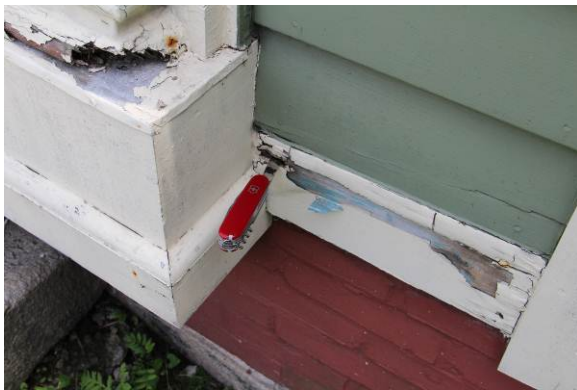
Deteriorated exterior building features at north elevation door.

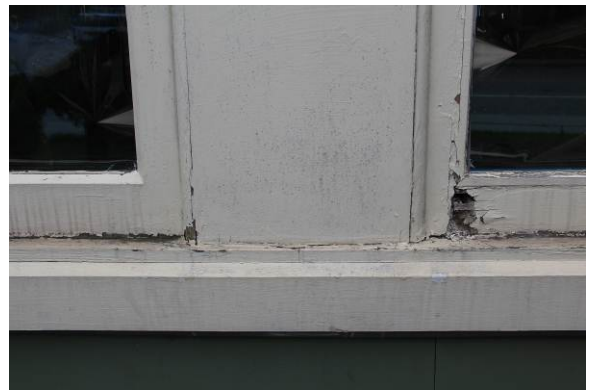
Deteriorated storefront window frame at east elevation.

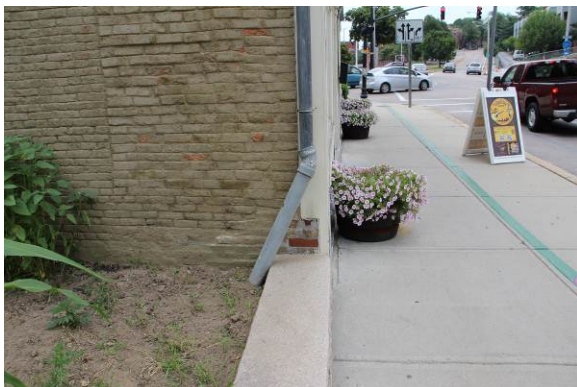
Improper installation of downspout connection to underground drainage system (may be a temporary repair).

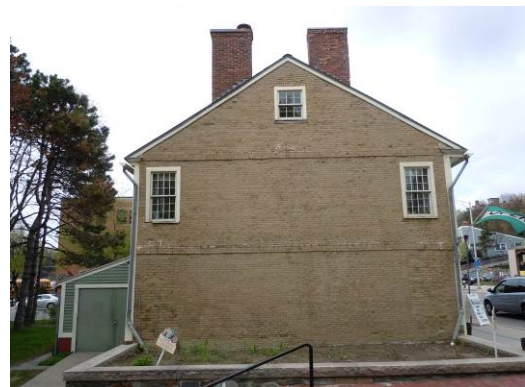
Both building downspouts discharge entire roof water output into planted bed adjacent to historic south brick gable. It is unclear if there is an underground drainage line or foundation waterproofing in this vulnerable area.

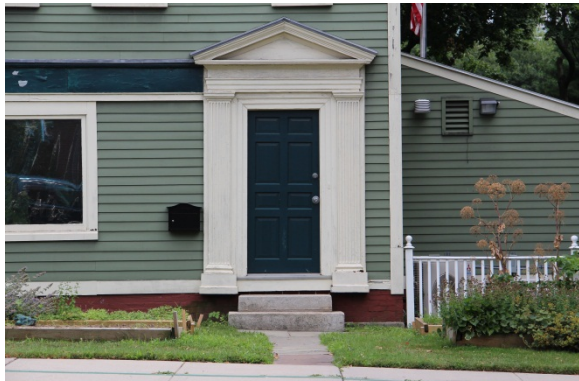
Exposed portions of foundation at north elevation.

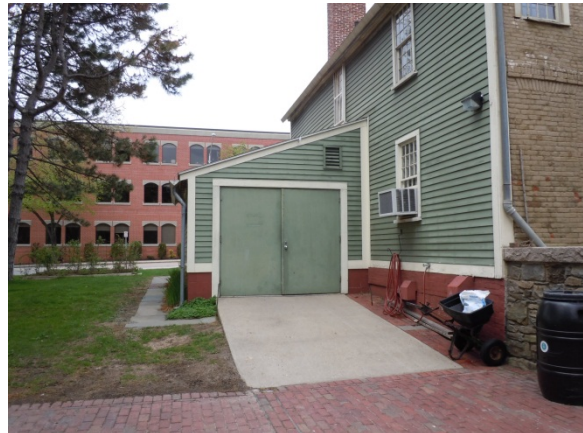
Exposed portions of foundation at west and shed elevations.

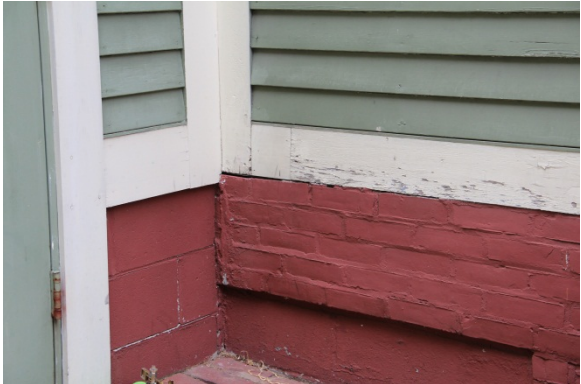
<p>Detail of brick veneer at north elevation.</p>	<p>Detail of brick and block construction at west elevation at intersection with shed addition.</p>
<p>A1010-1</p>	<p>Standard Foundations (House)</p>
<p>Qualitative Condition Rating</p>	<p>GOOD</p>
<p>Maintenance Deficiency Rating</p>	<p>Minor</p>

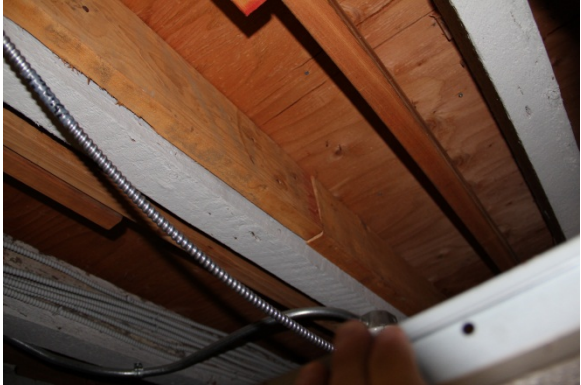
<p>Supplemental framing is clearly seen alongside white painted historic floor joists.</p>

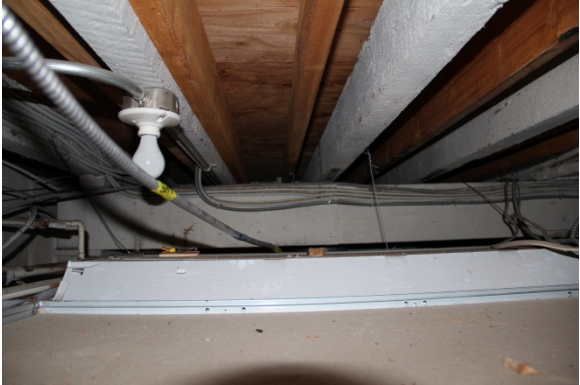
<p>Historic joists (white) are seen sandwiched between modern framing members installed when 1st floor was renovated (see also plywood sub floor system).</p>
B1010		Floor Construction – Overall (Main Block)	
Qualitative Condition Rating:		FAIR	
Maintenance Deficiency Rating:		Serious

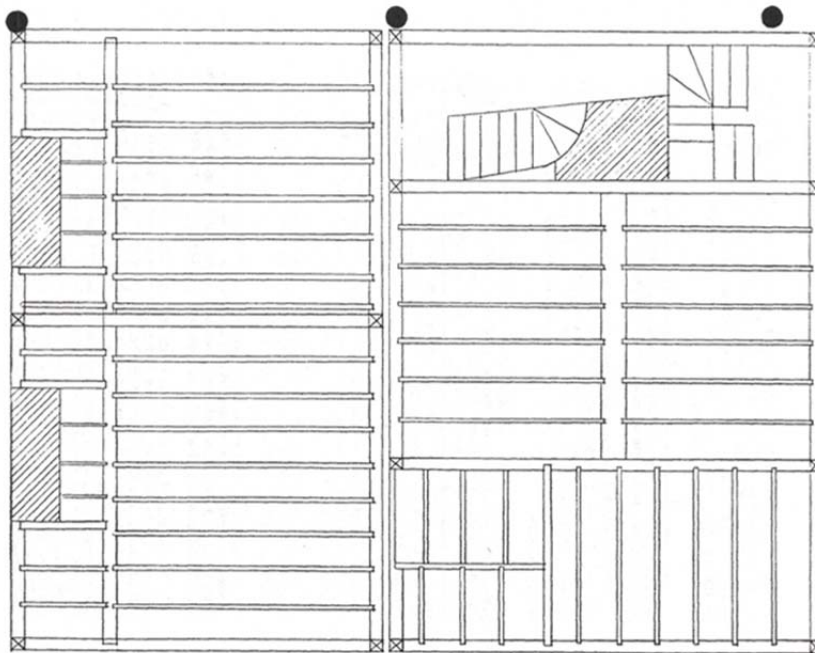
Illustration 21. Antram-Gray House: Second-Floor Framing Plan. Scale 1/4" = 1'-0"

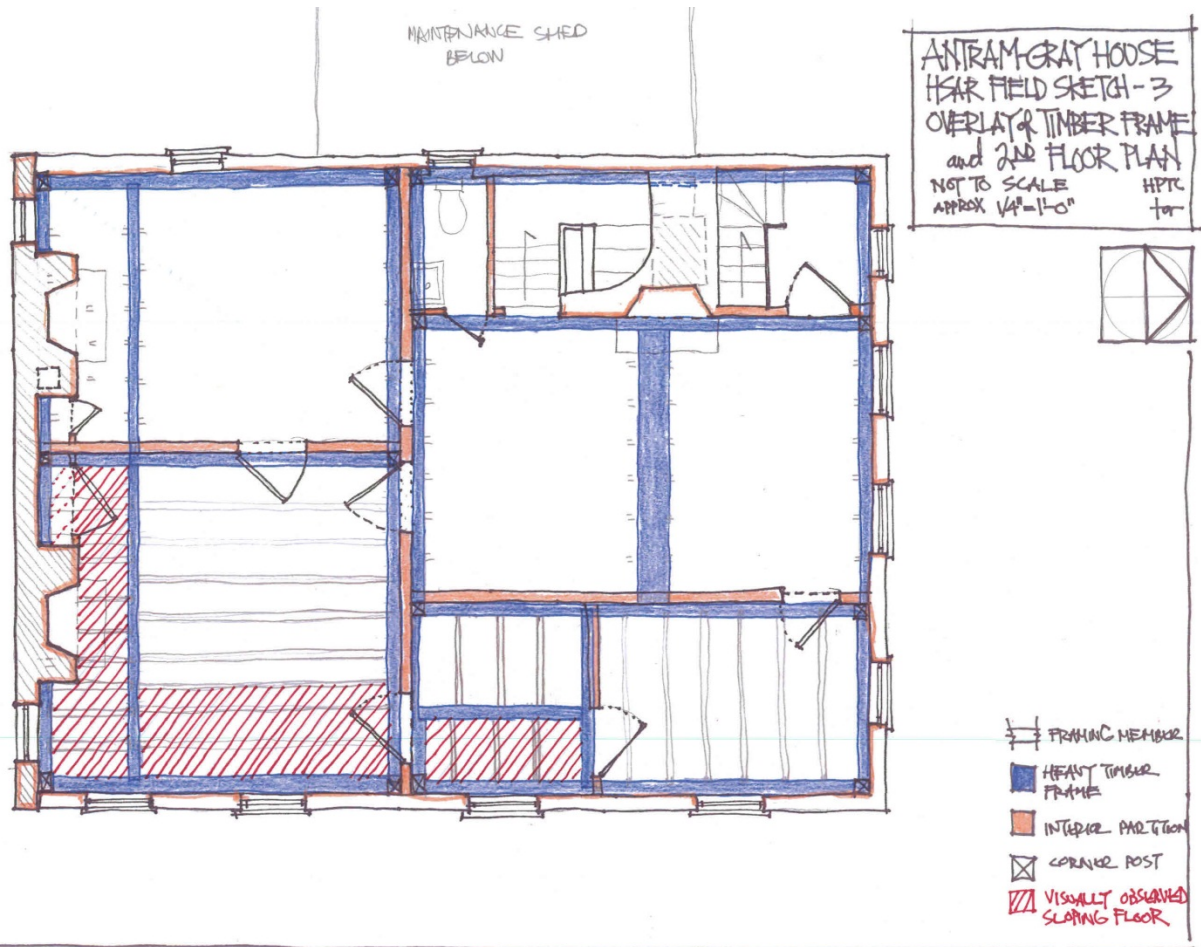
This sketch plan (not to scale) illustrates areas of visually observed sloping floor (red hash lines) overlaid on the 2nd floor; these spaces are currently occupied by staff offices. In this plan the interior walls are illustrated by the orange wall lines and the heavy timber frame is illustrated by the blue lines. Not all frame members are shown, only those in the areas occupied by sloping floors.

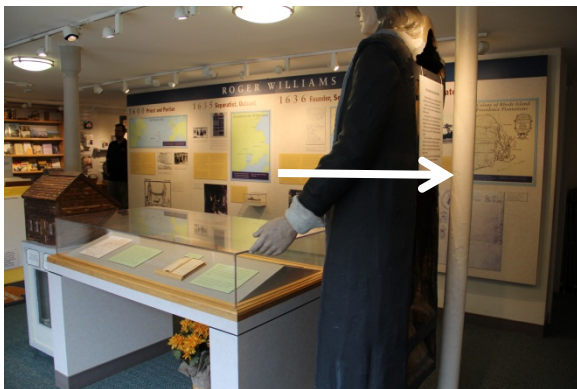
Metal column is used in lieu of original wood corner post in the visitor contact area.

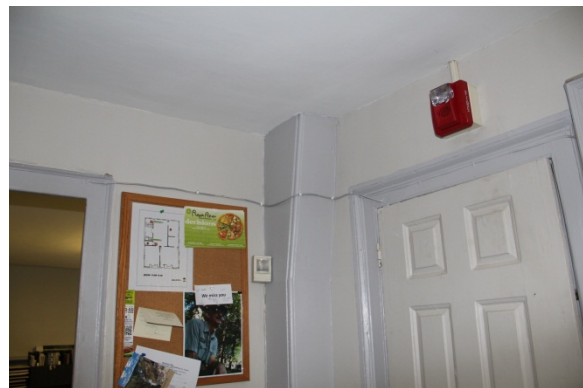
Beaded gunstock column visible on 2nd floor is part of primary structural system (structural frame).

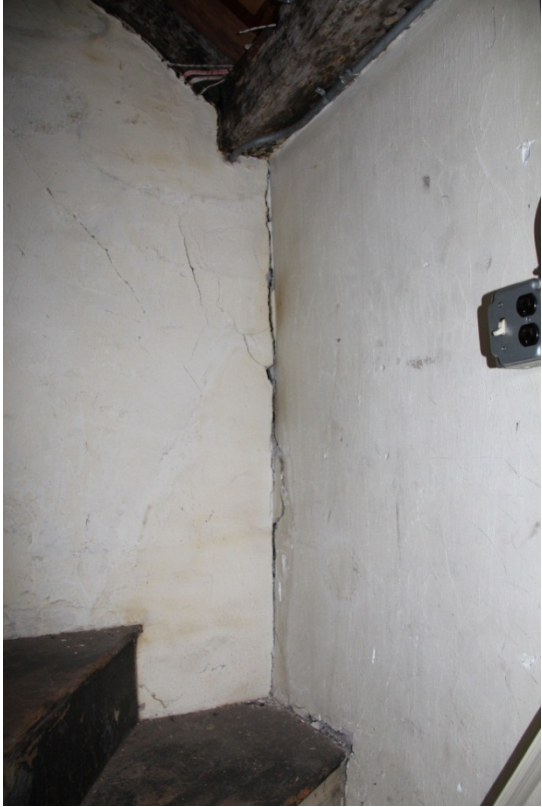
<p>View of interior crack at historic plaster wall within enclosure of northwest winder stair. Crack may be associated with deterioration of the northwest corner post or perhaps crushing of the sill plates as this area exhibits deterioration of exterior cladding and corner-boards.</p>

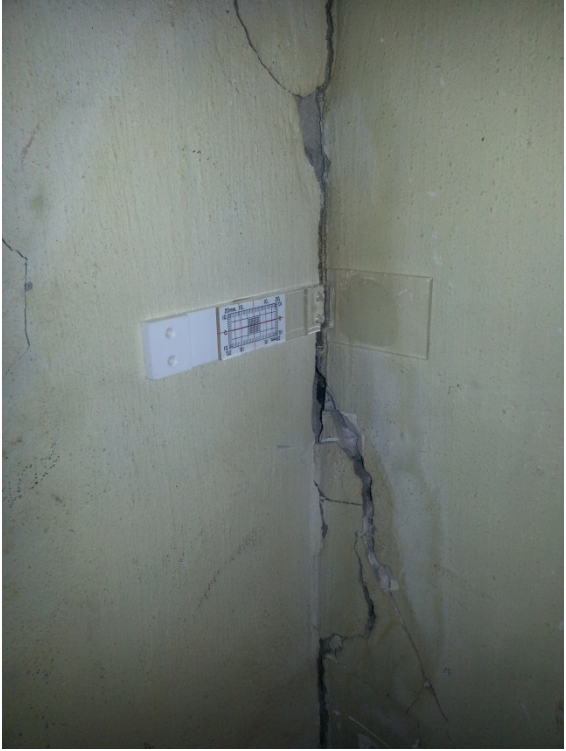
<p>Avongard style crack monitor installed by ROWI maintenance staff, July 2014. Park should monitor on a monthly basis and record any movement from initial setting on chart provided with monitor. Changes in movement may indicate cyclical, seasonal or steady movement over time and will assist in future treatment recommendations.</p>
--	--

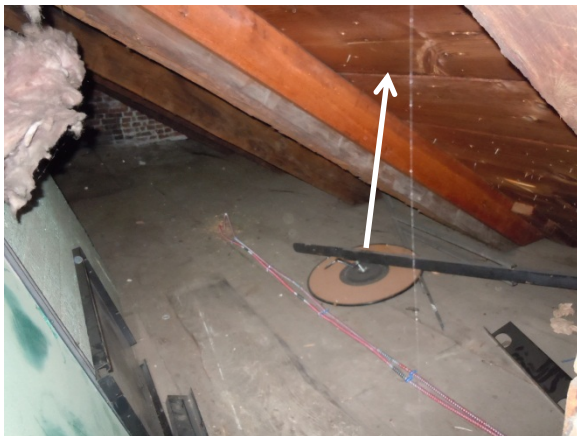
View of supplemental framing (lighter colored wood) installed along-side historic rafters. Note the roof sheathing has been replaced with modern materials.

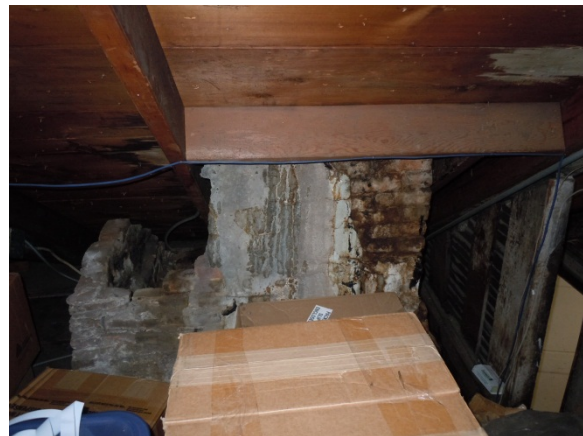
Area around chimney CH03 which has been reframed as part of a renovation project. Plywood has been used as the roof sheathing and substrate for the exterior three-tab shingle roof.

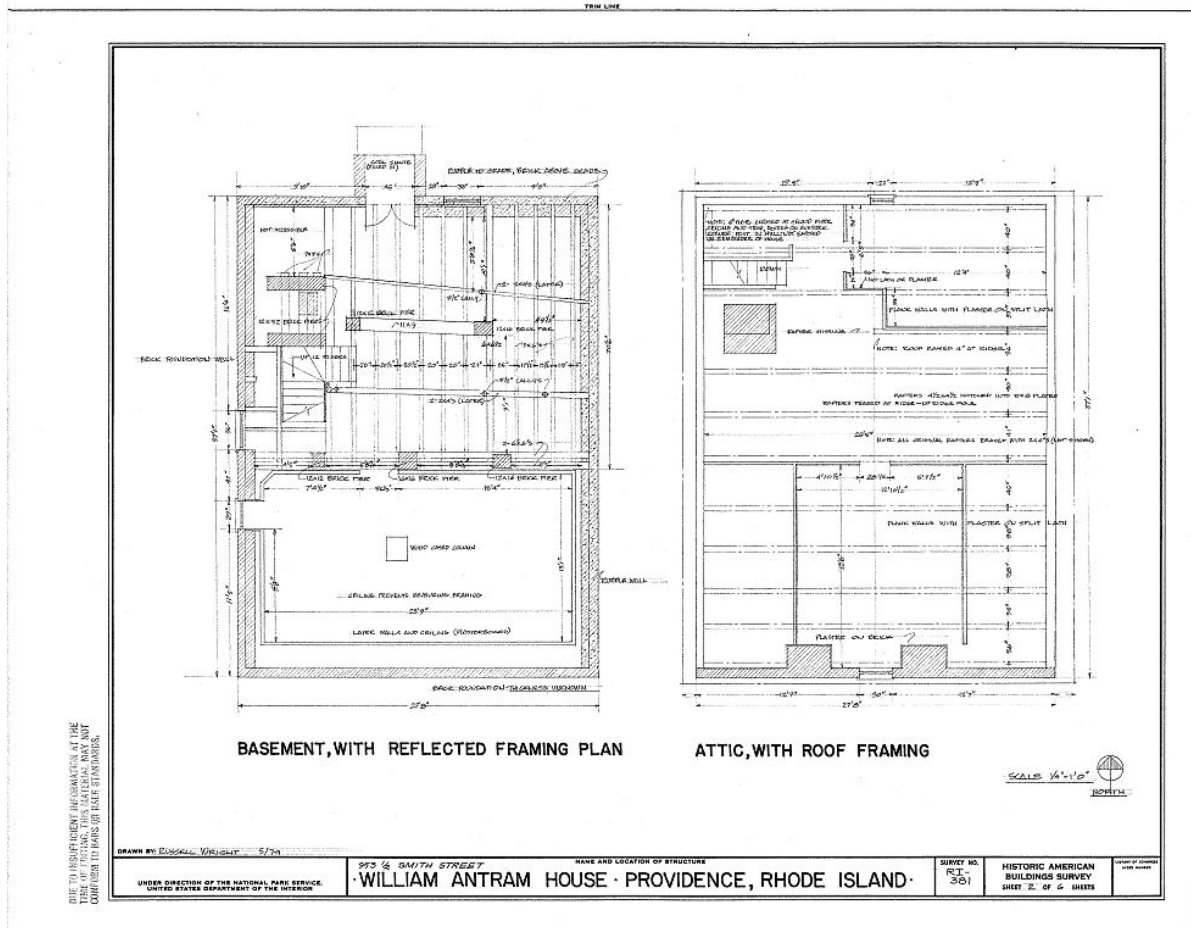
Sheet 2 of the HABS drawings show the attic roof framing plan as it was in 1974; supplemental framing members have been added but not recorded in any of the NPS materials available at this time.

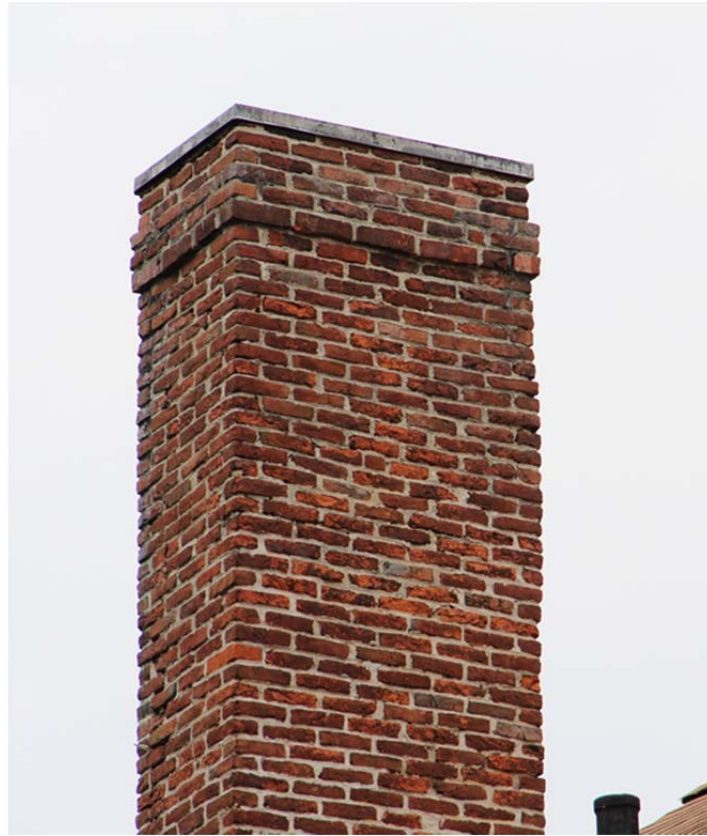
View shows areas of spalled brick faces (lighter orange areas) indicating areas of brick deterioration possibly derived from capped chimney and trapped interior moisture of exposed brick chimney shafts. Sheet metal cap is evident at top of chimney.

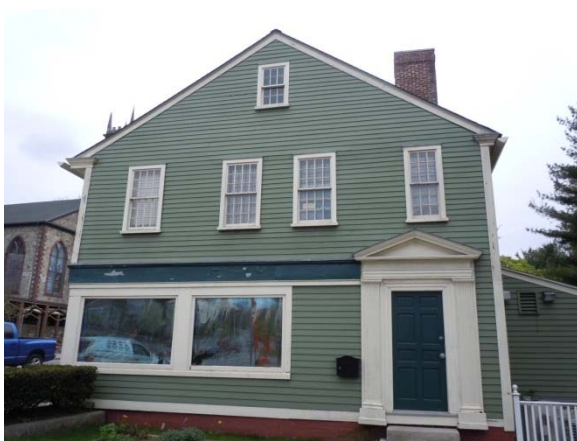
North elevation with exterior clapboarding in good condition.

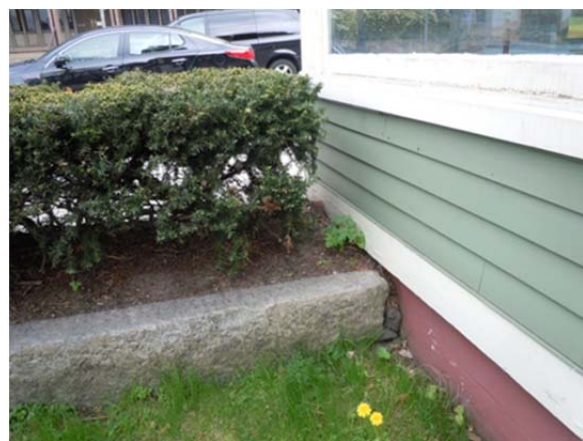
Detail lower panel under storefront showing exposed modern foundation painted red and siding in fair condition.

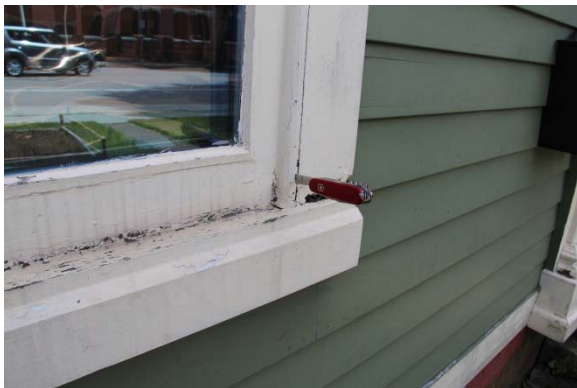
Deteriorated window trim at north elevation.

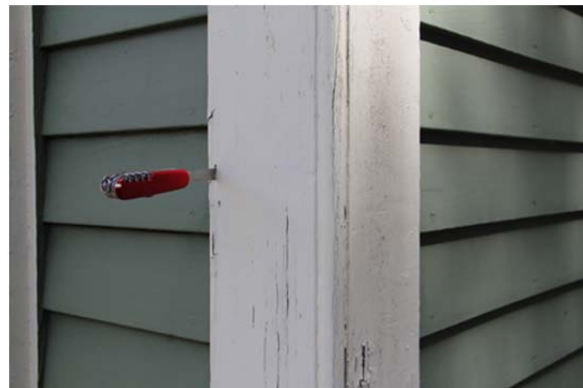
Deteriorated corner boards at northwest corner.

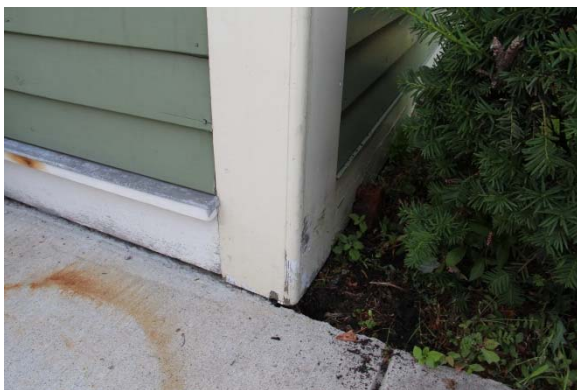
Proximity of earth and sidewalk to lower wood elements favors deterioration due to water infiltration and saturation. Flashing detail at exterior baseboard will prevent seepage into wall cavity.

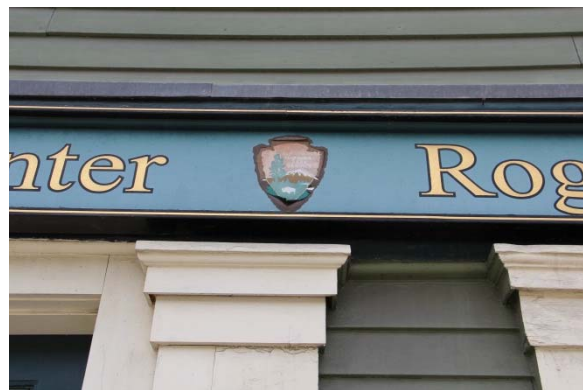
NPS park quarter-boards are faded and decals are peeling.
