Antram – Gray House

Historic Structure Assessment Report Roger Williams National Memorial

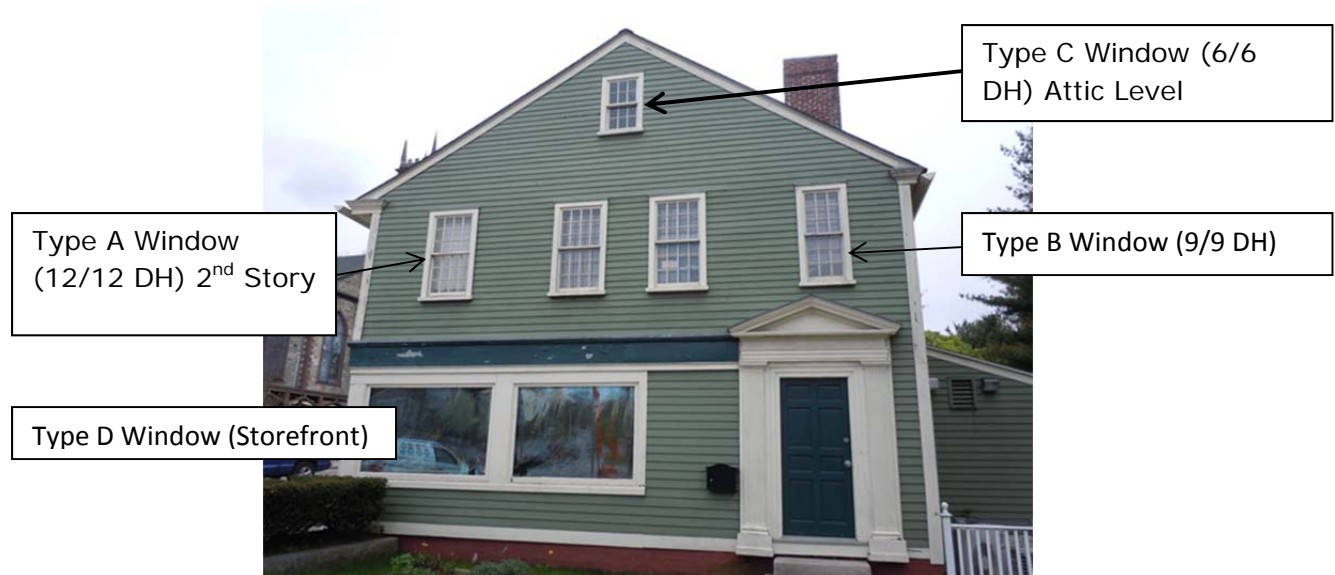
Overview of Window Types

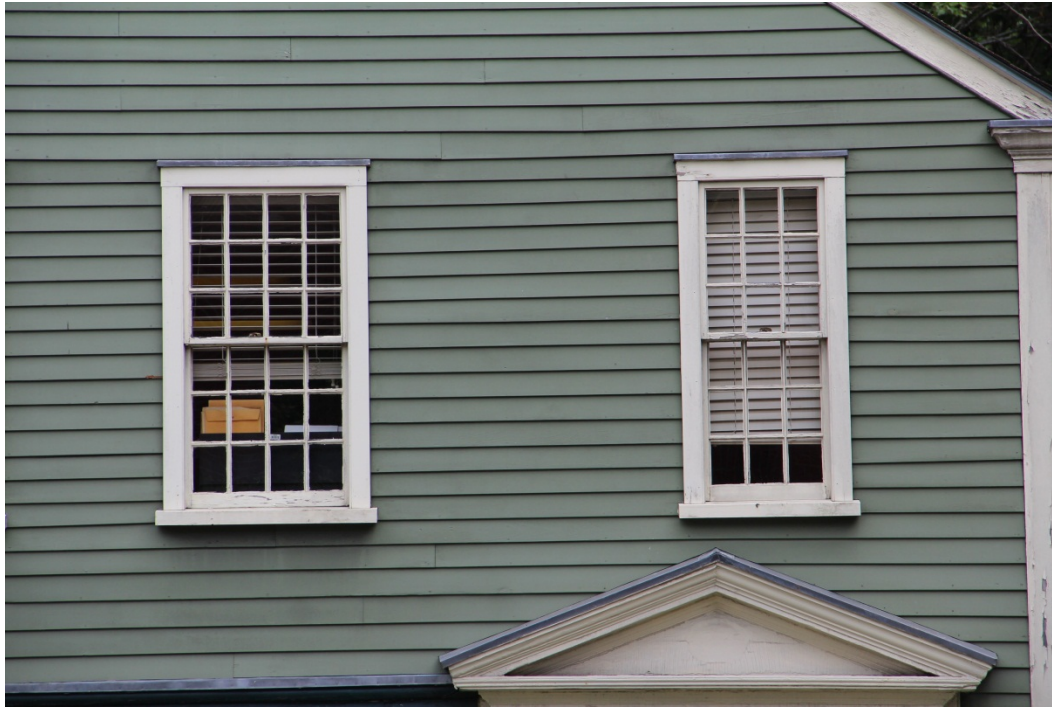
Detail W210 (12/12) Type A window and W 209 (9/9) type B window on north elevation. Both windows are rated Fair and have sills with reglet cuts, no interior storms and many typical exterior maintenance deficiencies (peeling paint, loss of glazing, no weather-stripping, no interior storm window, condensation, mildew, dirt). Projecting window frame headers (lintels) are covered with lead-coated copper flashing installed by the NPS in 1999-2000 exterior rehabilitation project. July 2014.

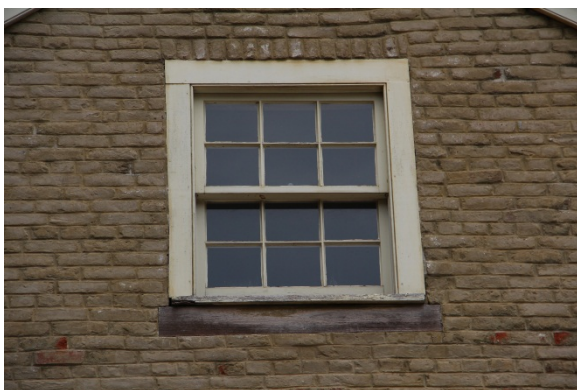
W301, Type C (6/6) window, south elevation with deteriorated exterior flush sill condition. July 2014.

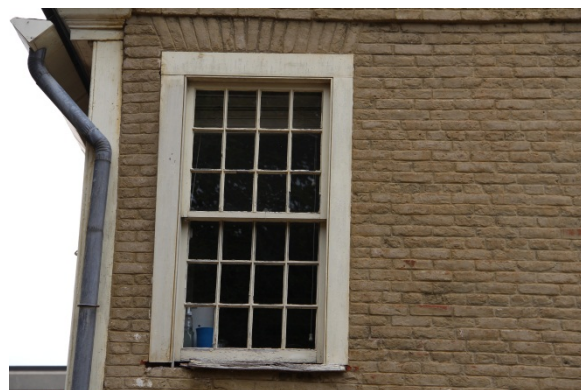
W206, Type A (12/12) window, south elevation with deteriorated lower sash unit and exterior projecting sill and jambs (frame). July 2014.

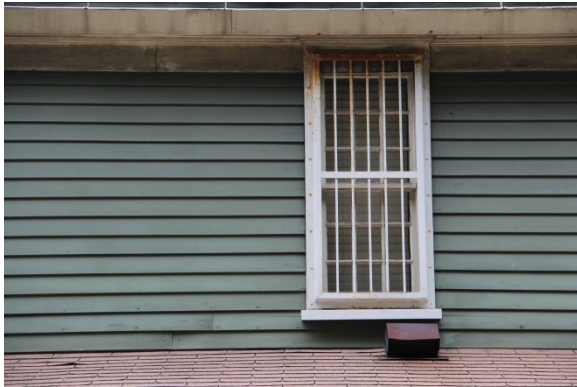
W208: exterior security grate is rusted and requires detachment from building to further inspect window sill and frame.

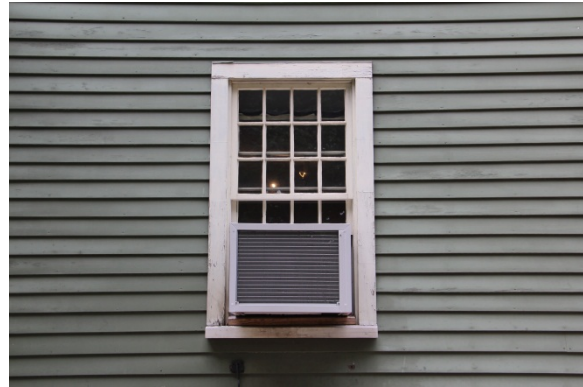
W104: supplemental air-conditioner is propped into window frame using lumber shims on exterior; window exhibits signs of advanced deterioration.

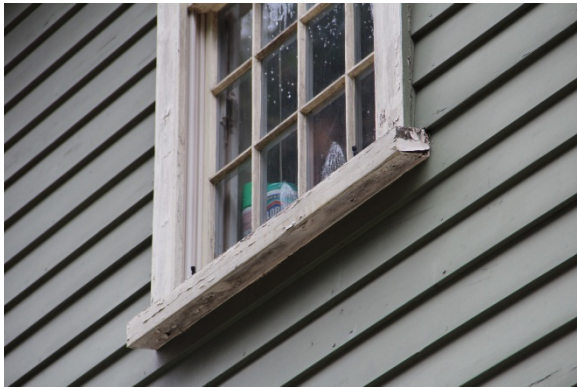
Typical deteriorated exterior projecting wood sill at clapboard siding. July 2014.

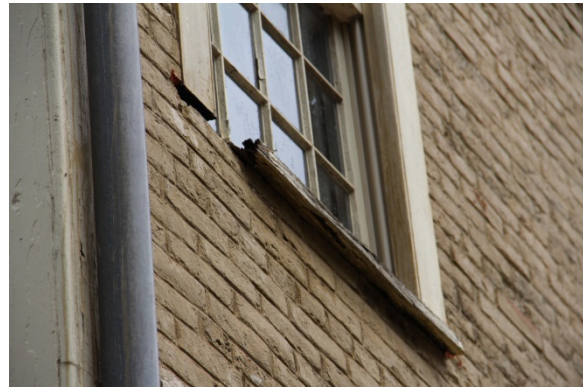
Typical deteriorated exterior projecting wood sill at masonry wall. July 2014.

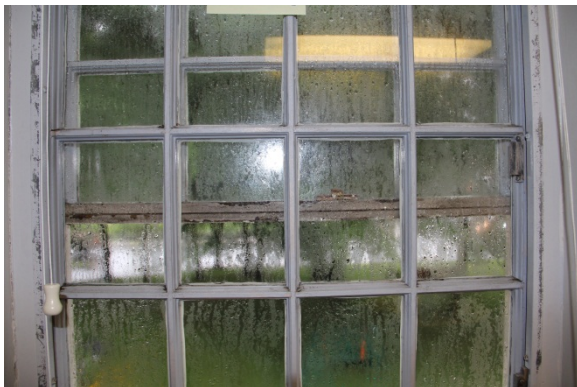
Typical interior condensation seen in July 2014.

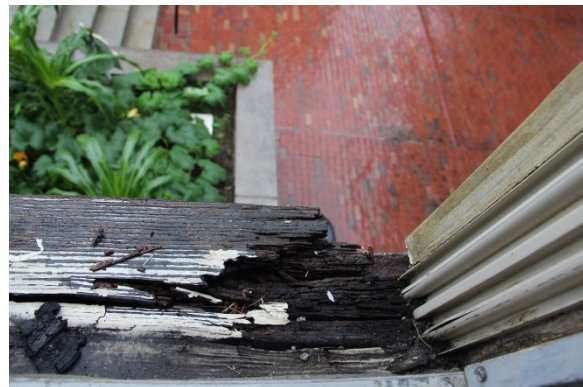
Extreme deterioration of exterior sill and jambs. July 2014

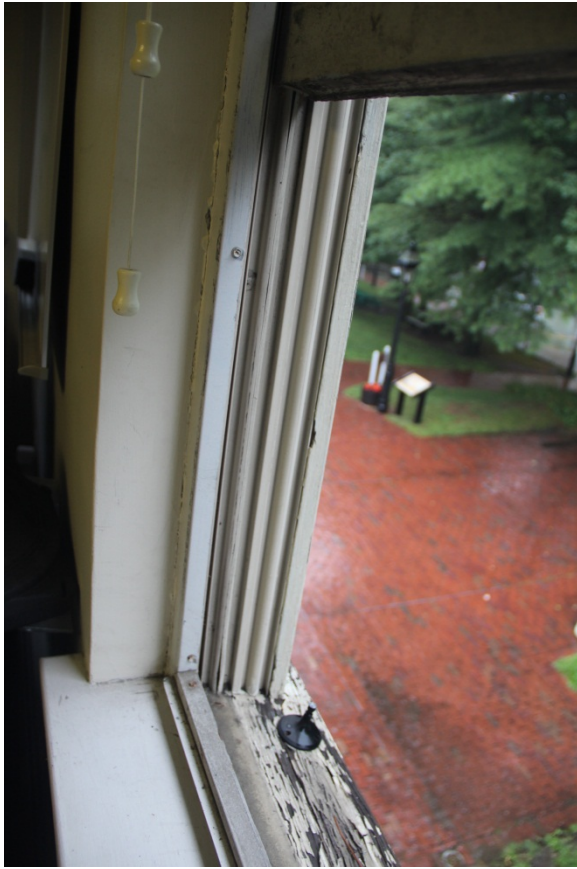
View of typical spring loaded plastic jamb liners which function also as weather-stripping. Metal frame (interior stop position) is for interior storm (not installed)

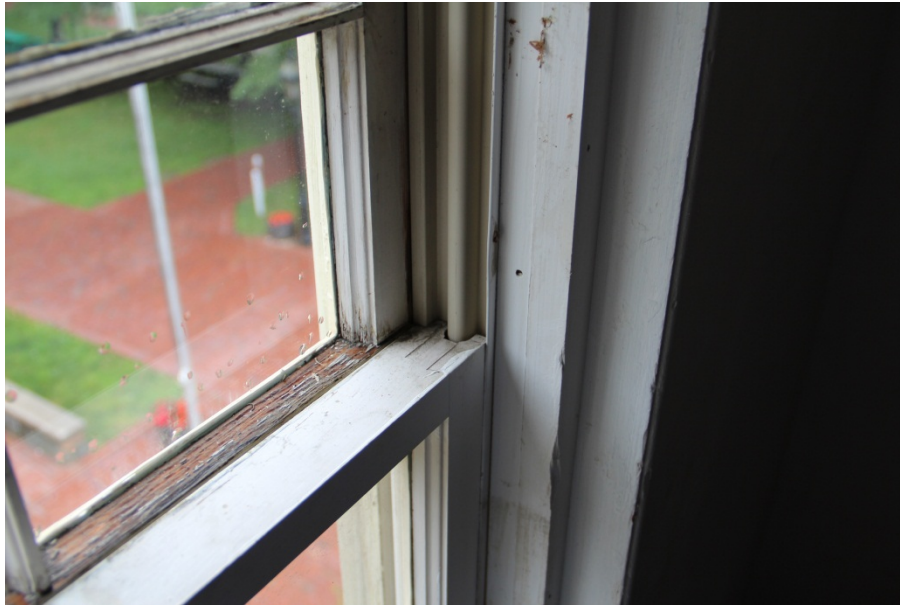
Interior upper sash frame with loss of paint and saturated wood due to water intrusion at window panes due to poor condition of exterior glazing at window.

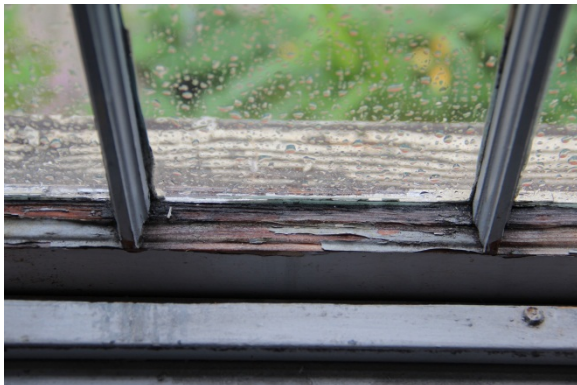
View of peeling paint on interior window sash due to similar water infiltration conditions.

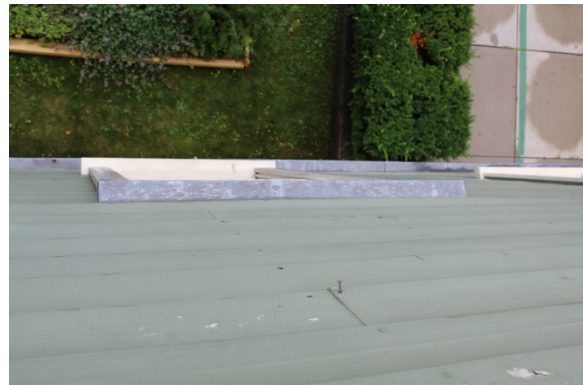
View of lead-coated copper window flashing as seen from attic window.

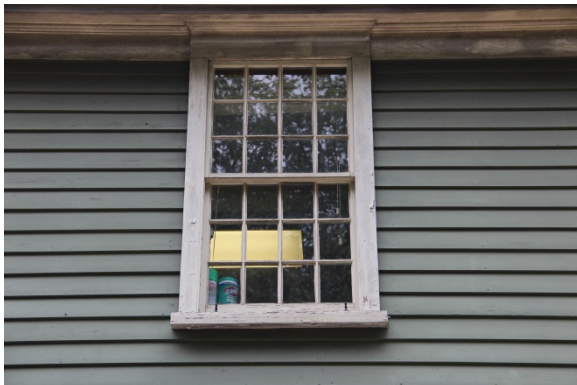
Exterior window frame with mildew, dirt and failing paint system.

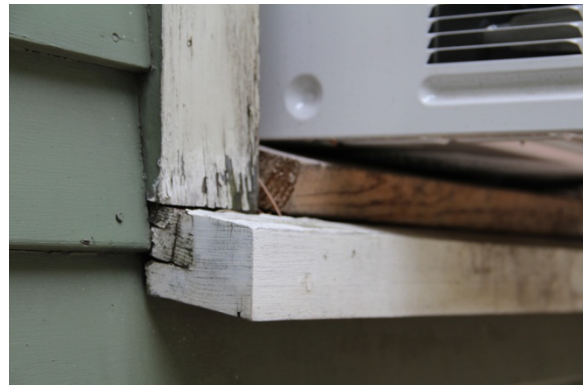
D104 – poor sill repair technique.

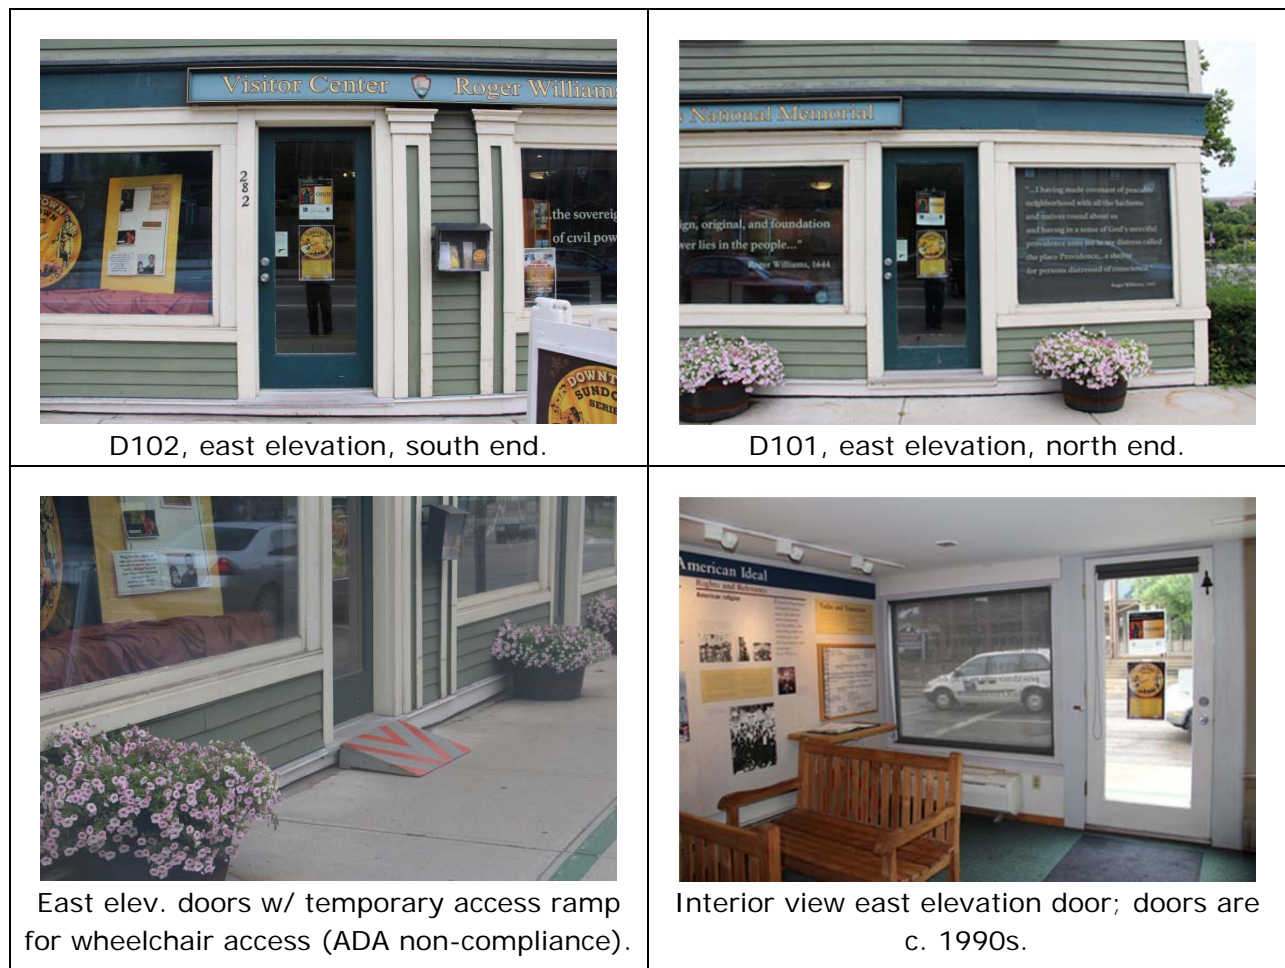
Doors D101 and D102 are painted wood framed doors with large insulated glass panels; they date from the late 1990’s and contain Best system locking hardware, weather-stripping and self-closing hinges. They are considered to be in Good condition, with the exception of not meeting ADAAB design guidelines for access into a public building. The temporary ramp does not bring them into compliance.

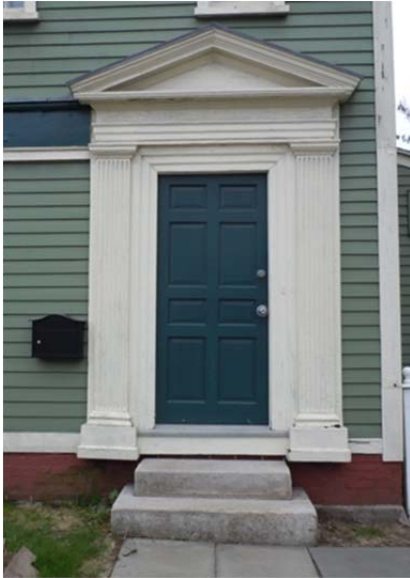
North elevation door with historic door surround; D103 is a modern panel door.

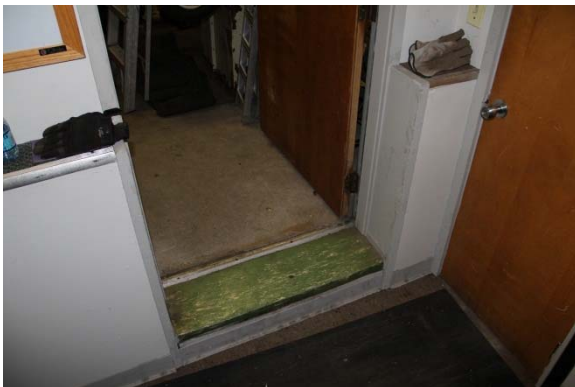
D104 threshold between house and maintenance shed; door is delaminating at the base and weather-stripping is rabbeted into door; this likely voids any fire rating the door may have had from the factory. No UL rating was found on the door.

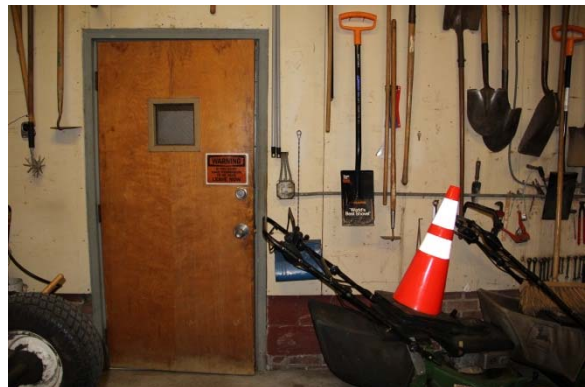
D104 from maintenance shed; this is most likely a 2 hour rated fire door with a fire glass viewing window in a metal frame; note deterioration at base of door.

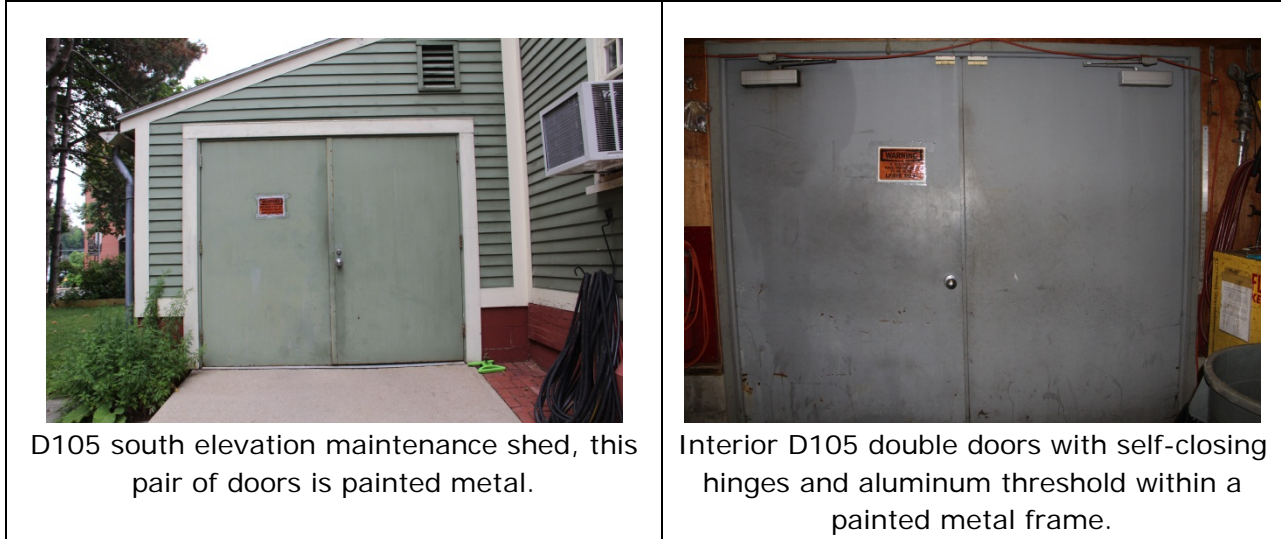
B2030-1E	1 st Floor East
Qualitative Condition Rating:	FAIR
Maintenance Deficiency Rating:	Minor

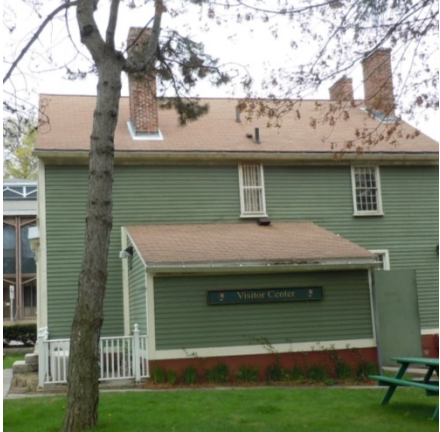
<p data-bbox="201 783 787 905">View of shed roof from west elevation with exhaust fan (from bathrooms) on roof; also shows simple exterior trim and matching shingle roofs.</p>

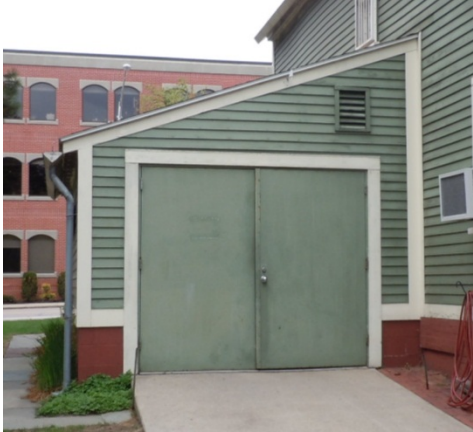
<p data-bbox="834 783 1421 873">South elevation of shed depicts gutter and downspout installation at southwest corner, also simple rake board trim.</p>	
B3010-2	Shed Addition	
Qualitative Condition Rating:	GOOD	
Maintenance Deficiency Rating:	Minor

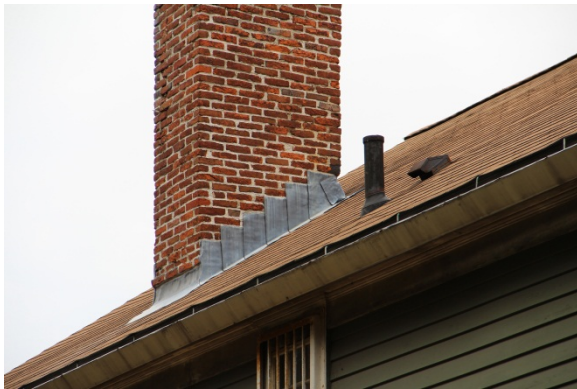
CH03 seen from the southwest with exposed step flashing; plumbing vent stack and bathroom exhaust hood seen in foreground.

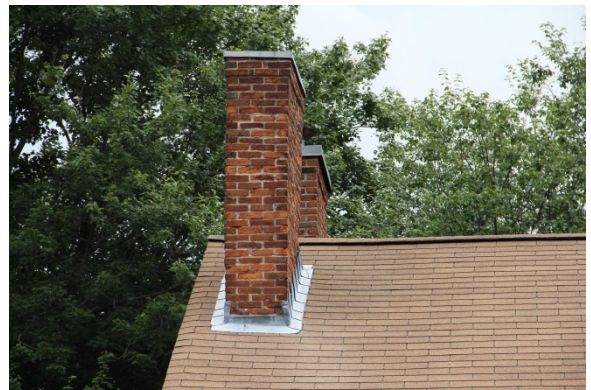
South gable chimneys seen from the east; Exposed flashing flange at base of chimneys is unusual application of base flashing.

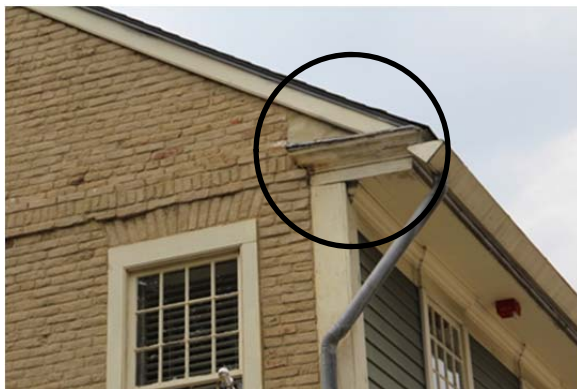
View of V-shaped hanging gutter and concealed box cornice and cornice return on building at south east corner of house. Note triangular area of infill flashing above cornice return; likely originally wood (in circle).

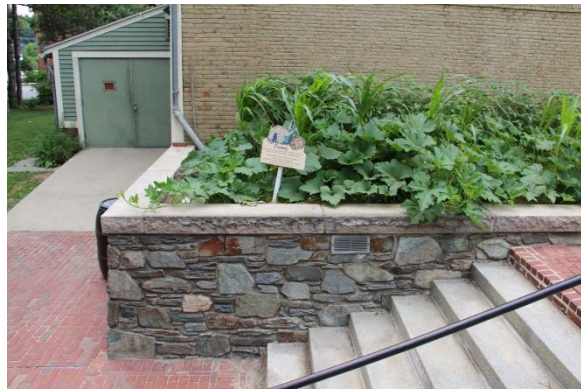
Similar condition at southwest corner of building.

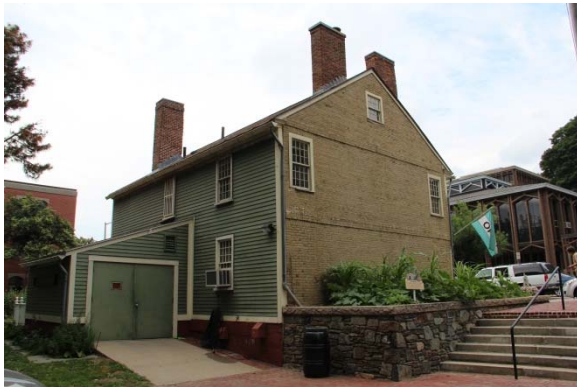
General slope of site is away from southwest corner of house.

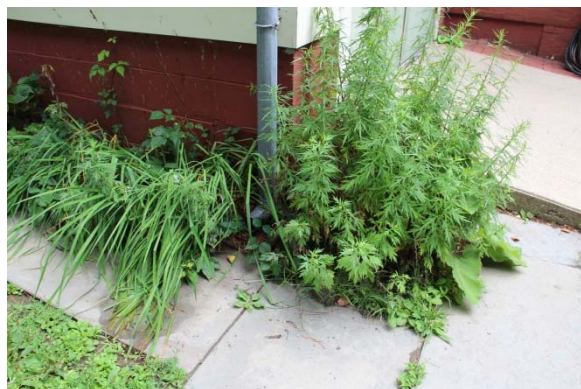
Downspout daylights at base of building.

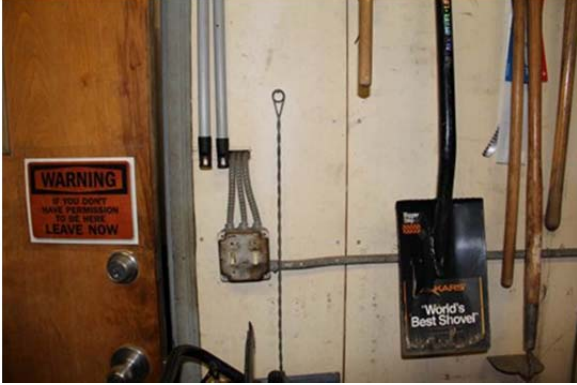
<p>Unsealed horizontal penetrations through Type X wall board (1 hour fire resistant rated material) (at conduit penetrations into wall and other locations) are deficiencies in the fire rated enclosure of the maintenance shed. Penetrations negate any fire resistant rating of the materials.</p>
C10	Interior Construction – Shed
Qualitative Condition Rating:	POOR
Maintenance Deficiency Rating:	Critical

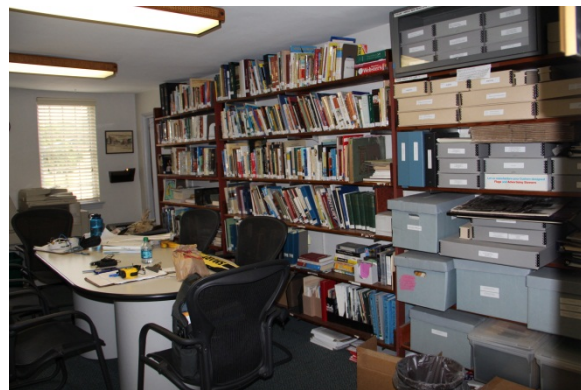
Possible over-loaded conditions at 2nd floor – all heavy loads are placed around perimeter of room where structure is usually located lessening the chances of structural failure.

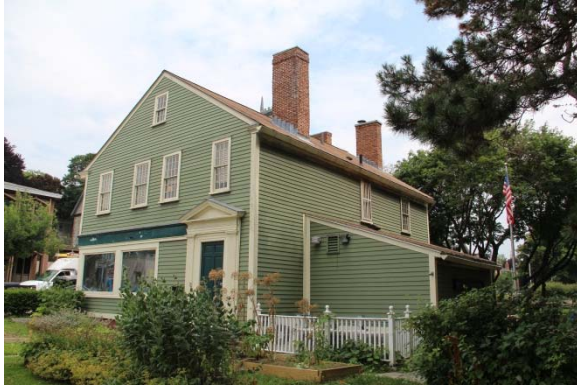
Fenced area to west of primary architectural feature of north elevation contains condensing units for Mitsubishi split system.

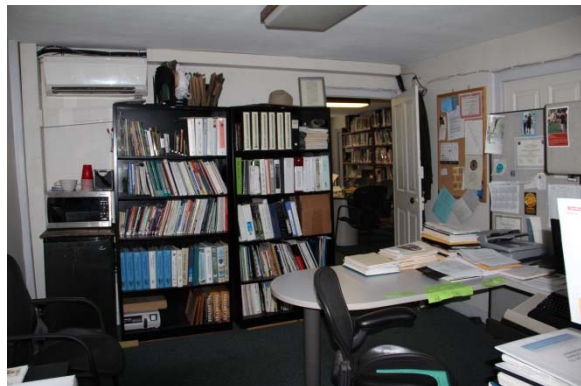
HVAC unit in-situ with exposed power and condensate lines.

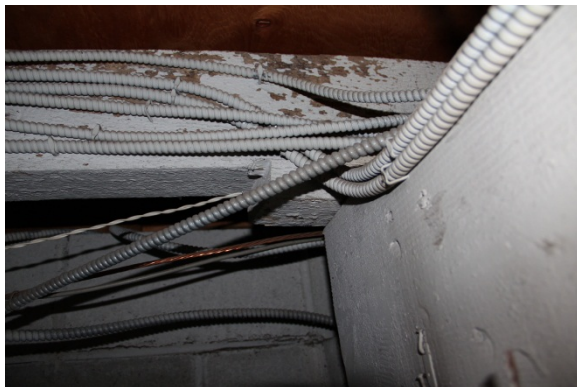
Previous installation of electrical lines and other communications systems paid no regard to labeling of wiring or attachment to National Register eligible historic framing materials.

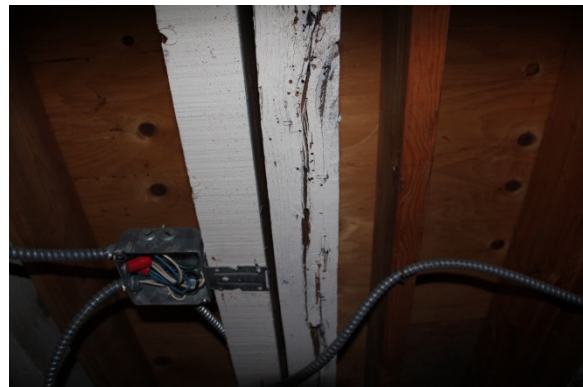
Casual observation reveals a number of electrical code violations and the concealed wiring above the dropped ceiling of the basement work areas.

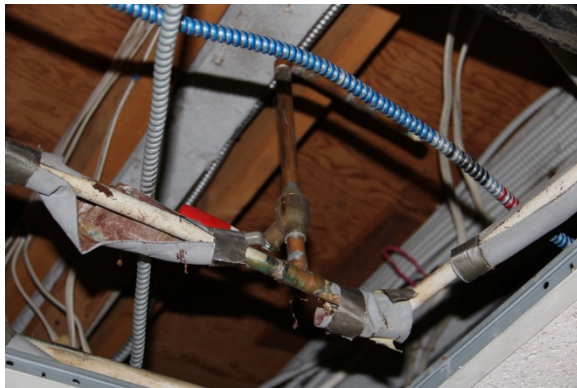
Plumbing, electrical, communications and alarm system lines all held within interstitial space above basement dropped ceiling.

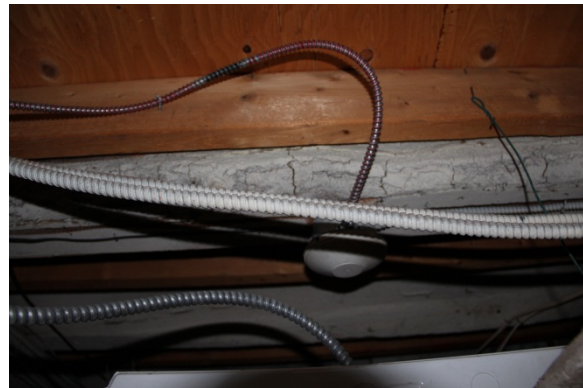
Previous generations of detectors are still in-situ above the dropped ceiling. It is unclear if these are meant to be functional or if they are operable.

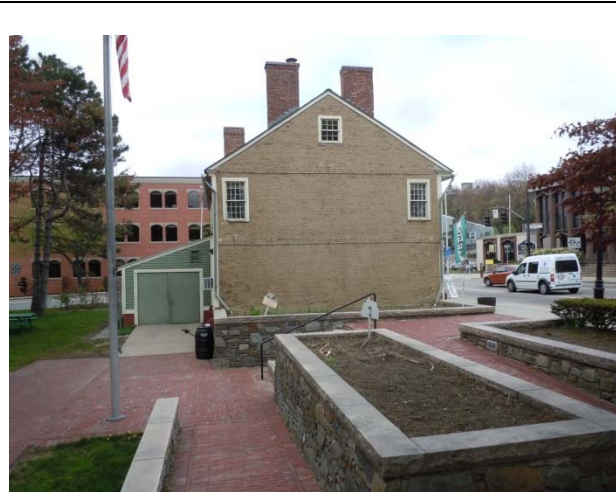
Sloped ramp from parking area to North Main Street entrances.

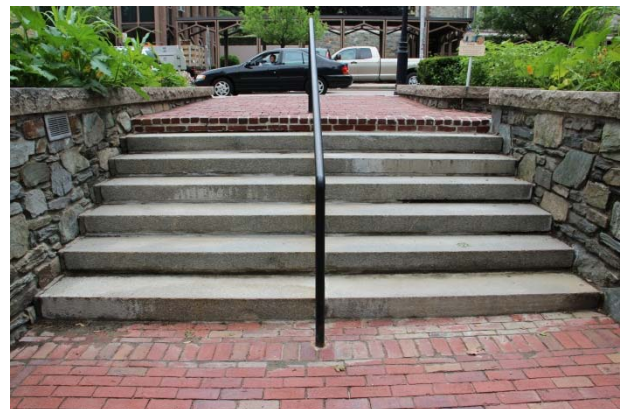
Staircase adjacent to ramp; able bodied option for traveling to Antram-Gray House entrance on North Main Street.

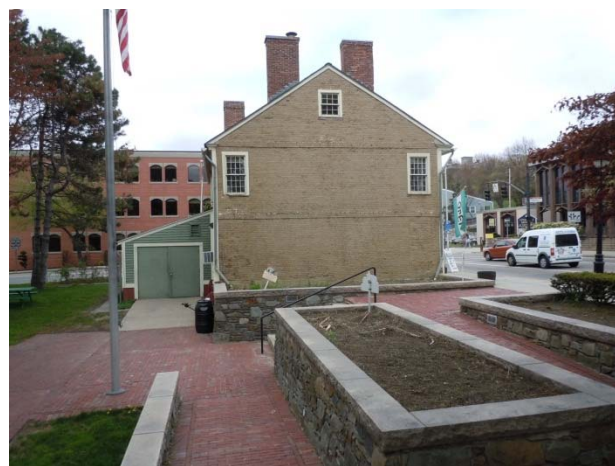
Positive drainage at pedestrian pathways to front entrance.

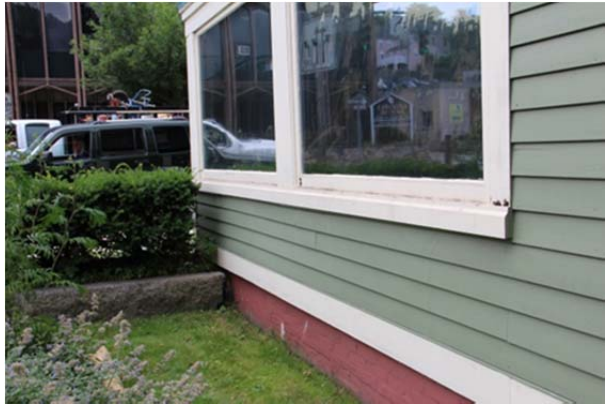
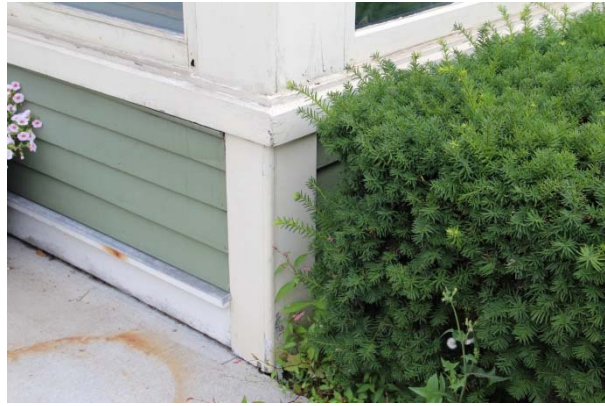
<p>Vegetation in close proximity to wood elements of building along north elevation.</p>	<p>Northeast corner of building where vegetation is overgrown and blocking air movement around wood components.</p>
<p>G9087</p>	<p>Site Drainage & Vegetation</p>
<p>Qualitative Condition Rating:</p>	<p>FAIR</p>
<p>Maintenance Deficiency Rating:</p>	<p>Serious</p>

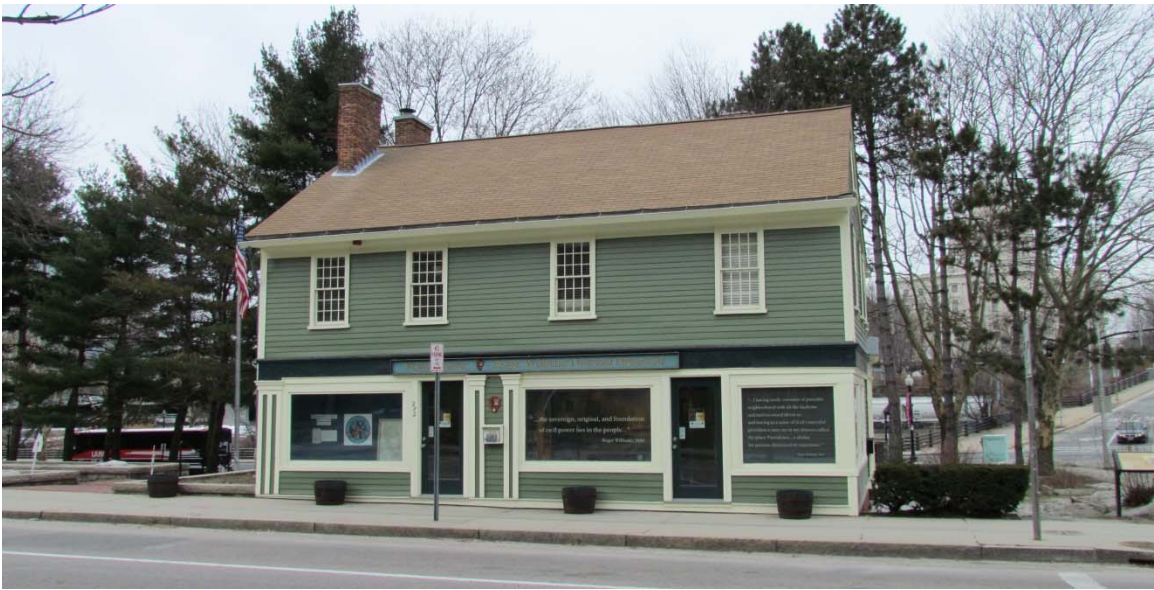
East Elevation at North Main Street. March 2015.

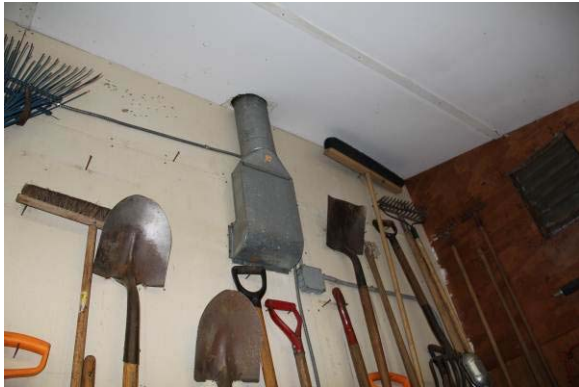
C10: Penetrations in shed ceiling negate any fire resistant separation offered by rated materials. According to NPS construction drawing it is 1/2 inch gypsum board; this assembly does not achieve a 1 hour fire resistant rating.

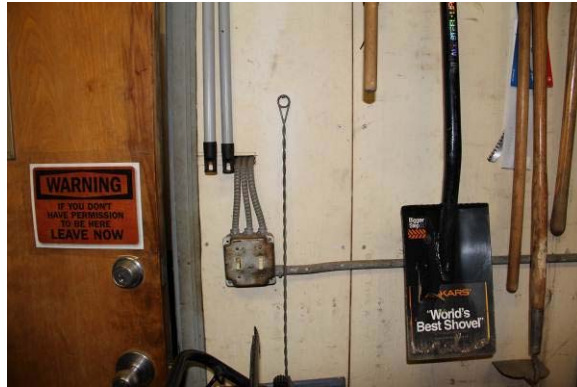
C10: Penetrations through Type X wall board (1 hour fire resistant rated material) are deficiencies in the fire rated enclosure of the maintenance shed and void the 1 hour fire resistant rating.

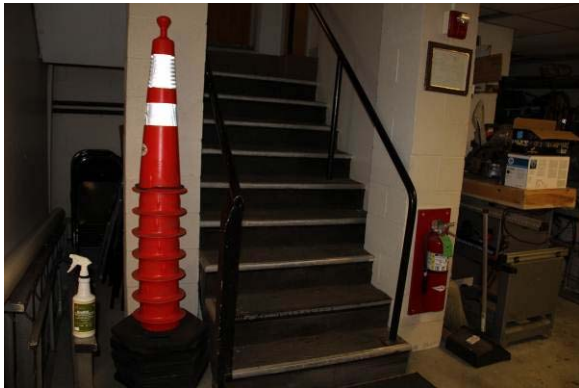
C10: Open stair between floors; also functions as main egress from basement offices.

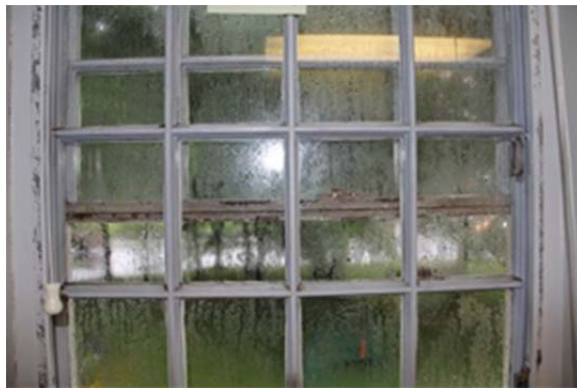
D30/ B20: Condensation on interior of window glass in summer indicates high interior humidity levels and use of uninsulated glass in windows.

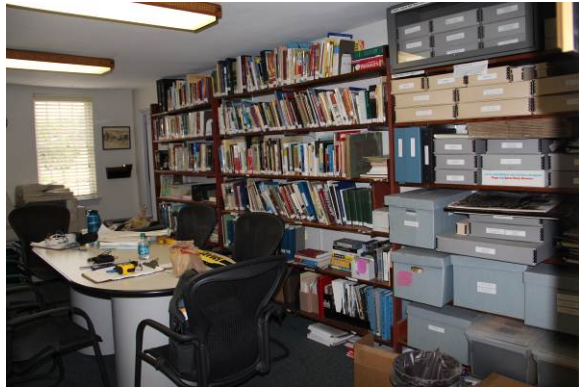
B10: Possible over-stressing of historic post and beam structure due to overloading of interior spaces.

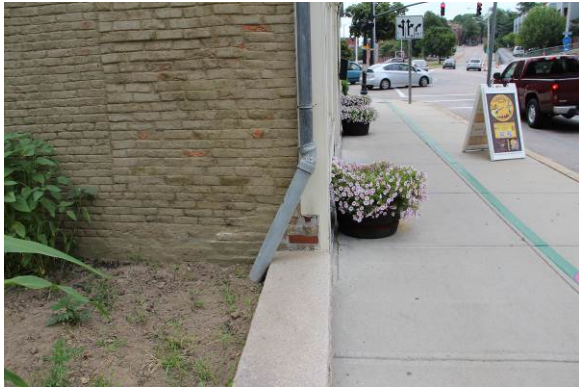
A10: Improper installation of downspout connection to underground drainage system.

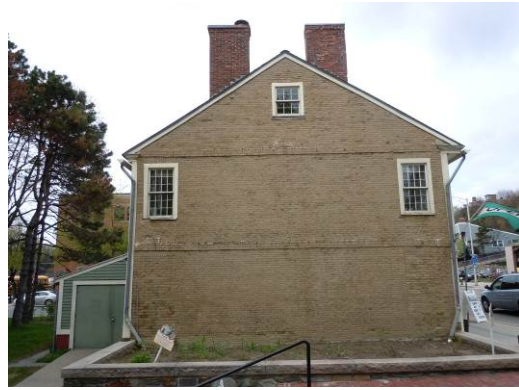
A10: Building downspouts discharge entire roof water output into plant bed adjacent to historic south brick gable. It is unclear if there is an underground drainage line or foundation waterproofing in this vulnerable area.
