HISTORIC STRUCTURE REPORT

# Schooner *C.A. Thayer*

National Park Service | June 2022

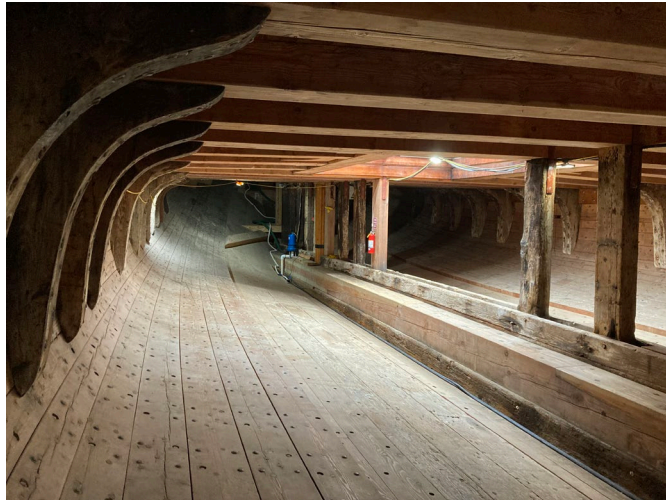
Photo 1. The hold construction is similar to a land-based heavy timber style. This can be difficult to ignite and when ignition does occur, the fire will initially burn along the surface to form a char layer that helps to insulate the timbers from further fire damage. The borate treatment that the Park applies for wood preservation will also function as an intumescent treatment to retard the initial rate of fire spread. The Thayer's hold does not contain a sizable amount of combustible contents that could produce a fast growing fire. The present fire risk is extremely low.

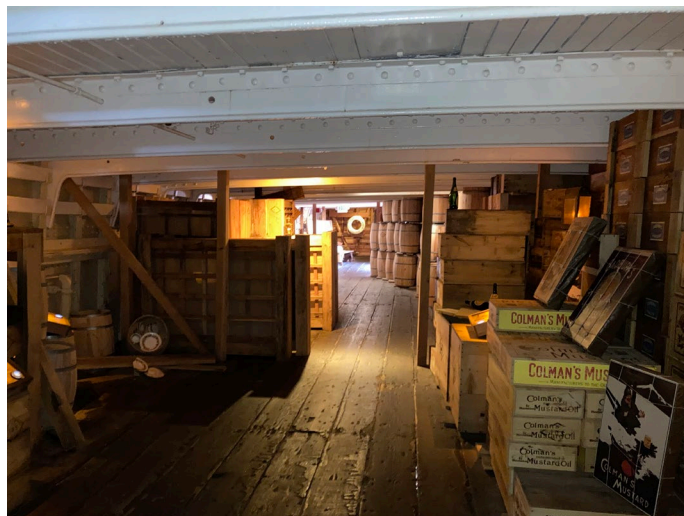
The present situation could be altered if in the future the deck is fitted with simulated cargo displays, similar to those on the adjacent Balclutha. At that point the fuel loads would be significantly increased to produce an SFPE rated medium to fast growth fire of 30-60 minutes duration.

Photo 2: The hold on the adjacent Balclutha has a different situation where simulated cargo displays pose a higher quantity of readily ignitable fuels that could result in relatively fast fire spread throughout the vessel. If a similar display arrangement is eventually placed on the Thayer, then the fire threat to the vessel will significantly increase.

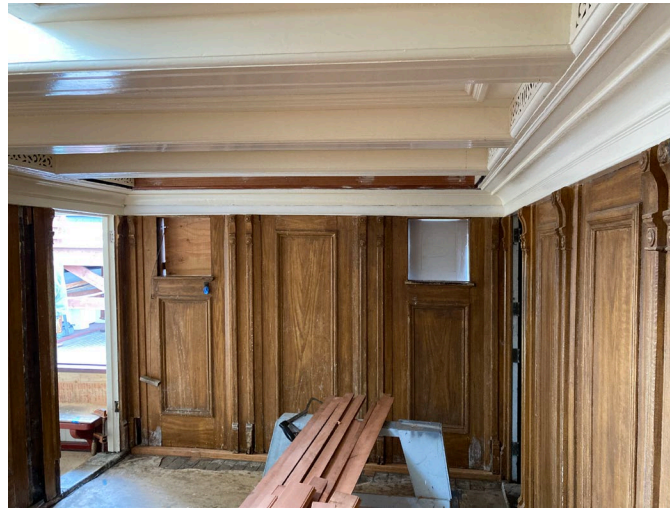
The Thayer's fore and aft deck houses are lighter weight wood construction, comparable to a land based type 5 wood framed construction. If ignited the anticipated fire growth rate is SFPE that if moderate and capable of producing a fire of 30-45 minutes duration. This type of fire could ignite rigging and travel vertically up mast assemblies. The probability of an initial lateral fire spread across the main deck is low but could be increased by burning rigging materials raining down on the decks.

Photo 3: The deck houses are lighter wood framed construction and pose a potential moderate fire growth rate.

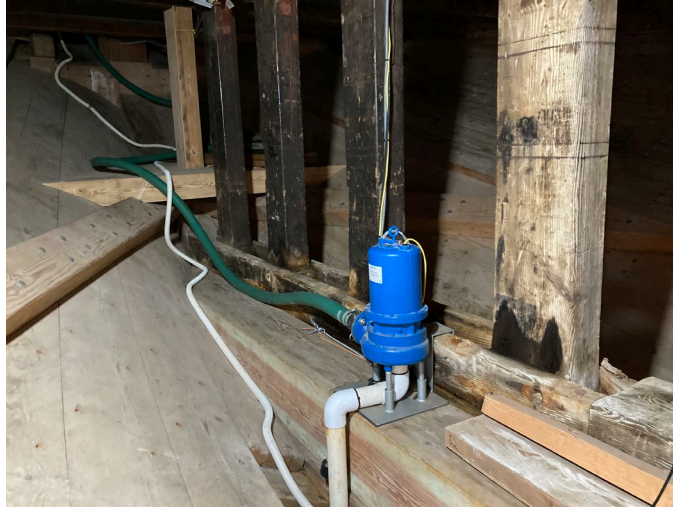
Photo 4: The bilge pump is one of the higher ignition threats but this hazard can be controlled by placing the pump in a metal cabinet to prevent the pump from contacting the wood elements.

- Replace existing lighting with low voltage LED equipment.
- Place the bilge pump in a fire resistant steel cabinet to add an extra level of physical separation between this possible ignition source and the ship's combustible decking.
