TUGBOAT *HERCULES*

Historic Structure Report

1990

Prepared by
Tri-Coastal Marine, Inc.
200 Burrows Street
San Francisco, California 94134

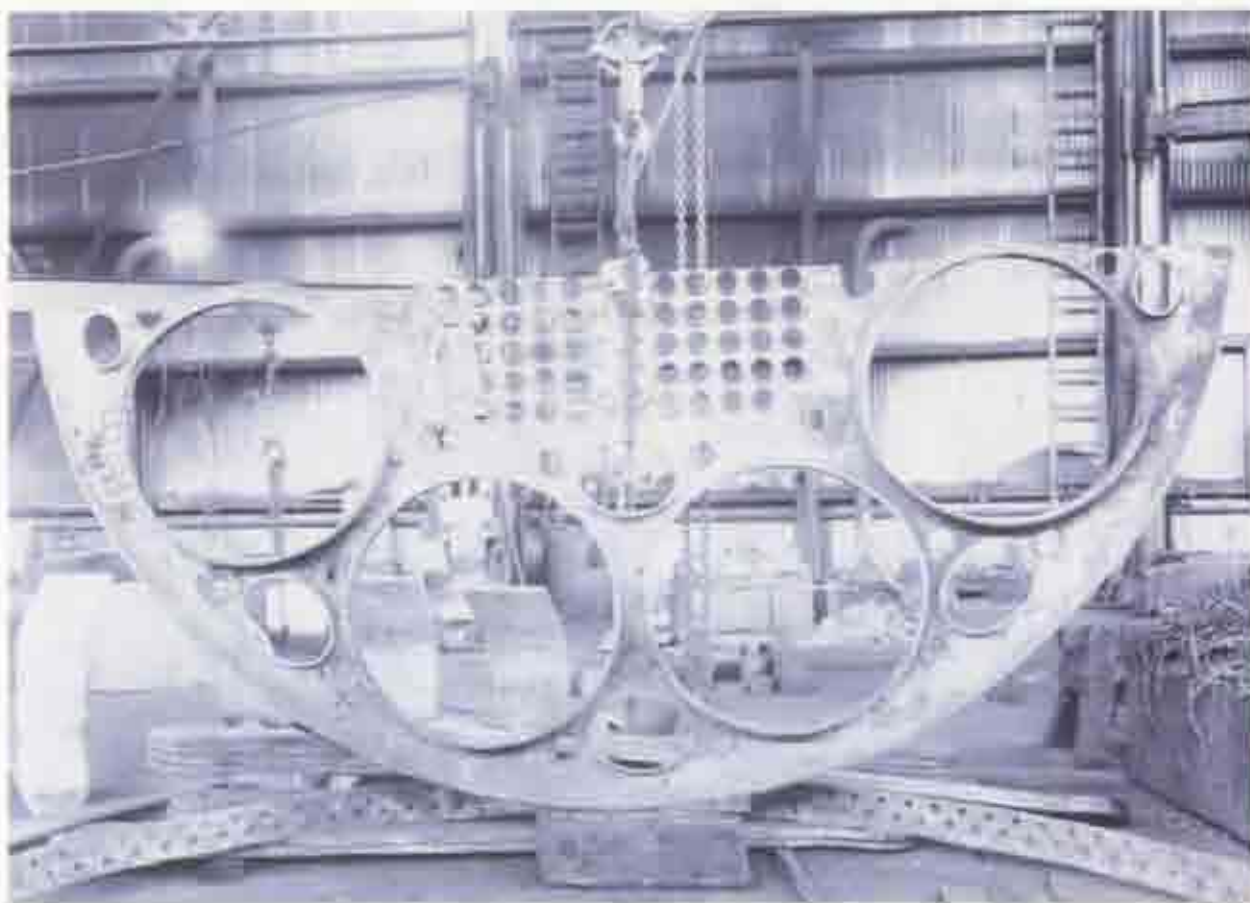
Photo: SPMNHIP P81.005.316a

Boiler disassembled for major repairs.

Fig. 6. "Tug HERCULES owned by Rolph Navigation & Coal Company. Showing lower front head removed from boiler. Repairs being made by the Moore Shipbuilding Company, Oakland, Cal. Oct. 2, 1919." (Photo Caption)

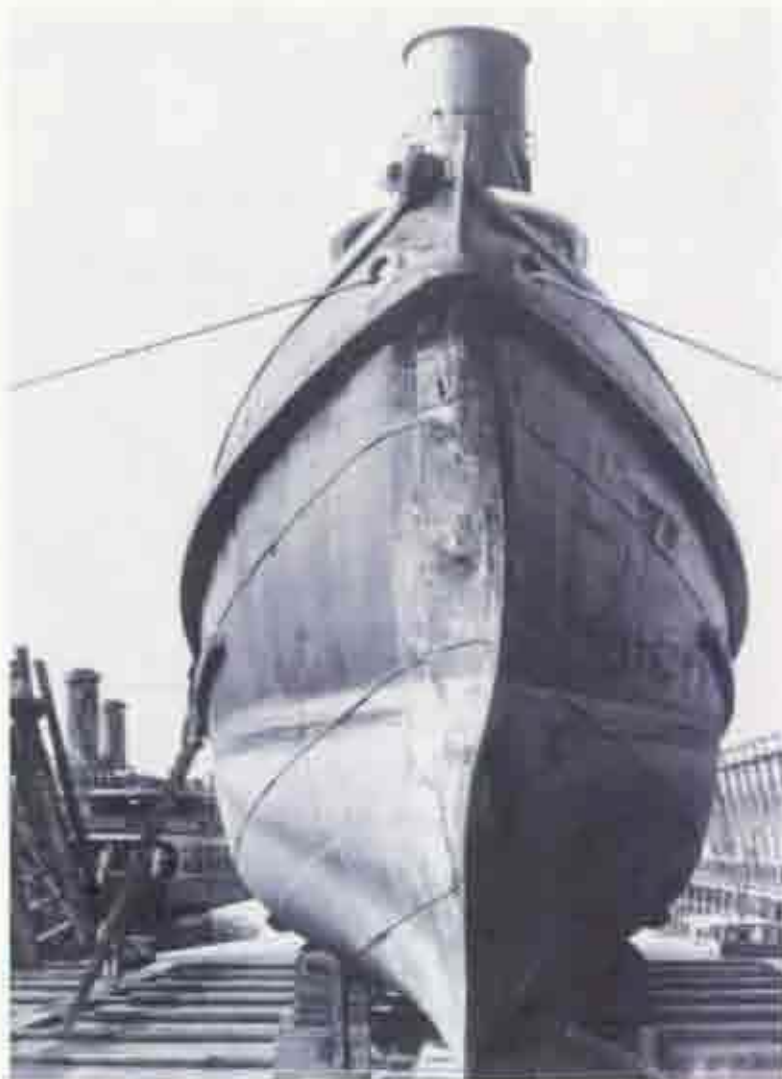
Photo SPMNHF SCU 35n p106n

Fig. 9. HERCULES on dry dock following collision with steamer SAN PEDRO, 9 May 1933.

HERCULES in collision with McCormick lumber steamer POINT SAN PEDRO near Grove Street Terminal, San Francisco; tug sustains considerable damage to bow, propeller, stern frame, and rudder. Hauled out at Moore Drydock for repairs.

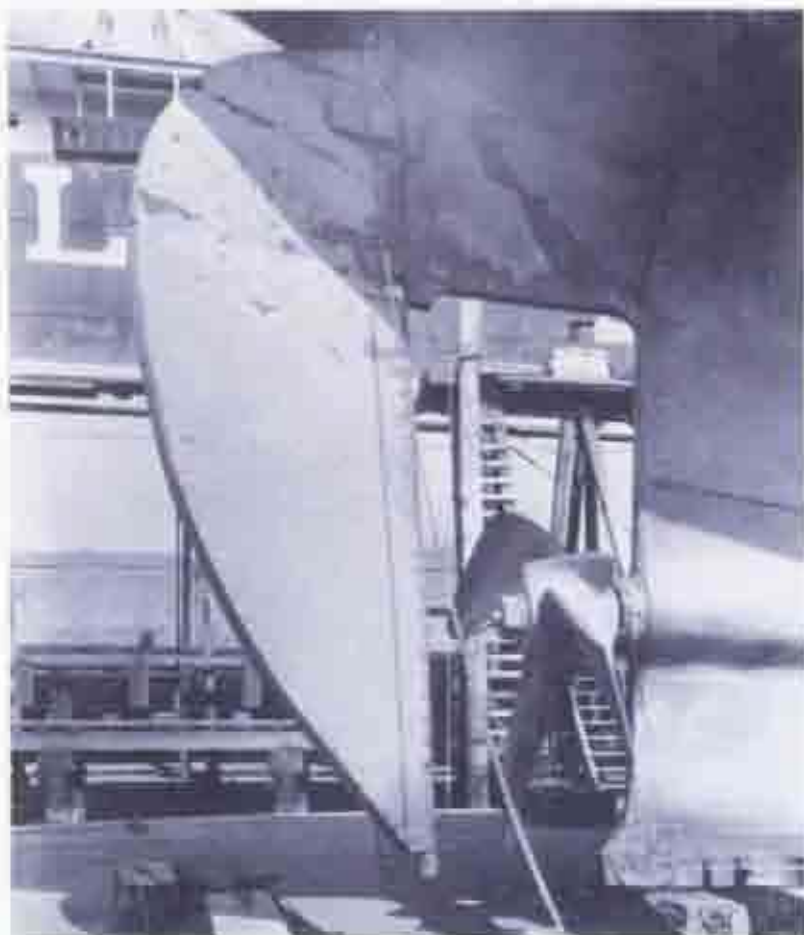
Photo SPMNHF SCR. 55N pg 107

Fig. 10. Rudder and propeller damage resulting from collision with steamer SAN PEDRO.

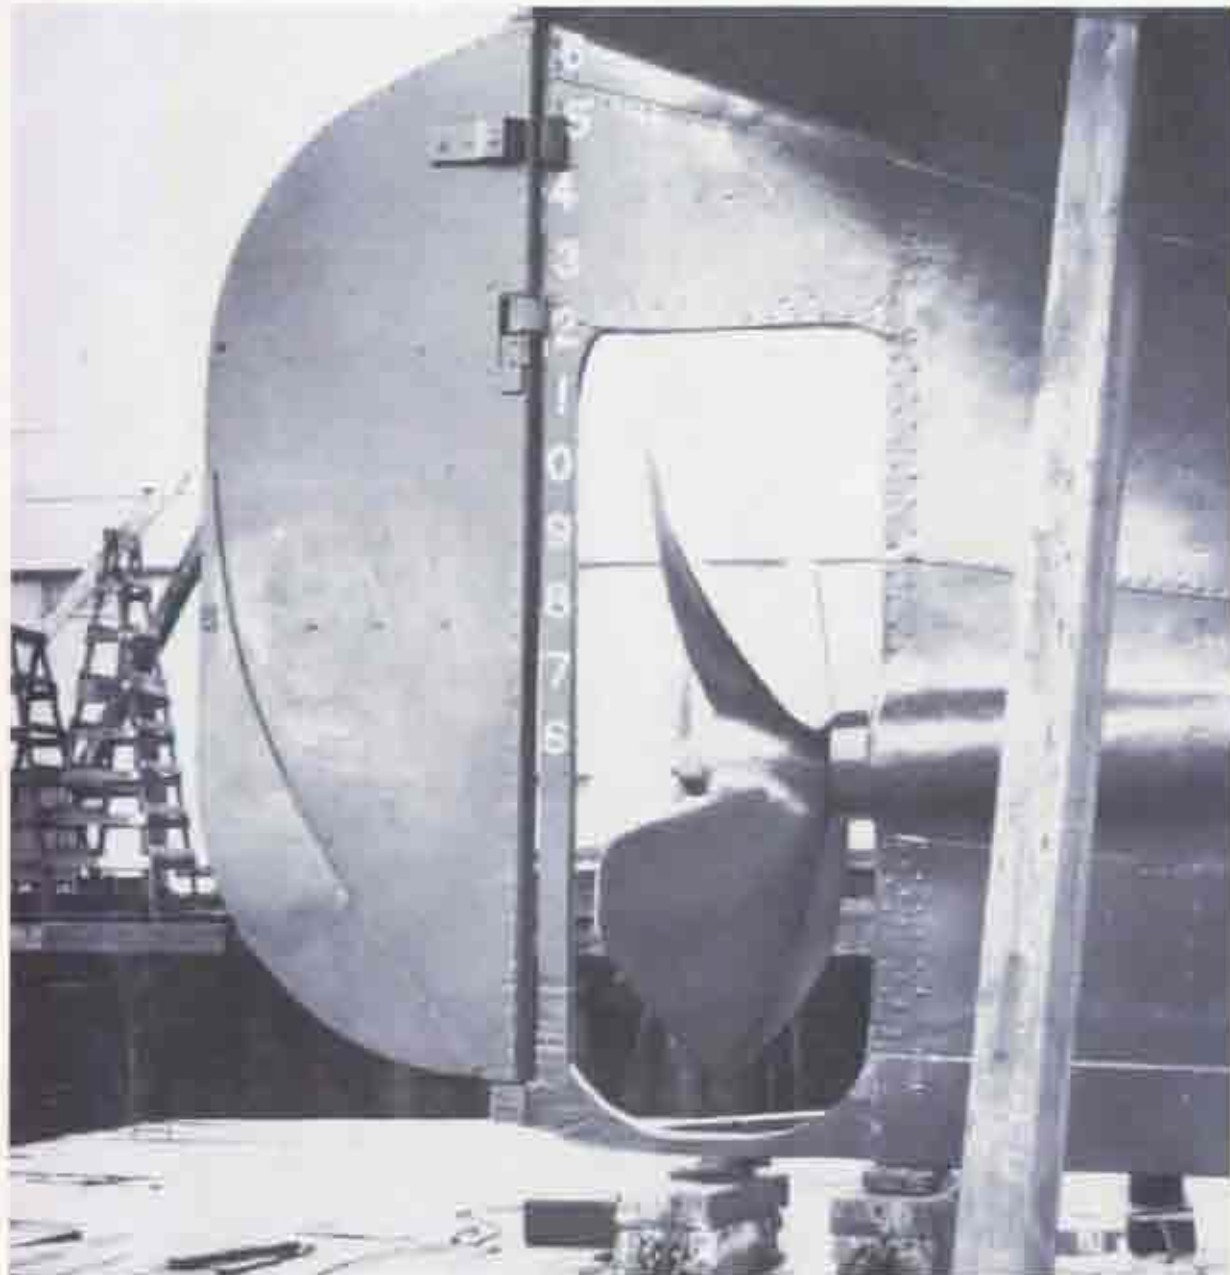
SFMNHIP 887.001.68c

Fig. 17. HERCULES in drydock for enlargement of her rudder, Oakland, California, February 1940. Added portion can be seen at lower left side of rudder.

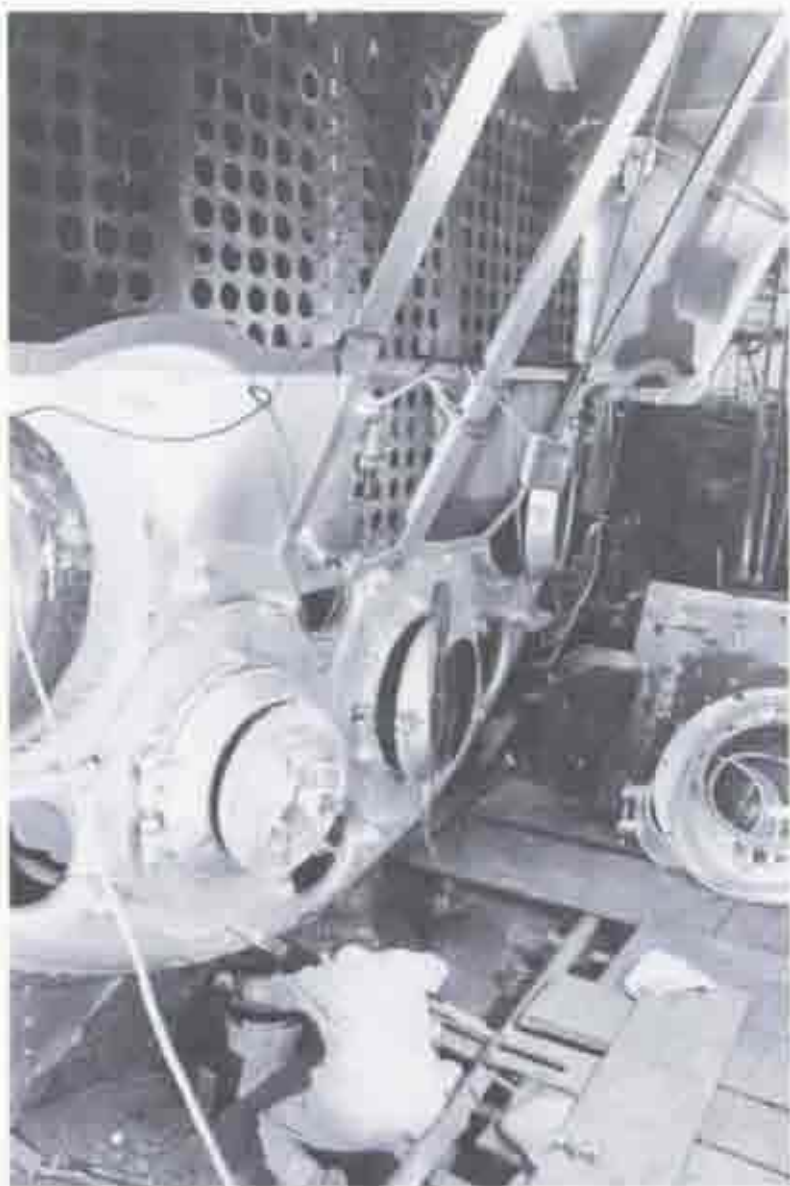
Photo: L. Newcomb

Fig. 22. View of the front end of HERCULES' boiler during restoration in the mid-1980s. Doors of the "front connection" have been removed for replacement of fire tubes.

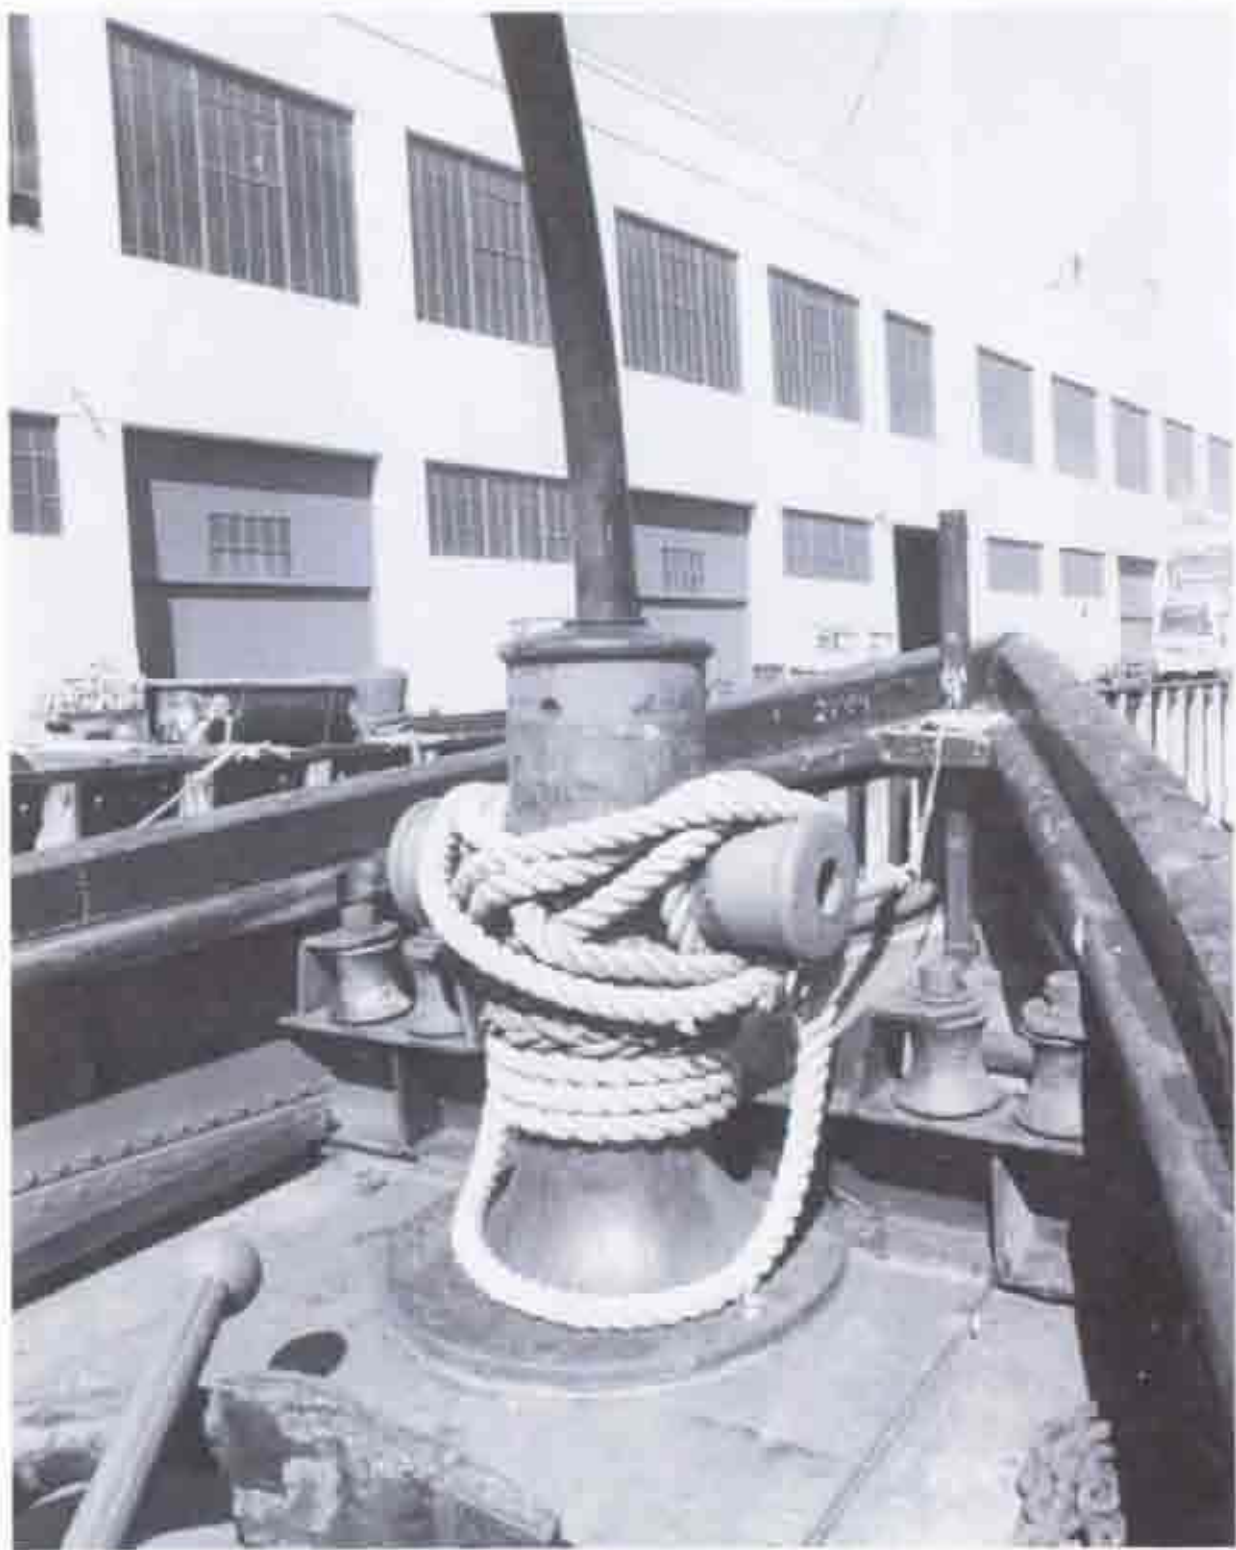
Photo: T. J. Casati Marine

Custom Deck Fittings, Including Bow Bitt, Mooring Bitts, and Towing Bitts: Intact and original, with exception of the anchor davit mounted on the bow

Fig. 24. Kingpost bitt on foredeck, one of several original custom-made items HERCULES is fitted with. Roller-chocks to port and starboard of the bitt are a later addition.

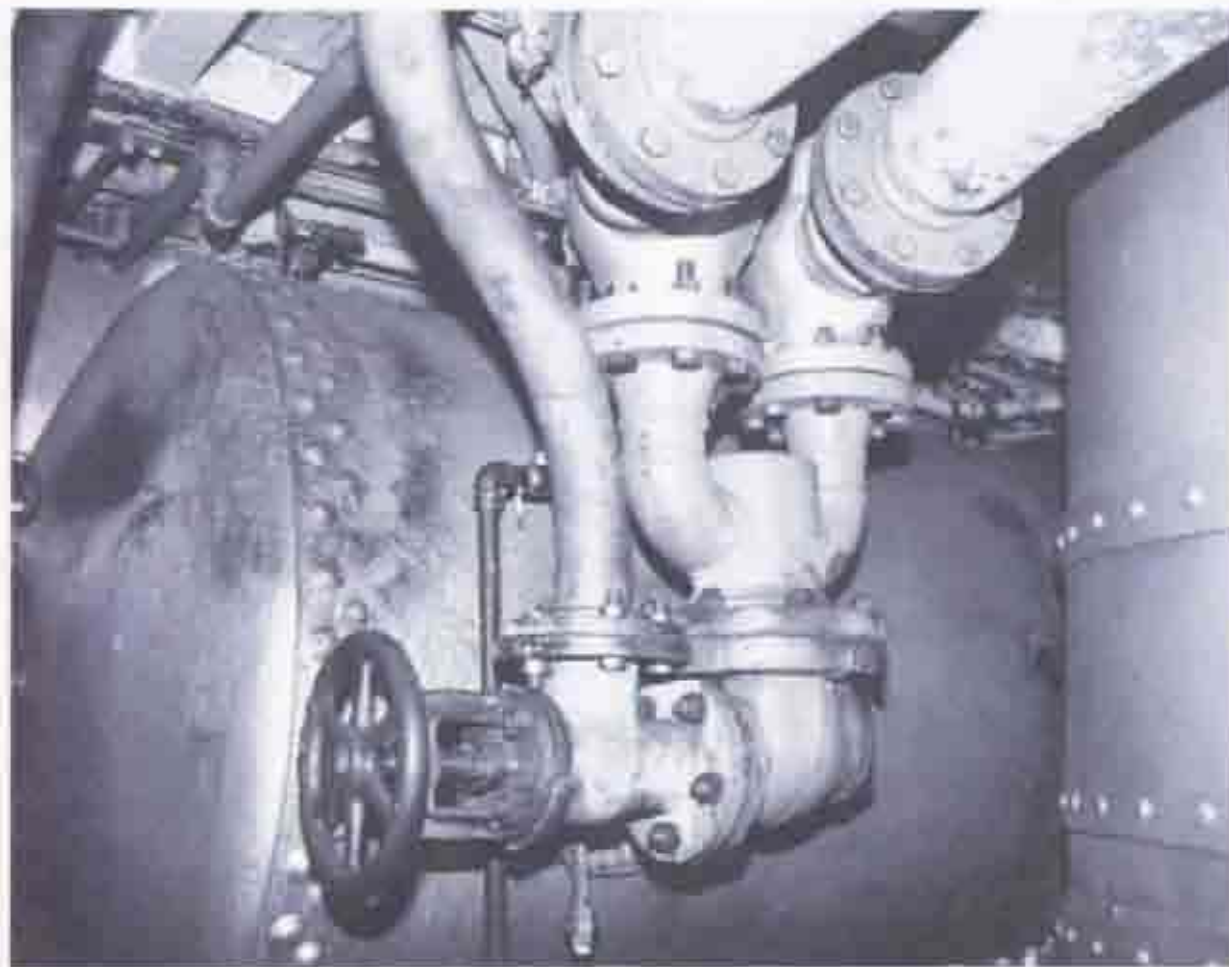
Photo: D. Burkholz

Fig. 27. The boiler safety valves, part of the complex system of steam piping. The riveted steam drum can be seen beyond, and the smoke stack is at right.

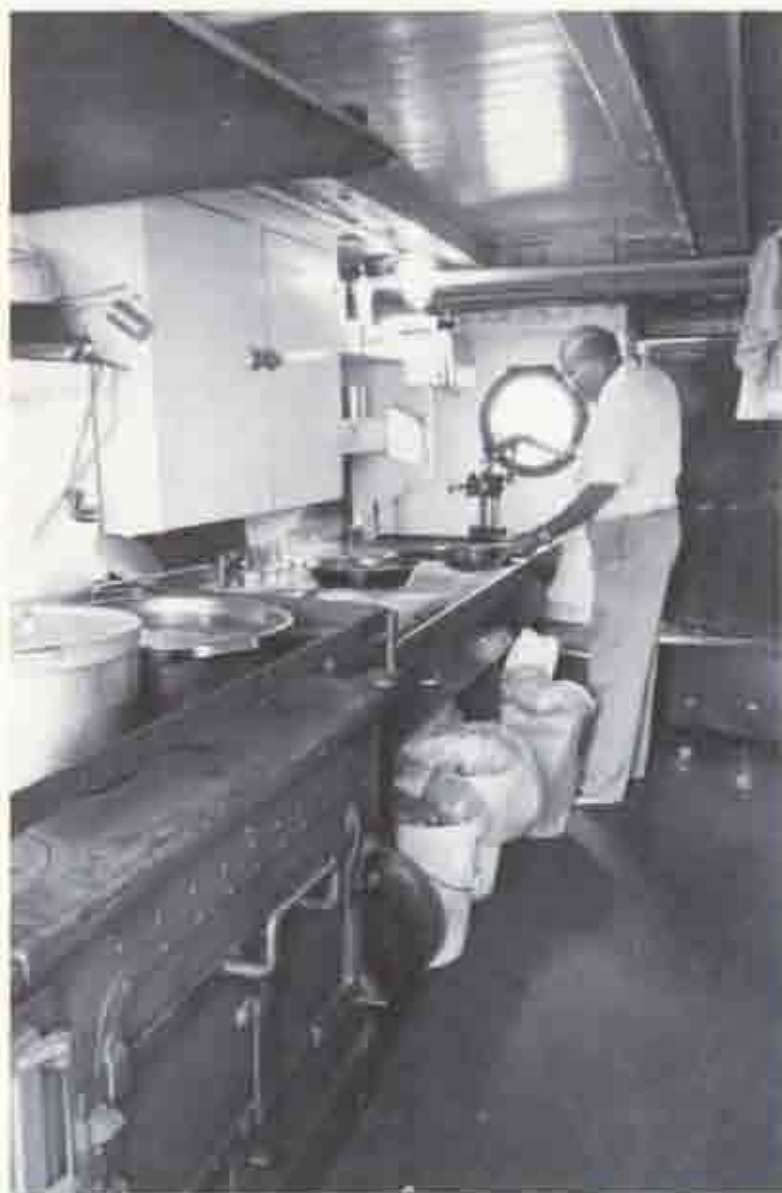
Photo: Leigh Newcomb

Fig. 28. The galley, as seen from the starboard entrance. The stove, sink, hand pump are operational.

Galley: Restore to configuration from oceangoing era after repair of steel deck beneath.
