# HEDGE MANAGEMENT PLAN FOR SAINT-GAUDENS NATIONAL HISTORIC SITE

CORNISH, NEW HAMPSHIRE

Olmsted Center for Landscape Preservation  
National Park Service, Boston, Massachusetts, 2008

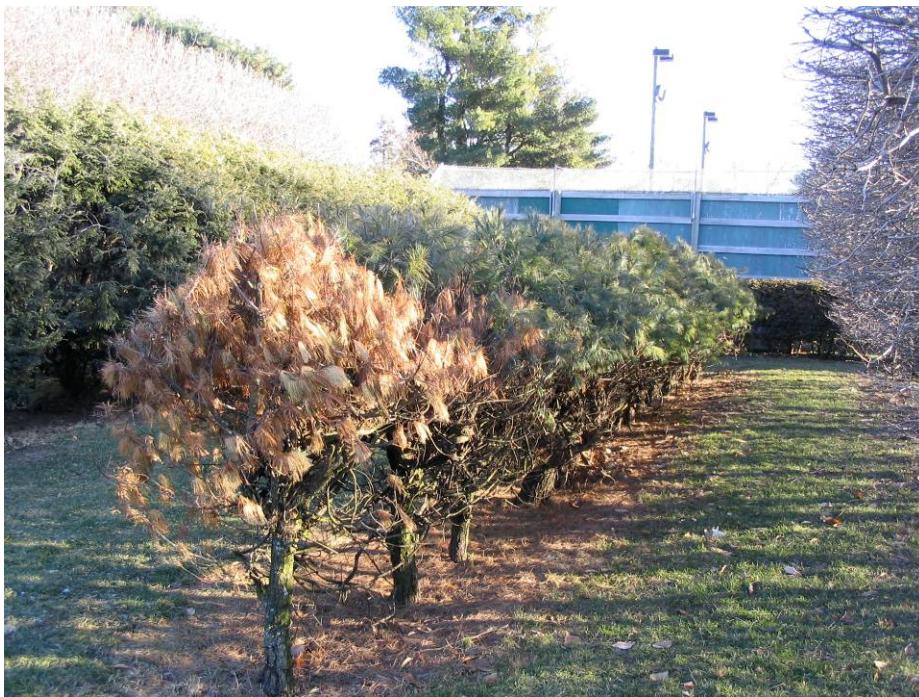
**Figure 0.4:** A current view of the same white pine hedge as shown in figure 0.3, illustrating loss of lower canopy most likely due in part to increased level of shade, 2006 (SUNY ESF).

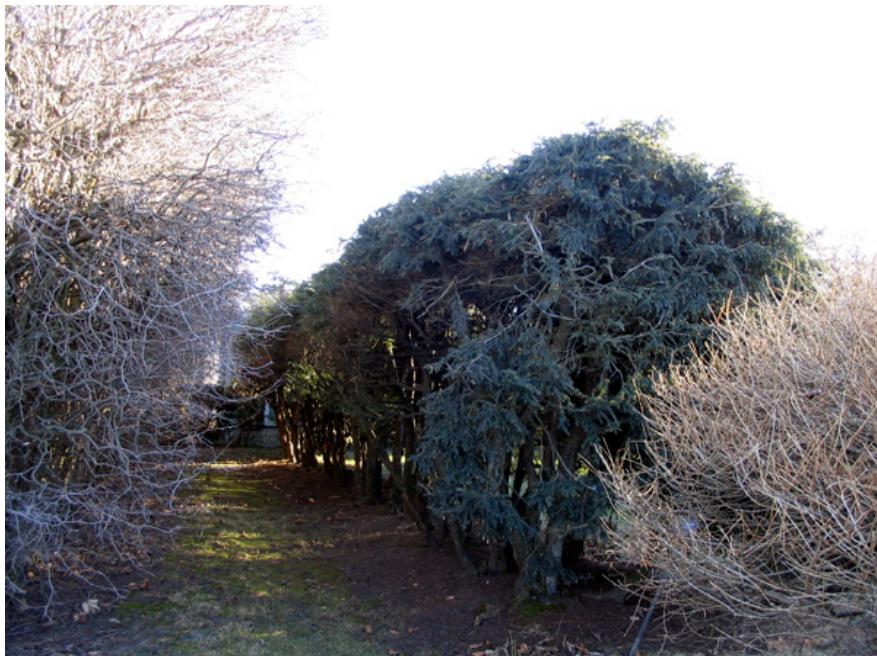
**Figure 0.6:** Hemlock hedge (similar to figure 0.5) at the Canadian Central Experimental Farm in Ottawa, planted in 1889, photographed 2007. Note loss of side canopy, probably due from excessive shade from adjoining hedge (SUNY ESF).

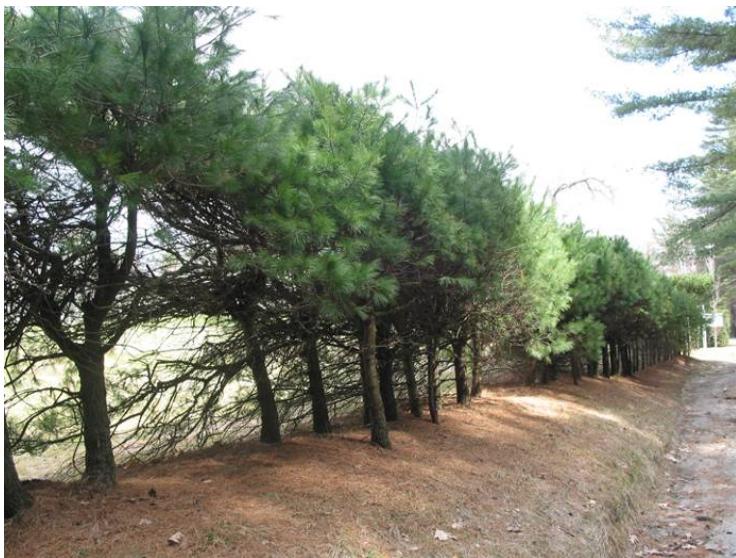
**Figure 3.1:** West meadow hedge, view looking east along Saint Gaudens Road showing character of c.1970 plants thirty-six years after planting, 2006. Note bare side canopy on the road side (right) and lack of even canopy (Olmsted Center for Landscape Preservation).

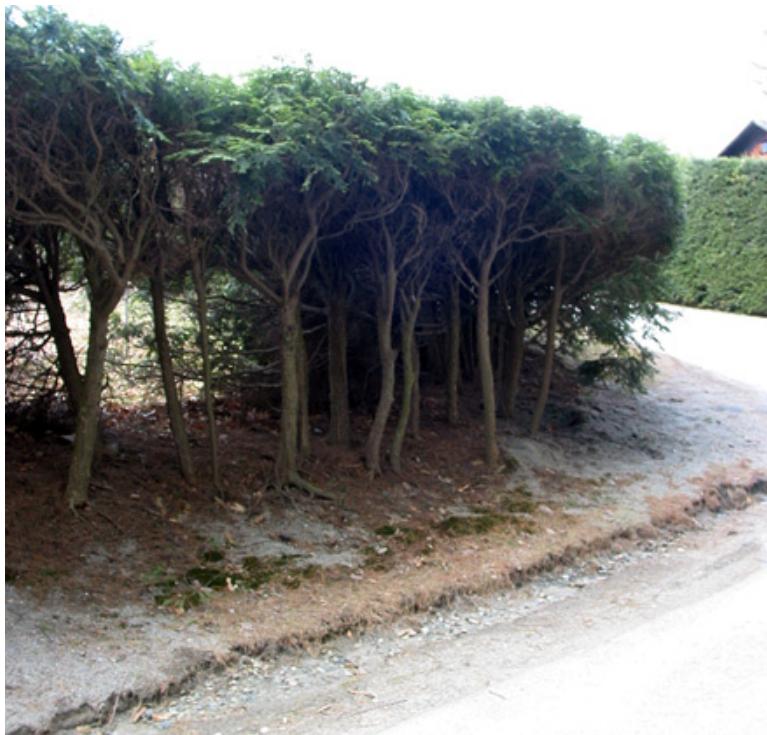
**Figure 3.10:** The cutting garden hedge, view looking northeast at bare understory of section H-5 facing Saint Gaudens Road, 2006. The gray sediment is left over from winter snowplowing (Olmsted Center for Landscape Preservation).

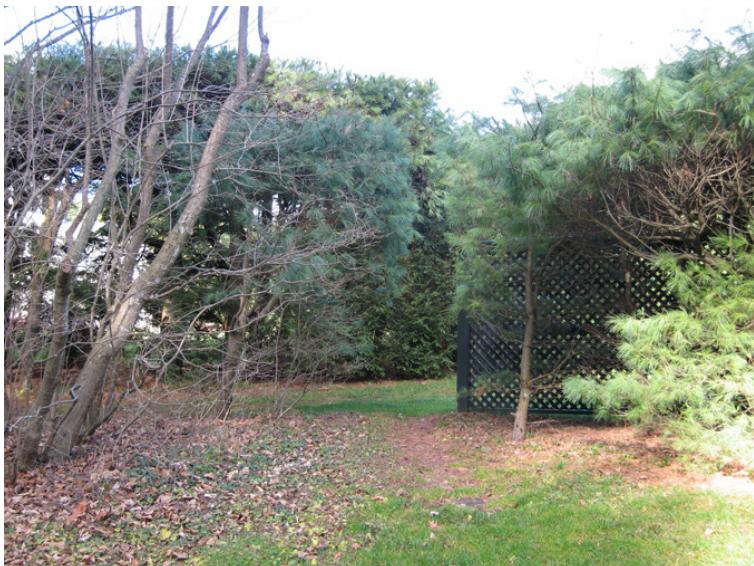
Figure 3.11: The cutting garden hedge, view looking northwest at the gap in the west end of section H-6, 2006. Note the Japanese tree lilac hedge at left and the kitchen hedge in the background (SUNY ESF).

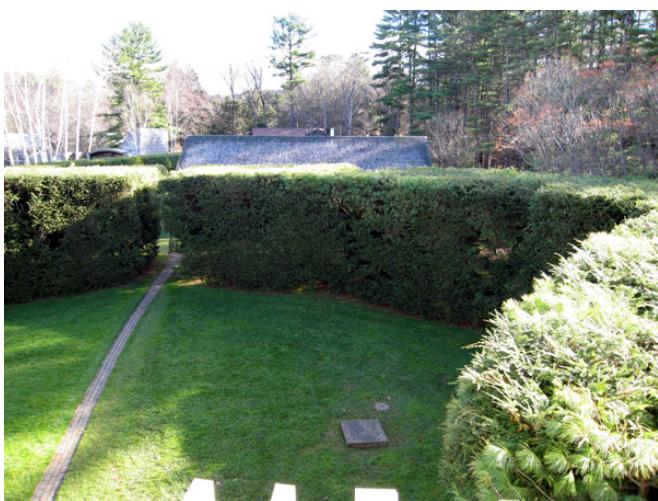
Figure 3.13: The kitchen hedge, view looking east from the second floor of Aspet showing general conditions, 2007 (SUNY ESF).

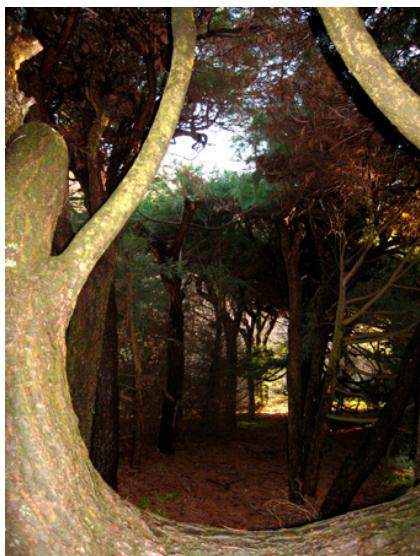
Figure 3.14: The kitchen hedge, view looking through the interior showing massive branching of aged hemlocks, 2006 (SUNY ESF).

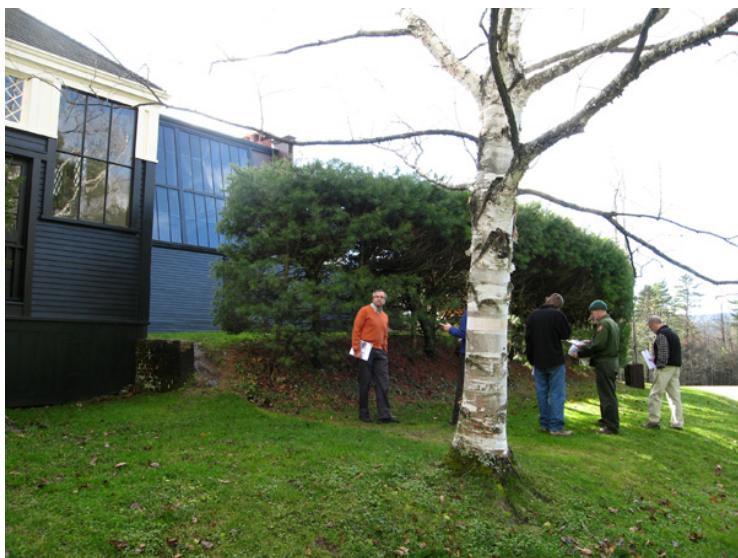
Figure 3.20: The Little Studio hedge view looking west showing non-historic alignment and opening, 2006. (SUNY ESF)

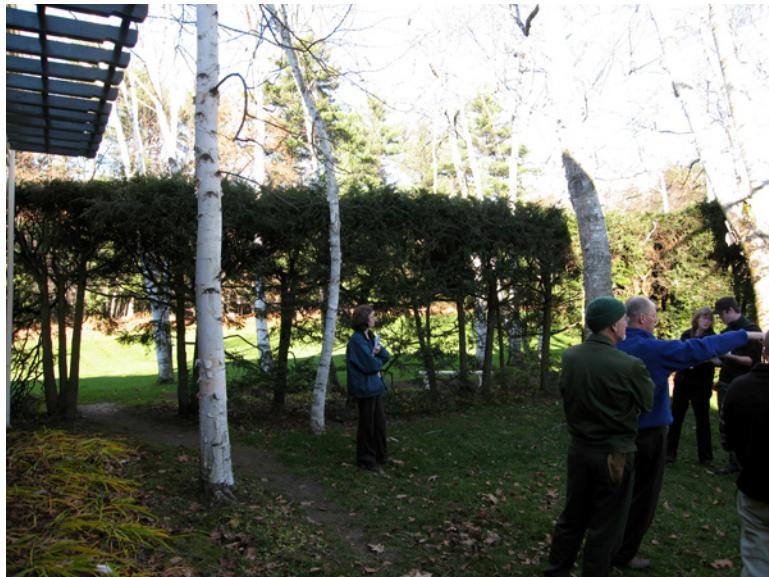
Figure 3.23: The Pan grove hedge, view looking north at section H-10 showing weak canopy and non-historic opening/path, 2006 (SUNY ESF).

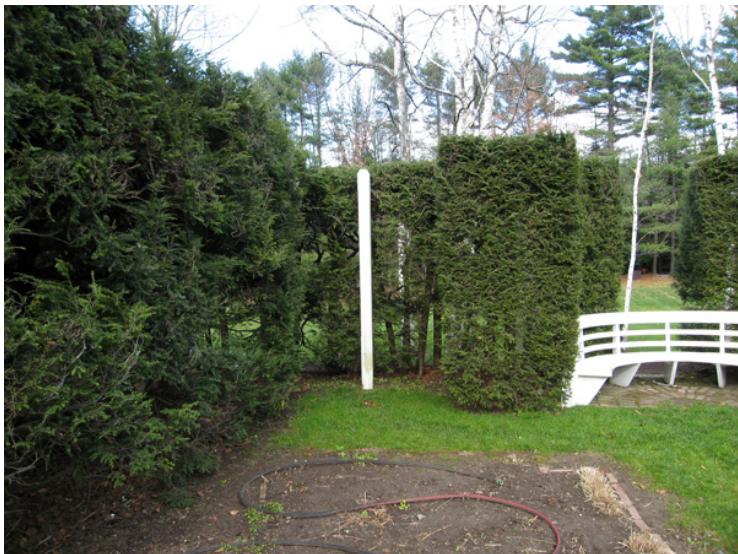
Figure 3.28: The terrace garden hedge, view looking north at a detail of H-12, 2006. Note curved alignment around bench, recess around post, and weak side canopy (SUNY ESF).

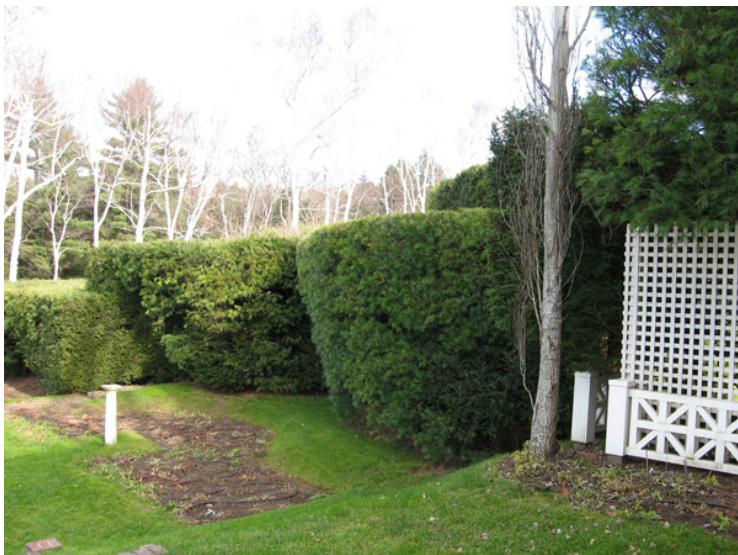
Figure 3.29: Section H-13 of the terrace garden looking northeast from the upper terrace, 2006. Note inward batter toward the base and convex alignment (SUNY ESF).

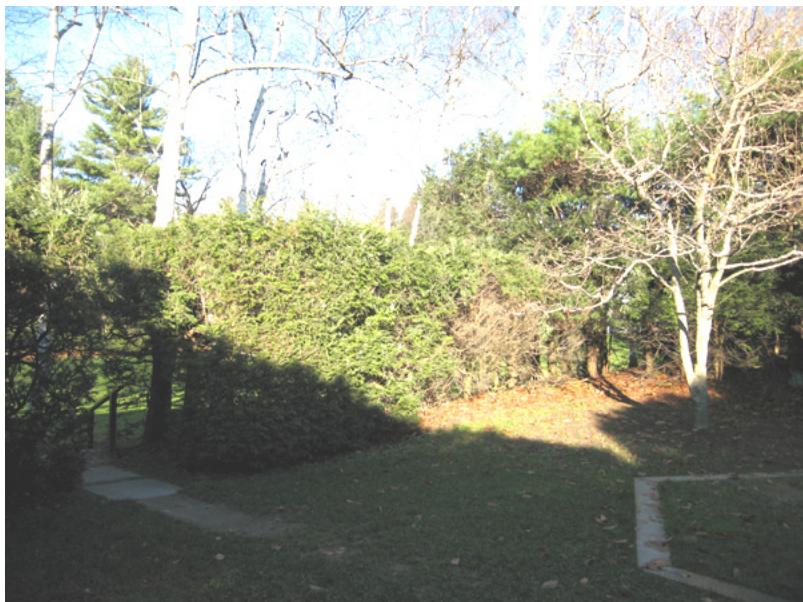
**Figure 3.31:** The Adams hedge, view looking northeast at sections H-15 and 17, 2006. Note weak canopy and recent dieback from shade of the magnolia tree, and shade cast from adjoining sections (SUNY ESF).

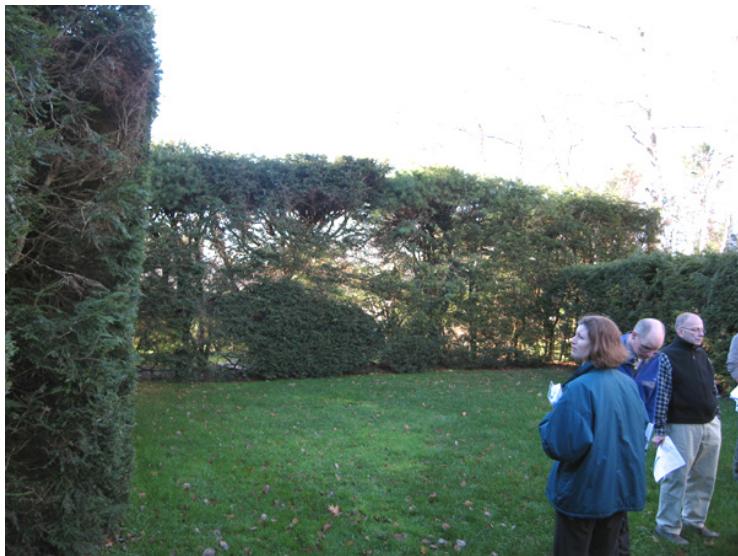
**Figure 3.35:** The Shaw hedge, view looking west at section H-17, the divide with the Adams hedge, 2006. Note openings in canopy and difference in height with H-18 at right (SUNY ESF).

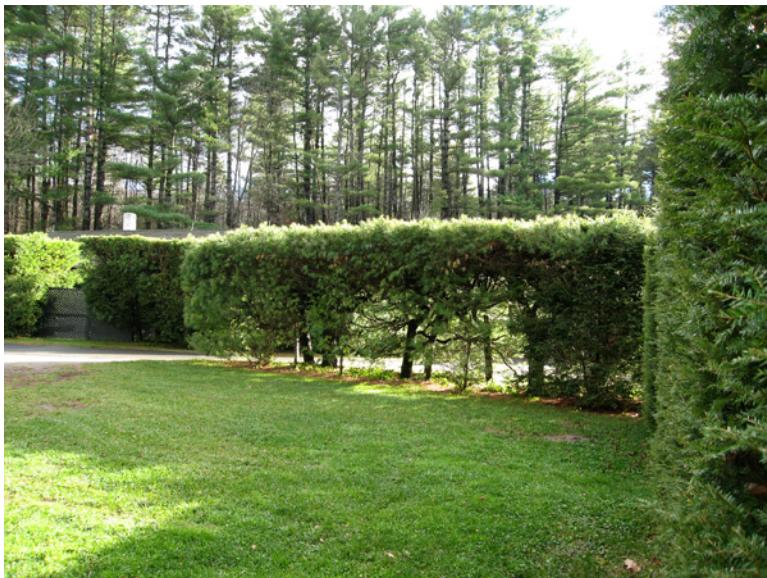
Figure 3.38: The Shaw hedge, view looking south at dogleg (H-20) showing weak lower canopy, 2006 (SUNY ESF).

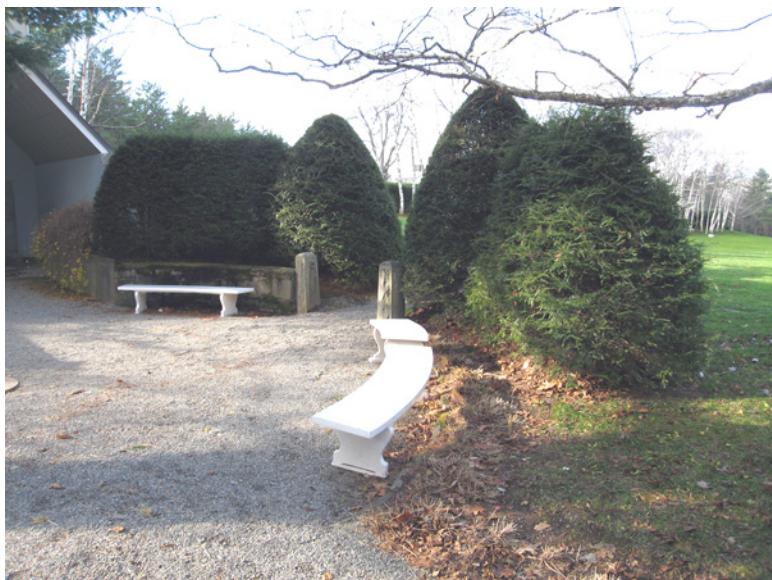
Figure 3.41: The galleries entrance hedge, view looking southwest from interior of courtyard, 2006. The missing north end of section H-23 is in the foreground (SUNY ESF).

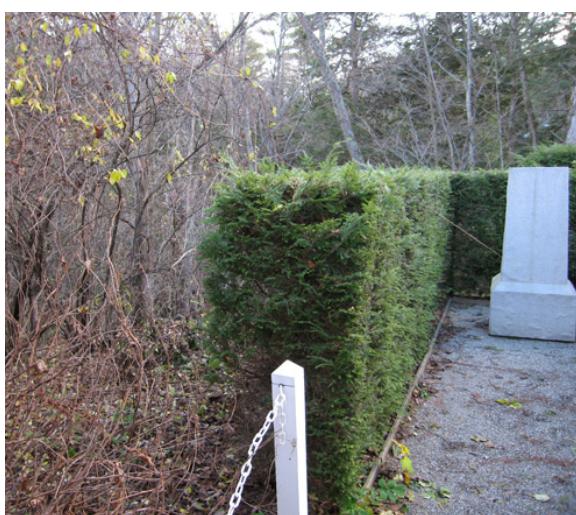
Figure 3.43: The north side of the Lincoln bust hedge, view looking east from Atrium showing encroachment of volunteer vegetation, 2006 (SUNY ESF).

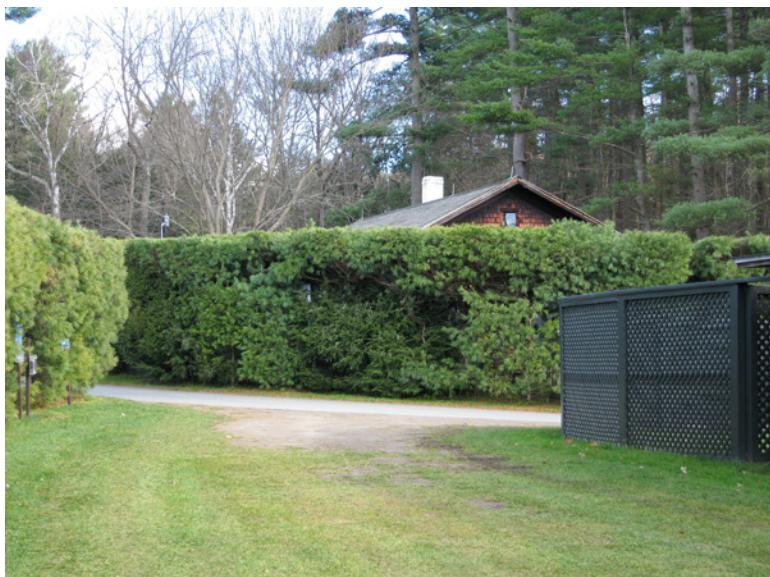
Figure 3.47: The Caretaker's Cottage hedge, view looking east from the stable, 2006. Note existing height above eaves of the cottage and mixed white pine-hemlock (SUNY ESF).

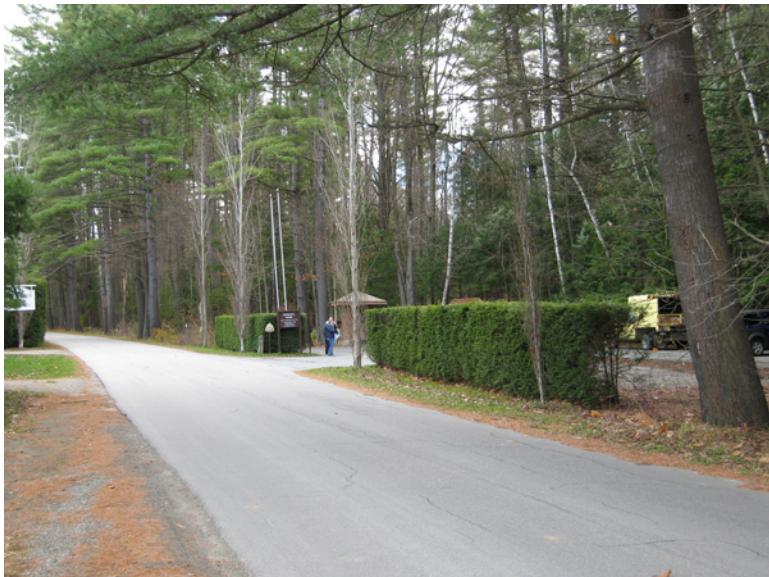
**Figure 3.51:** The parking lot hedge, view looking east along Saint Gaudens Road, 2007. The white pine at the right is recommended for removal because of the heavy shade it casts on this hedge (and Lombardy poplar) and the horseshoe hedge (SUNY ESF).
