HISTORIC STRUCTURES REPORT  
PART I  
ARCHITECTURAL DATA SECTION  
ON  
SAGAMORE HILL  
HOME OF THEODORE ROOSEVELT  
Sagamore Hill National Historic Site

Prepared by  
Norman M. Souder  
Architect  
July 1964

United States Department of the Interior, National Park Service  
Eastern Office, Design and Construction  
Division of Architecture

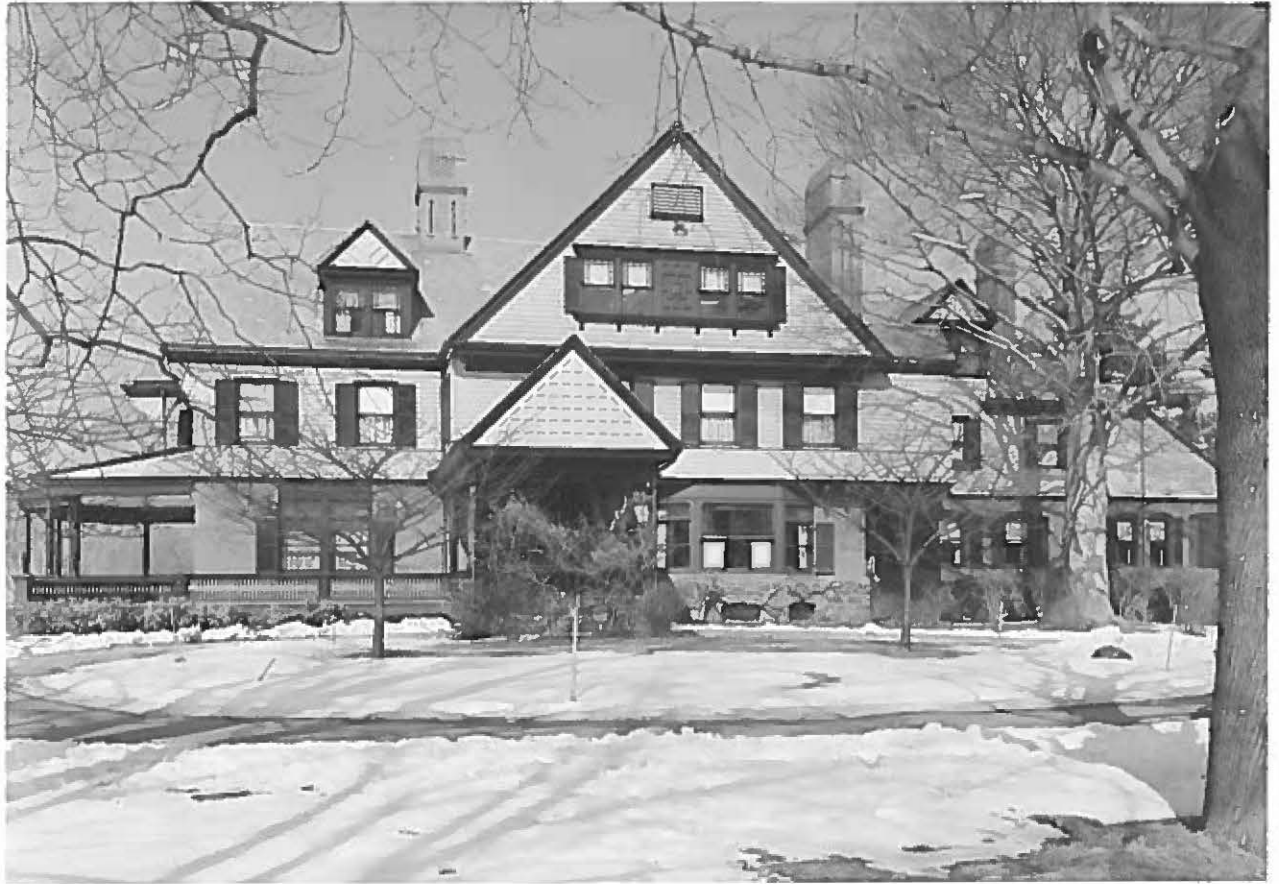
ILLUSTRATION NO. 1

Photograph showing the south elevation of "Sagamore Hill." The house, built in 1884 by Theodore Roosevelt, has remained much the same. The only changes shown on this photograph are an extension on the right of the second floor of the center wing to add a bathroom and the louver added to the gable at the attic level.

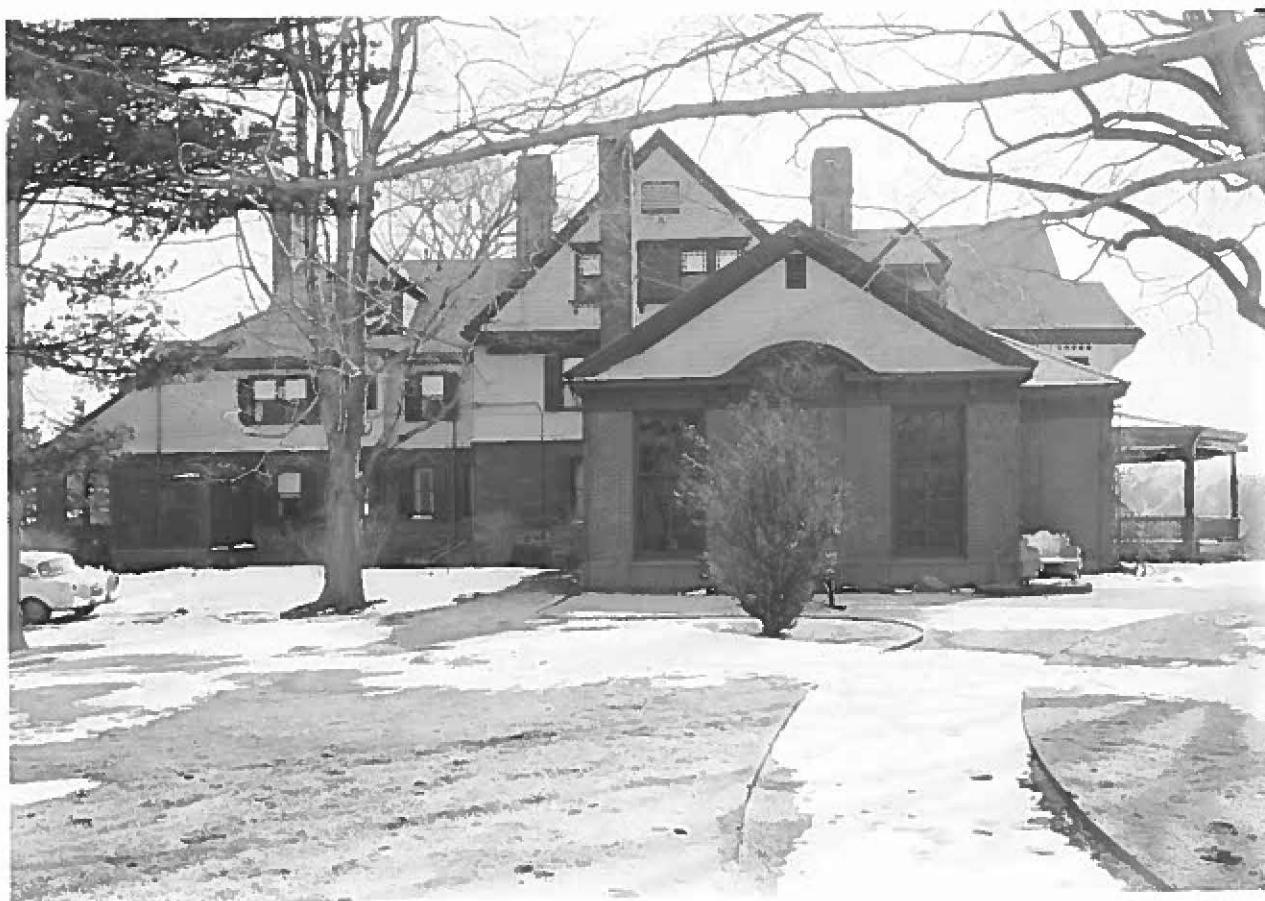
ILLUSTRATION NO. 2

Photograph showing the north side of house. The 1904 Trophy room wing is in the right foreground. The latticed service porch on the left is a later addition.
