THE FARM BUILDINGS at SAGAMORE HILL

Sagamore Hill National Historic Site
Oyster Bay, New York

HISTORIC STRUCTURES REPORT

James J. Lee III
Architectural Conservator

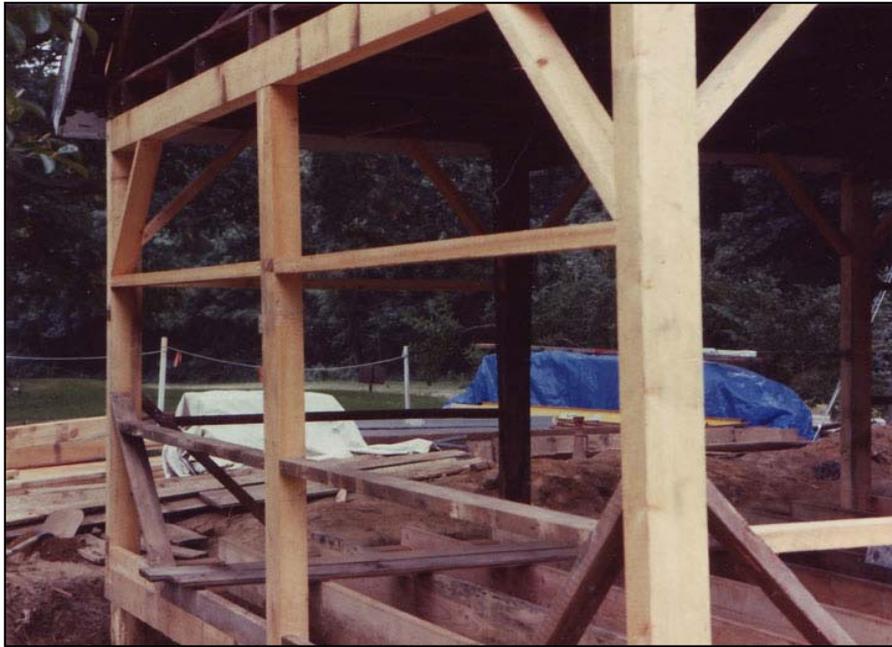
Figure 25. Gardener's Shed: South elevation showing in-kind replacement framing, 1986.

During the rehabilitation and stabilization of the Gardener's Shed, all materials that were deteriorated were replicated and replaced in-kind.

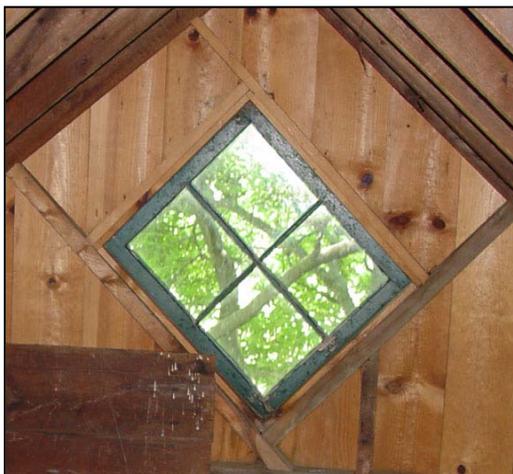
south window appears to be equal on all sides and the sash has square lights (figs. 19 & 20). However, the window currently on that elevation is rectangular (fig. 29). Examination of the extant north window, which is equal on all sides, indicates that it was not the original window in that opening. The framing of the north window opening was altered to accommodate the square sash and the earlier rectangular opening was filled in (fig. 30). It is not known whether the sashes were replaced or whether they were switched. However, the sashes do appear to be correct for the period of construction, which suggests that for some unknown reason they were switched during the TRA renovations.

Figure 29. Gardener's Shed: Interior of south gable window and sash, 2007.

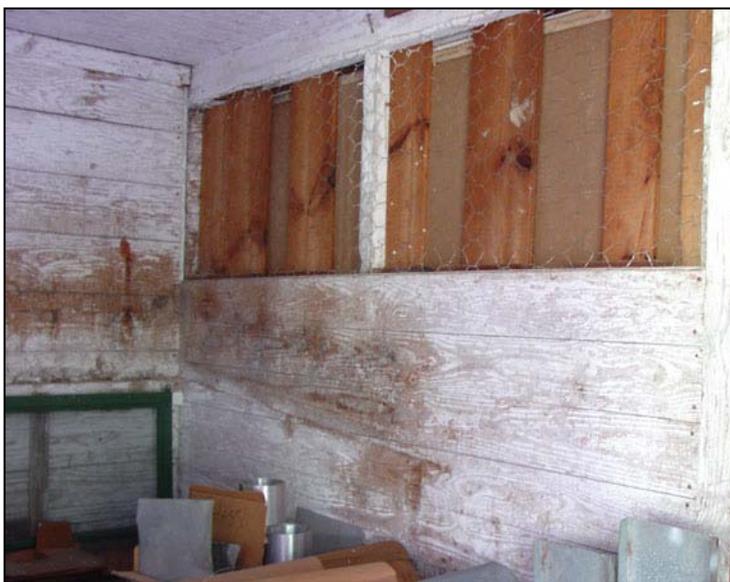
Figure 49. Chicken House: Room 102, east partition wall and evidence of roost on both the north and east walls, 2007.

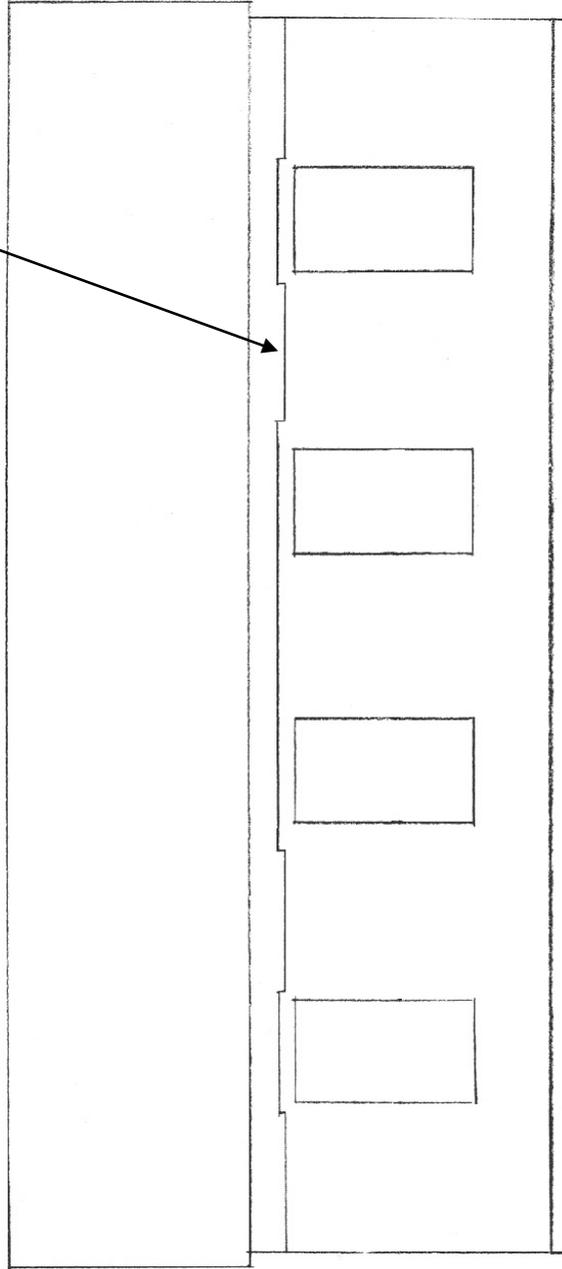
Figure 51. Chicken House: South elevation illustrating anomaly in siding that may represent evidence of earlier openings (not to scale), 2007.

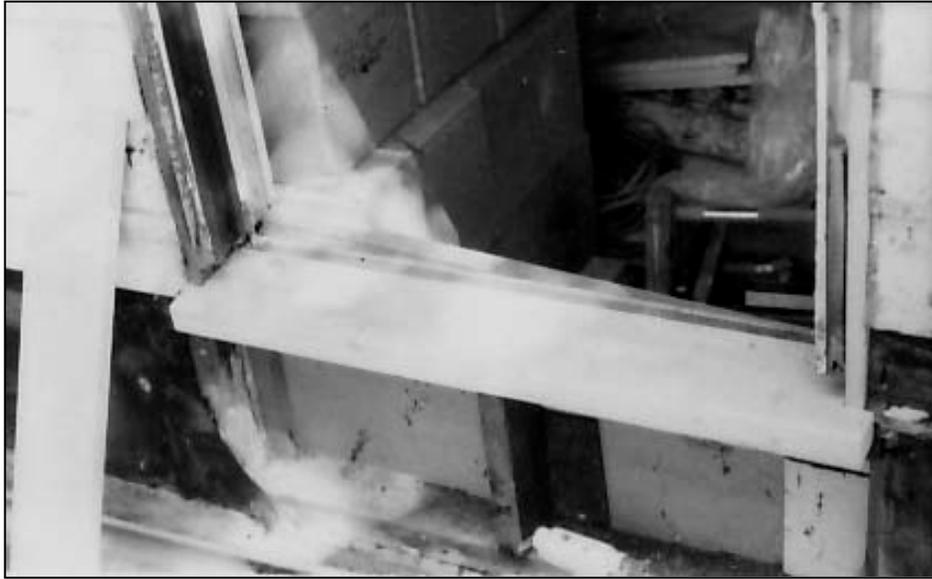
Figure 56. Chicken House: South elevation, west window. Repairs to the sill, frame, and rails, 1986.

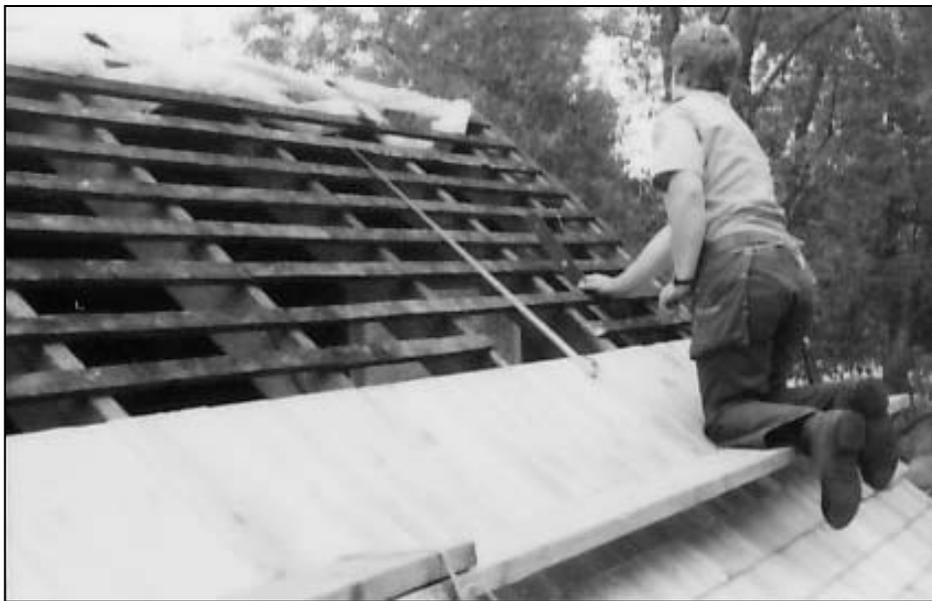
Figure 57. Chicken House: Repairs to roof, including replacement of wood lath and installation of wood shingle roof, 1986.
