Sagamore Hill Visitor Center Structure Fire

Serious Accident Investigation

Factual Report

National Park Service
Sagamore Hill National Historic Site
Draft August 27, 2019

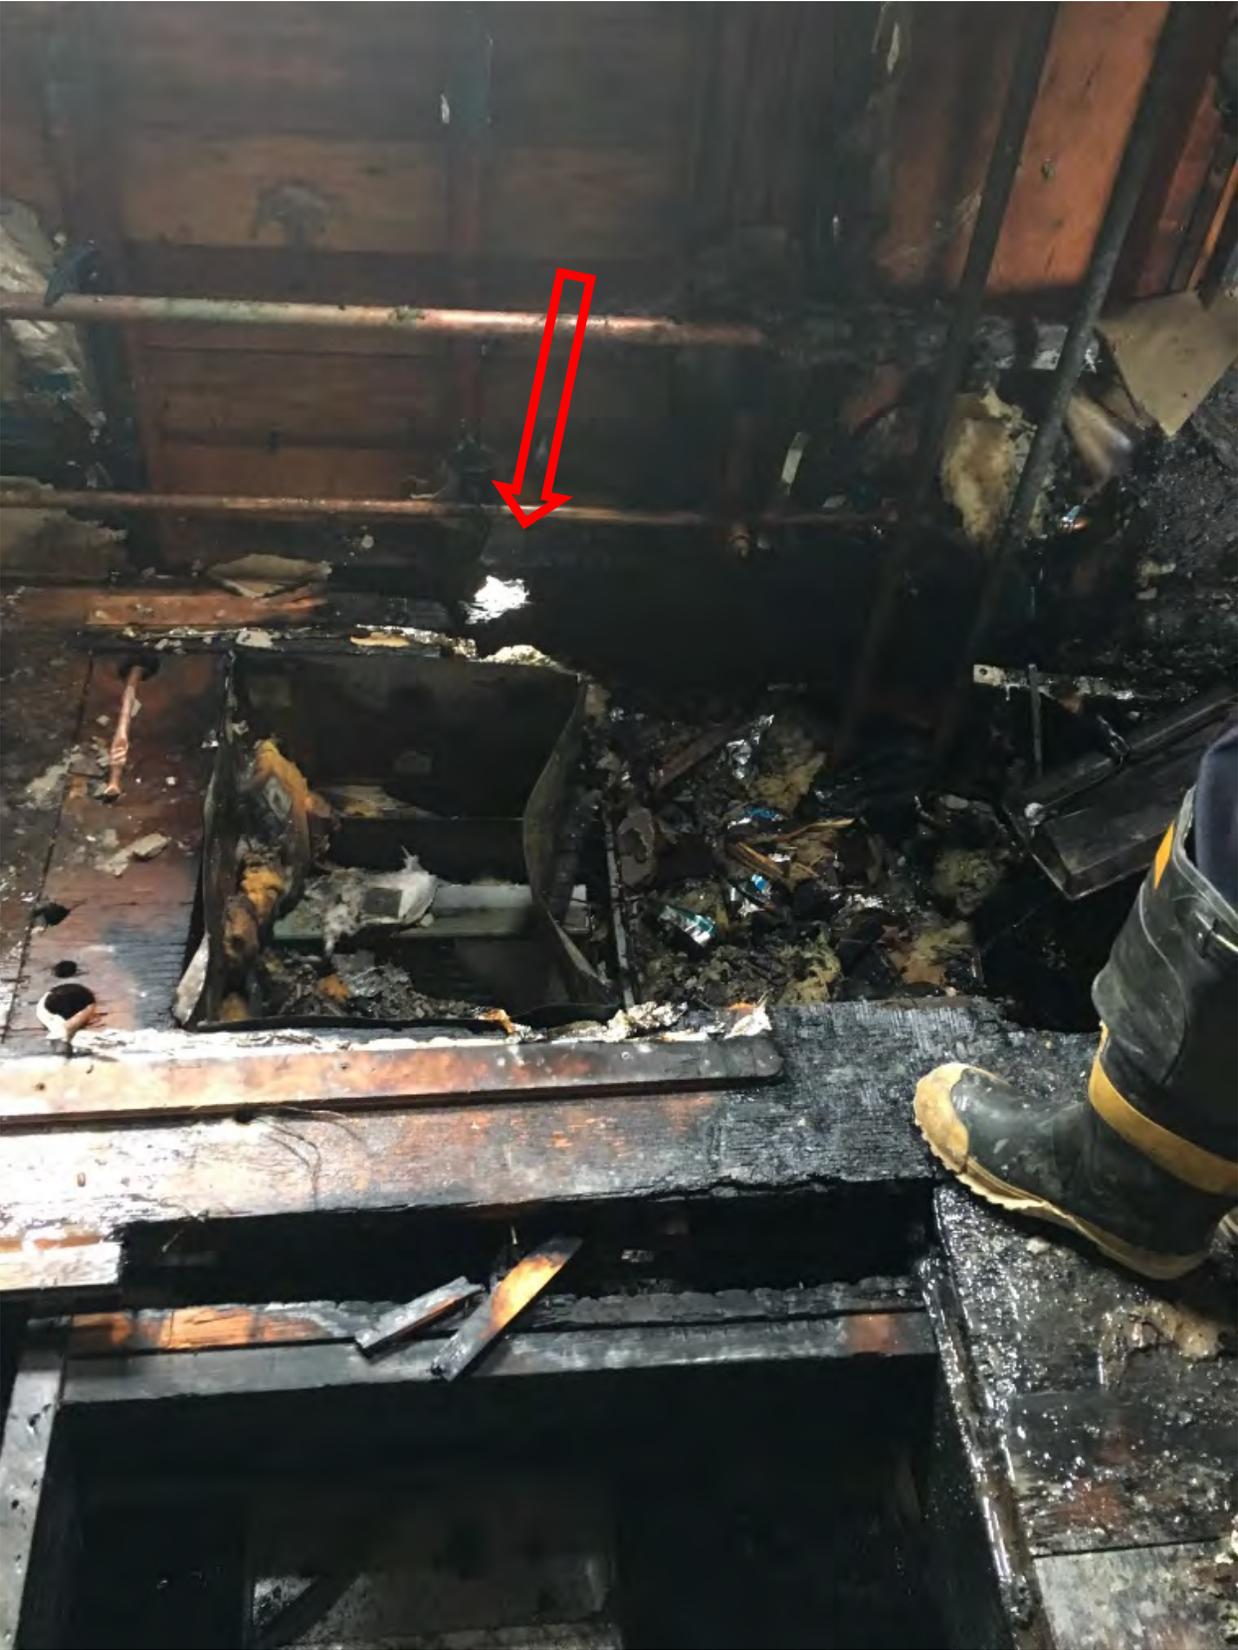
- Areas of heavy char and low burn were noted adjacent and below the floor decking in close proximity to the furnace connection to the crawlspace ductwork connection. This area of low burn corresponds with a 3" x 3" hole that is burned through the north wall. The combustible floor decking and floor joists are potential first fuels that could have been ignited by a properly operating furnace if the original furnace installation did not include the required combustible floor base accessory.

Photo 7 – Furnace Room Floor (Arrow denotes 3"x3" hole through the north wall)

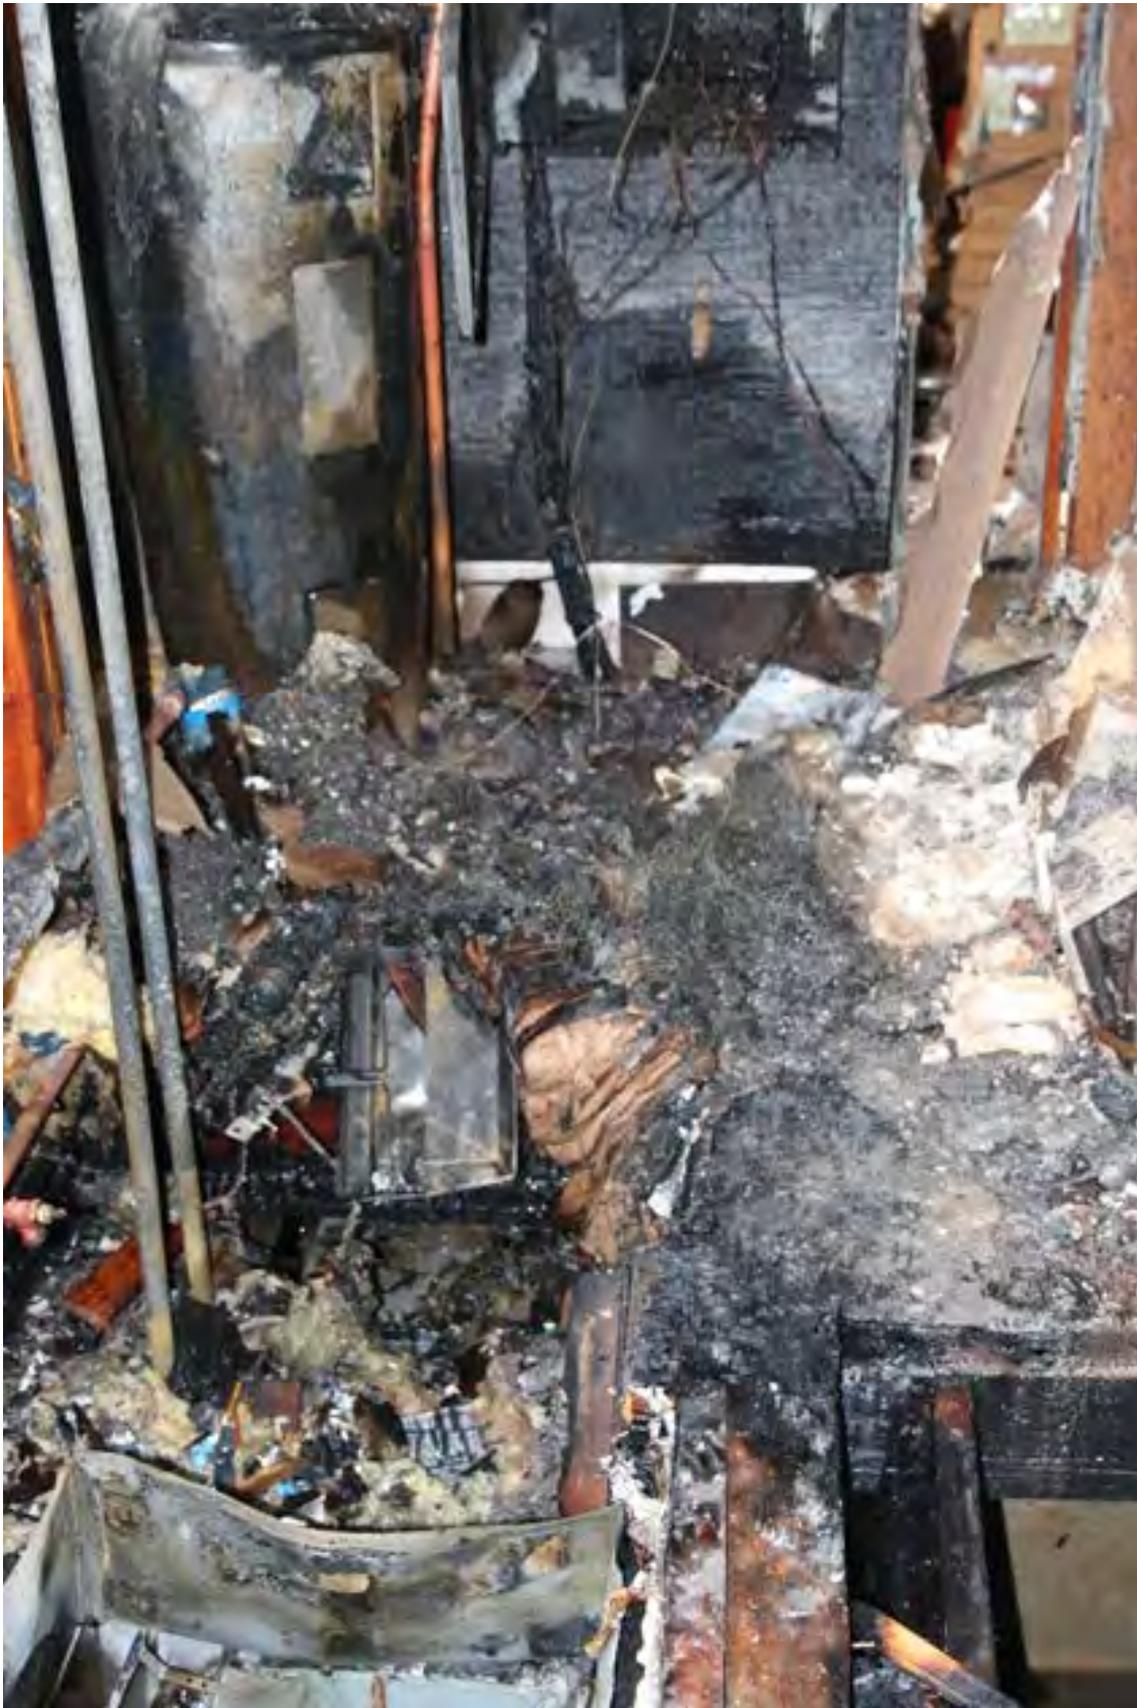
- Spontaneous heating: Plastic chemical containers located in the storage room were reported to be stored on shelving approximately four feet from the areas of low burn. Although the chemicals could result in spontaneous heating if mixed, no melting of the plastic containers was evident in the post-fire photos and the containers were not located in the area of low burn. Additionally, the chemicals had not been recently used.

- Flammable/combustible liquids: There was no reported storage of flammable/combustible liquids in the vicinity of the furnace.
 - Cleaning supplies in plastic containers were reportedly stored on shelving approximately four feet from the furnace and did not show fire damage or melting. Areas of low burn below floor decking can sometimes be related to flammable/combustible liquids involved in fires, but no evidence of liquids was apparent in this area of the furnace room.

Photo 8 – Furnace Room (Combustible storage, electrical conduits, water heater)

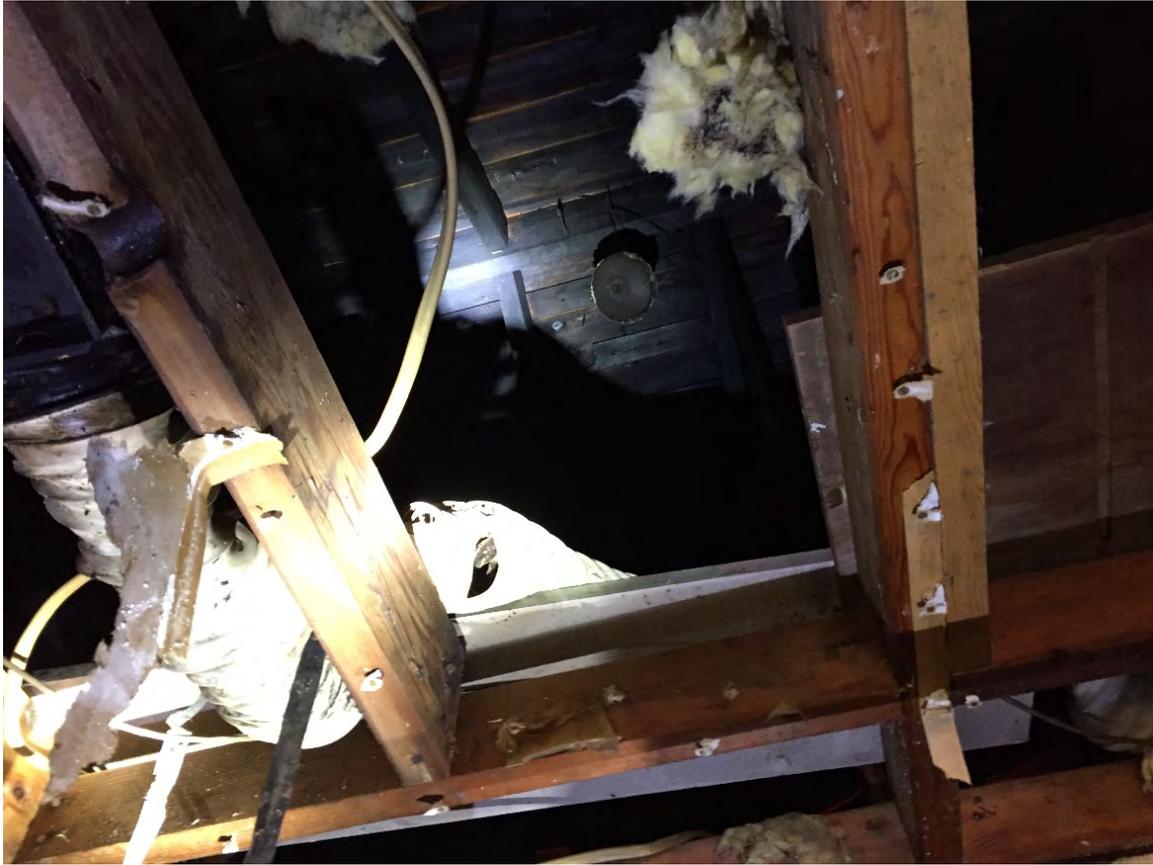
Photo 9 – Furnace Room Ceiling (heat detector)

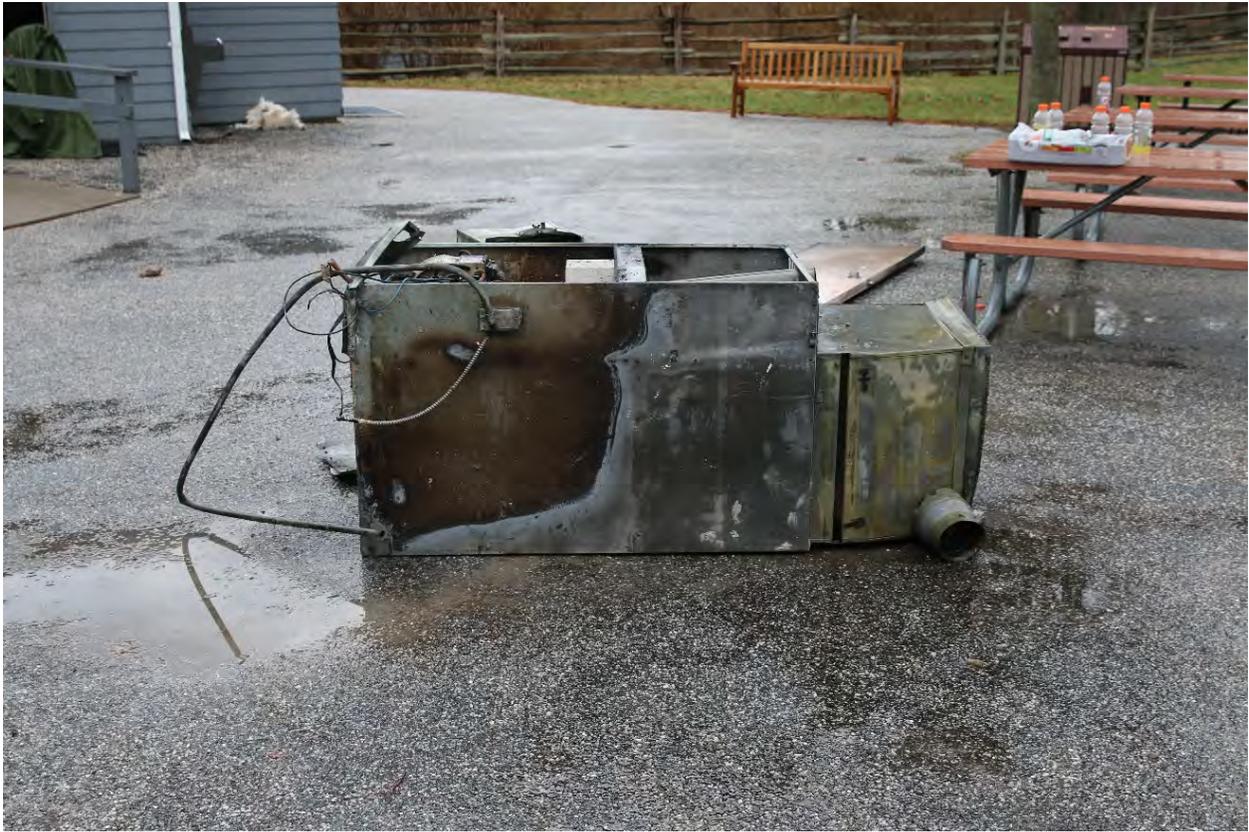
The furnace, which had been relocated to the exterior covered entryway, was examined for fire damage and possible fire cause. The blower motor, which would have been approximately 3 feet above the floor level, was found to be completely destroyed along with all adjacent electrical wiring, as a result of fire exposure. The fuel pump and ignitor area were examined and no apparent damage was visible to the equipment or the electrical wiring/insulation.

Photo 11 – Rheem Furnace (north side, laying on west side)

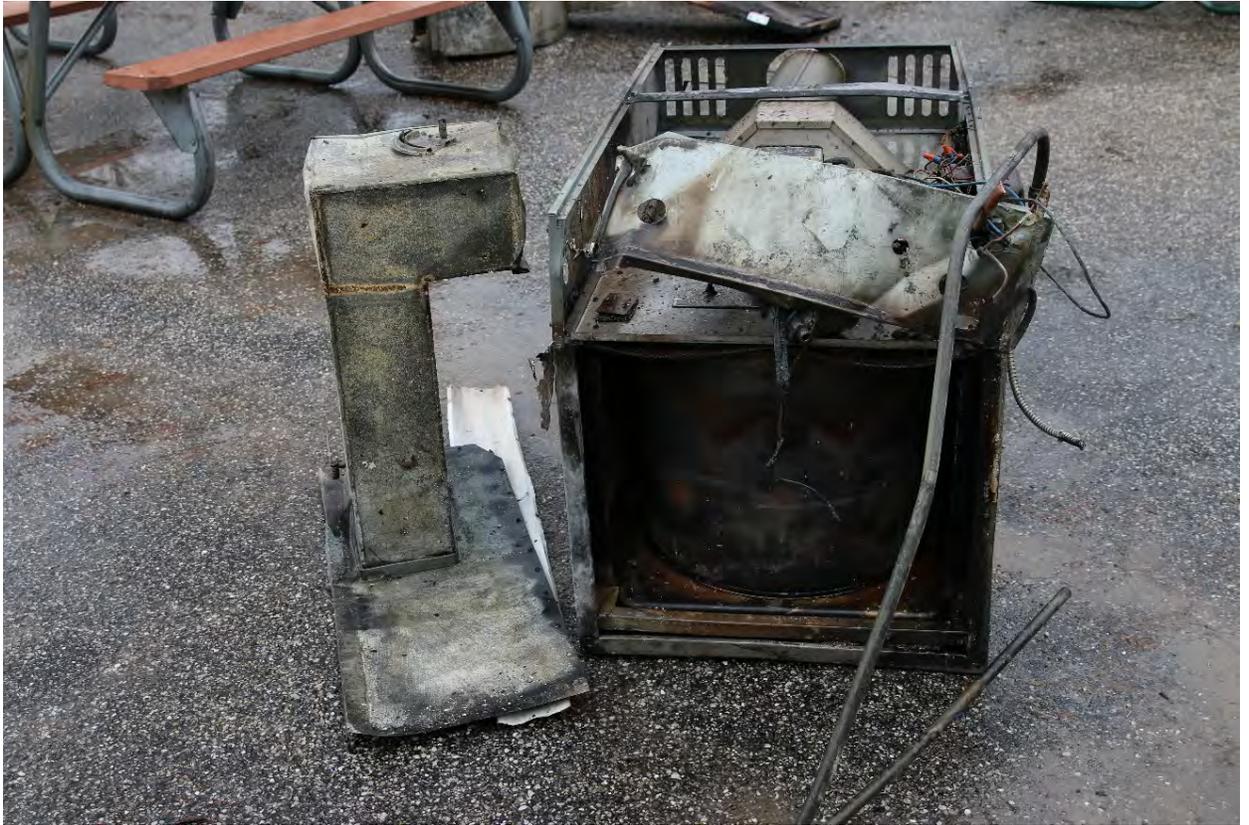
Of note, information contained with the Rheem installation manual, as well as the data plate inside the furnace, indicated this furnace is certified for use on non-combustible floors and also that installation on combustible floor surfaces would require the installation of a special factory supplied floor base. An exception is listed for installations where the furnace is installed on top of an air conditioning plenum. The floor area was examined to determine if a factory floor base was installed and none was apparent. It is unknown if a floor base was in place and removed during firefighting efforts or if a base had not been installed. It is also unknown if the air conditioning plenum under the furnace met the exception for installing a non-combustible floor base.

Photo 12 – Rheem Furnace (bottom, laying on west side)

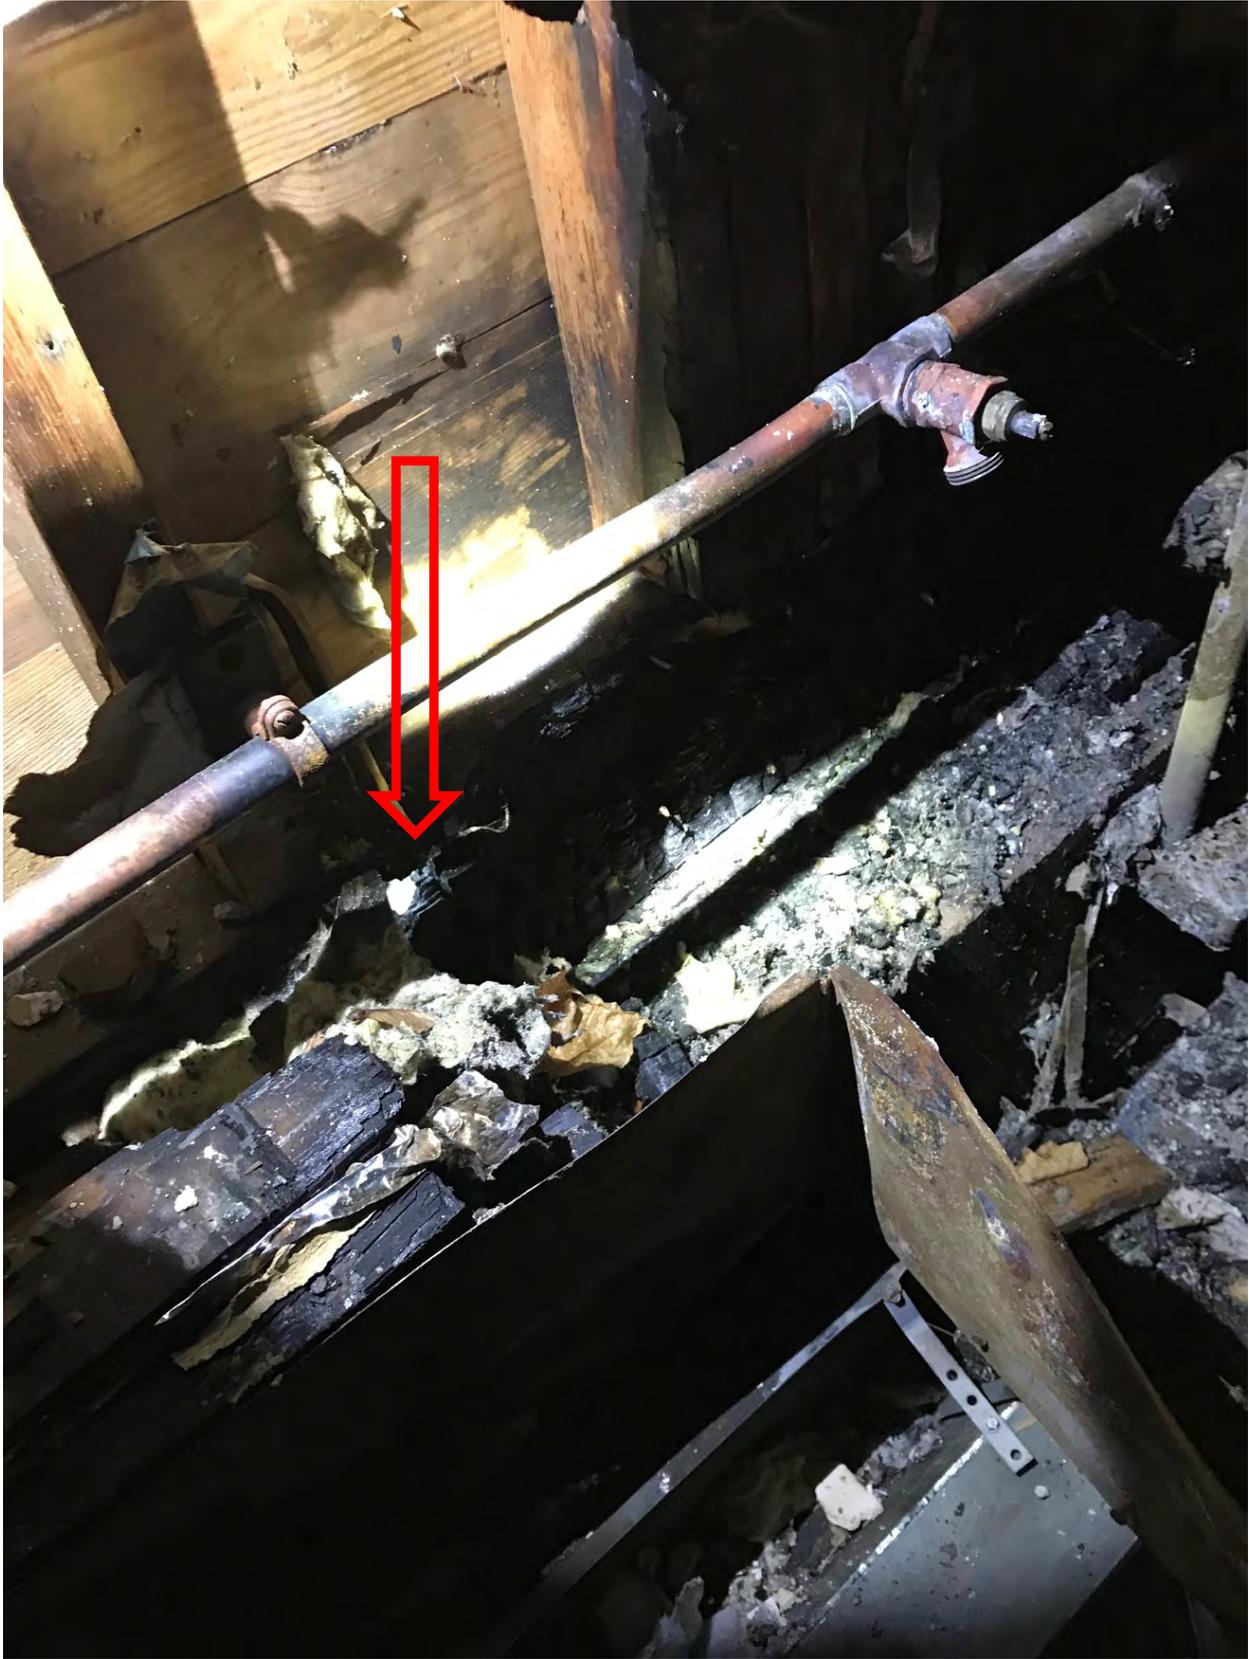
Photo 16 - Furnace Room Floor (Arrow denotes 3"x3" hole through the north wall)

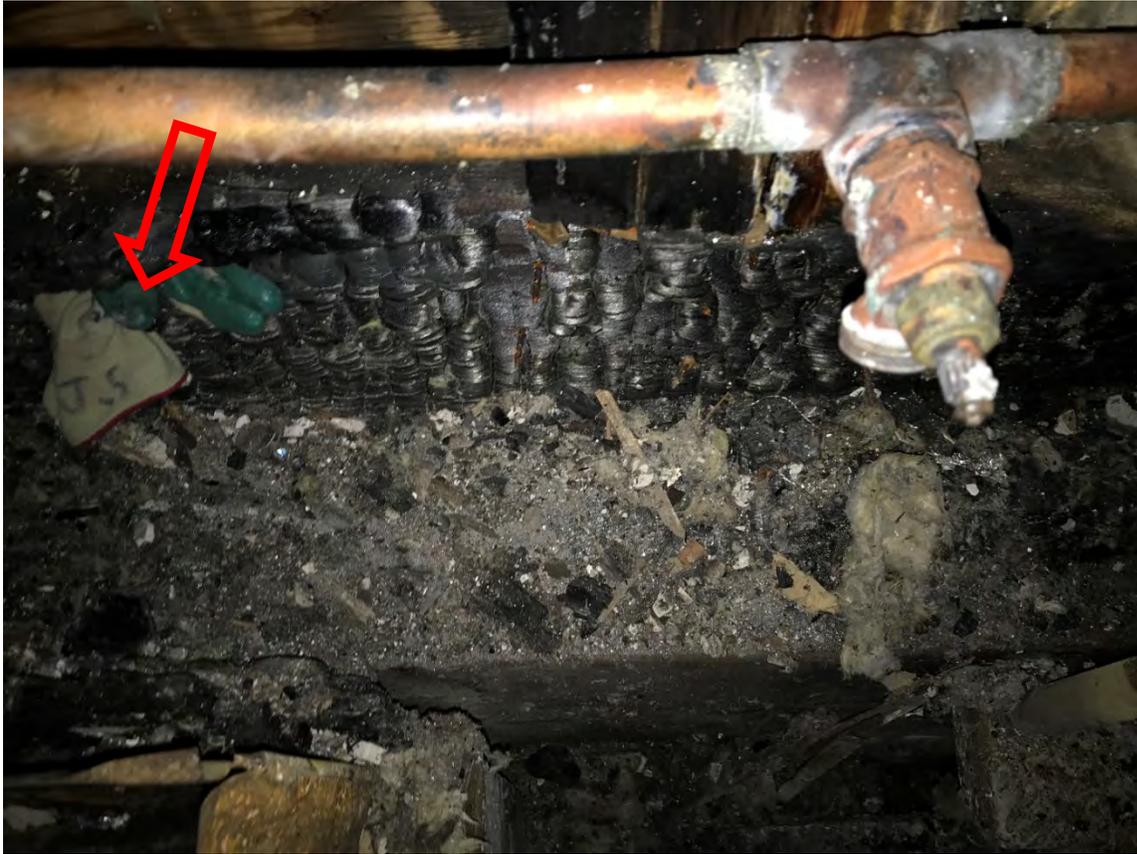
Photo 17 - Furnace Room, North Wall Sill Plate (glove placed in 3"x3" hole to block sunlight)

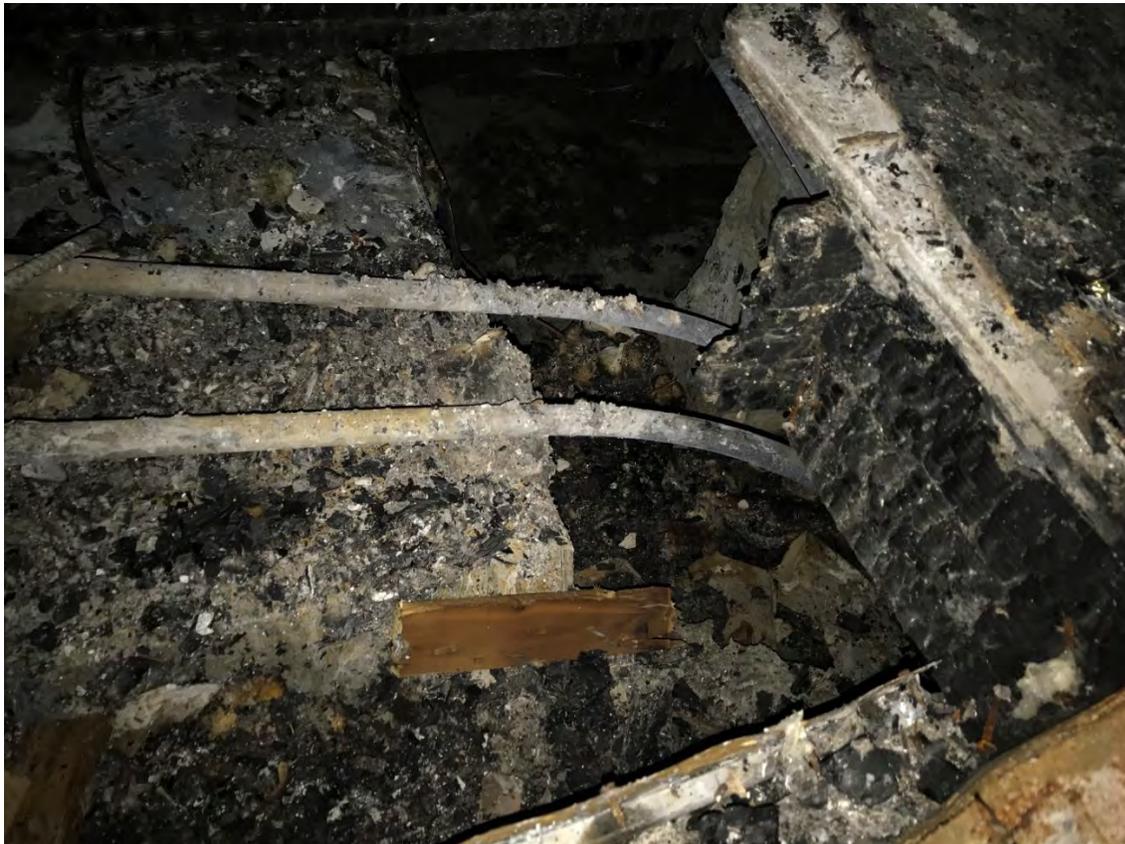
- The possibility exists that long-term exposure to heat in this area could have caused pyrolysis³ of the combustible floor decking and joists, making them more susceptible to ignition by the high temperature of the heating air. This condition could have existed over a long period of time and could have also been part of the smoke incident that occurred on December 3, 2019.

Photo 18 - Crawlspace, Charring of Floor Joists

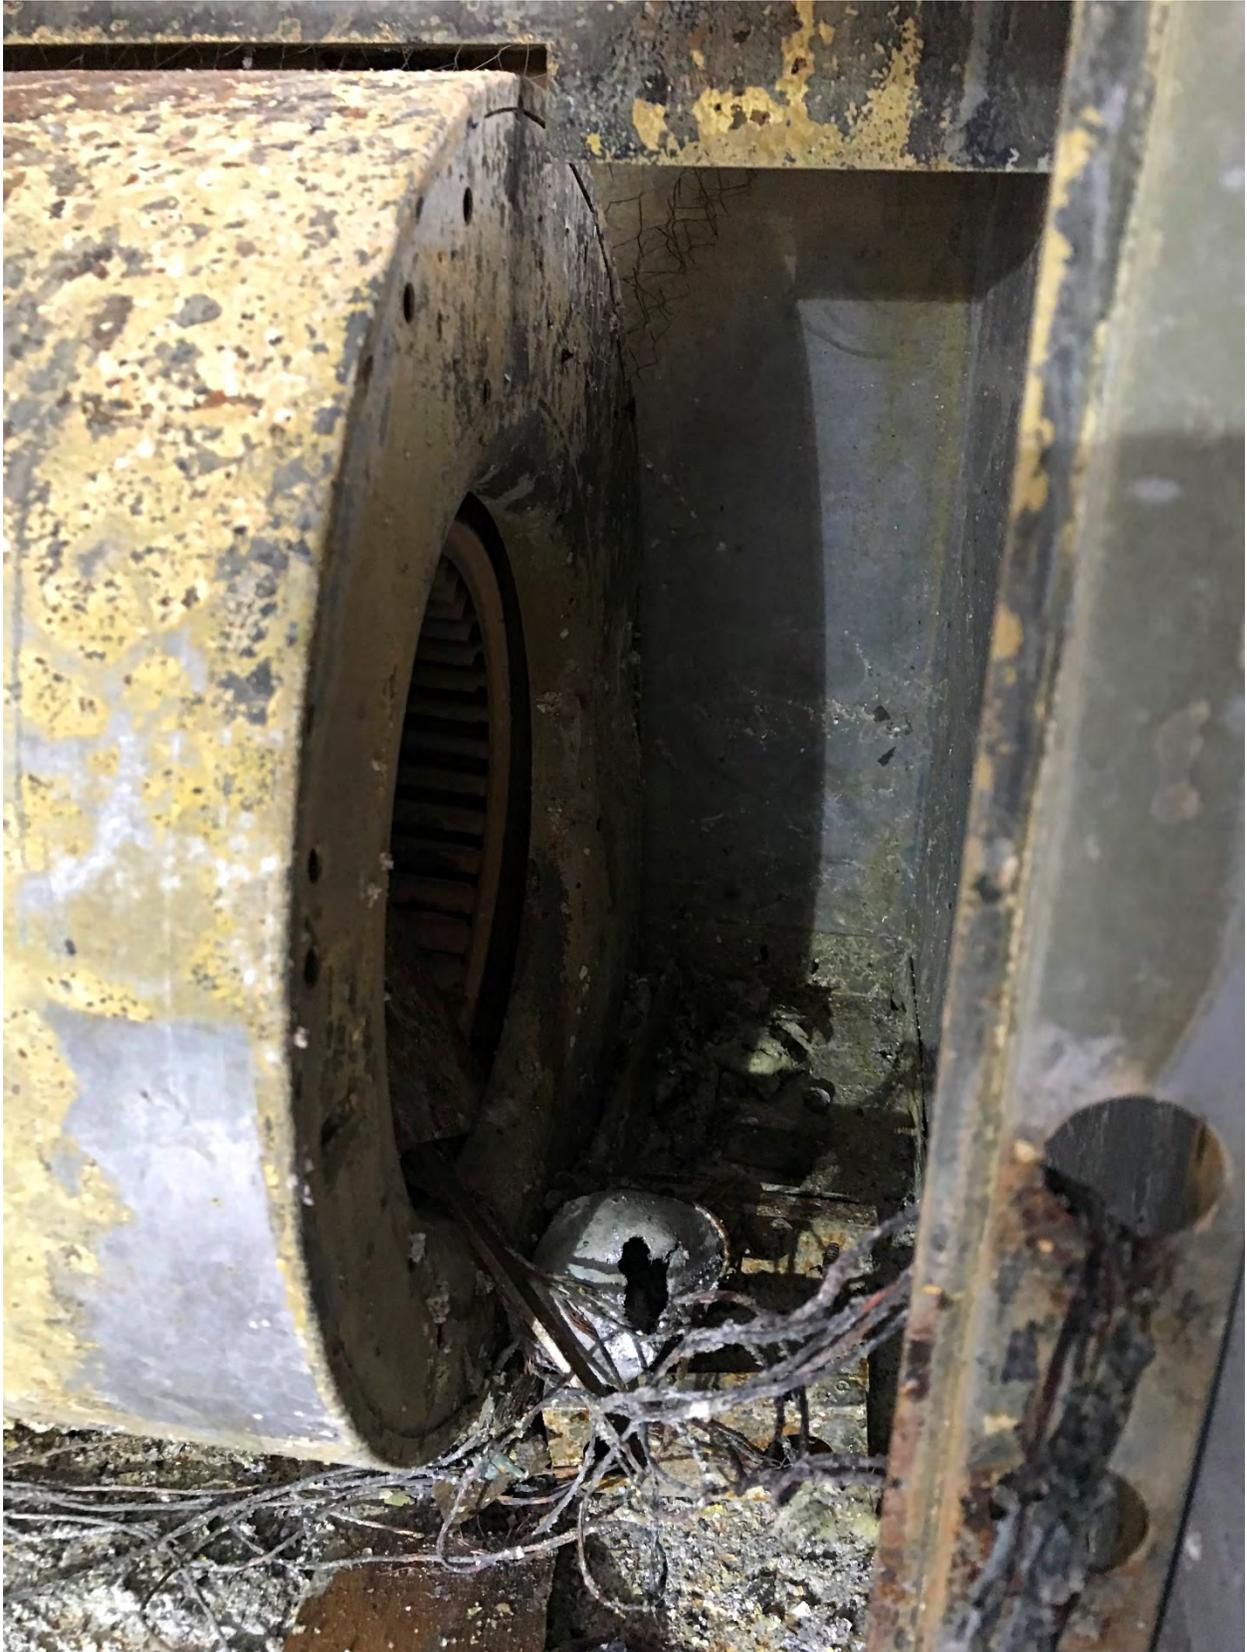
- Furnace repair work: The ignition electrodes and combustion chamber did not display any apparent failure. Service records indicate the replacement motor and capacitor were properly sized. The blower motor, fan, capacitor, and adjacent wiring suffered significant fire damage, but it is unknown if this damage was an area of fire cause or a result of fire exposure. The furnace operated without reported issues after the repair.

Photo 19 – Furnace Blower and Capacitor

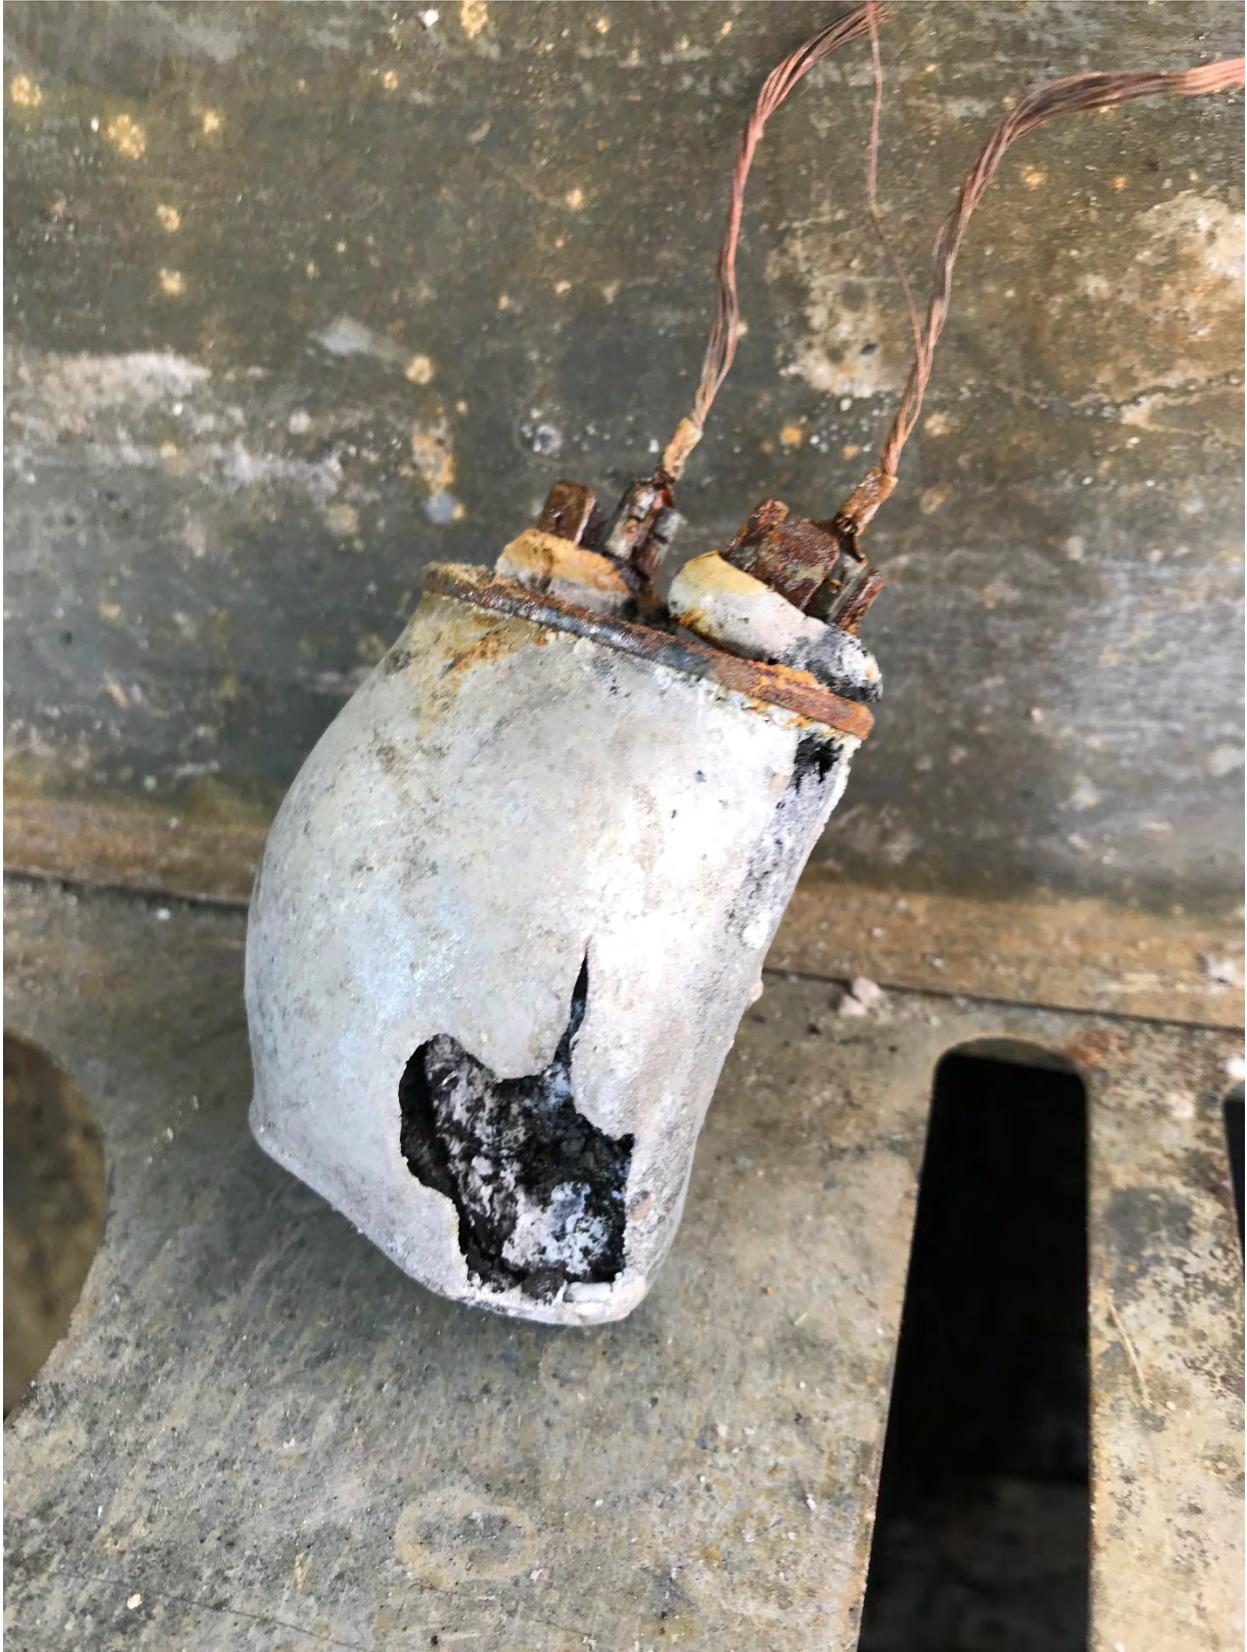
Photo 20 – Furnace Capacitor

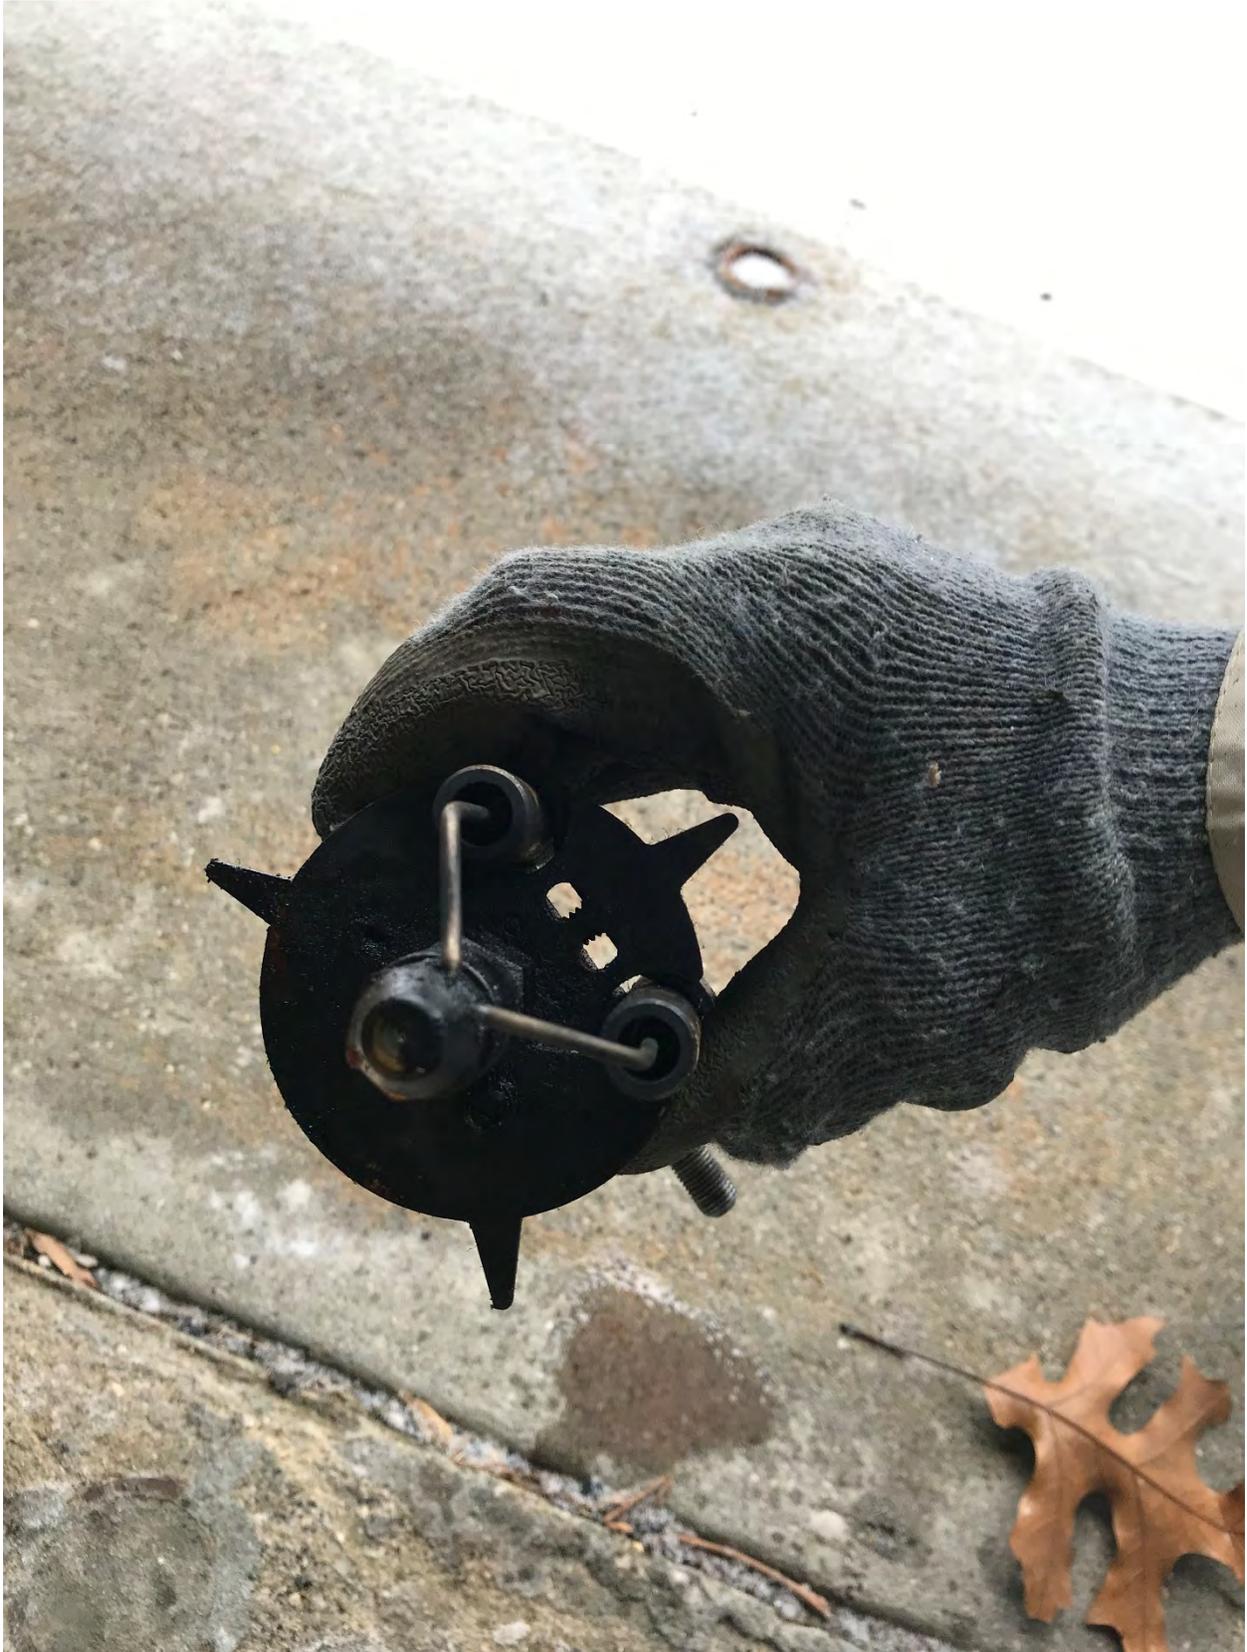
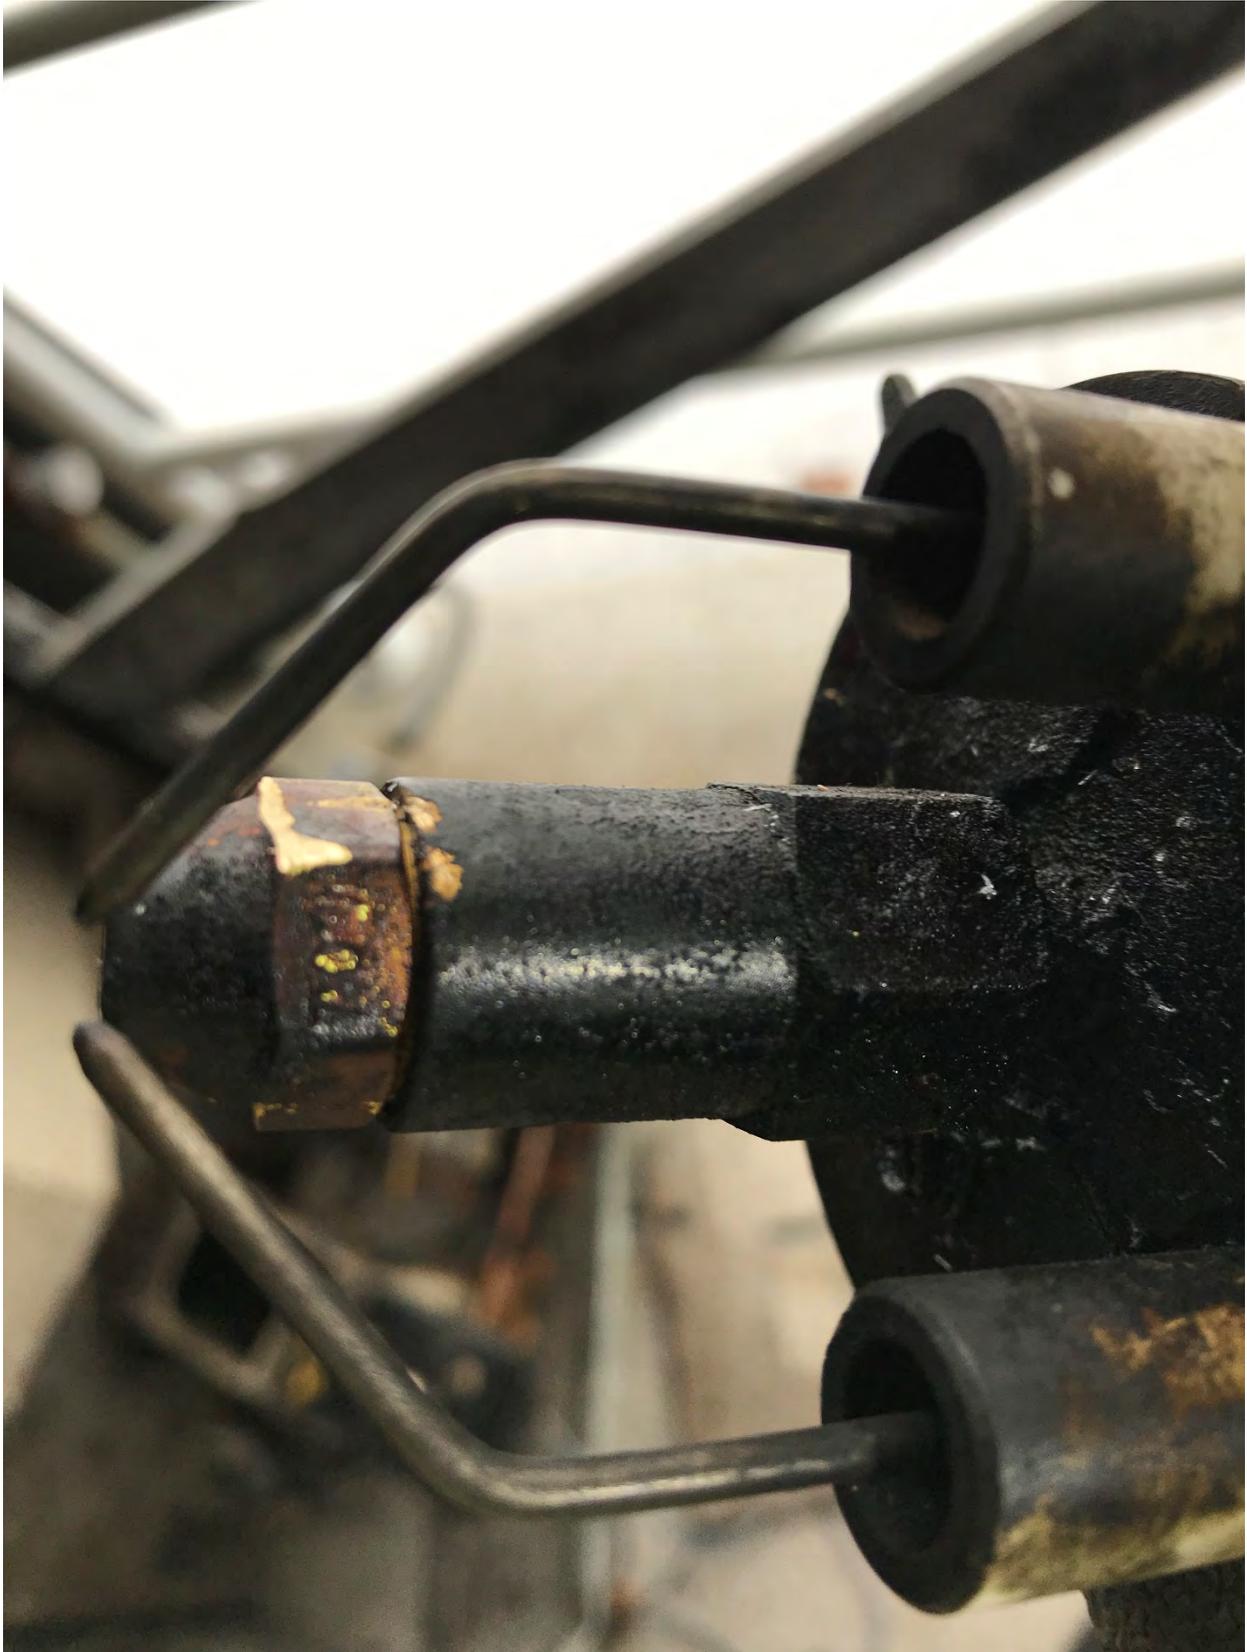
The ignition housing was disassembled and the ignitor was examined. No apparent damage or defect was noticed. The ignitor chamber and residual fuel appeared clean.

Photo 23 – Furnace Burner Electrodes

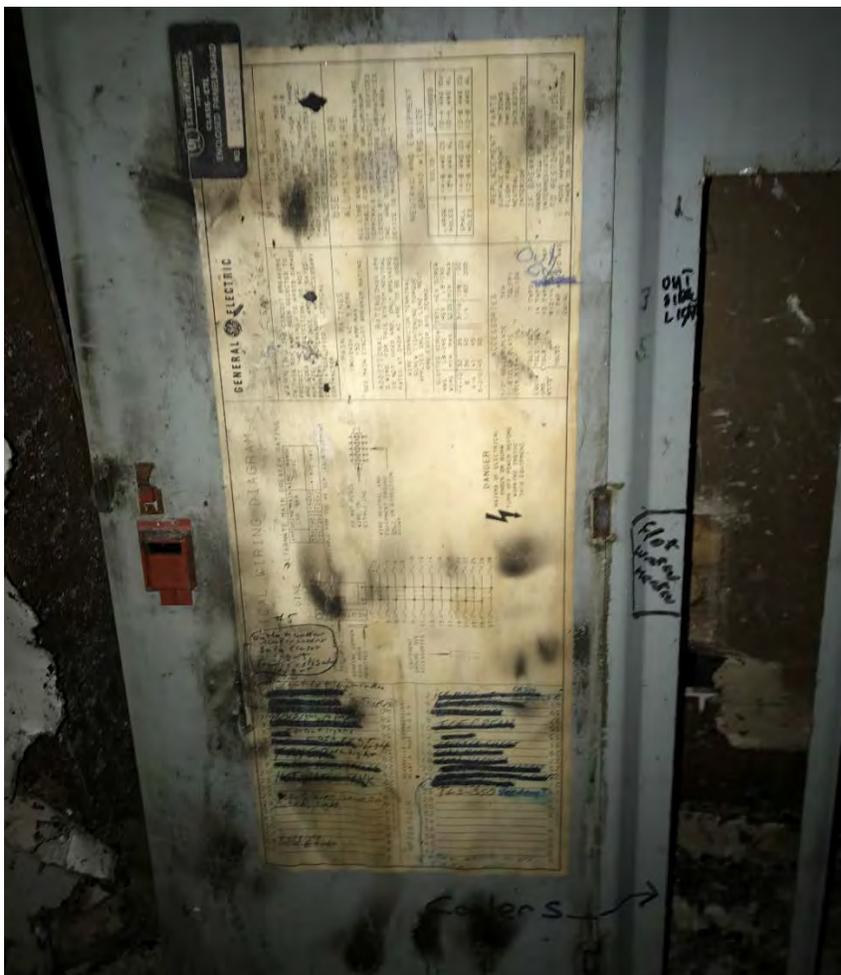
- 13) The electrical panel labeling and circuit designation was found unreliable during the post-fire investigation. NFPA 1, Section 11.1.7.3.1 states "Each disconnecting means shall be legibly marked to indicate its purpose unless located and arranged so the purpose is evident. The marking shall be of sufficient durability to withstand the environment involved." Although this finding is not related to the fire ignition/cause, proper labeling of electrical circuits enhances the ability to locate and isolate circuits quickly and correctly.

Photo 26 – Visitor Center Electrical Panel Labeling (unreliable labeling)
