Sagamore Hill Visitor Center Structure Fire

Serious Accident Investigation

Factual Report

National Park Service
Sagamore Hill National Historic Site
Draft August 27, 2019

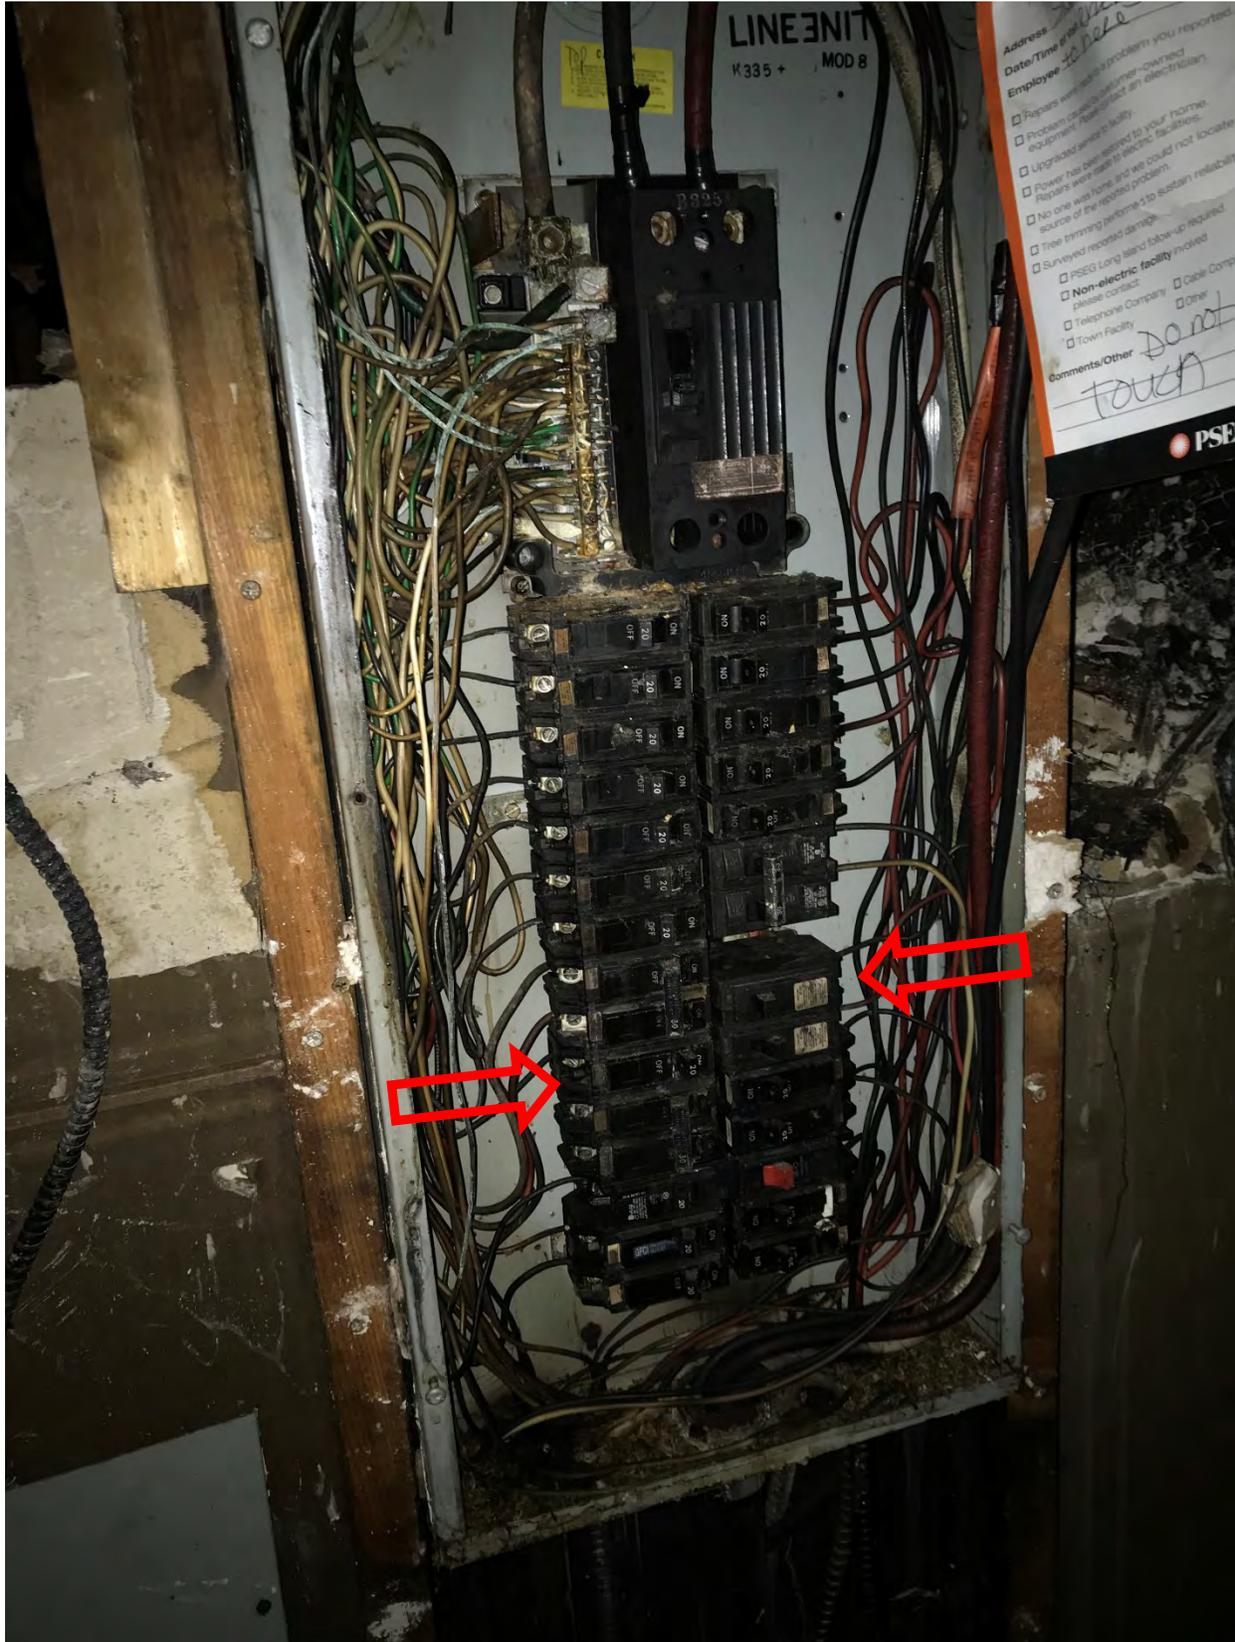
The electrical panel for the building was examined to determine if there were any tripped circuits. The panel cover had been previously removed and electrical service to the building was disconnected. Two breakers were found in the tripped position. All other breakers were found in the off position. It is unknown if these were turned off by firefighters or by park personnel.

Photo 27 - Visitor Center Electrical Panel (red arrows denote tripped breakers)
