**A STUDY OF THE PROBABLE ORIGINAL LAYOUTS,
USES, AND INTERIOR APPEARANCE OF THE
OFFICERS' QUARTERS (HS-11)
AT AMERICAN CAMP**

San Juan Island National Historical Park

Prepared by: Kingston Heath, Fred Walters and Aaron Lemchen
Historic Preservation Program
School of Architecture and Allied Arts
University of Oregon

FINAL REPORT: AUGUST 15 , 2005

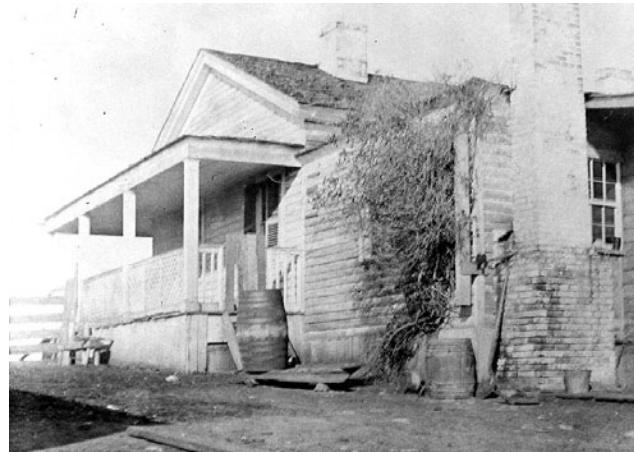
Fig. III-3. Southwest corner of HS-11. The date of the photo is unknown and the westward expansion of the rear addition (flush with the main building and chimney) was not recorded in historic documents from the military period. The rear addition is likely a kitchen and/or dining space.

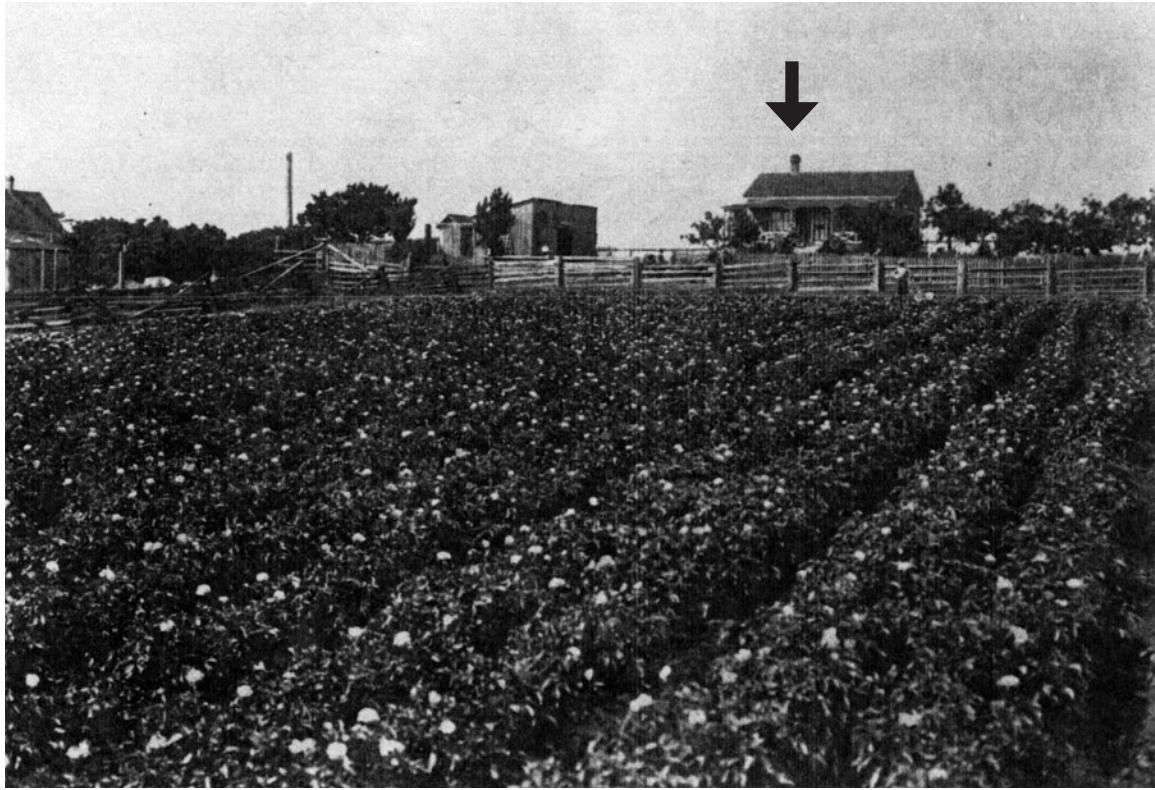
Fig. III-4, above. This photograph, dated June 16, 1912 is of the McRae House / HS-11's southern elevation. Note that Rooms 7 and 8 are missing in this photograph. They were present in the c. 1903 photograph. Here, a south facing porch has been added. Also, note the presence of a single, thinner chimney flue to the west. (see arrow). The fields in the foreground were related to the McRae House / HS-11.

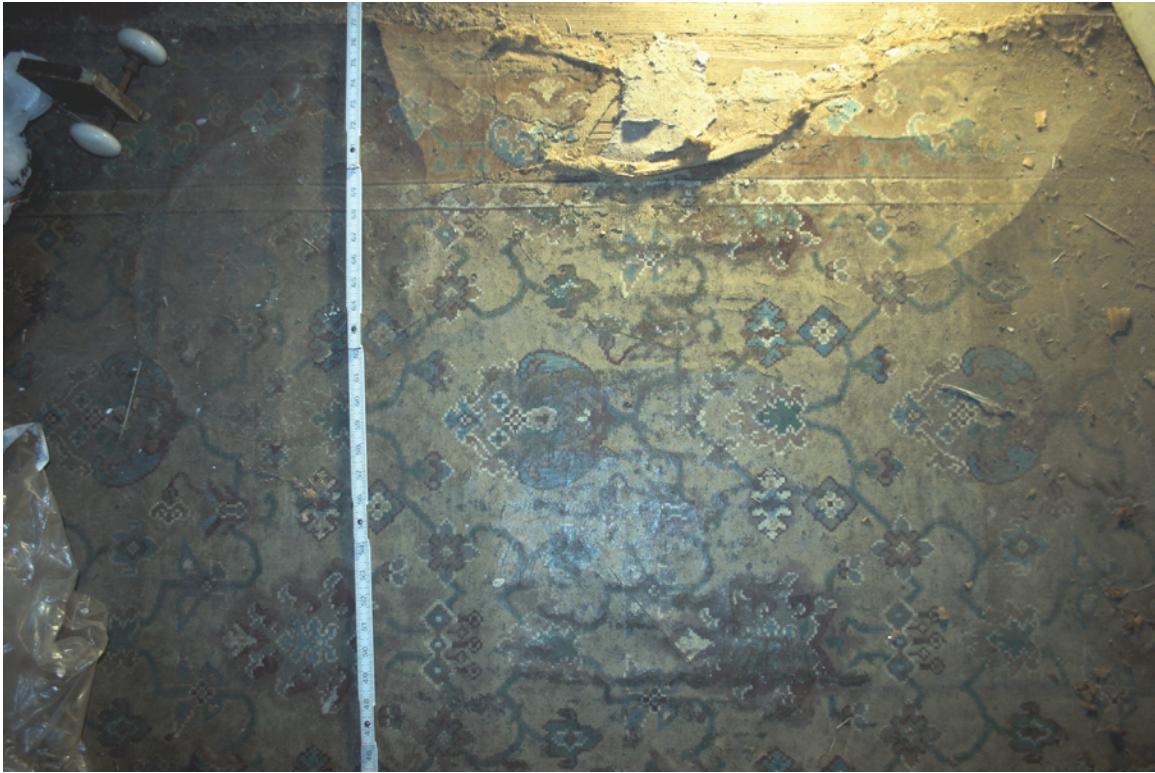
Fig. V-3. Linoleum carpet detail in Room 1 (E2) Photograph by Aaron Lemchen March 2005.

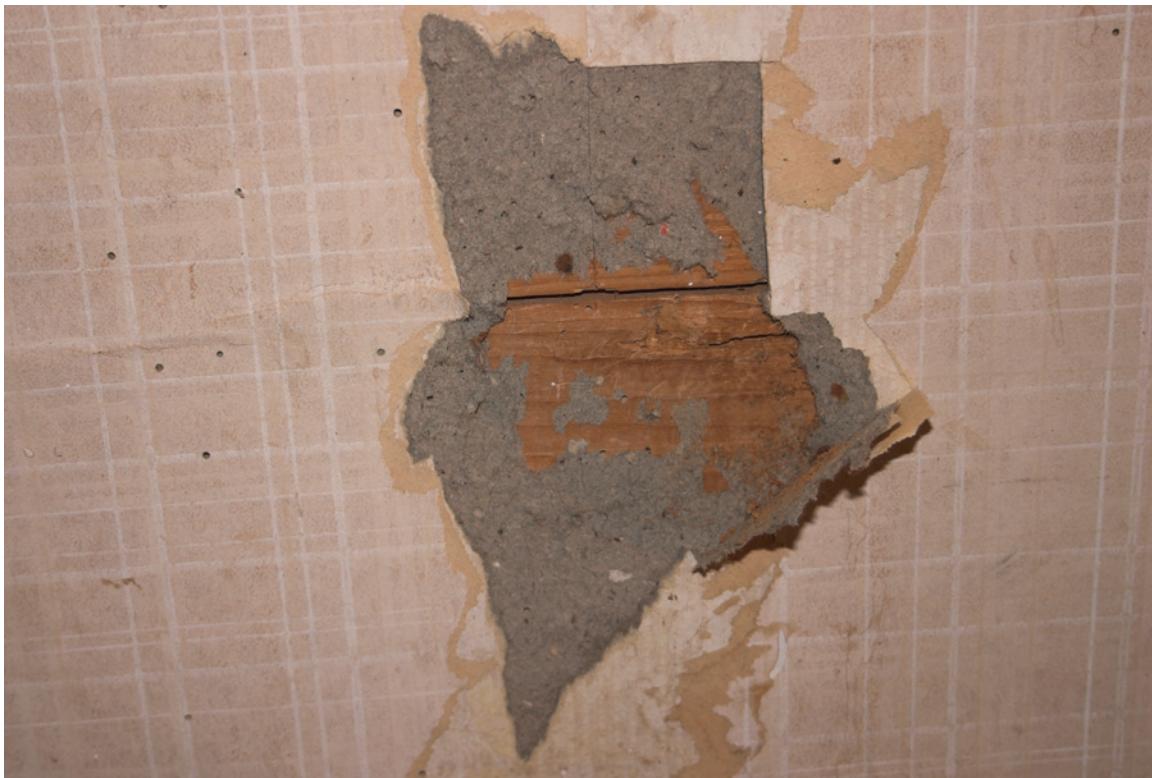
Fig. V-4. Opening in the south wall of Room 1 (E2) showing layers of heavy paperboard and wallpaper over horizontal wood planks. Photograph by Aaron Lemchen October 2005.

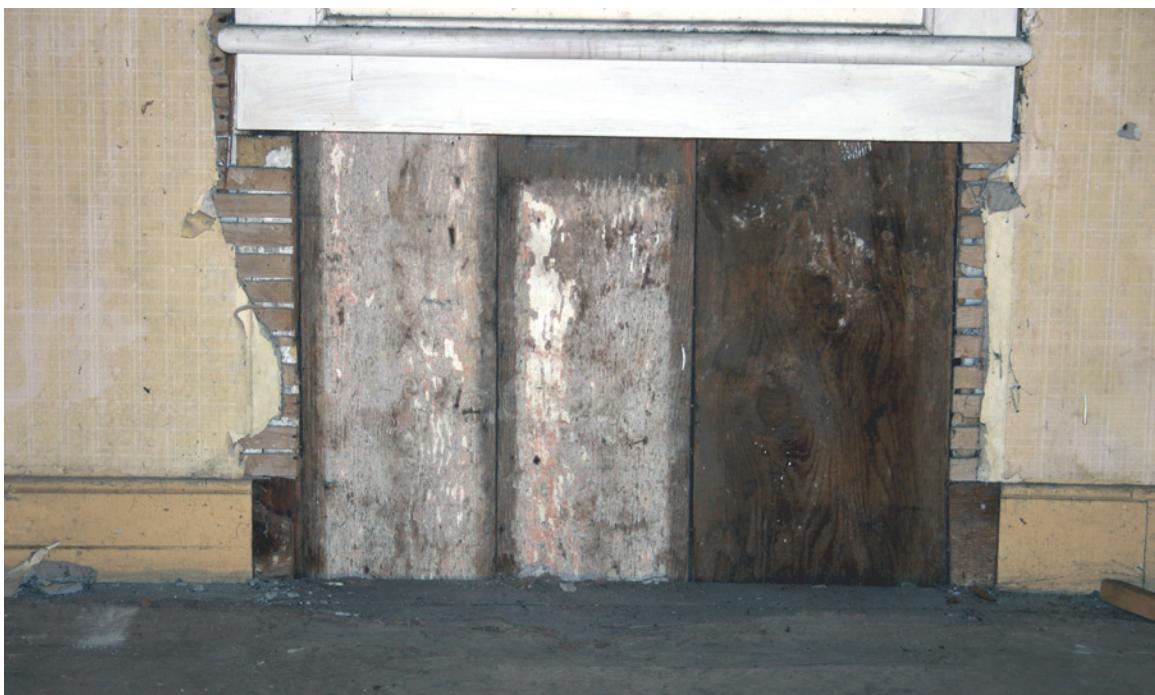
Fig. V-5. Opening in the east wall of Room 1 (E2) beneath the window showing evidence of modern reuse of what appears to be Military era whitewashed planks exhibiting the ghosts of former battens and perhaps molding. This was a former (c. 1925) doorway to Room E1, before restoration by the NPS. The planks were installed during the c. 1978 restoration. Photograph by Aaron Lemchen October 2005.

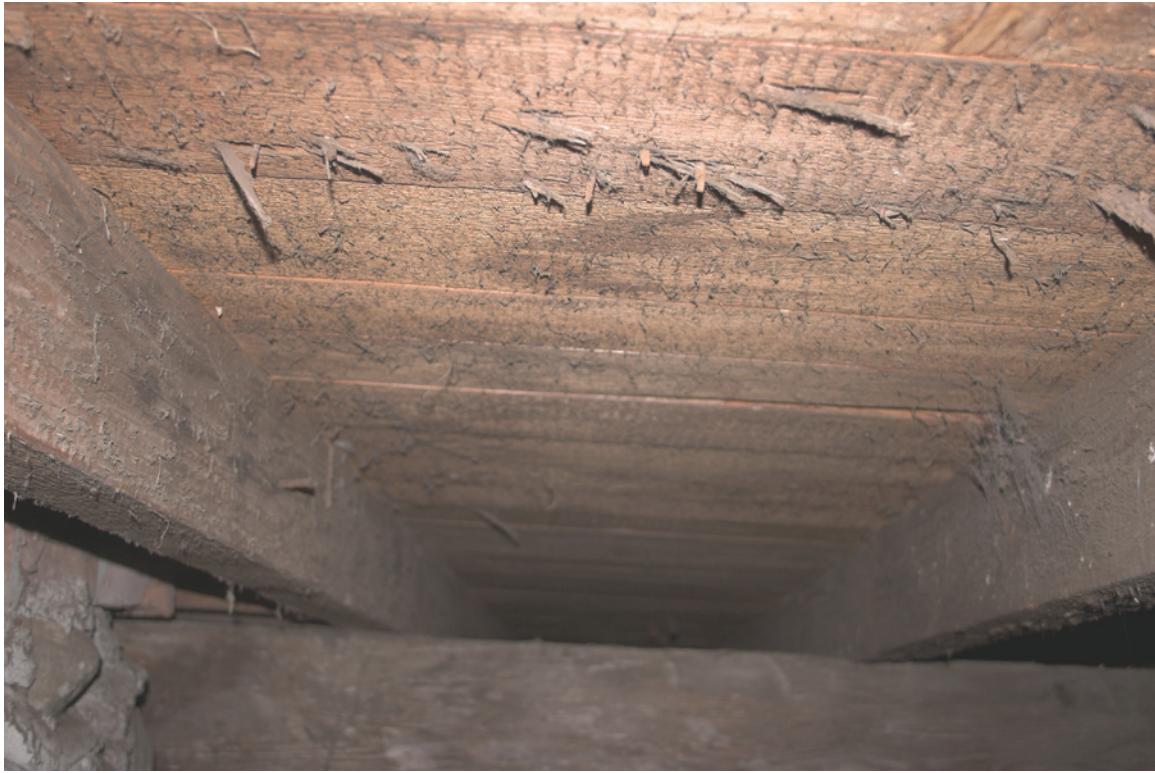
Fig. V-6. Near the top of this photo is evidence of machine cut and wire nails protruding through the first layer of flooring into the crawlspace. Note that they are in line, following butt joints in the second layer of flooring above. It suggests that a wall was likely affixed to the other side of the flooring through toe nailing, and corroborates the evidence in the room above that there was a former division in this room between Rooms 1 and 2 at this location. This example is just west of the restored east hearth under Room 2 (E5). Photograph by Aaron Lemchen March 2005.

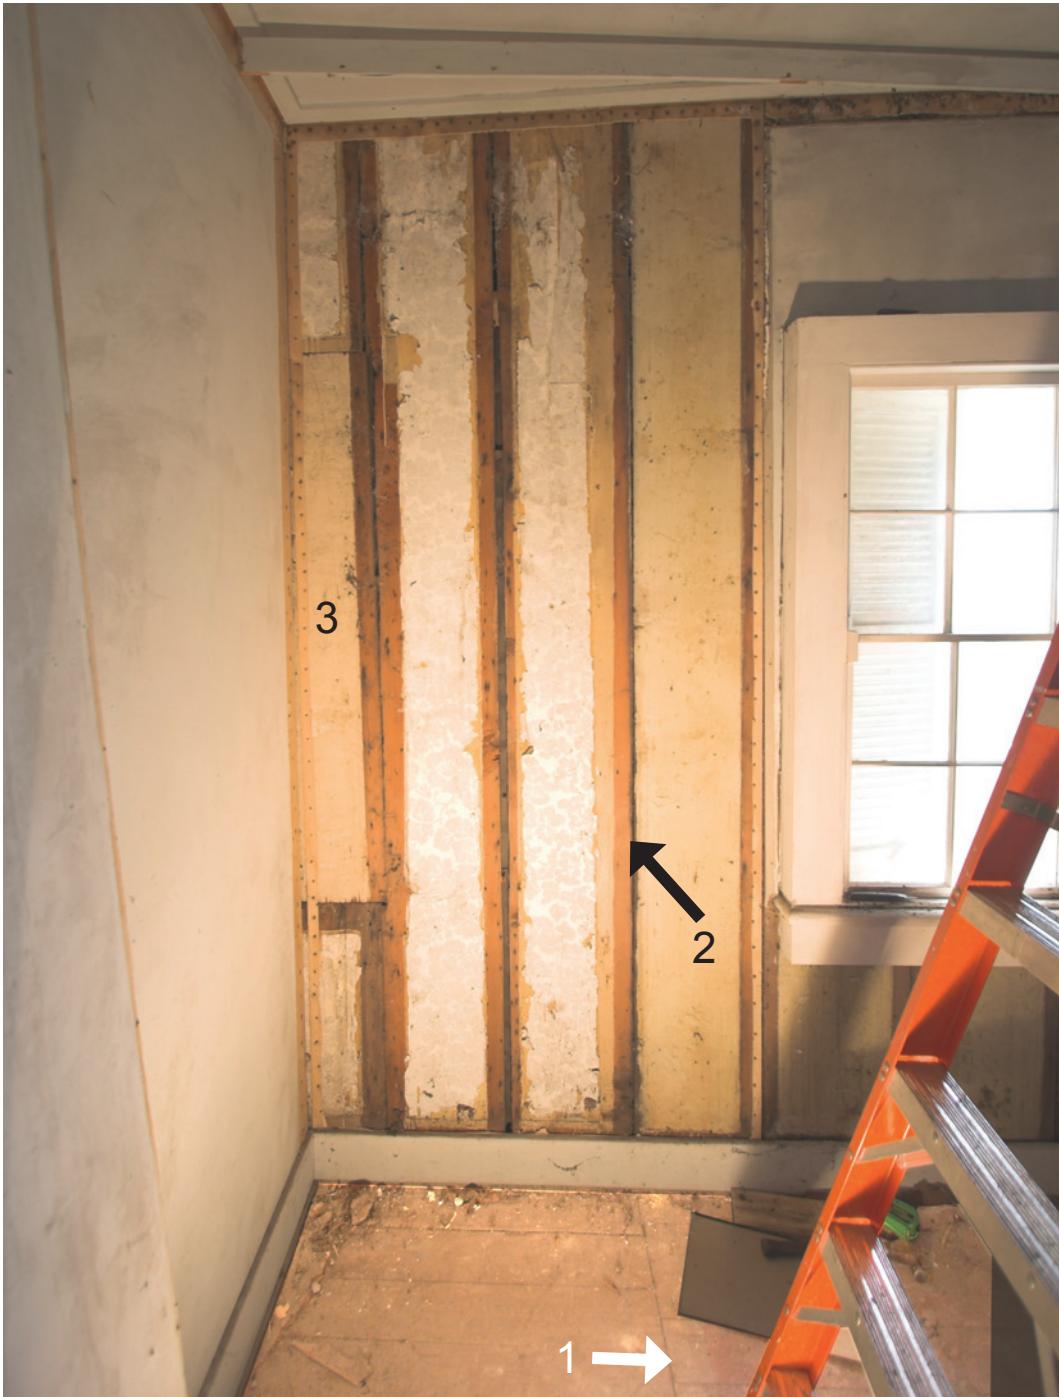
Fig. V-7. East wall of Room 2 (E5). Note the aligned butt joint and paint shadow in the floor boards at the bottom of the picture (1). Also note its alignment with the paint shadow on the vertical structural planks, which also appear to have shadows in the paint and wallpaper from previous battens (2). This suggests the presence of an earlier wall division that ran on either side of the hearth. A patch where a window once was can be seen in the board at the leftmost section of the east wall in this picture. It was butted against by the north wall (3). This patch was likely an original window during the military or agricultural era. Photograph and image enhancement by Aaron Lemchen March and June 2005.

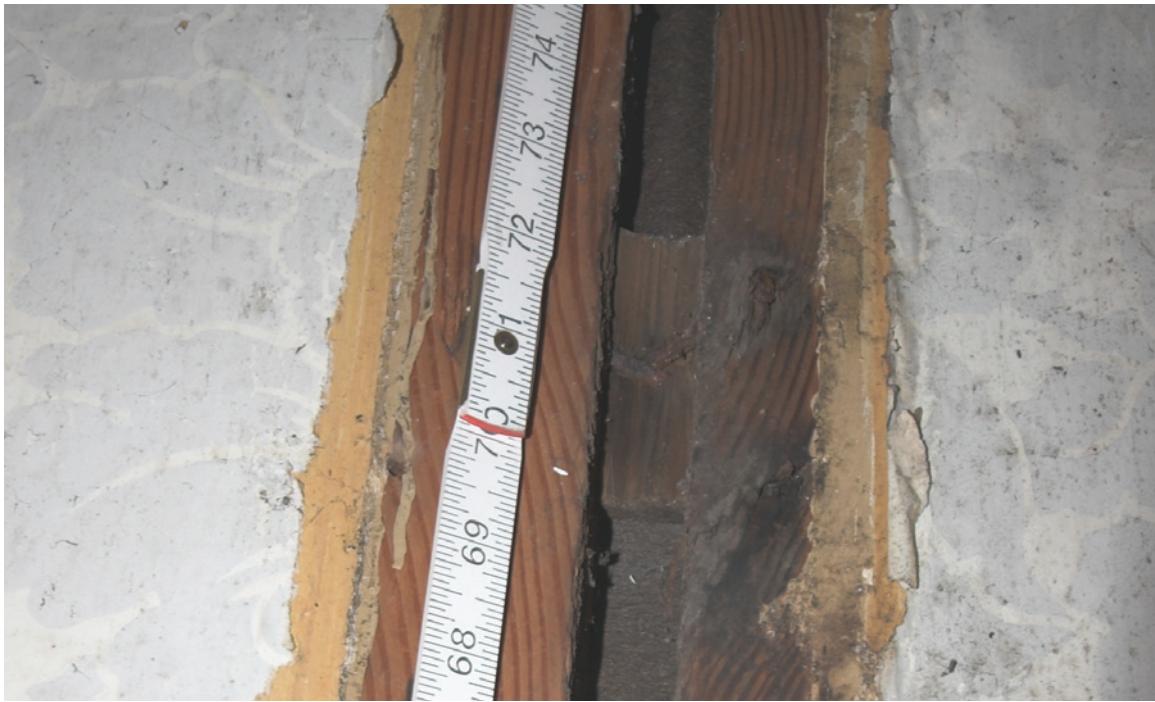
Fig. V-8. Room 2 (E5), Detail of block located between two planks. Photograph by Aaron Lemchen March 2005.

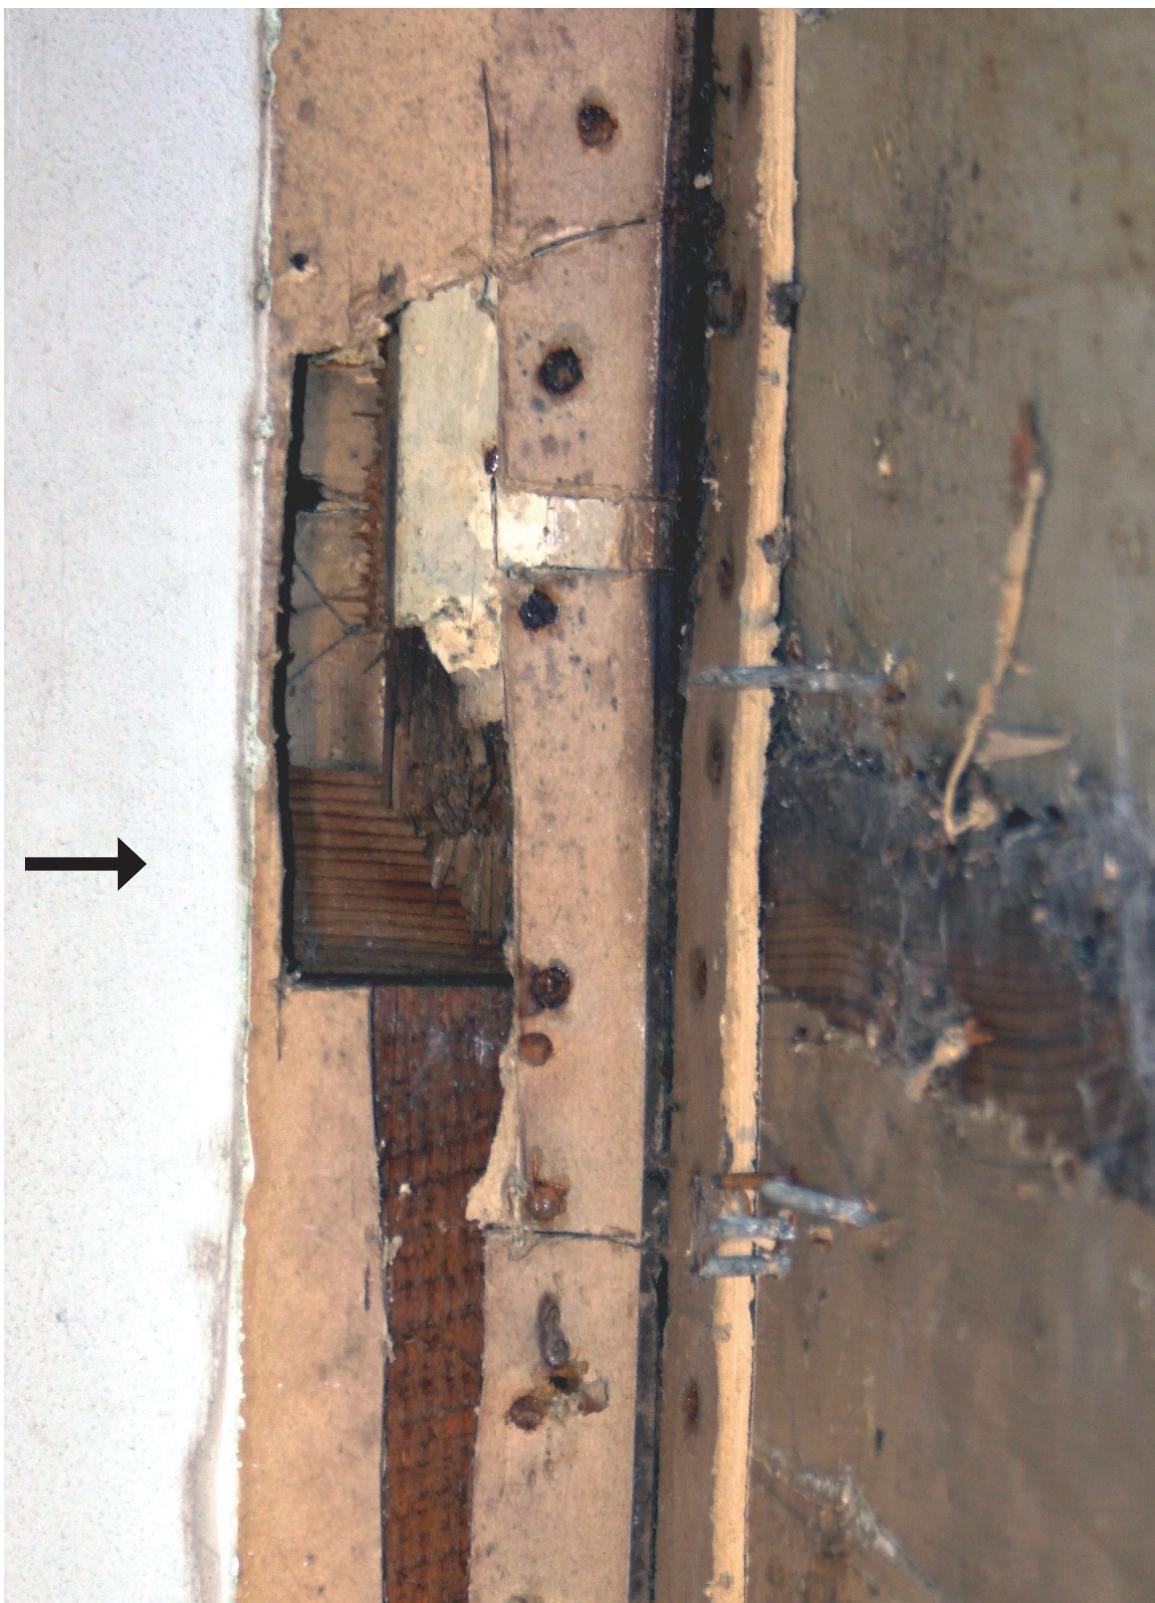
Fig. V-9. Exploratory hole cut into the ceiling's Beaver Board covering (see arrow) at the point where it is normally covered by battens. It is in alignment with a paint shadow and butt joints the floor relating to the former north wall in Room 2. Photograph by Aaron Lemchen March 2005.

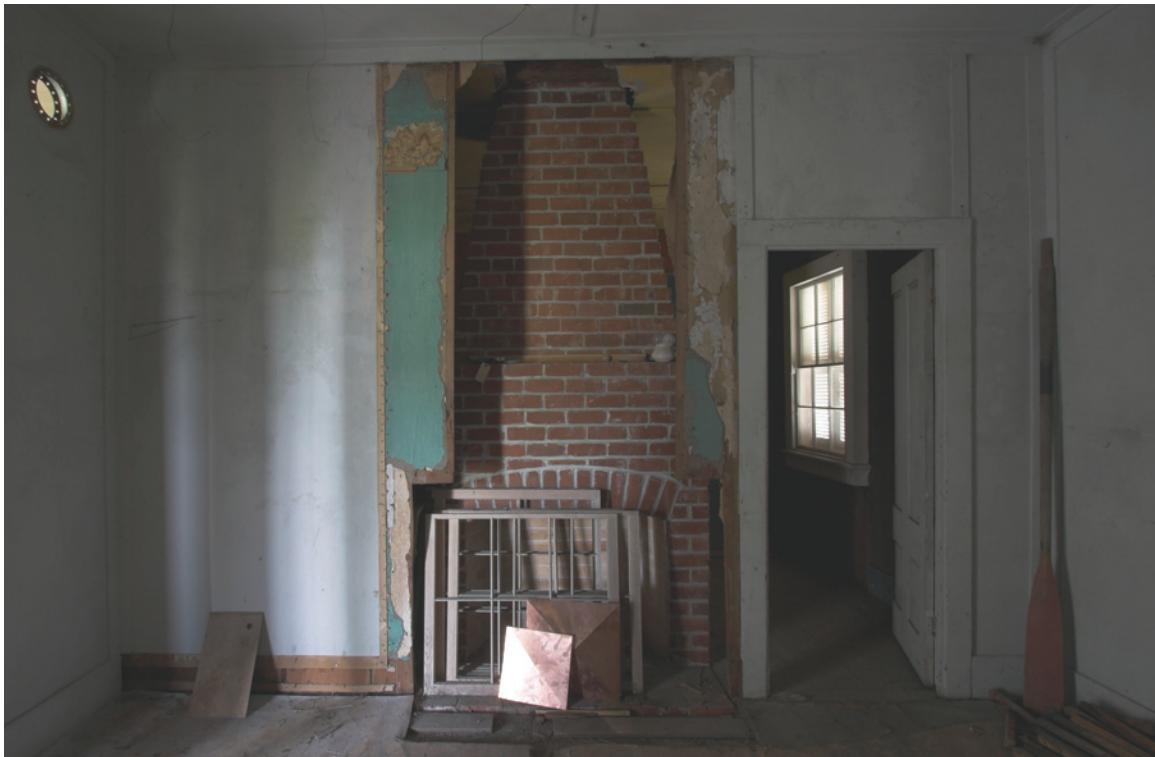
Fig. V-10. Room 3 (E7), south wall showing restored fireplace as well as the various layers of finishes.
Photograph by Aaron Lemchen March 2005.

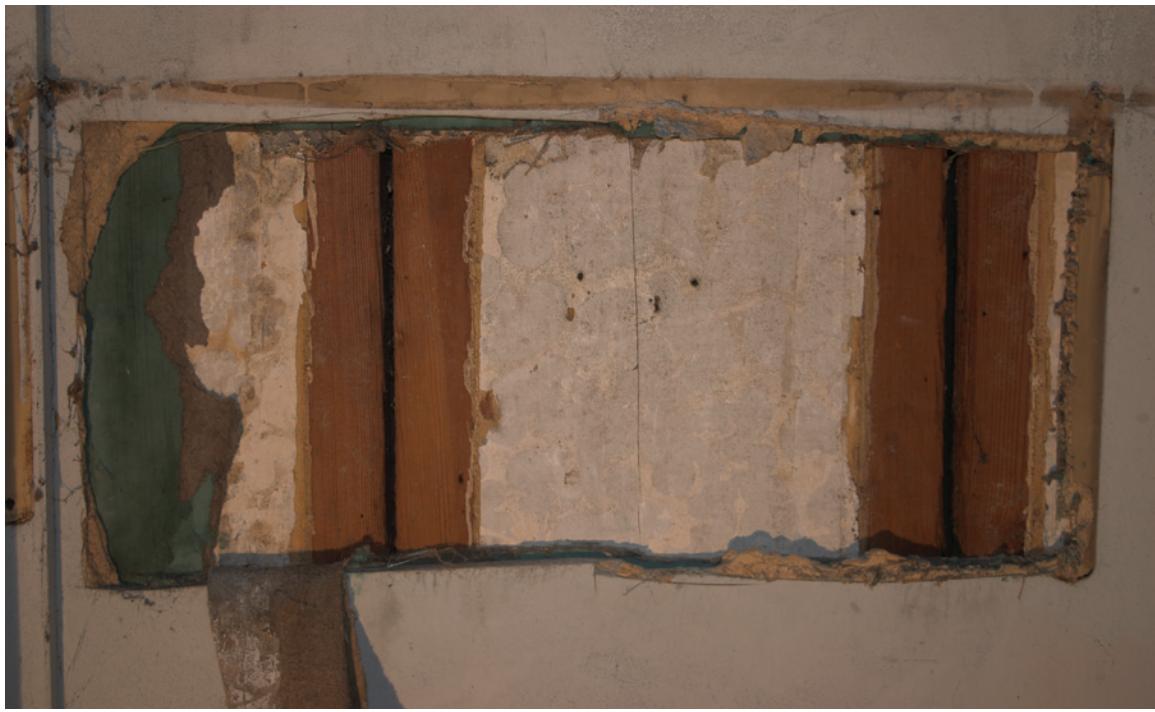
Fig. V-11. North wall of Room 3 (E7) showing areas without paint or wallpaper. Note, evidence of interior battens on the joints of the vertical wood that have since been removed. Photograph by Aaron Lemchen March 2005.

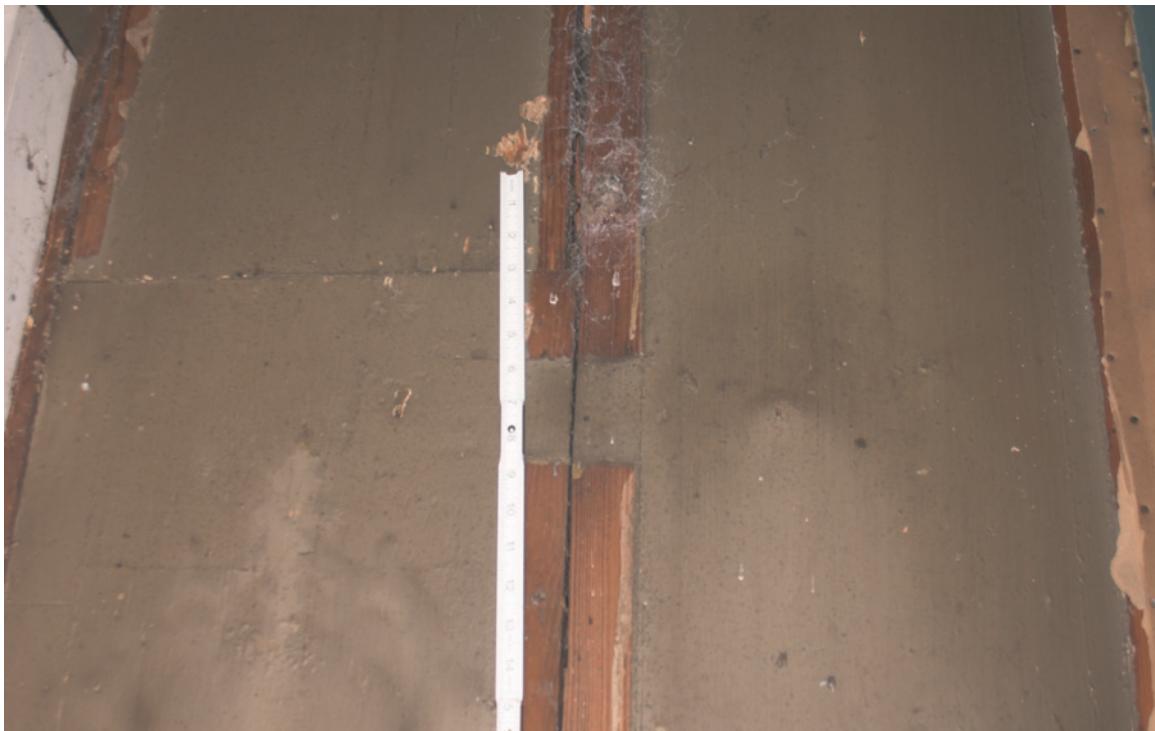
Fig. V-12. West wall of Room 4 (E8) showing break in paint shadow at approximately the same height as the marking in Room 2's east wall seen in Figure V-7. This suggests the likelihood of a cabinet / closet affixed to this location as in the case of the block in Figure V-7. Photograph by Aaron Lemchen March 2005.

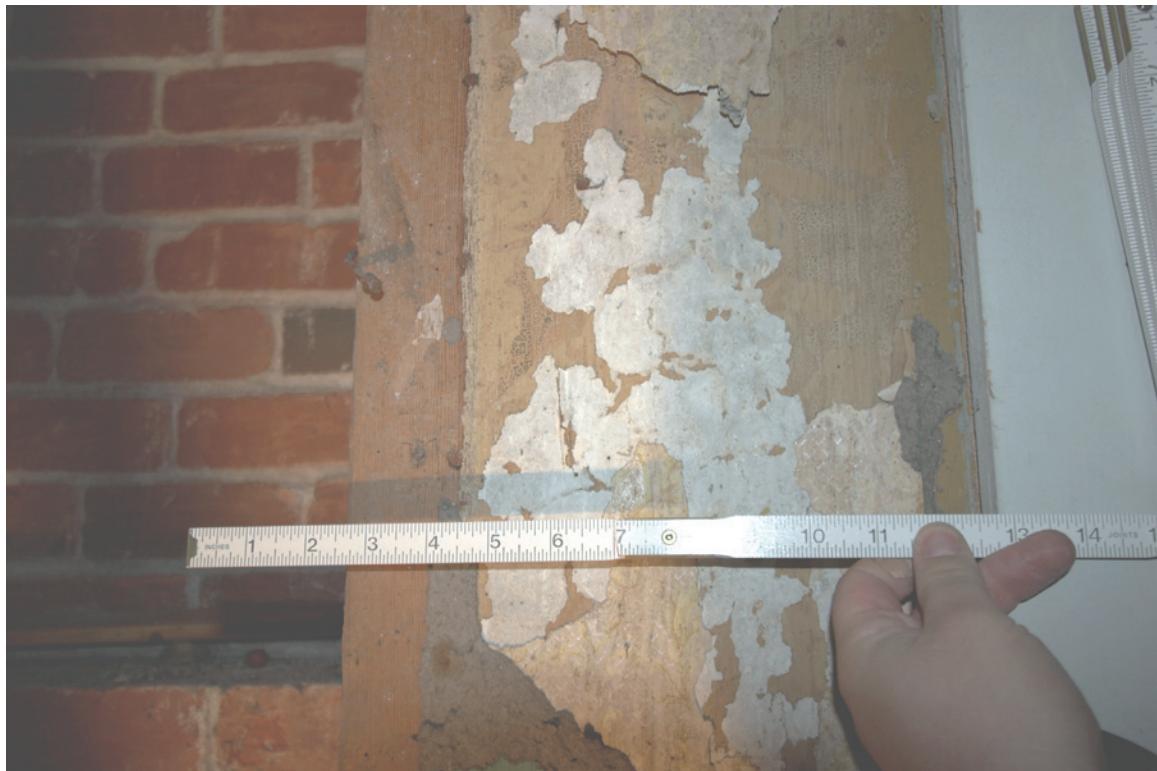
Above; Photo of remnant wallpaper on the south wall of Room 3 (E7), note the restored chimney to the left.

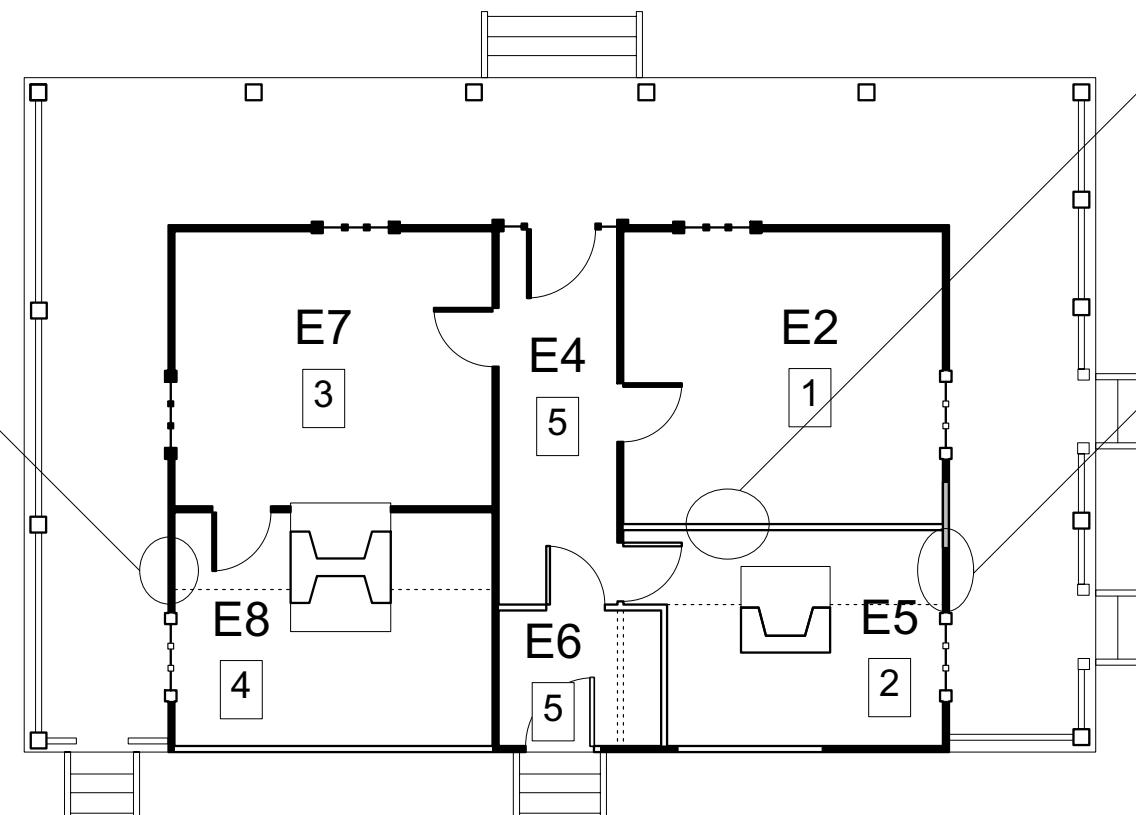
REMOVAL OF A
VERTICAL BATTEN IN
ROOM 2 (E5),
ALLOWING A HOLE TO
BE DRILLED
UNDERNEATH TO
FURTHER GAUGE THE
CONSTRUCTION OF
THE CURRENT WALL
BETWEEN ROOMS 1
(E2) AND 2 (E5).
