Quarters 208

Historic Structure Report

San Juan National Historic Site, Puerto Rico

Prepared by:
Panamerican Consultants, Inc.
2390 Clinton Street
Buffalo, New York 14227

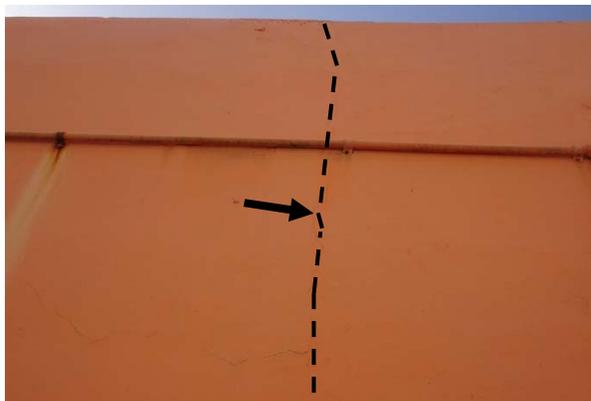
The east half of the wall has a punched window opening located 10 feet 4 inches to the east of the door (Figure 39). There is a vertical crack in the wall that appears to align with the break between the original portion of the building and the first addition (Figure 40).

FIGURE 40. Vertical crack separating the east and west halves of the south elevation (arrow and dashed line).

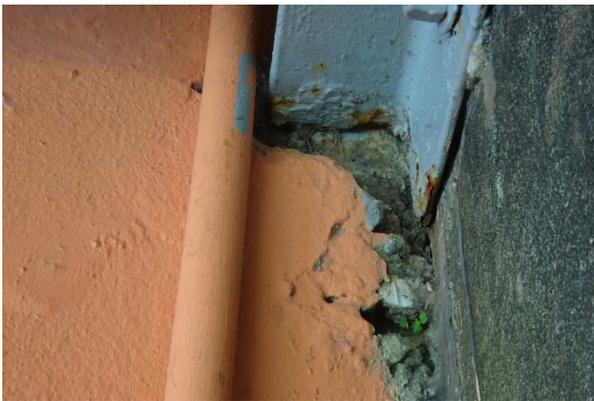
Walls at the east half of the building were likely constructed as part of a later, one-story addition and appear to match the depth of the adjacent original walls. Openings at the exterior walls are punched and not chamfered as at the original wall areas. At the east elevation, the walls are 13-1/2 inches deep. Based on physical evidence, the walls have similar construction to the original portion of the building, including rubble and brick masonry covered with stucco (Figure 53).

FIGURE 53. Area of missing stucco at the east half of building, where underlying masonry was observed.

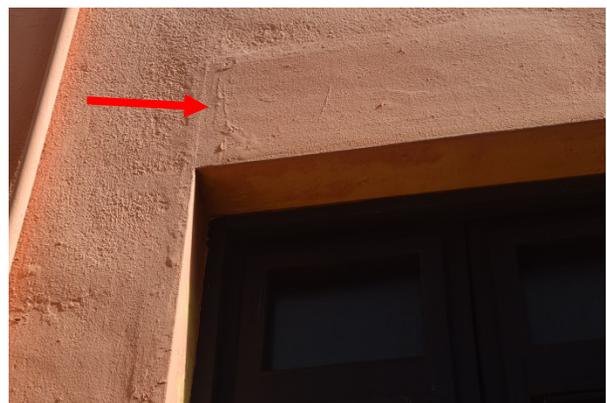
FIGURE 55. Physical evidence of previous repair or alteration at window head.

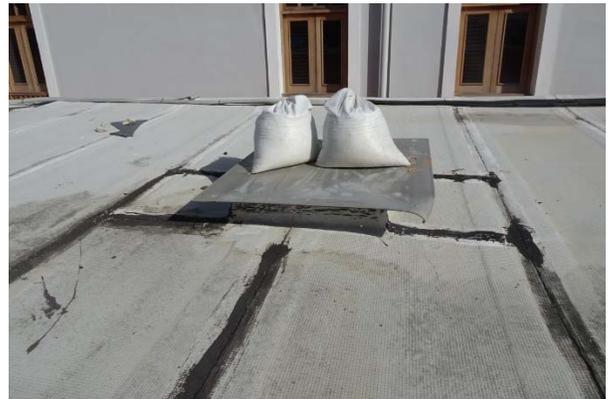
FIGURE 78. Missing skylight at the southside of the roof.

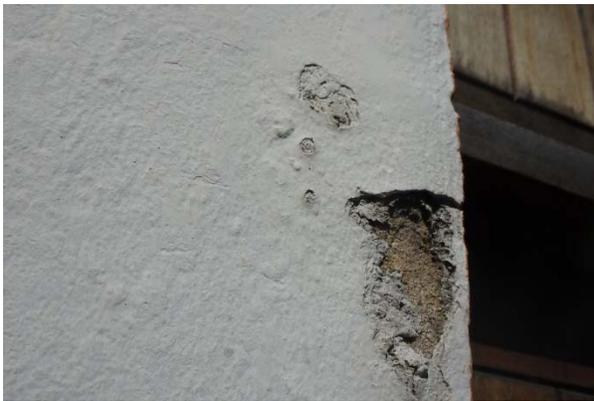
FIGURE 100. Spalled exterior stucco. Underlying brick is exposed to view.

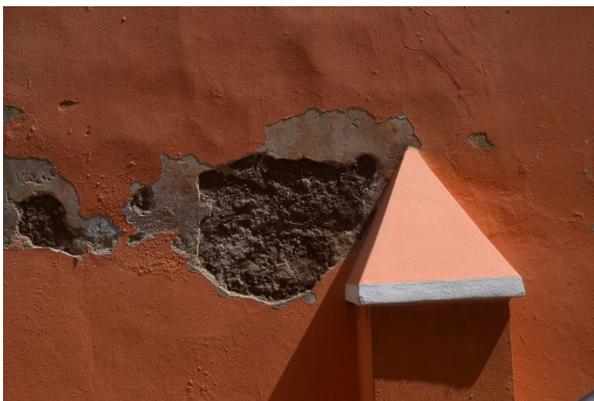
FIGURE 101. Spalled exterior stucco. Underlying mortar was exposed to view.

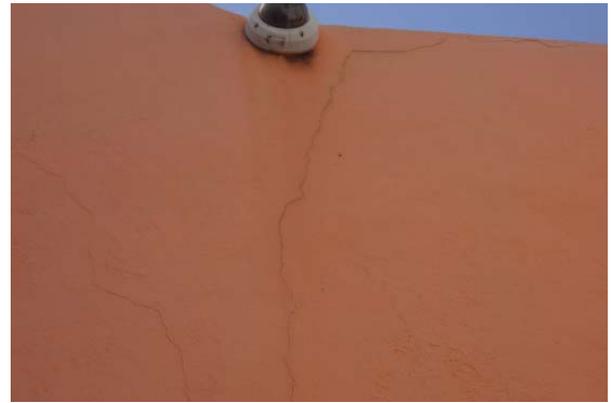
FIGURE 102. Cracking at exterior stucco was typically located along the parapet.

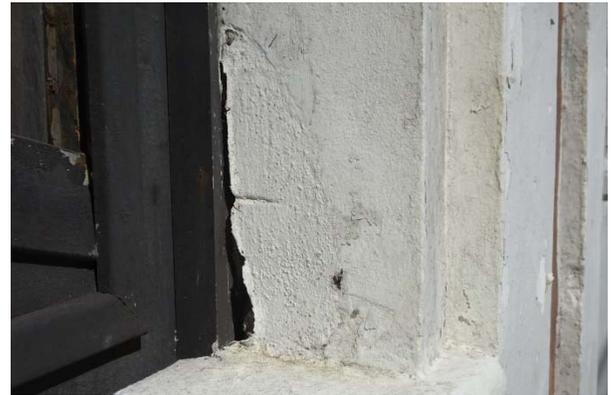
FIGURE 103. Spalled and previously repaired stucco was observed at some wall openings. At some locations, the underlying brick substrate was exposed to view.

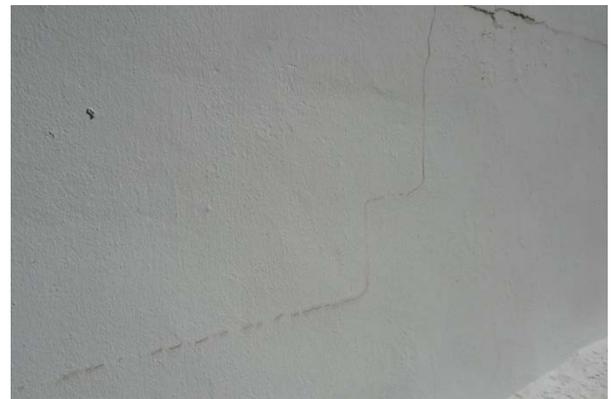
located at the north and south elevations and consisted of step cracking that appeared to follow the joint lines of the underlying structure. At the time of the survey, the area adjacent to the cracks appeared moist.

FIGURE 104. Step cracking observed at the masonry unit construction on the north elevation of the second-floor addition.

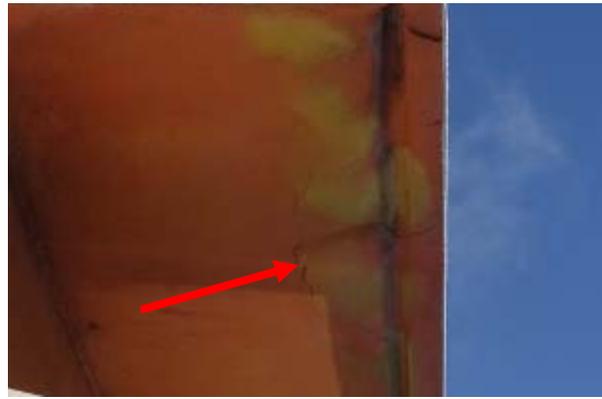
FIGURE 105. Cracking observed at the underside of the second-floor addition roof overhang

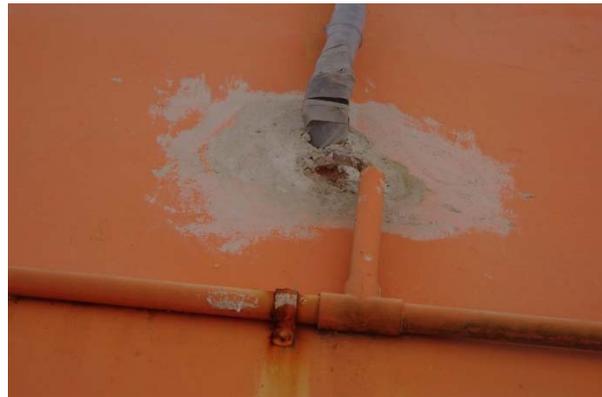
FIGURE 106. Open grouted wall penetration at south elevation.

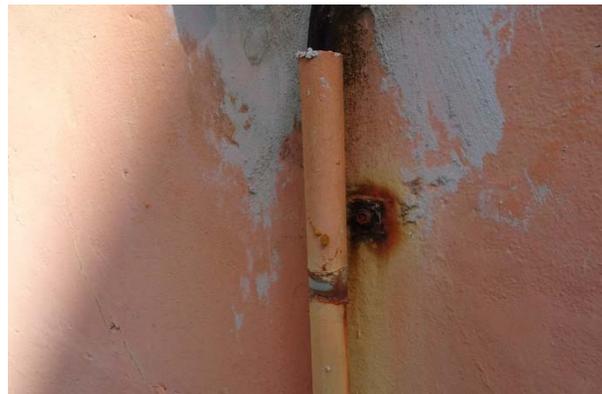
FIGURE 107. Corrosion staining at embedded anchor on north elevation.

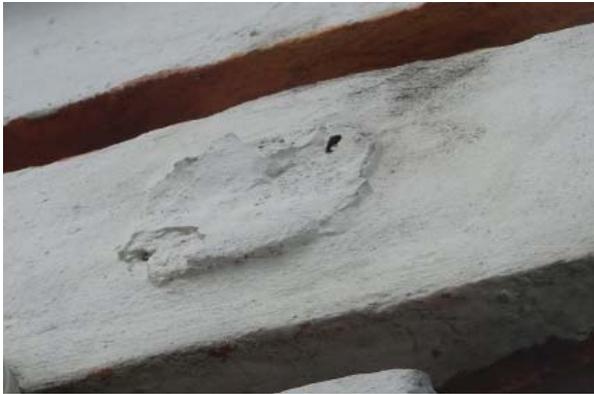
FIGURE 109. Patch at previously existing wall-mounted light fixture.

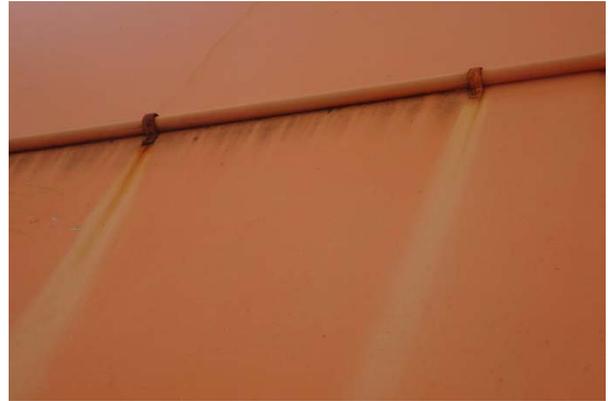
FIGURE 111. Corrosion staining at ferrous anchors supporting conduit clips and from conduit.

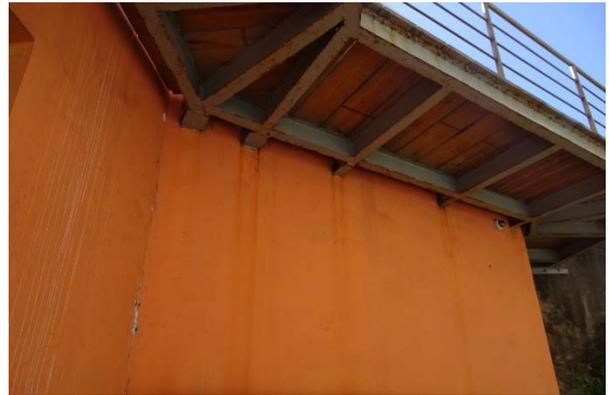
FIGURE 112. Corrosion and staining at the catwalk framing members and wall surfaces below.

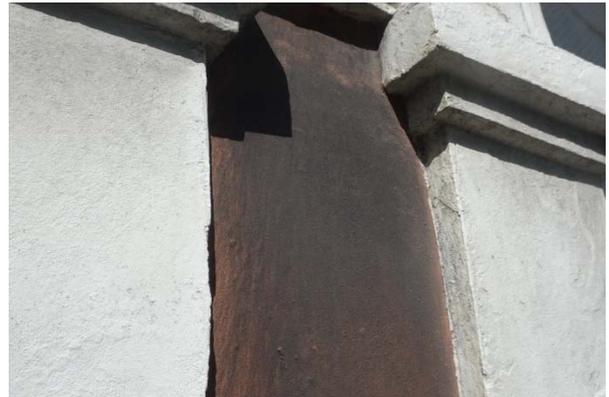
- Soiling was observed on the face of the stucco below the west cornice and at locations below wall-mounted conduit, wall penetrations, and roof copings on the north and south elevations (Figure 113). The soiling consisted of dark staining on the stucco and may represent biological growth.

FIGURE 113. Soiling on the face of the west elevation.

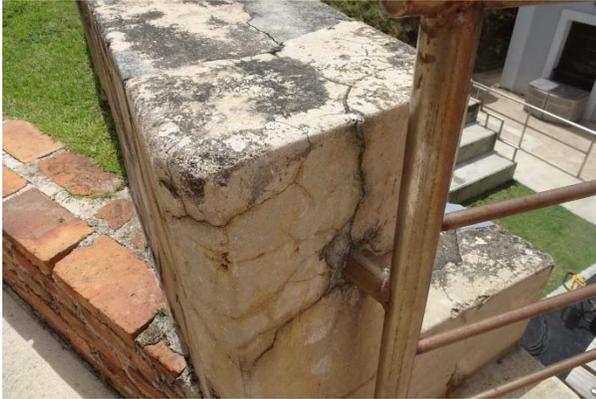
hairline cracks. Patch material was previously installed at the handrail pocket. It does not appear that the cracking and spalling associated with the handrail is currently active.

FIGURE 114. Extensive cracking and previous repairs at concrete handrail pier.

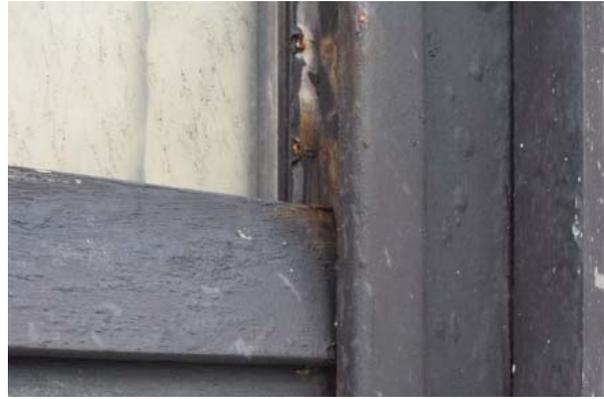
FIGURE 115. Displaced and missing wood louvers. Note corrosion staining attends of louvers.

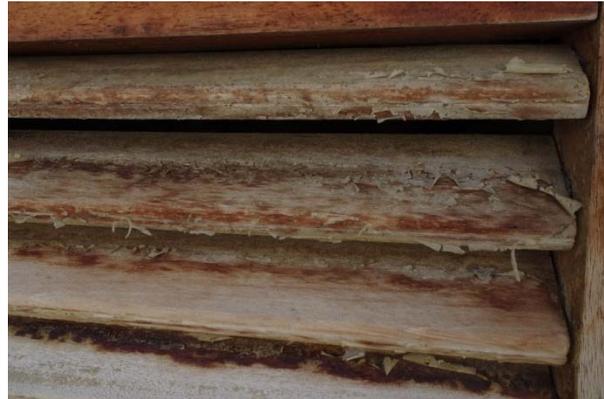
FIGURE 116. Peeling and deteriorated surface coating at exterior face of second-floor addition window opening on south elevation.

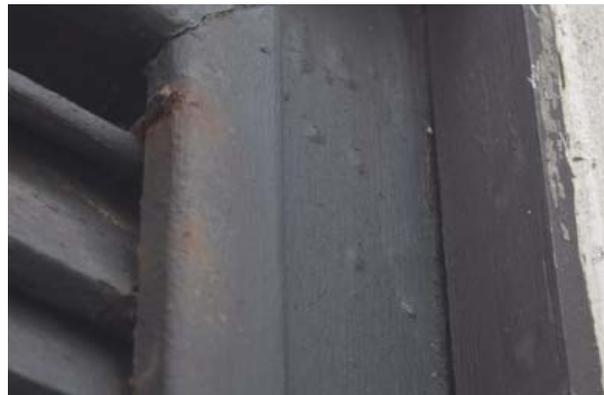
- Peeling and bubbling paint was observed at the exterior face of the doors on the west elevation (Figure 117 and Figure 118). Peeling paint was typically located near edges and at joints between wood members. Bubbling typically consisted of 3/8-inch diameter bulges in the surface coating.

FIGURE 117. Bubbling paint at door frame at west elevation.

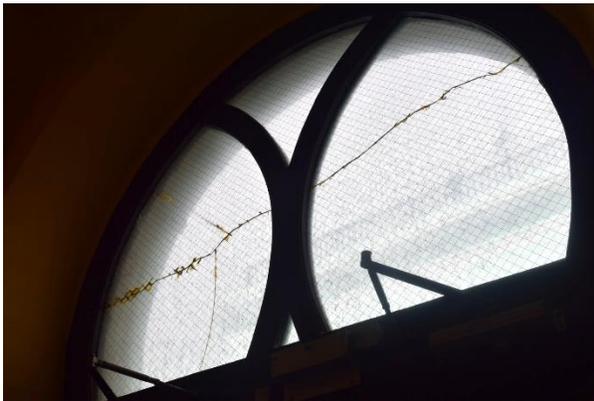
- Cracking was observed at all three wire glass transom windows (Figure 119). The cracking typically extended the full width of the transom. Some windows had multiple cracks.

FIGURE 119. Cracked transom glass.

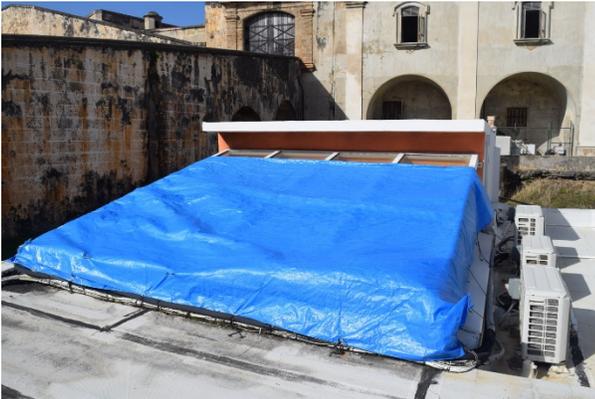
FIGURE 120. Skylight with blue tarpaulin covering lower portion, where leakage was reported.

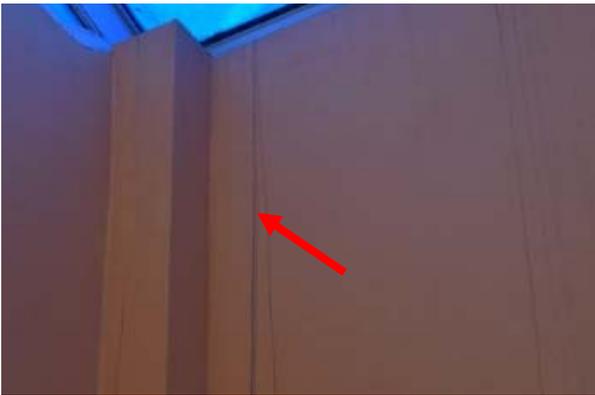
FIGURE 121. Evidence of water infiltration at courtyard wall below skylight.

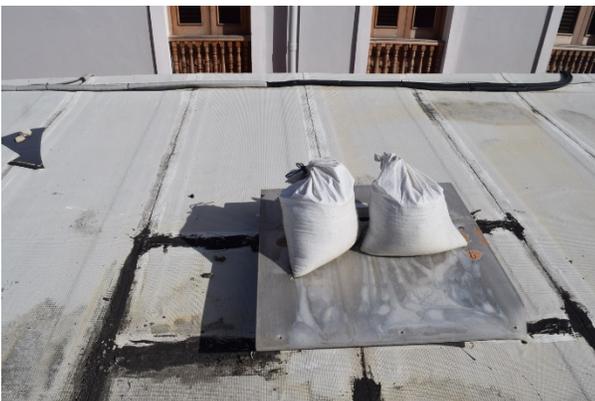
FIGURE 122. Missing skylight frame and light at south side of roof, above south entrance room.

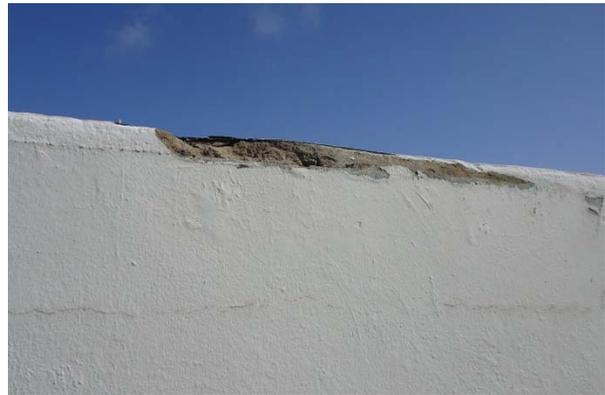
FIGURE 123. Concrete spalling along second-floor addition roof.

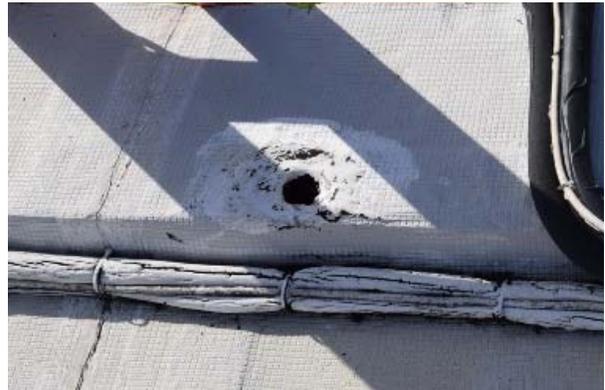
FIGURE 124. Open penetration at the north parapet of the main roof.

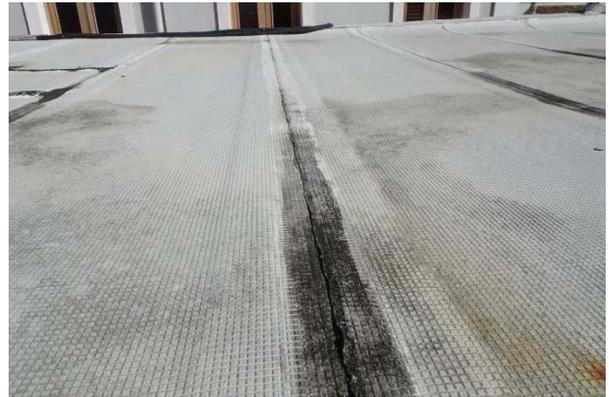
FIGURE 130. Missing seam tape at joints between sections of membrane.

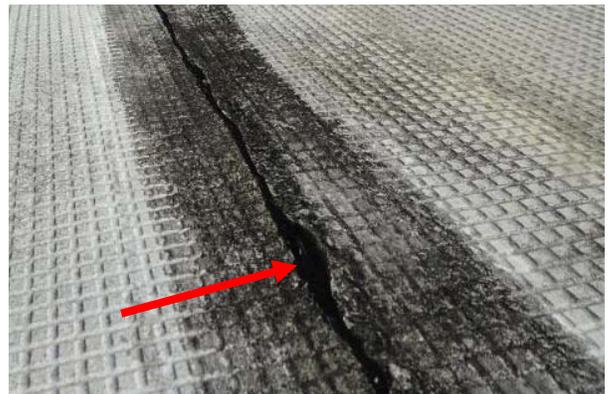
edge of the surfacing was not bonded to the modified bitumen roof membrane and had curled (Figure 131).

FIGURE 131. Open joint in surfacing between membrane sections.

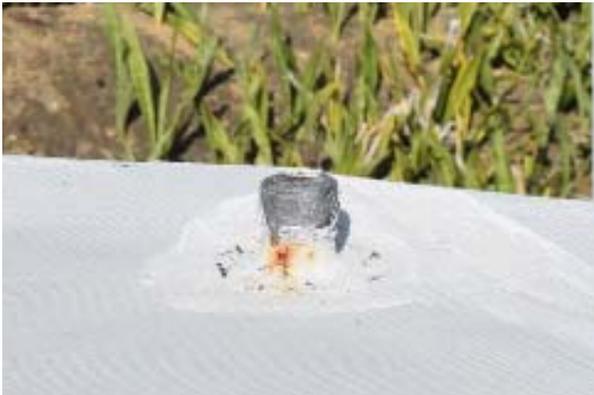
FIGURE 132. Corrosion staining and deteriorated flashing at vent pipe.

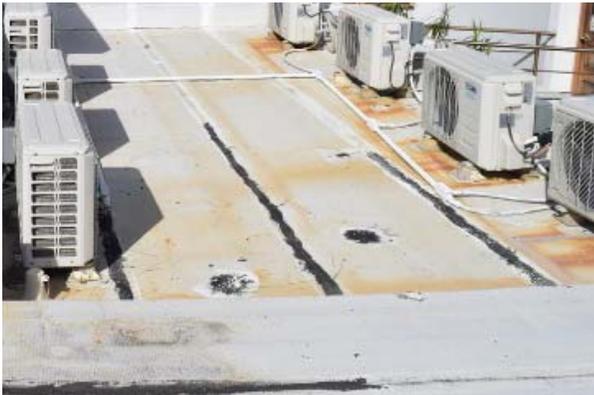
- Corrosion staining was observed on the roof membrane below rooftop air conditioning units at the southeast roof area (Figure 133). The corrosion consisted of streaks that followed the slope of the roof.
- Biological growth was observed along bundles of pipes that wrap the perimeter of the roof (Figure 134). The growth was most pronounced at the east end of the main roof, which is adjacent to the roof drain and partially concealed by the tarpaulin at the skylight.

FIGURE 133. Corrosion staining at the roof membrane below the individual air conditioning units.

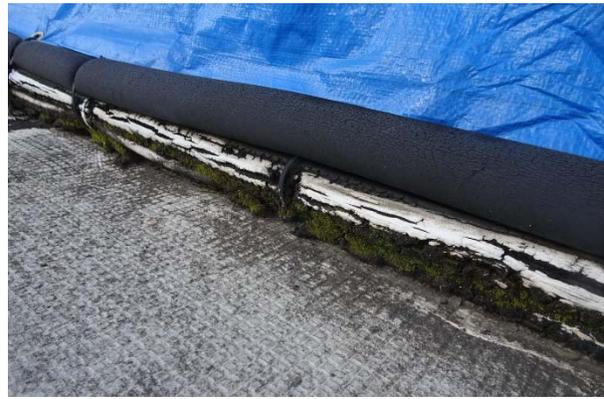
FIGURE 134. Biological growth adjacent to conduits and insulated pipes on the roof.

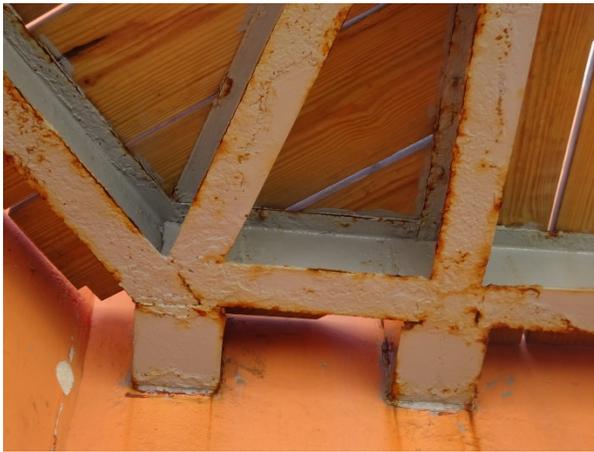
- Corrosion staining was observed along the edges of flanges, at joints between framing members, and along the face of webs of the steel catwalk framing (Figure 135)
- Corrosion was observed at the wall-mounted vertical bracing members that support the catwalk (Figure 136). The corrosion was concentrated near the top of the bracing, where it meets the handrail, and at the flanges in contact with the wall surface.
- Slight surface corrosion was observed on the face of the metal handrails at the catwalk and south entrance stair (Figure 137). Corrosion staining was present at small discolored spots and scratches on the surface of the handrail.
- Surface corrosion was observed at the steel framing for the accessibility lift adjacent to the south stair (Figure 138). The corrosion was most pronounced at the corners and anchor locations of the framing.

FIGURE 135. Corrosion of steel framing for catwalk.

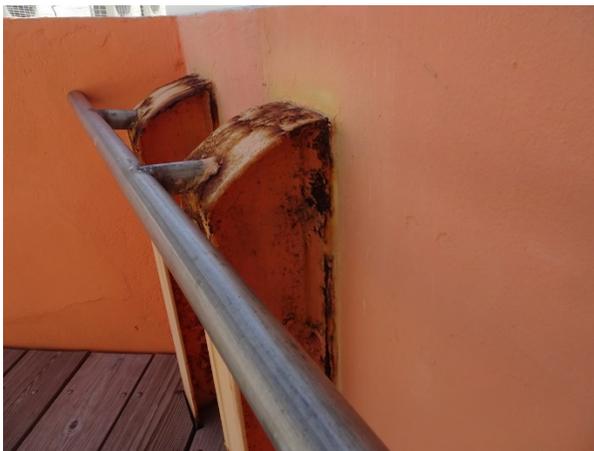
FIGURE 136. Corrosion at the steel vertical bracing members.

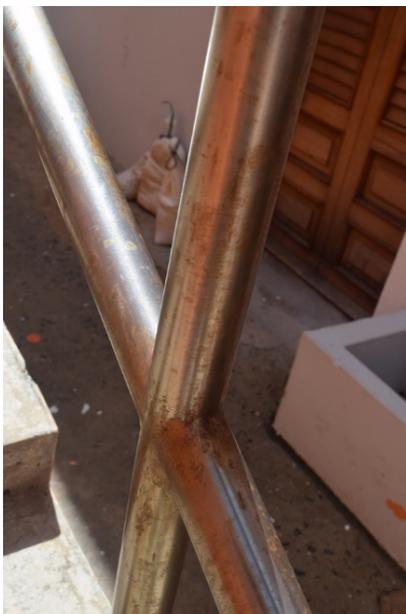
FIGURE 137. Mild scratches and surface corrosion at handrail.

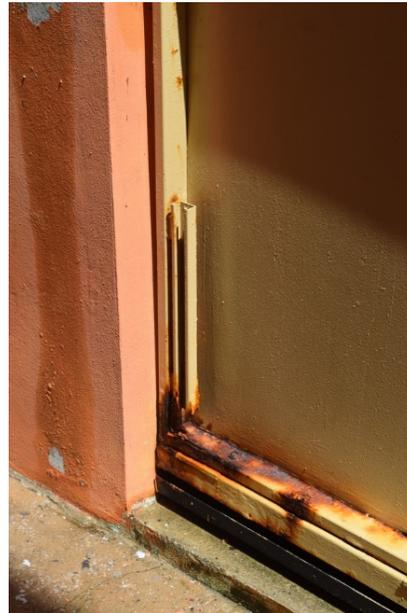
FIGURE 138. Surface corrosion at the framing for the accessibility lift. Corrosion is concentrated near the corners.

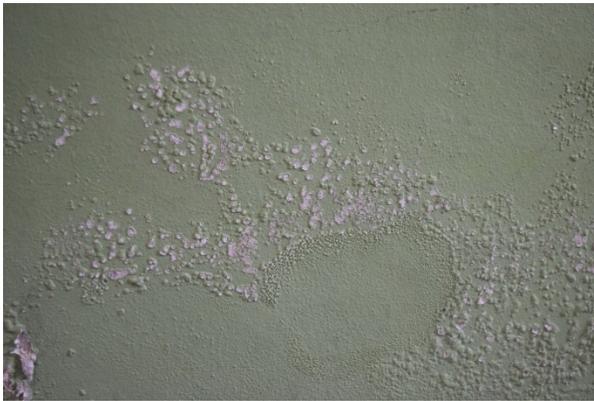
FIGURE 187. Bubbling paint at the base of an interior wall of the ranger's office.

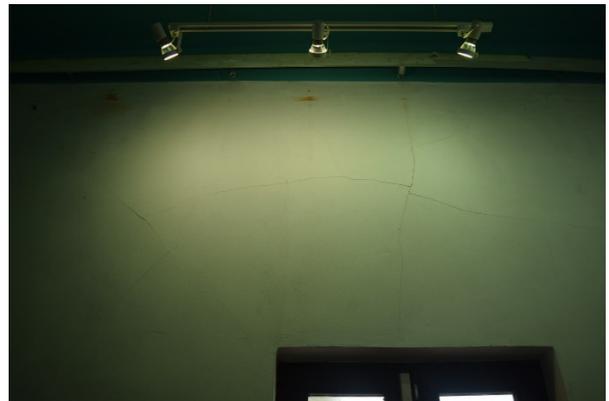
FIGURE 190. Cracking at the interior plaster. The plaster at some cracks appears to be displaced.

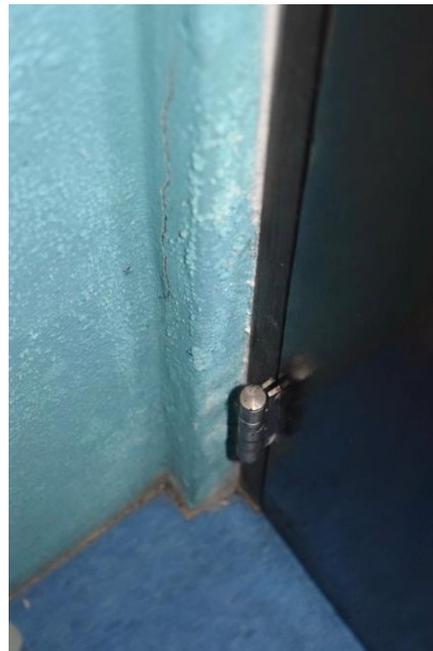
FIGURE 191. Cracked plaster at subframe of door between the officer's office and the south entrance room.

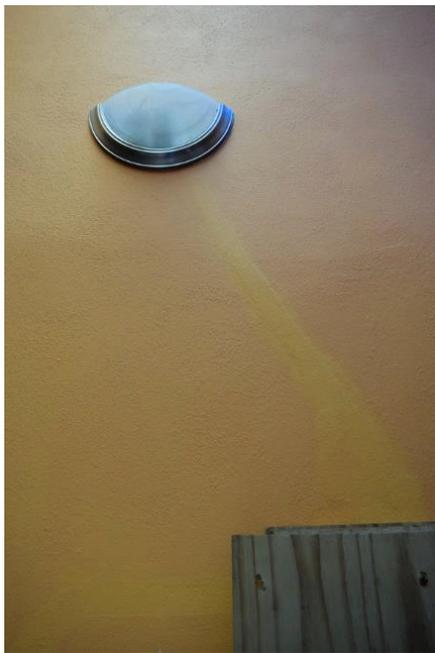
FIGURE 192. Evidence of previous electrical repairs at the covered courtyard.

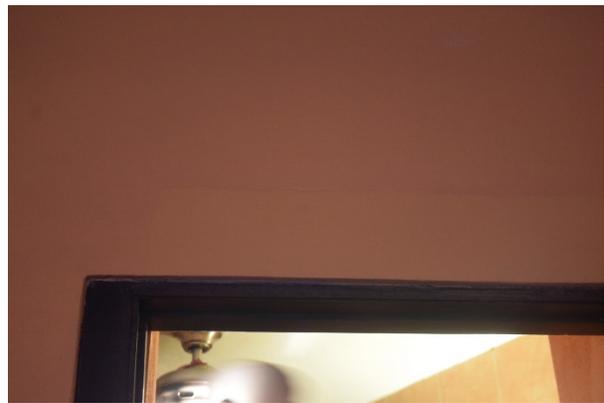
FIGURE 194. Evidence of previous repair at the door head of the men's restroom.

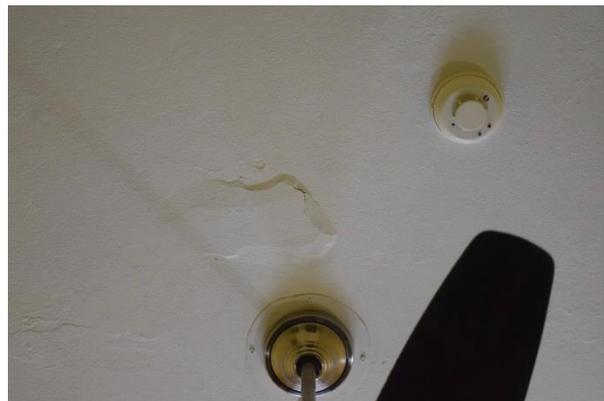
FIGURE 195. Spalled and peeling paint at the ceiling of the officer's office.

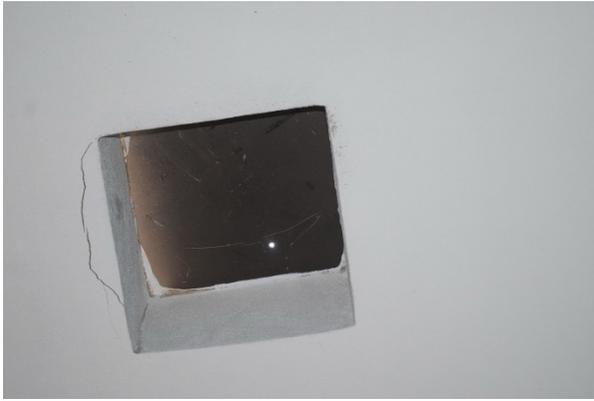
FIGURE 196. Cracked plaster adjacent to missing skylight at the south entrance room.
