HISTORIC STRUCTURES REPORT
ARCHITECTURAL DATA SECTION
ON
NARBONNE HOUSE
SALEM, MASSACHUSETTS

Prepared by
The Society for the Preservation of New England Antiquities
141 Cambridge Street
Boston, Massachusetts 02114

December 1972
for

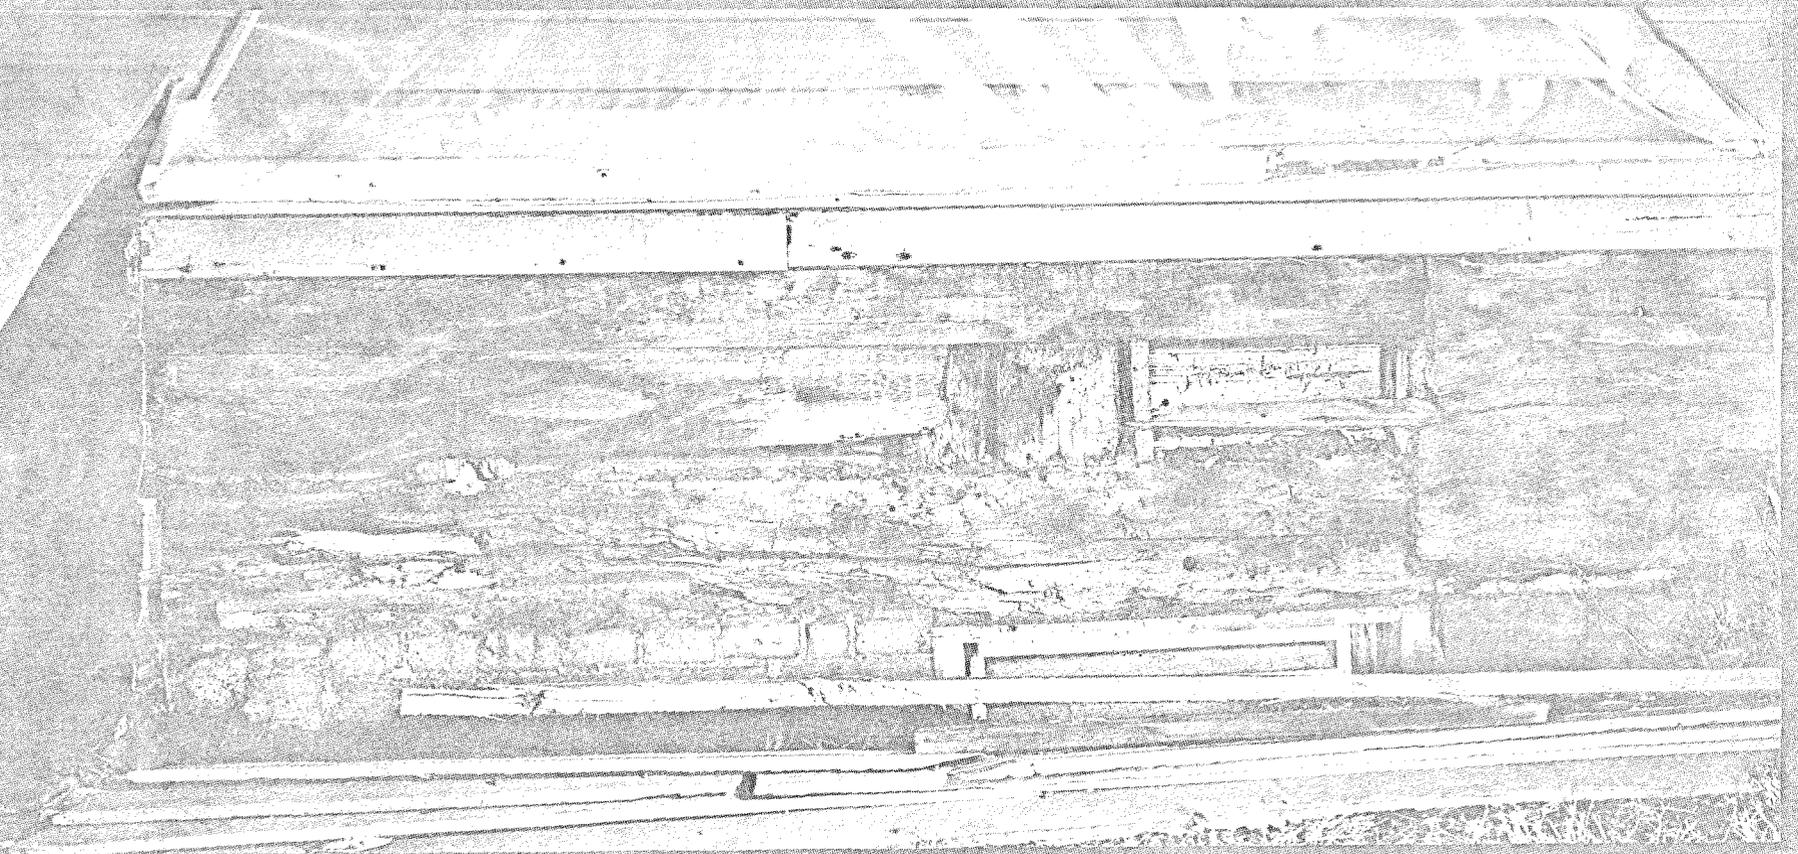
-The sill of the west wall is in reasonably good condition except for a point directly under the southwest post of the original house (at the joint between the original house and the addition to the south, Photograph 2). Here the sill seems to have been the victim of both rot and inept or incomplete repairs. In any event this post is unsupported by the sill. It apparently derives some imperfect and indirect support from a number of adjacent framing members, such as the interior door frames of the house and the nearby post of the addition to the south. In any event it has probably settled and may account in part for the forward lean of the west wall of the house near the door.

2. Narbonne House, Salem, Mass. Detail of west wall at ground level, adjacent to bulkhead with clapboards removed. Partially decayed sill rests on brick surfaced foundation.

The small missing portion of the west sill, directly under the southwest post of the original house, should be filled in with a hollow block of wood inserted in sections so as not to require the cutting away of any old wood, (Drawing No. 4). The loss of any old wood here would lead to the destruction of architectural evidence relating to the enlargement of the house to the south. The post above this point should be jacked up just enough to relieve the undue strain it is now placing on the other framing members and trim which support it.

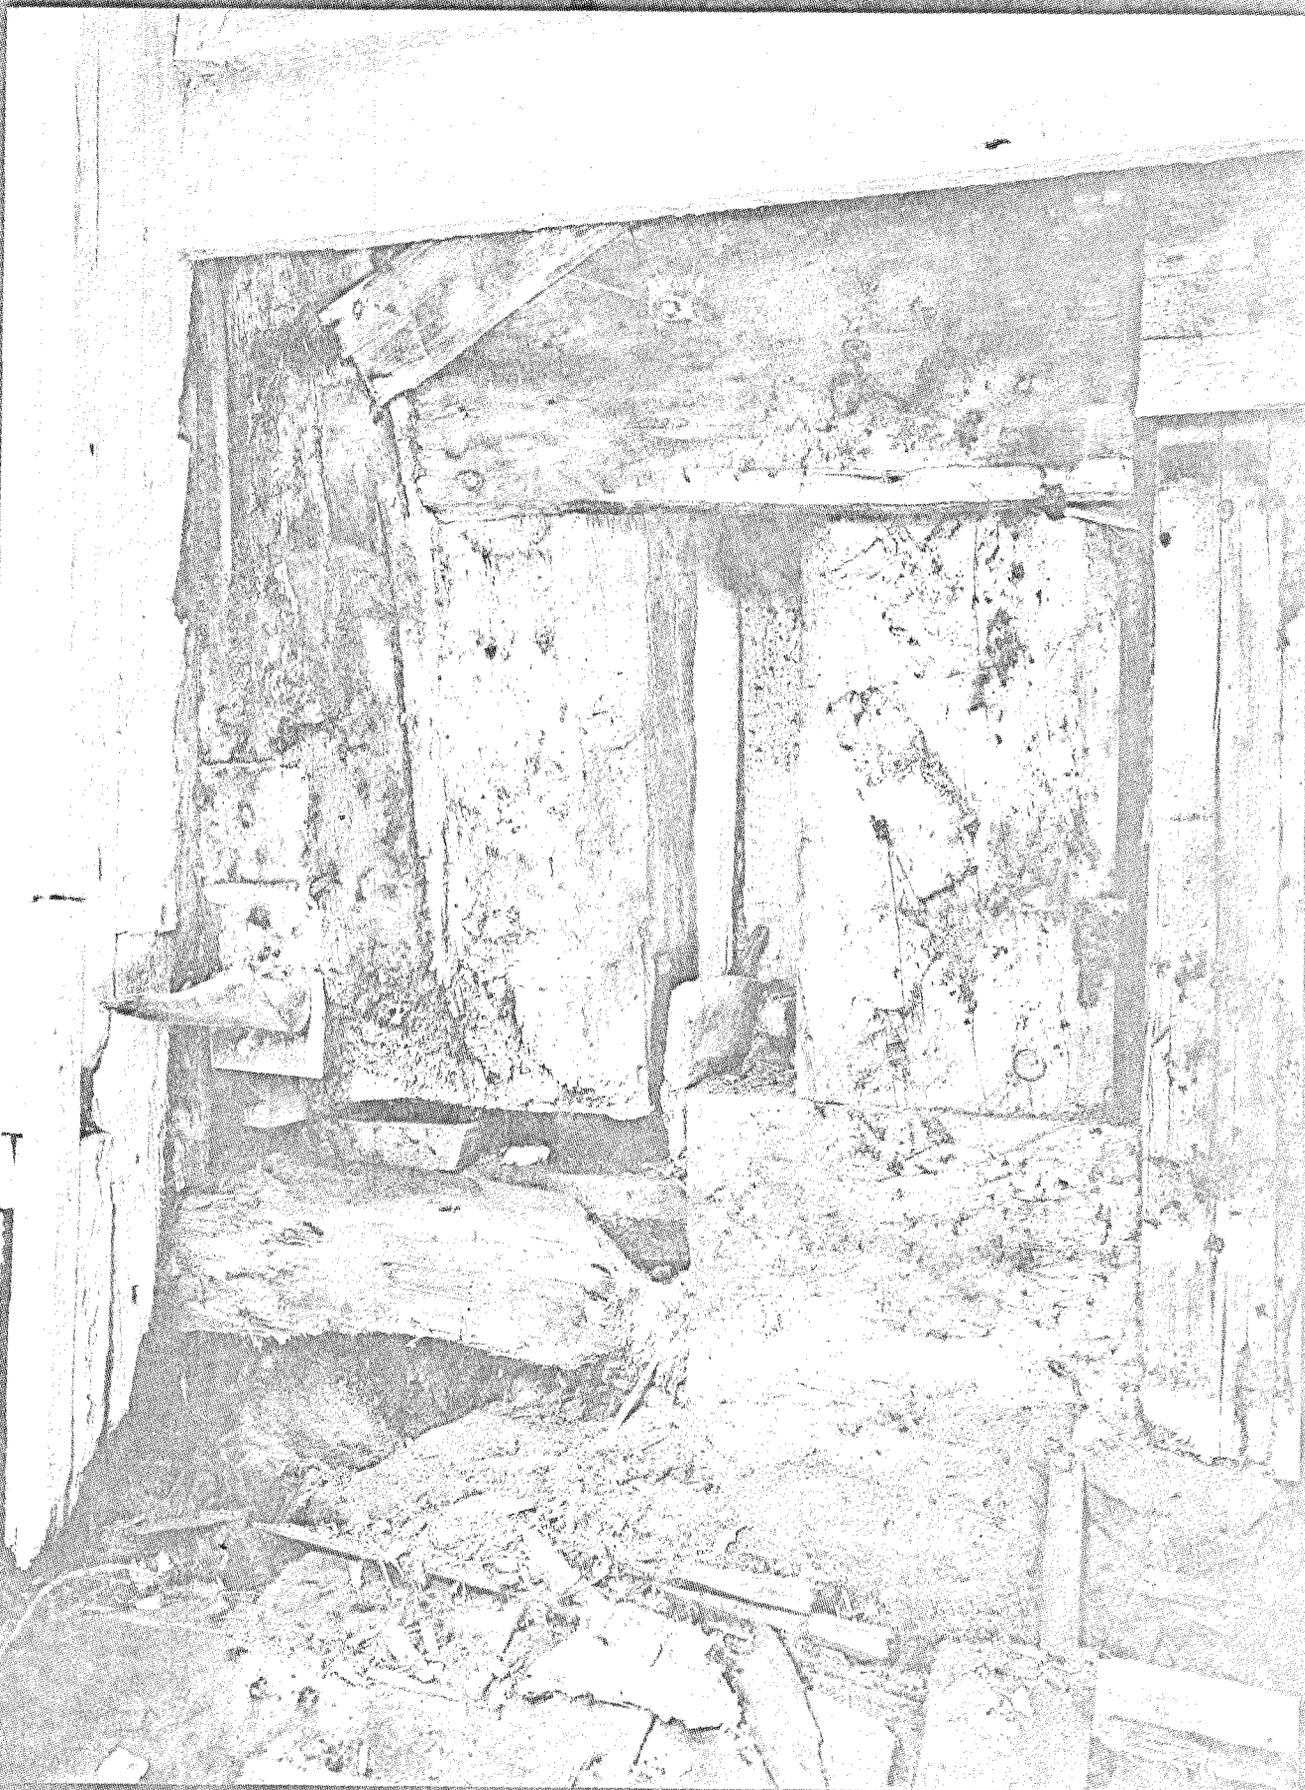
3. Narbonne House, Salem, Mass. Detail of west wall showing unsupported post (left center) of early structure at junction with the later ell.

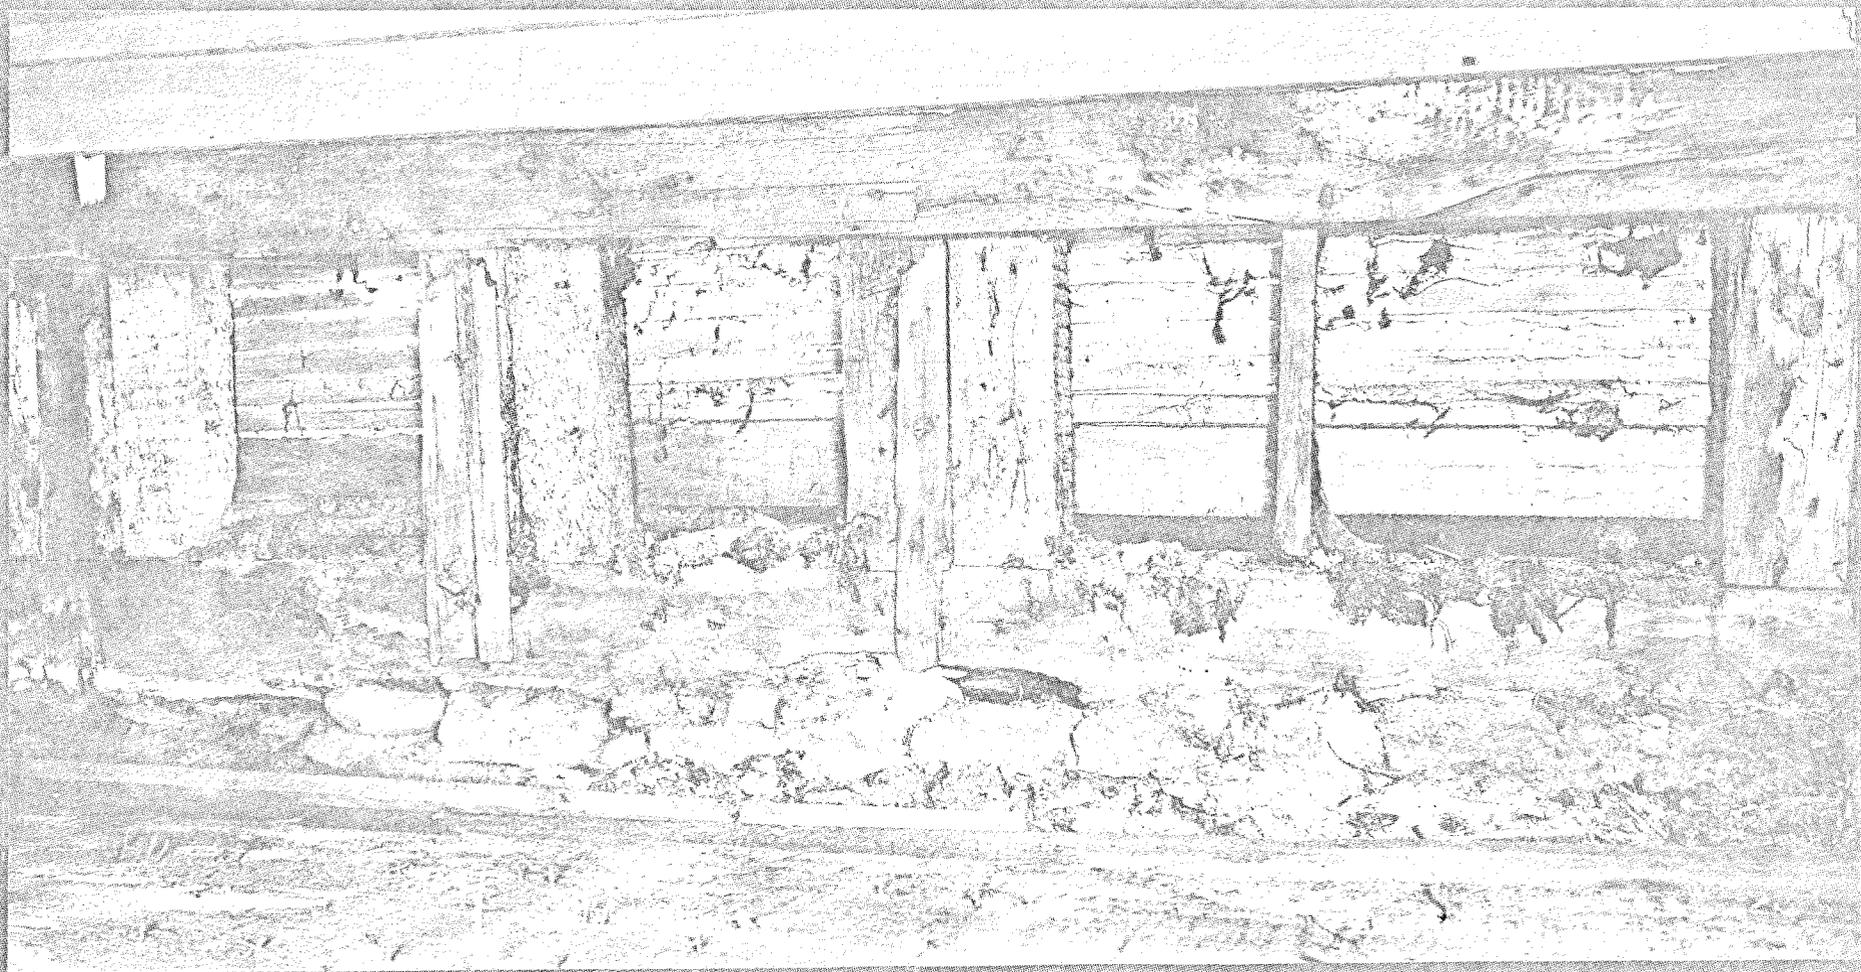
4. Narbonne House, Salem, Mass. Detail of west wall showing decay in sill of later ell.

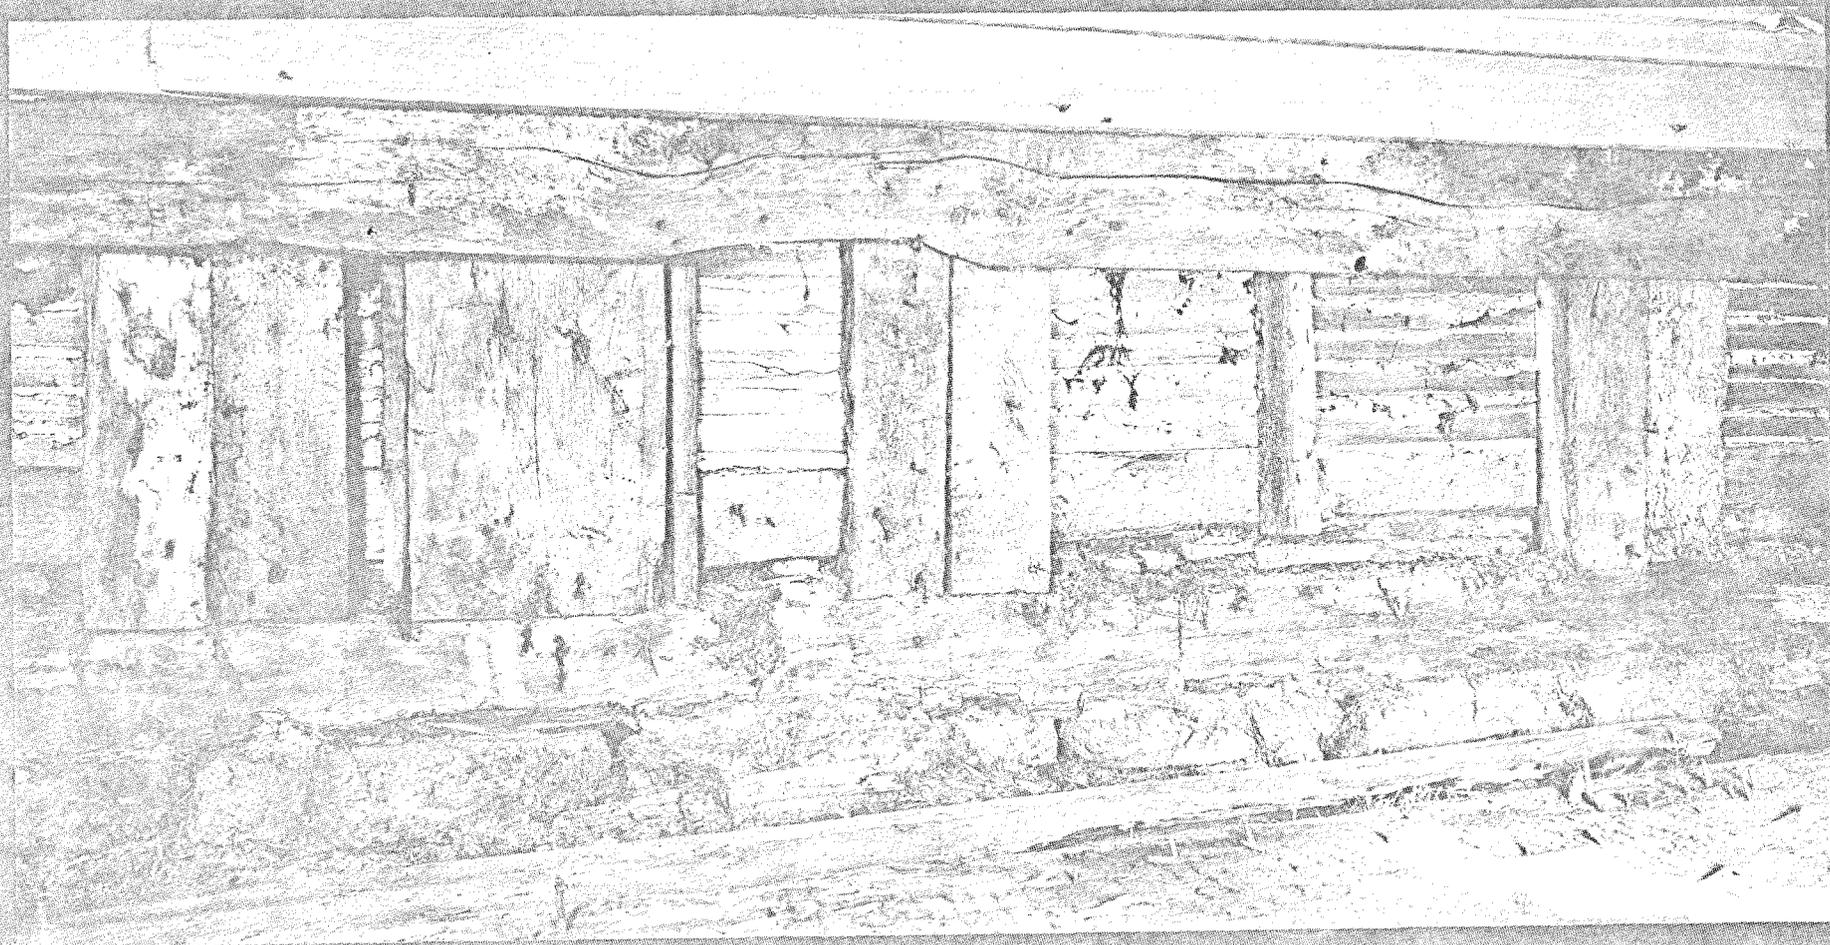
5. Narbonne House, Salem, Mass. Detail of west wall showing decay in sill of later ell.

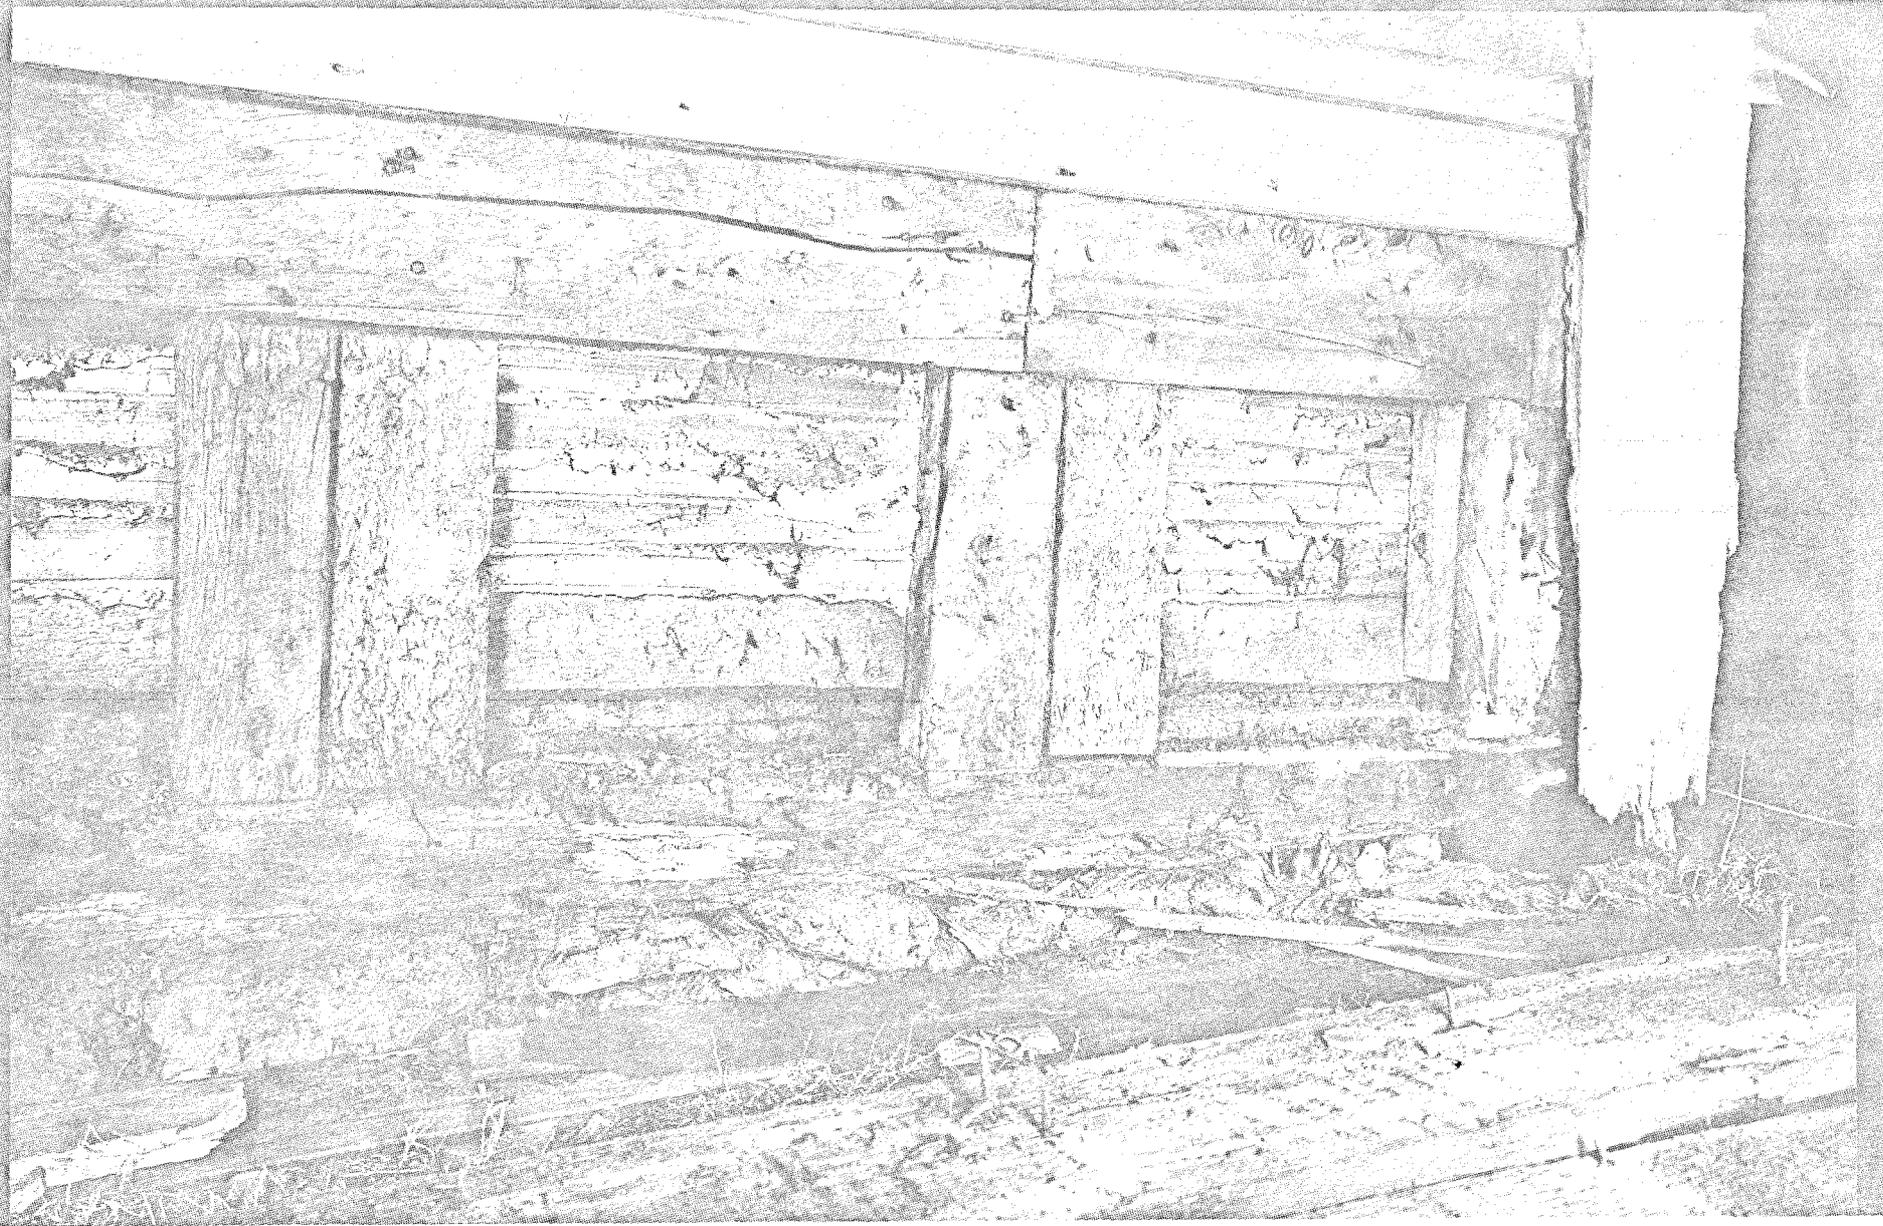
6. Narbonne House, Salem, Mass. Detail of west wall at southwest corner. Sill rests directly on a very low course of small stones which in turn rest on the soil. The end of the sill of the south wall is visible at the far right, resting on the ground.

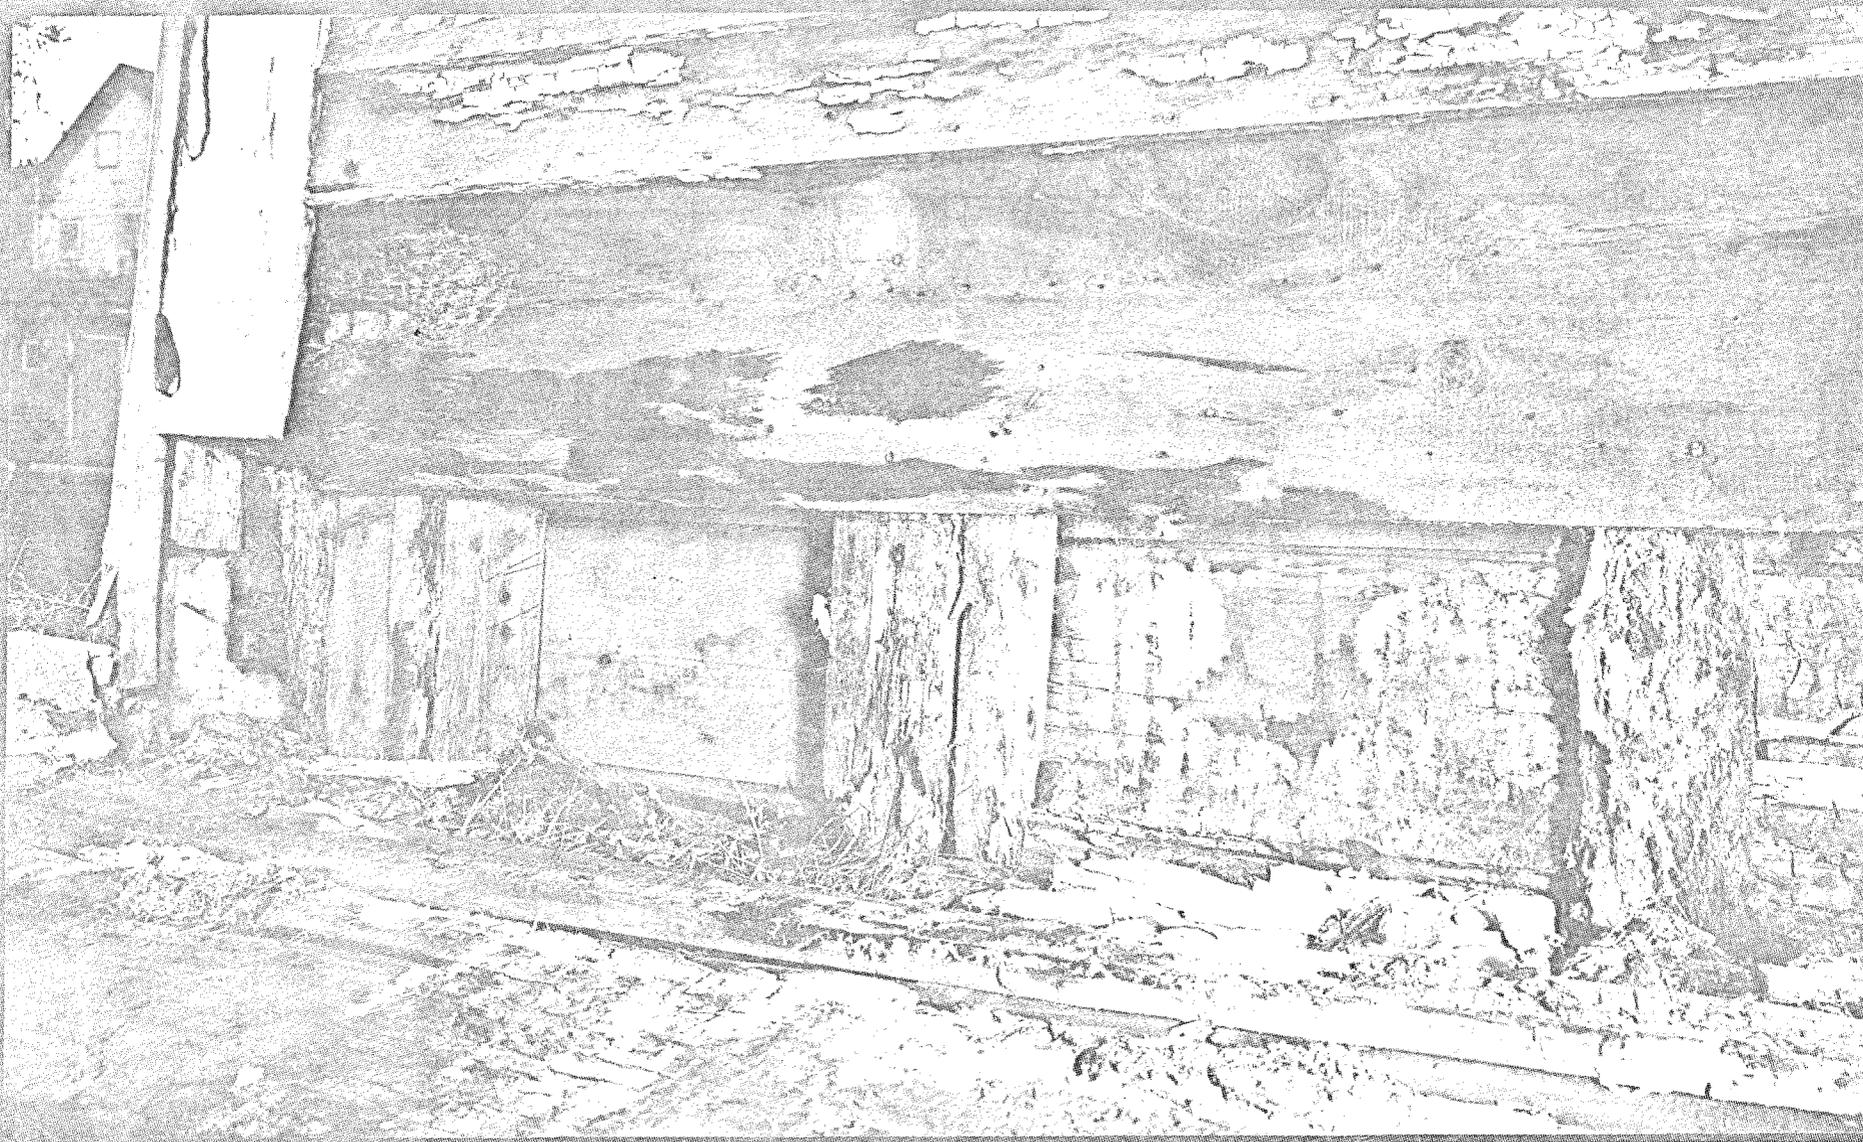
-Above this length of rotted sill, the south post, the studs, and the exterior sheathing boards are so badly rotted as to have lost almost all structural strength for the first 18" above the sill. The interior boarding here is also damaged by a white rot fungus, (Photographs 7, 8).

7. Narbonne House, Salem, Mass. Detail of east wall with clapboards removed at southeast corner. Posts and studs extend below grade and sill has completely deteriorated. Representative of area along three walls recommended for archeological excavation where earth must be disturbed for work on structure and lowering of grade.

a. Sills. Some parts of the sills, especially along the east wall, will require complete replacement. Other portions, being only partly rotted, should be pieced-in with new wood, preserving, for historical reasons, as much of the old as possible. Where the outer face of a sill is rotted and the inner face solid, a cut should be made parallel to the grain of the wood so as to remove badly rotted wood along more or less rectangular lines, facilitating the insertion of new wood.

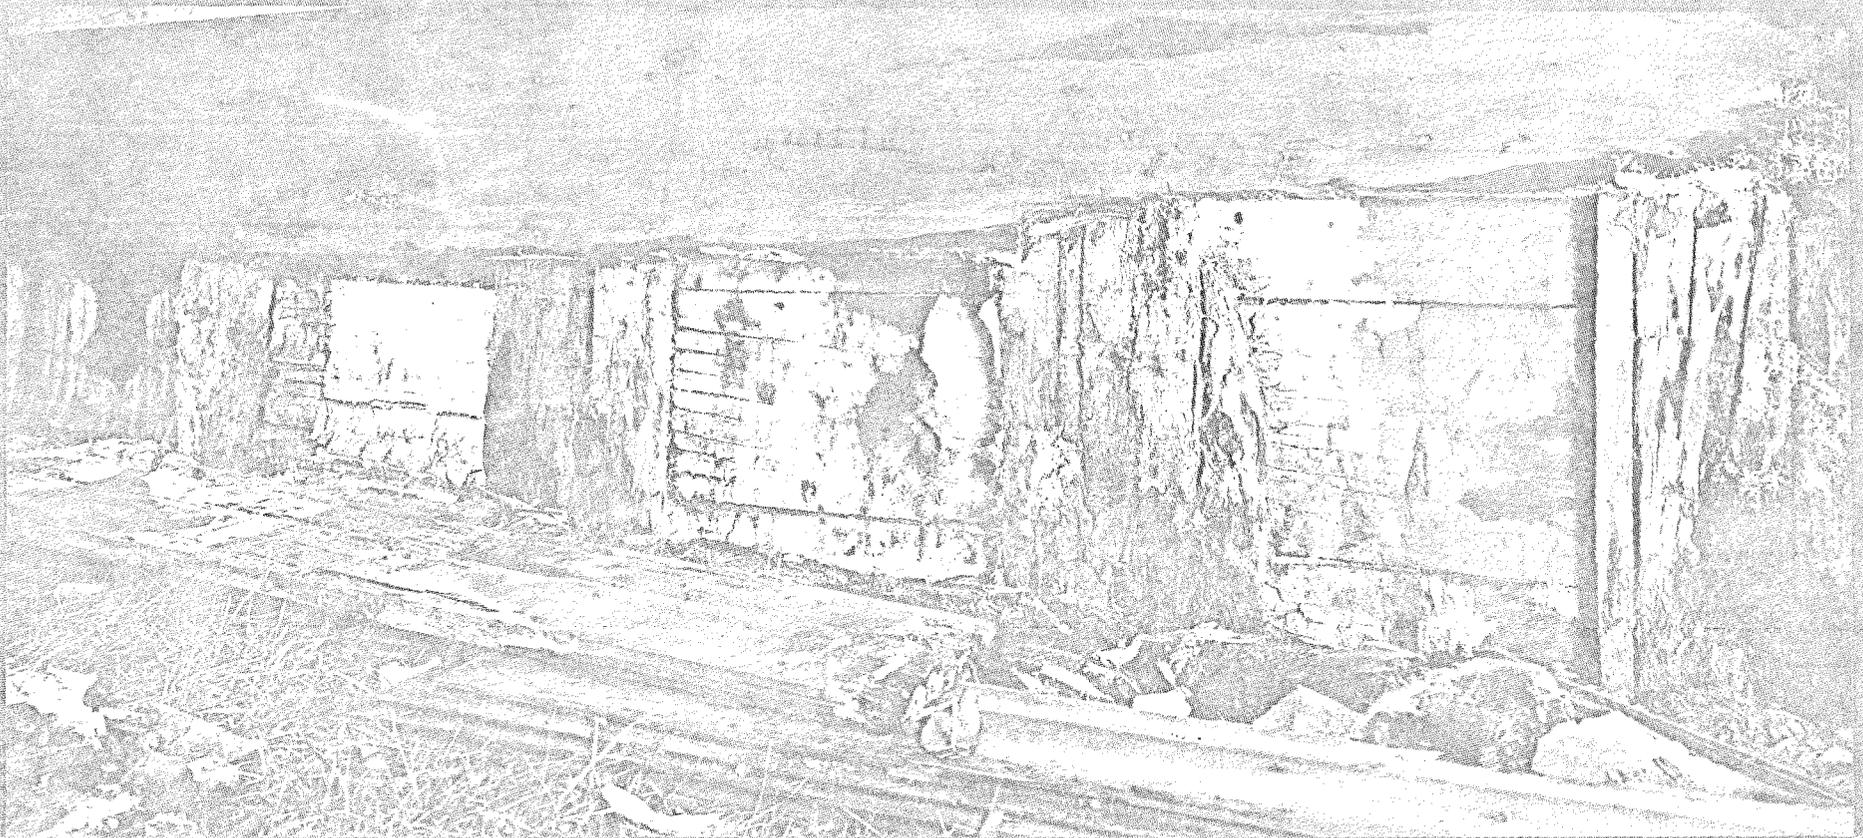
8. Narbonne House, Salem, Mass. Detail of east wall. Note the extensive deterioration due to dry rot at the lower ends of the framing members.

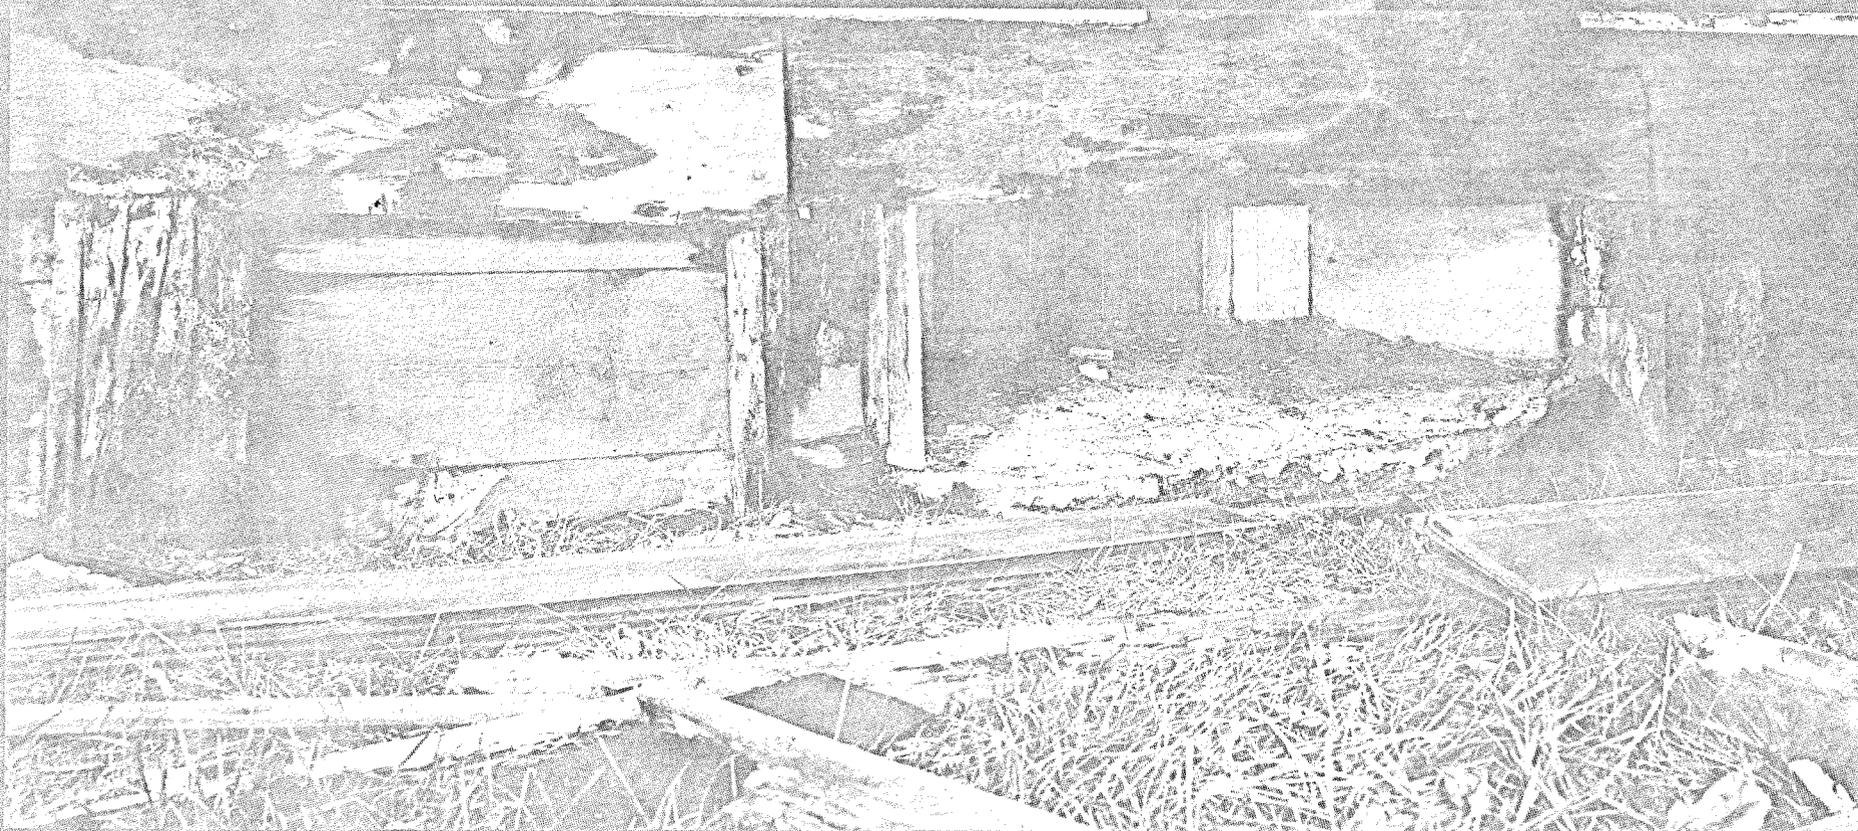
9. Narbonne House, Salem, Mass. Detail showing conditions along east wall.

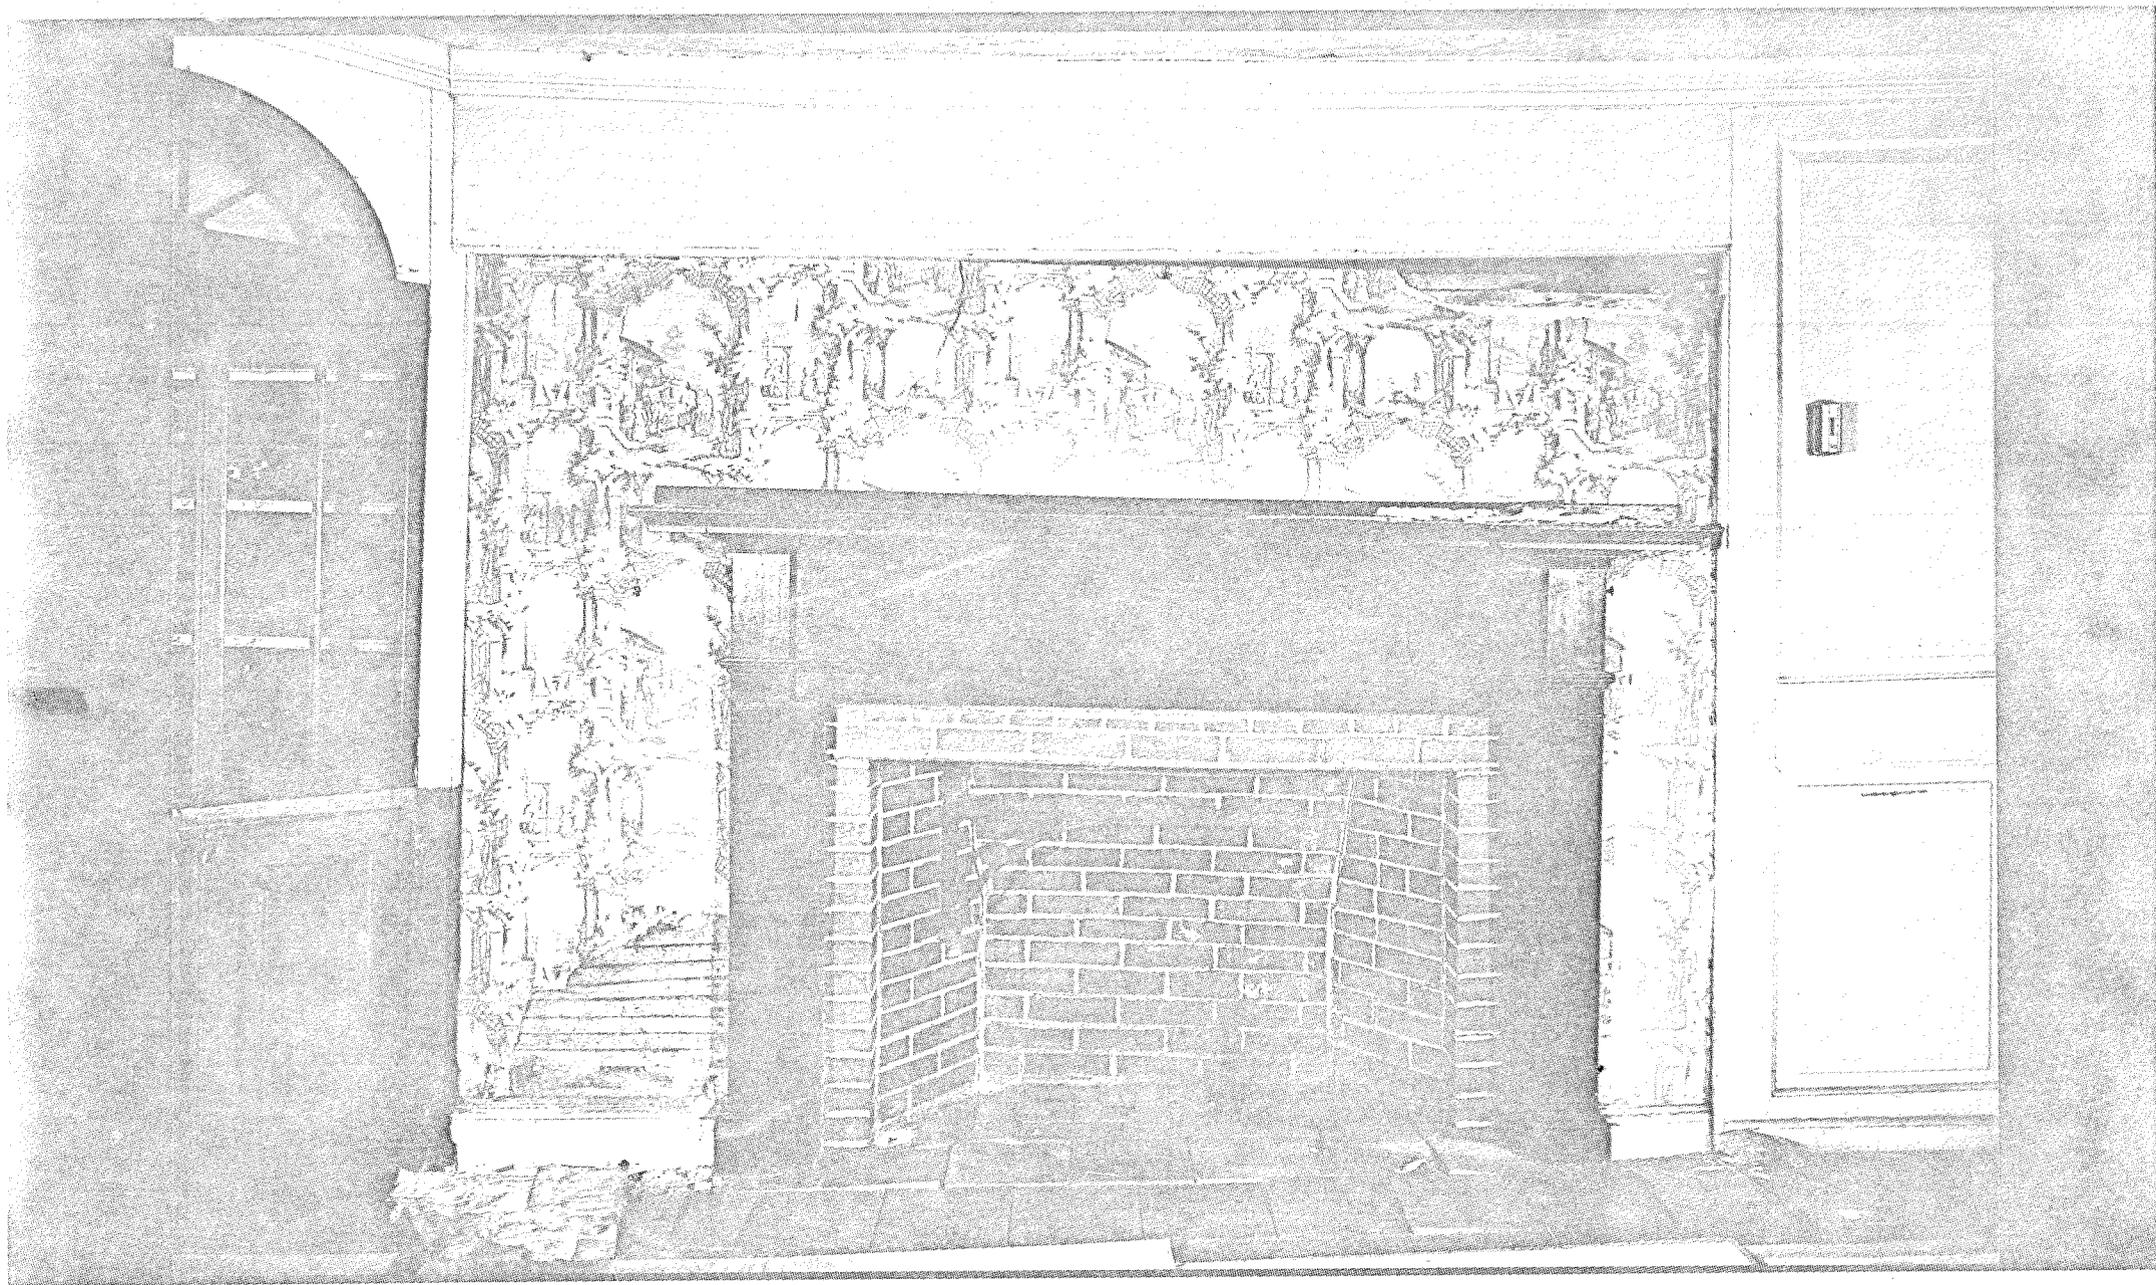
14. Narbonne House, Salem, Mass. Fireplace in north room, first floor before removal of mantel, lath and plaster. Settlement of northwest corner of chimney has caused fireplace to sink several inches (lower right).

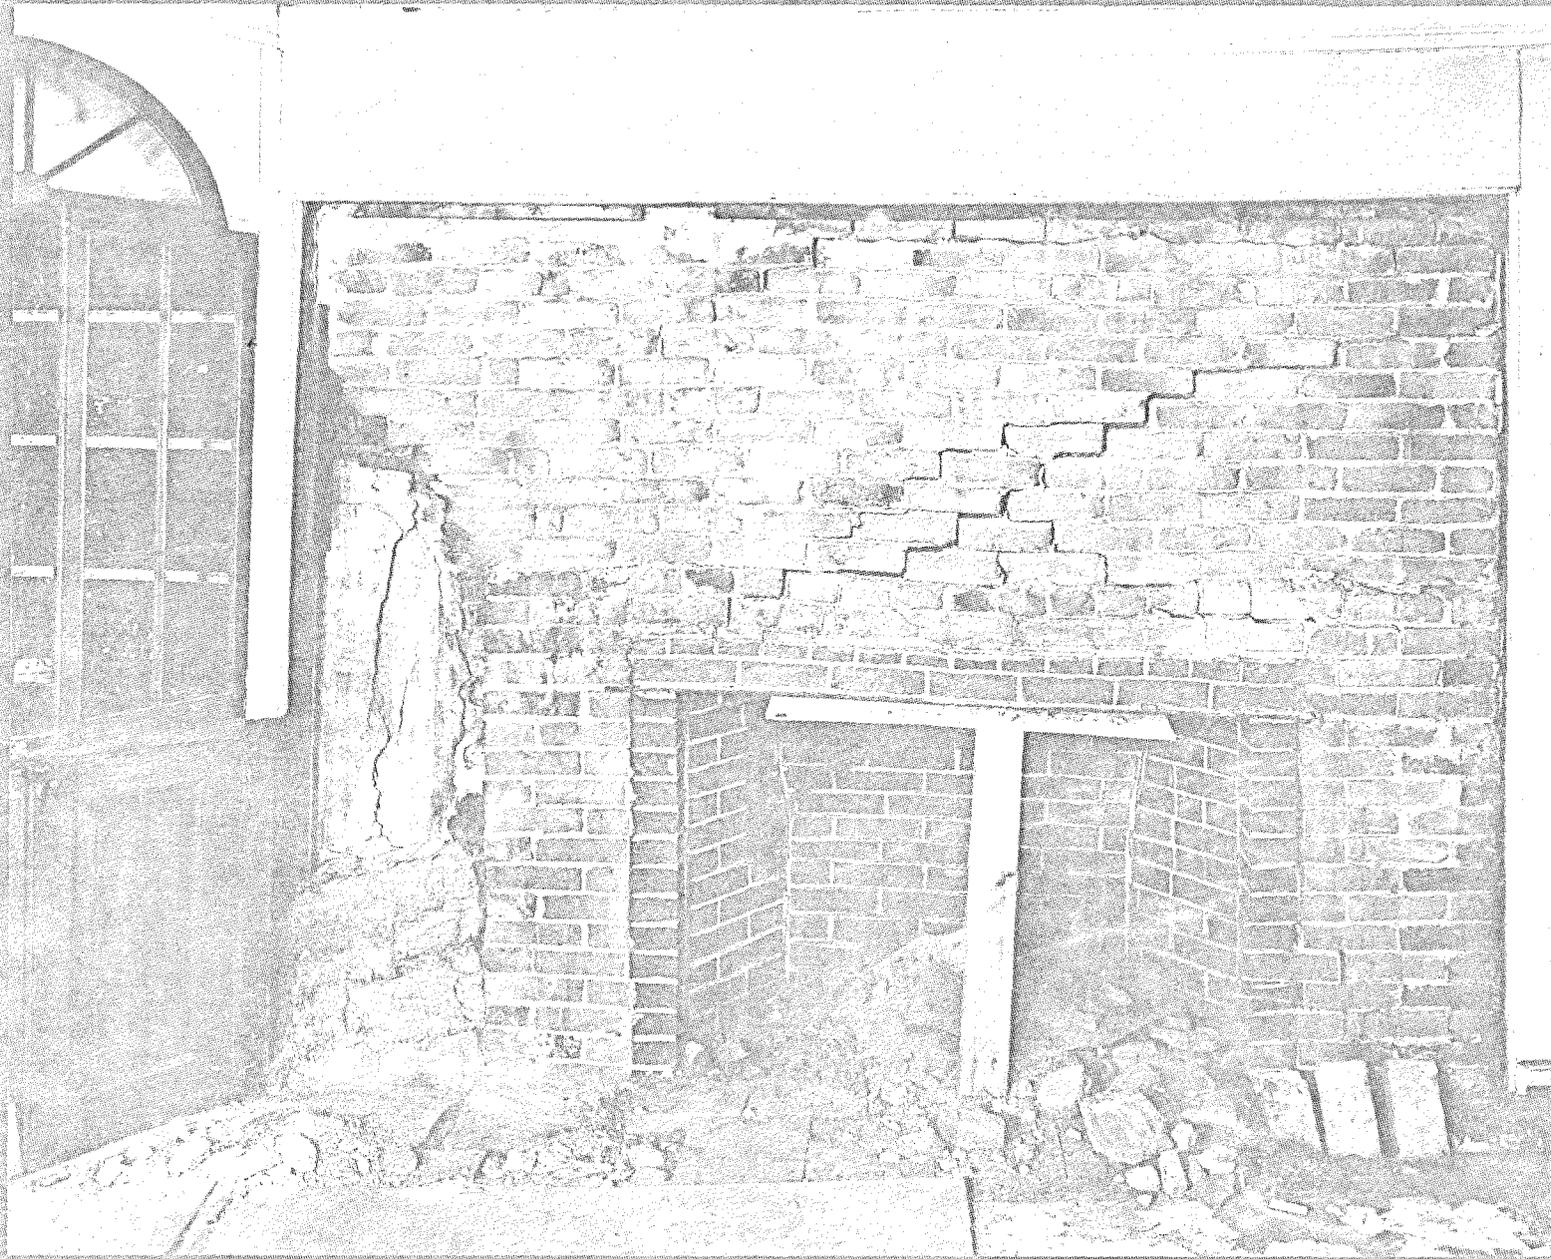
15. Narbonne House, Salem, Mass. Fireplace in north room, first floor after removal of mantel, lath and plaster showing condition of the brickwork.

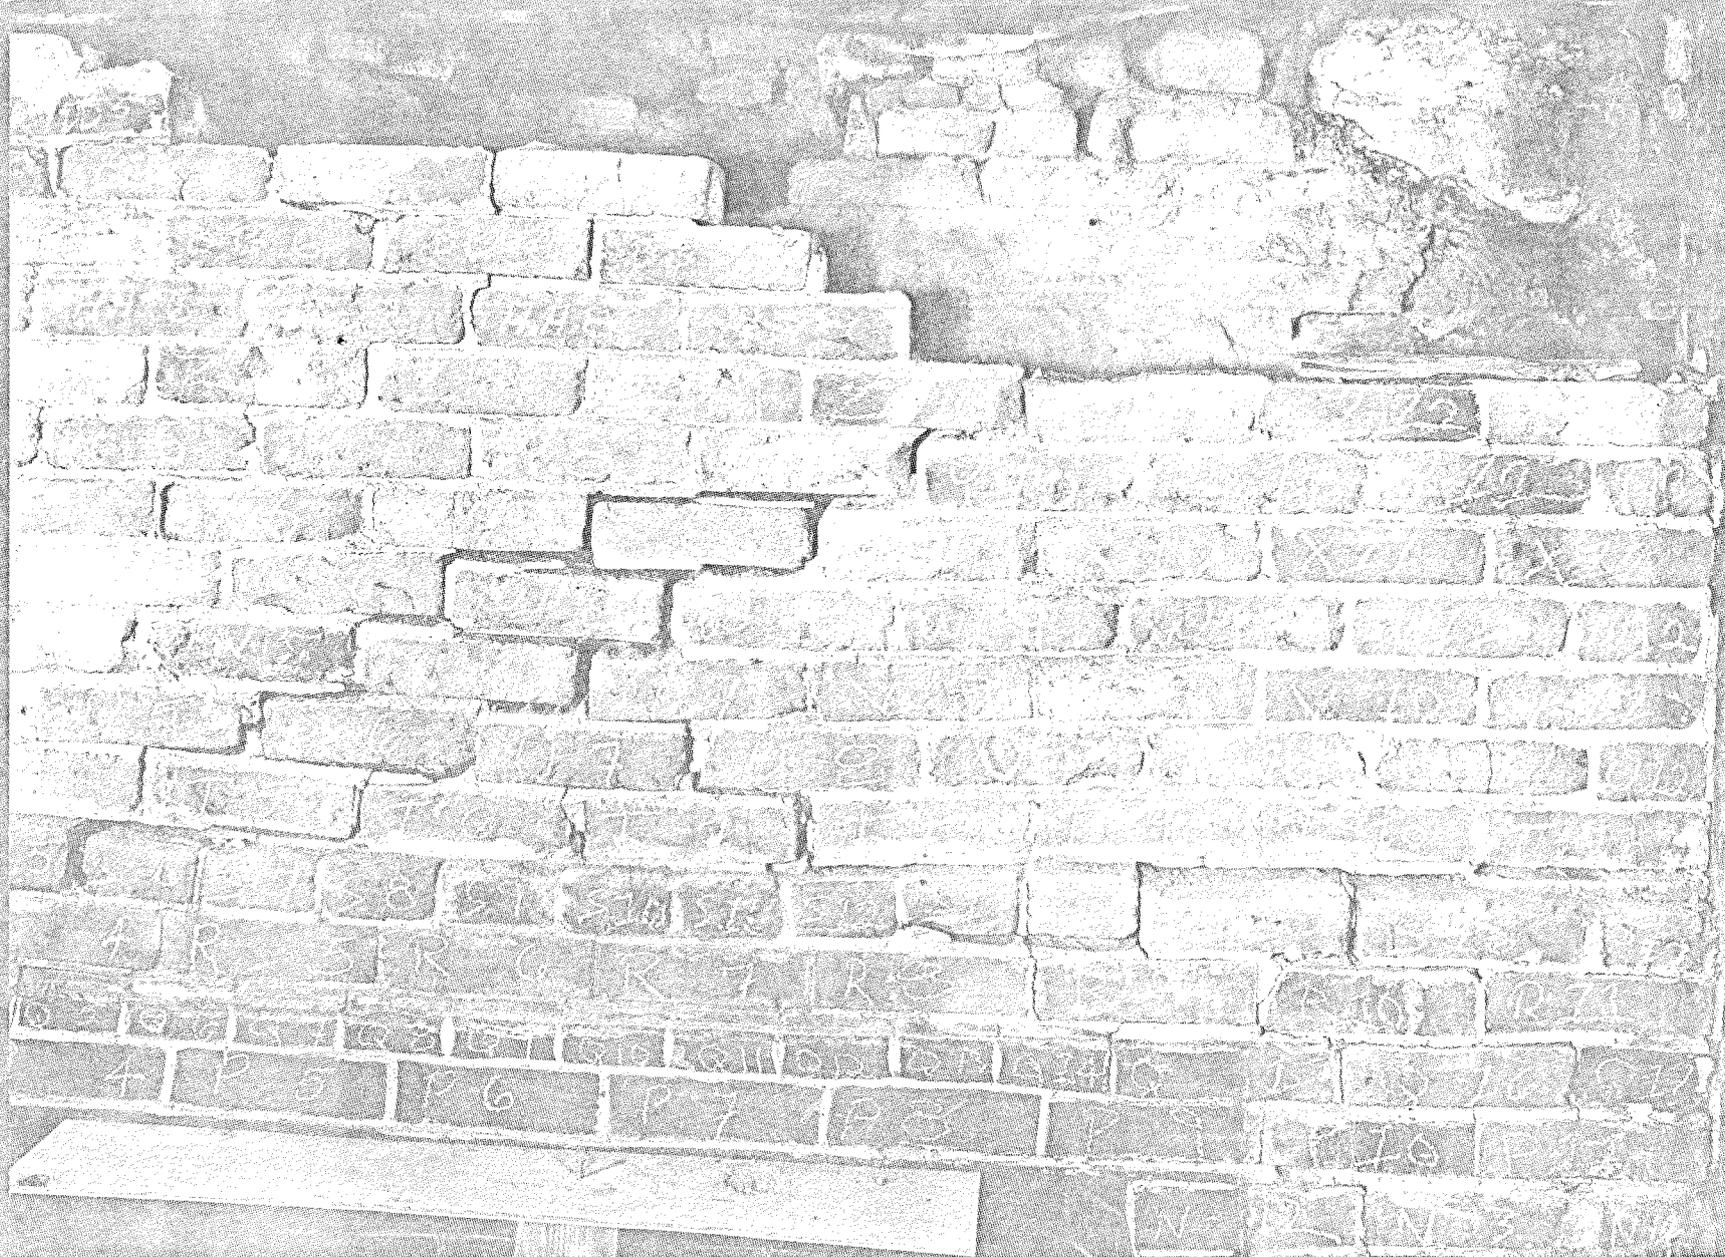
19. Narbonne House, Salem, Mass. Detail of fireplace in north room. Record photograph of numbered bricks above lintel before their removal. Cracks are the result of continuing settlement at the northwest corner of the chimney.
