HISTORIC STRUCTURES REPORT
ARCHITECTURAL DATA SECTION
ON
NARBONNE HOUSE
SALEM, MASSACHUSETTS

Prepared by
The Society for the Preservation of New England Antiquities
141 Cambridge Street
Boston, Massachusetts 02114

December 1972
for

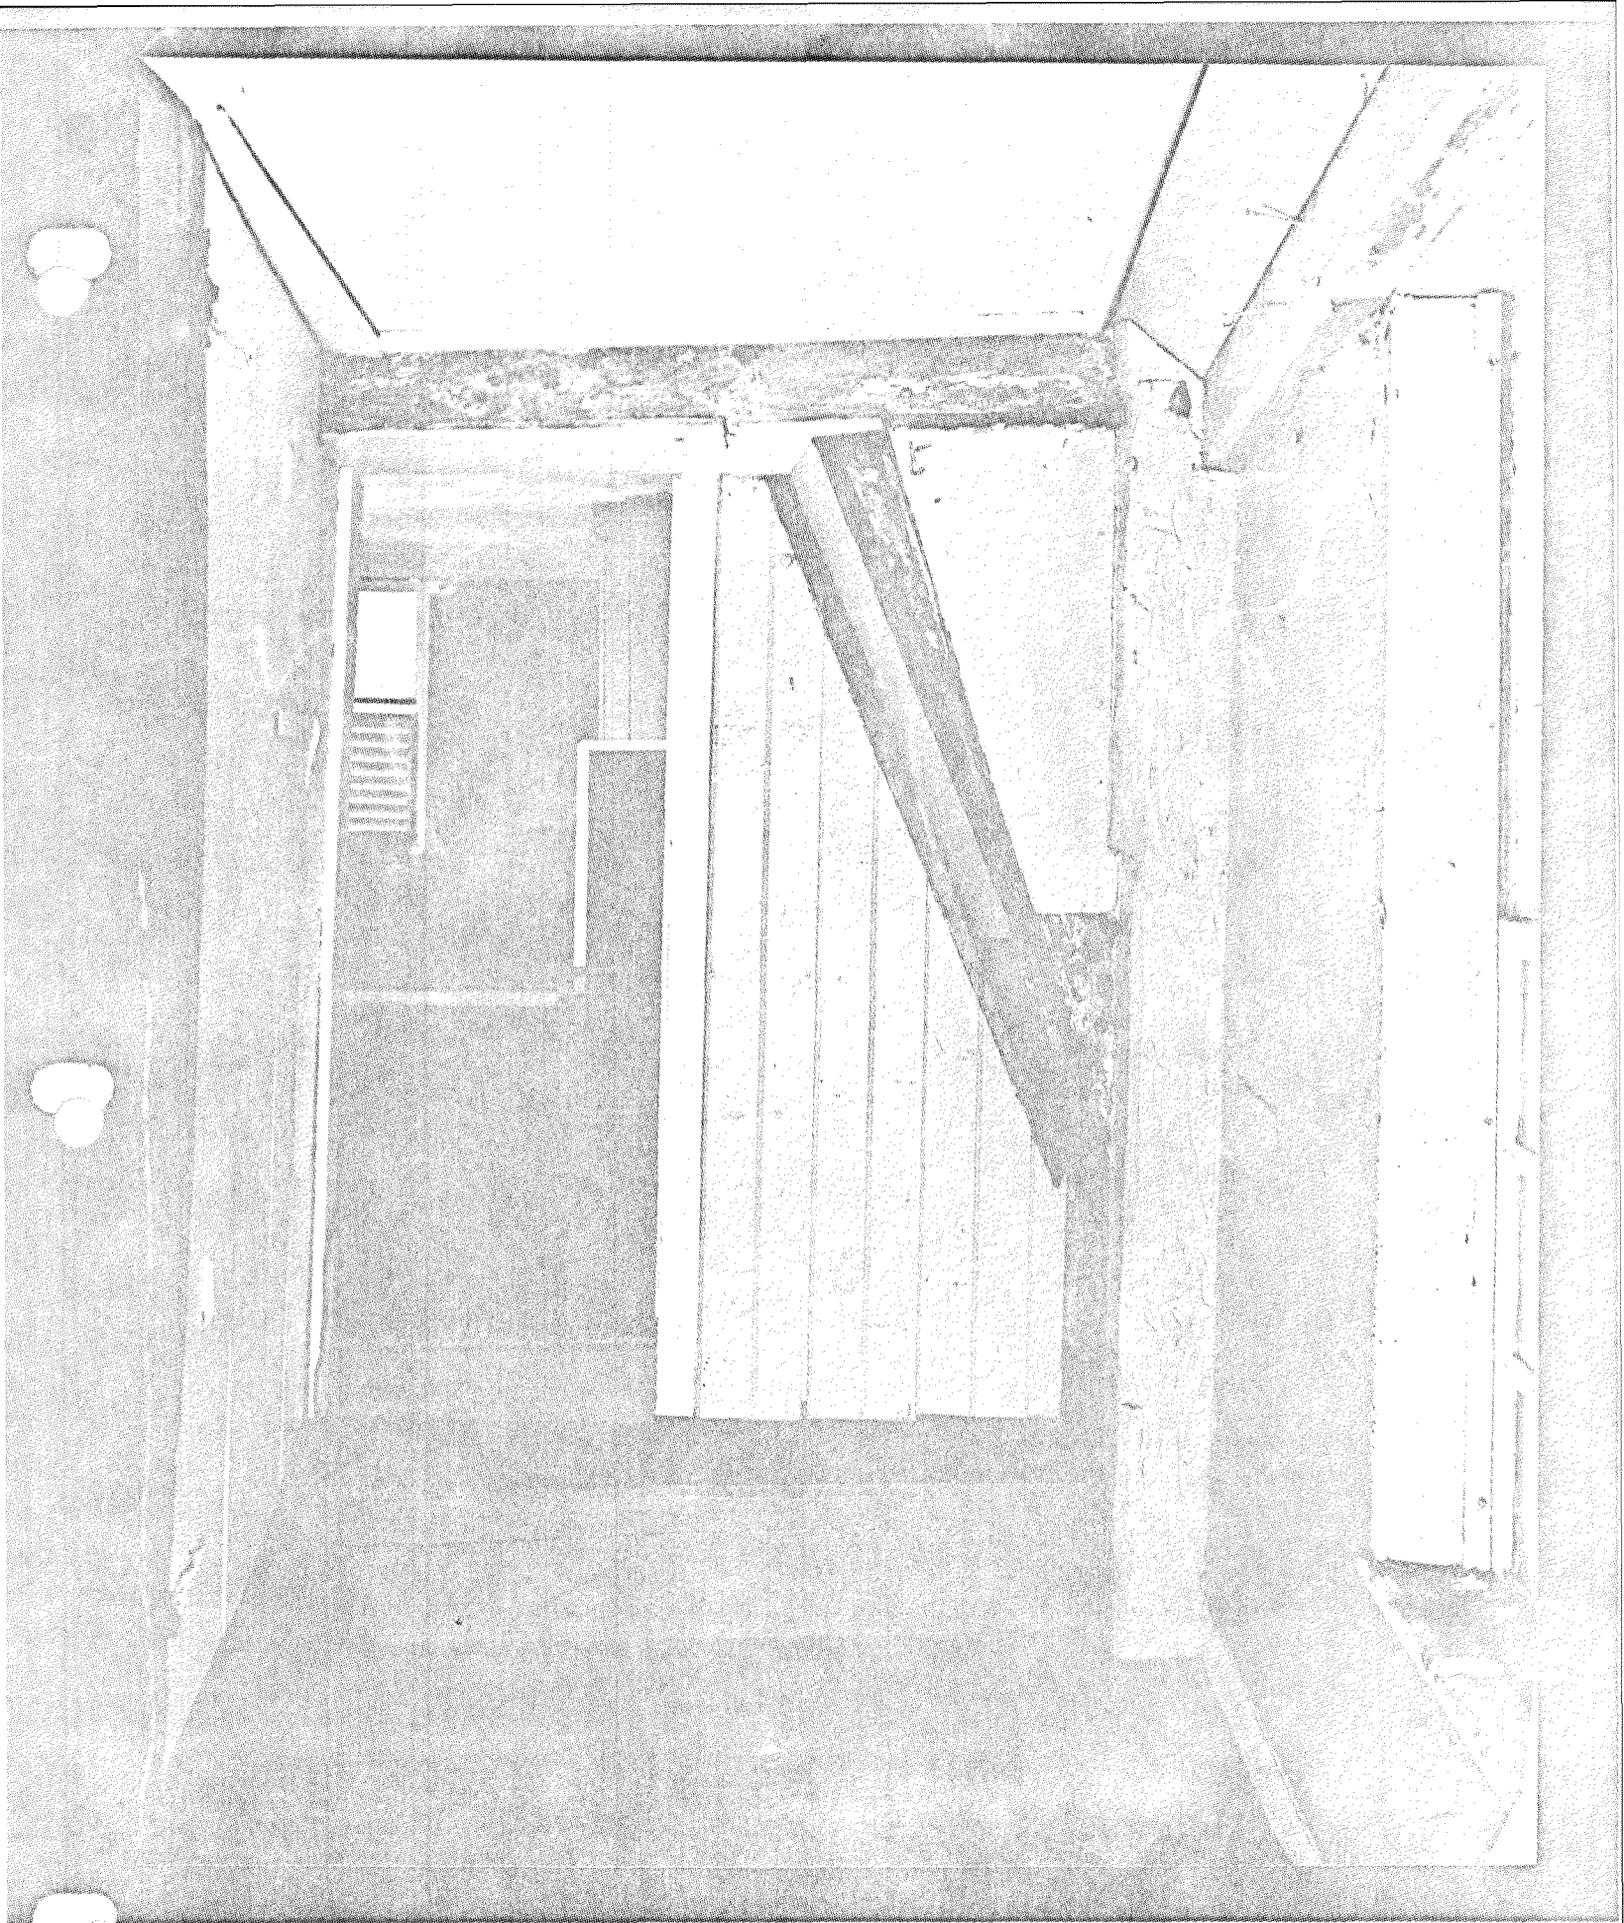
27. Narbonne House, Salem, Mass. Second floor hall showing juncture of original structure with later gambrel ell beyond. Deteriorating roofing members of ell are exposed.
