HISTORIC STRUCTURES REPORT
PART II
ARCHITECTURAL DATA SECTION
ON
THE RUM SHOP
Salem Maritime National Historic Site

Prepared by
Norman M. Souder
Architect
October 1964

United States Department of the Interior, National Park Service
Eastern Office, Design and Construction
Division of Architecture

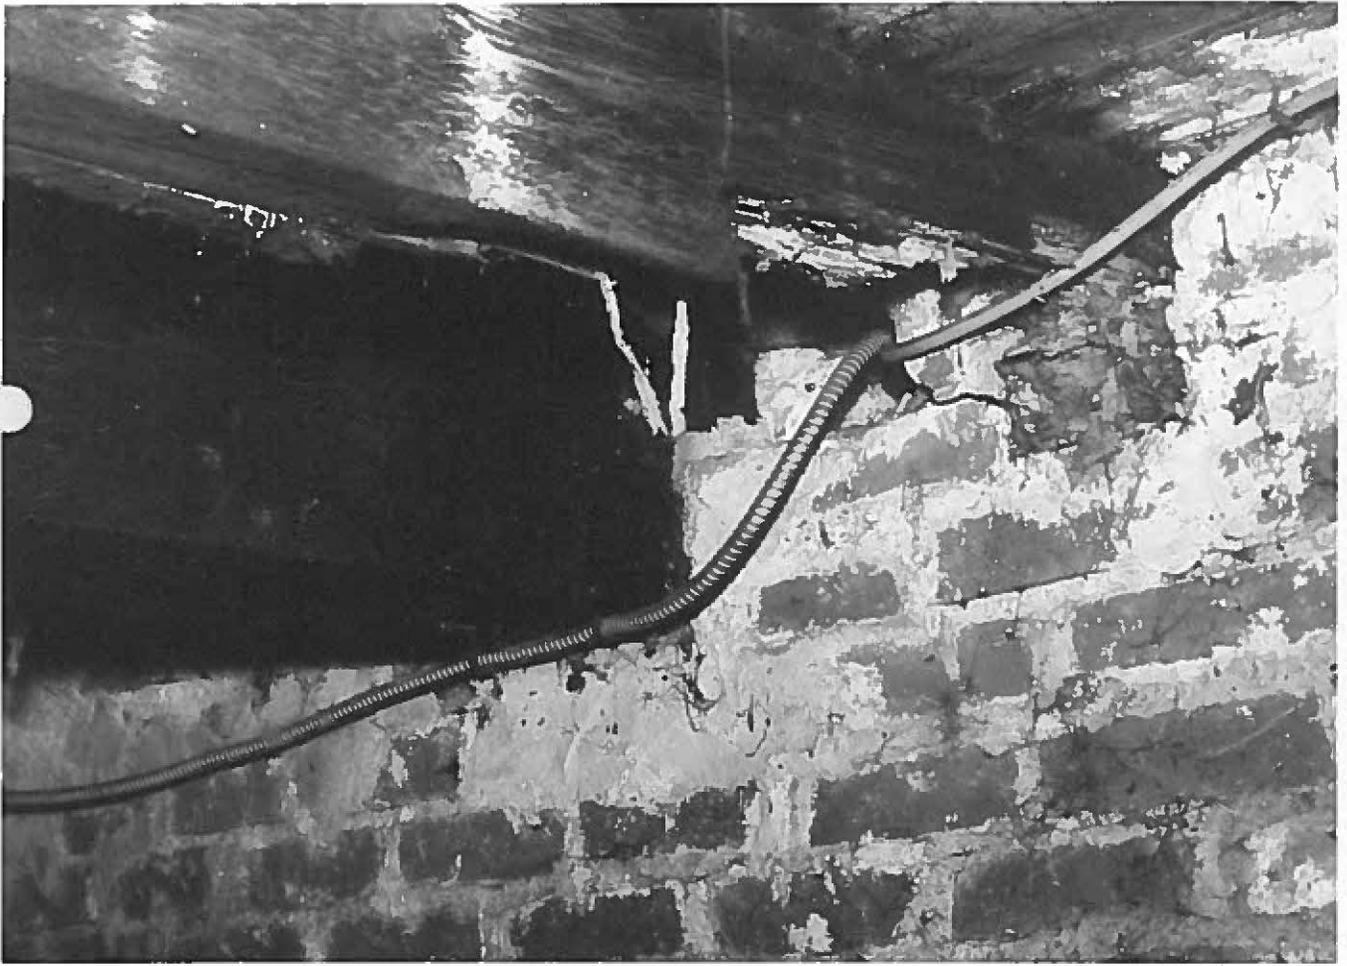
ILLUSTRATION NO. 1

An earth floored crawl space extends the length of the building. Due to lack of proper ventilation the joists at the bearing points show extensive dry rot and powder post beetle damage. It is recommended that the earth floor be covered with a vapor barrier and two inches of concrete.

Photograph showing the condition of one of the floor joists along the east wall in the crawl space. The bearing end of the old joist is infested with powder beetles. The dark joist adjoining the old one is a recent addition.

1. Repair and replacement of damaged first floor joists, including installation of longitudinal beams to support the joist ends and prevent further sag of the floor at the mid-point. All wood in crawl space to be treated with pentachlorophenol.
2. Installation of air vents in the foundation walls to reduce decay of structural members.
3. The removal of debris in crawl space and the installation of a 2" concrete floor slab over a vapor barrier.
4. Replacement of exterior woodwork as follows:
Replacement of vertical corner boards; replacement of the south cornice; replacement of clapboards on west, north and east sides as required.
5. Installation of a heating system by extending underground supply from the central heating system to the Rum Shop.

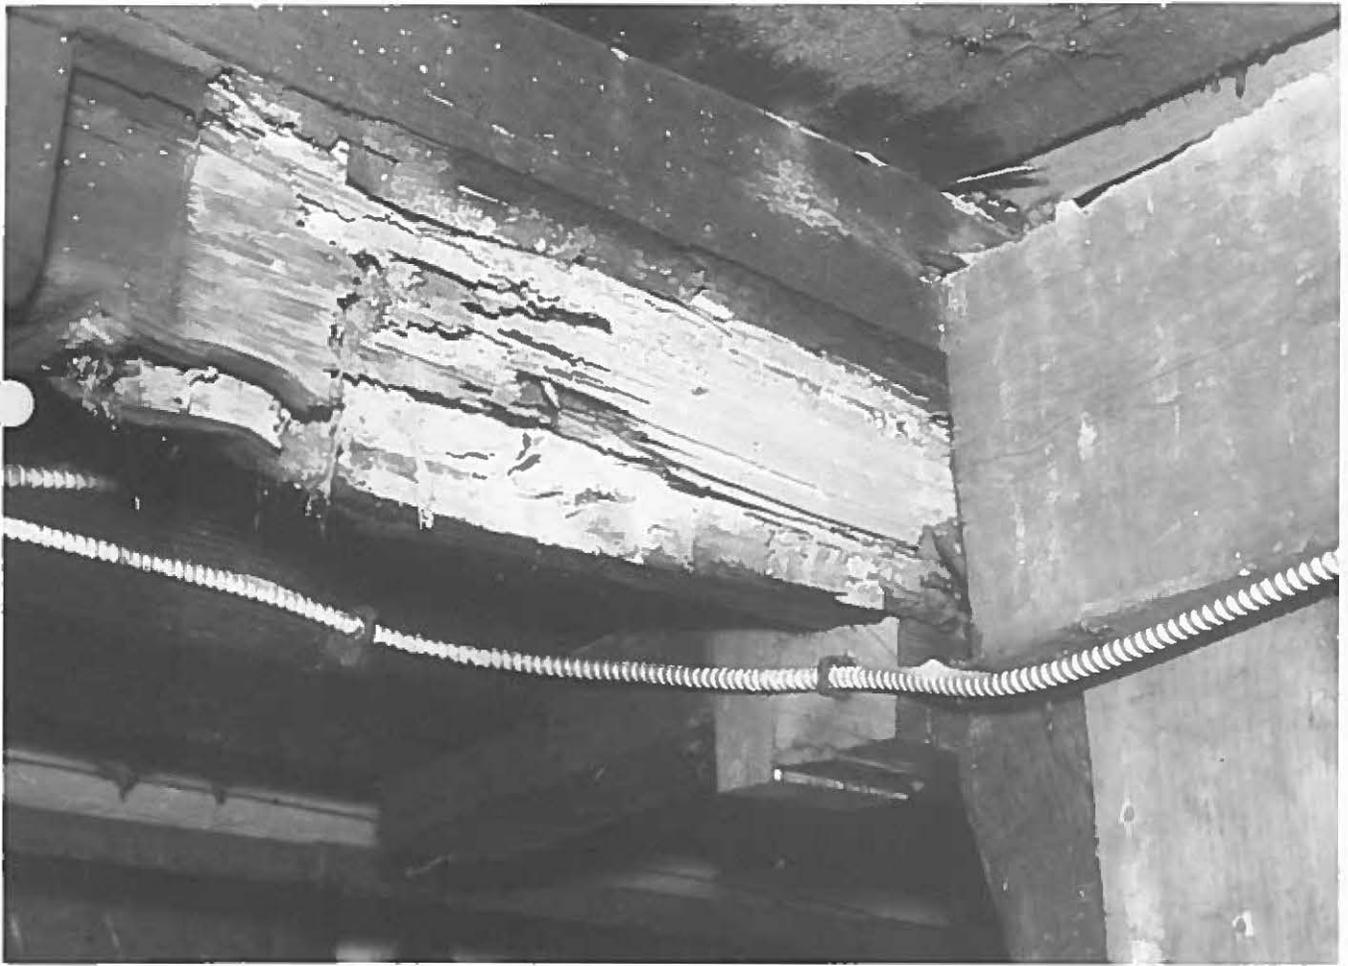
ILLUSTRATION NO. 2

The deteriorated condition of the joist and the crude patching of the floor support adjacent to the trap door framing near the rear of the building. The header framing the hatchway is at the right. Extensive repair and replacement of the floor framing is required.

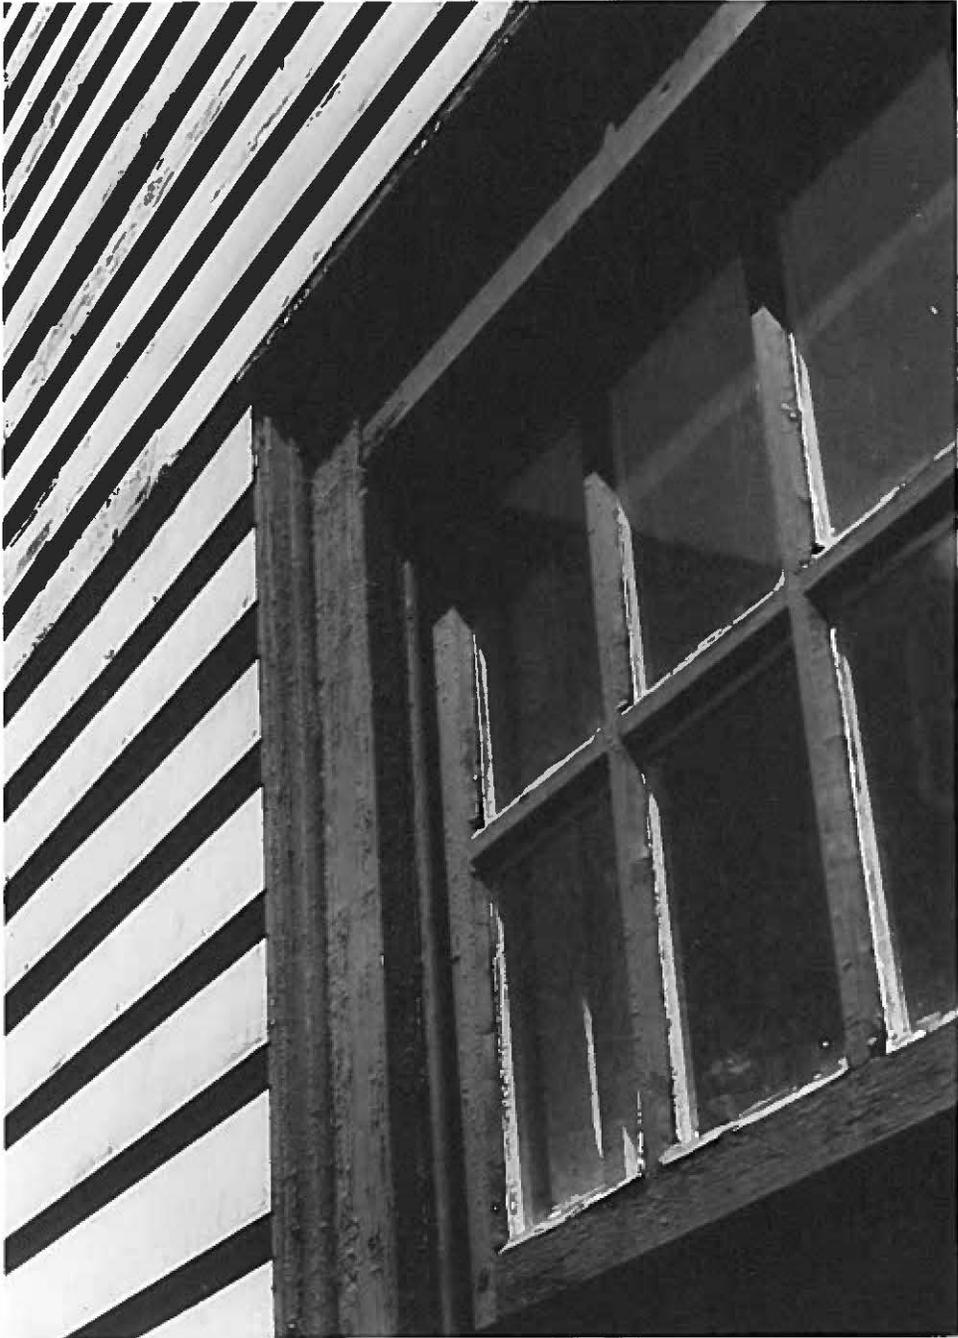
ILLUSTRATION NO. 4

A detail photograph of the west wall of the Rum Shop. The photograph shows the condition of the peeling clapboard siding and the window frame. The window frame is one of the few remaining original features of the building. Most of the existing frames are replacements.
